**Heyford Park  
Dorchester Living: Phase 9  
(Planning Consent 16/02446/F)**

**POL PIPELINE SUPPLEMENTARY SITE  
INVESTIGATION**

**For: Urban Regen Ltd. & Dorchester Living**

**R1742b-R21-v1**

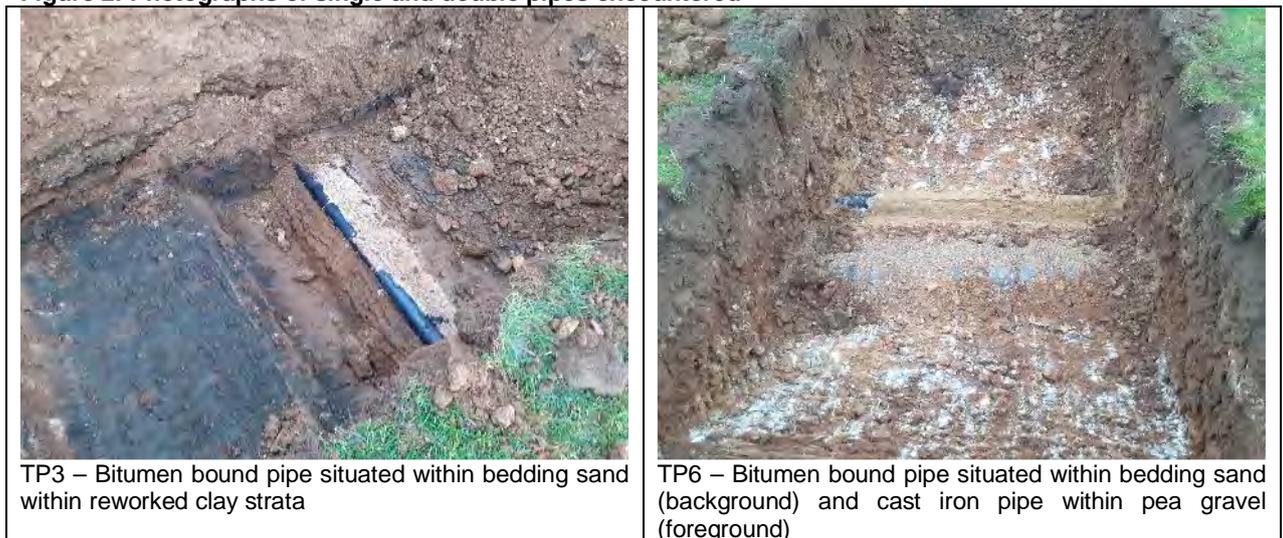
**Figure 2: Photographs of single and double pipes encountered**

- 4.1.11. Entries where two pipelines were observed were limited to TP1 (1.5m bgl), TP5 (1.1m bgl), TP6 (1.4m bgl).
- 4.1.12. Pipes were surrounded by either a bedding sand and/or pea gravel and it was observed within TP5 (1.1m bgl) and TP10 (1.5m bgl) that a plastic marker tape was present above the pipeline. Given the presence of marker tape in only limited locations, this may suggest its more recent placement, possibly during repair work.

- 4.1.13. The pipes, where encountered appeared to be in a good condition with no cracks or breakages. A photographic record showing the pipeline within each entry is provided in Appendix A with the corresponding trial-pit logs.

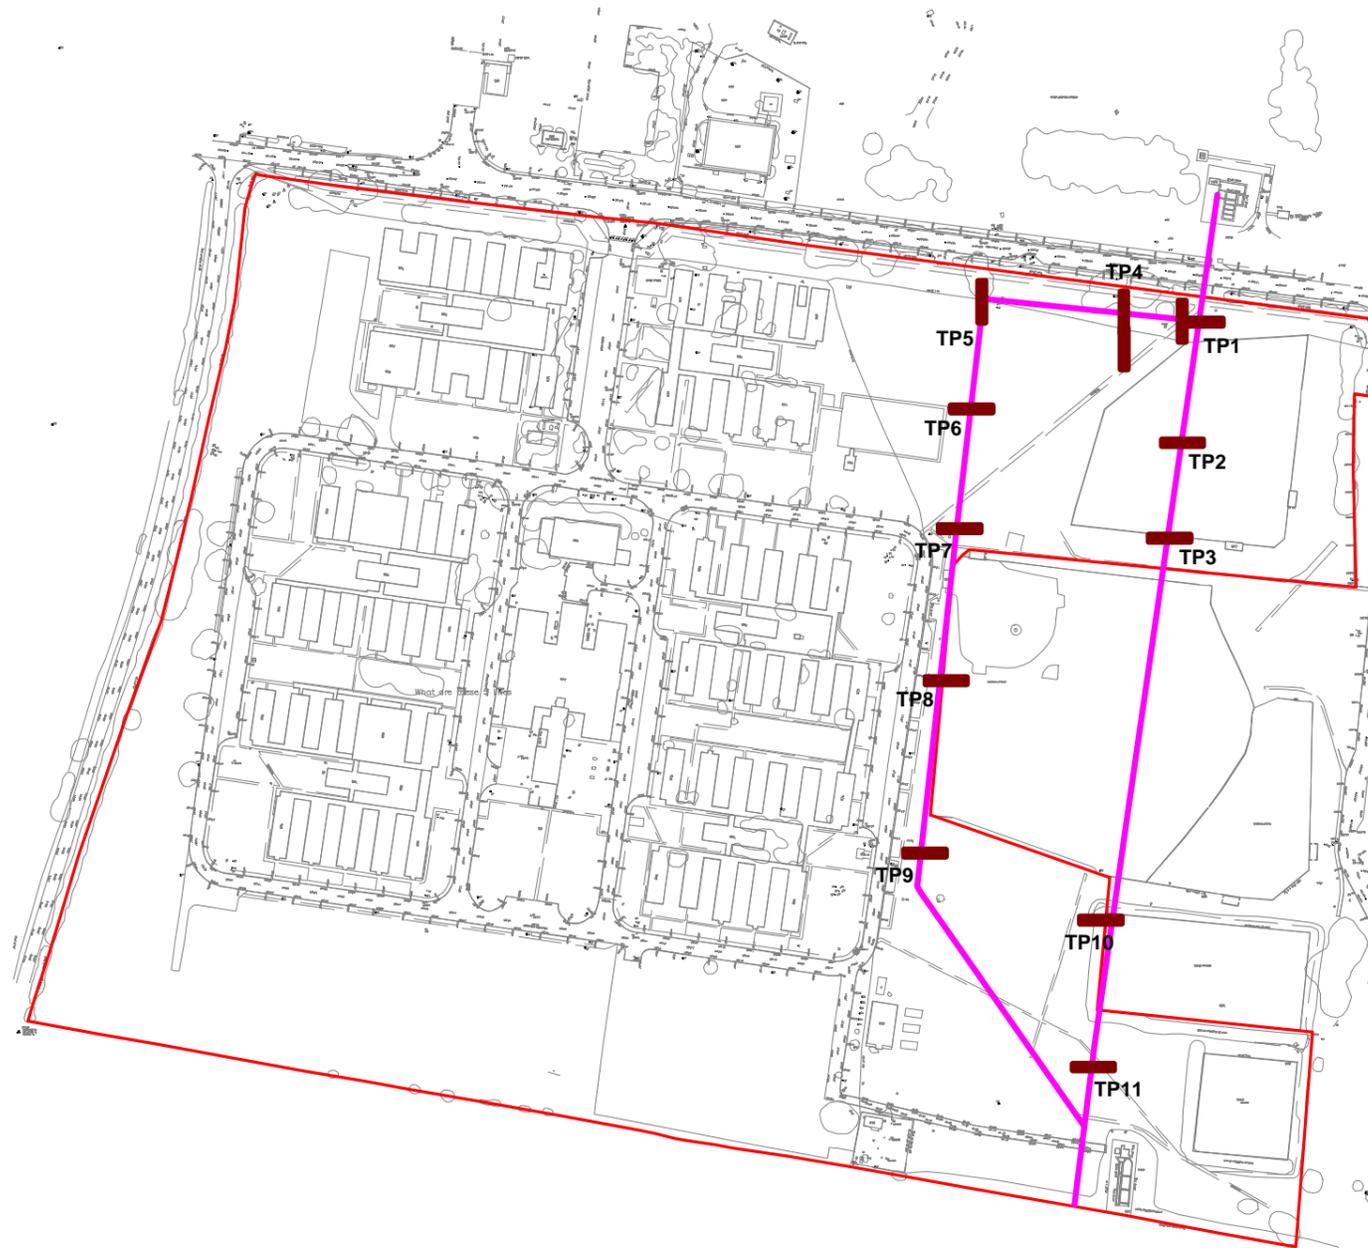
Job No: R1742d	Drg No: D02
-------------------	----------------

— Approx Line of POL pipeline

— Pipeline Trench / Extended TP

4.2.5. Following the presence of significant contamination indicators, TP4 was extended into a trench in a southerly direction to delineate the extent of impacted soils. The trench was extended by approximately 30m and whilst stained gravels were limited to the initial area of excavation, elevated PID readings and the presence of a grey clayey gravel layer with moderate hydrocarbon odours remained.

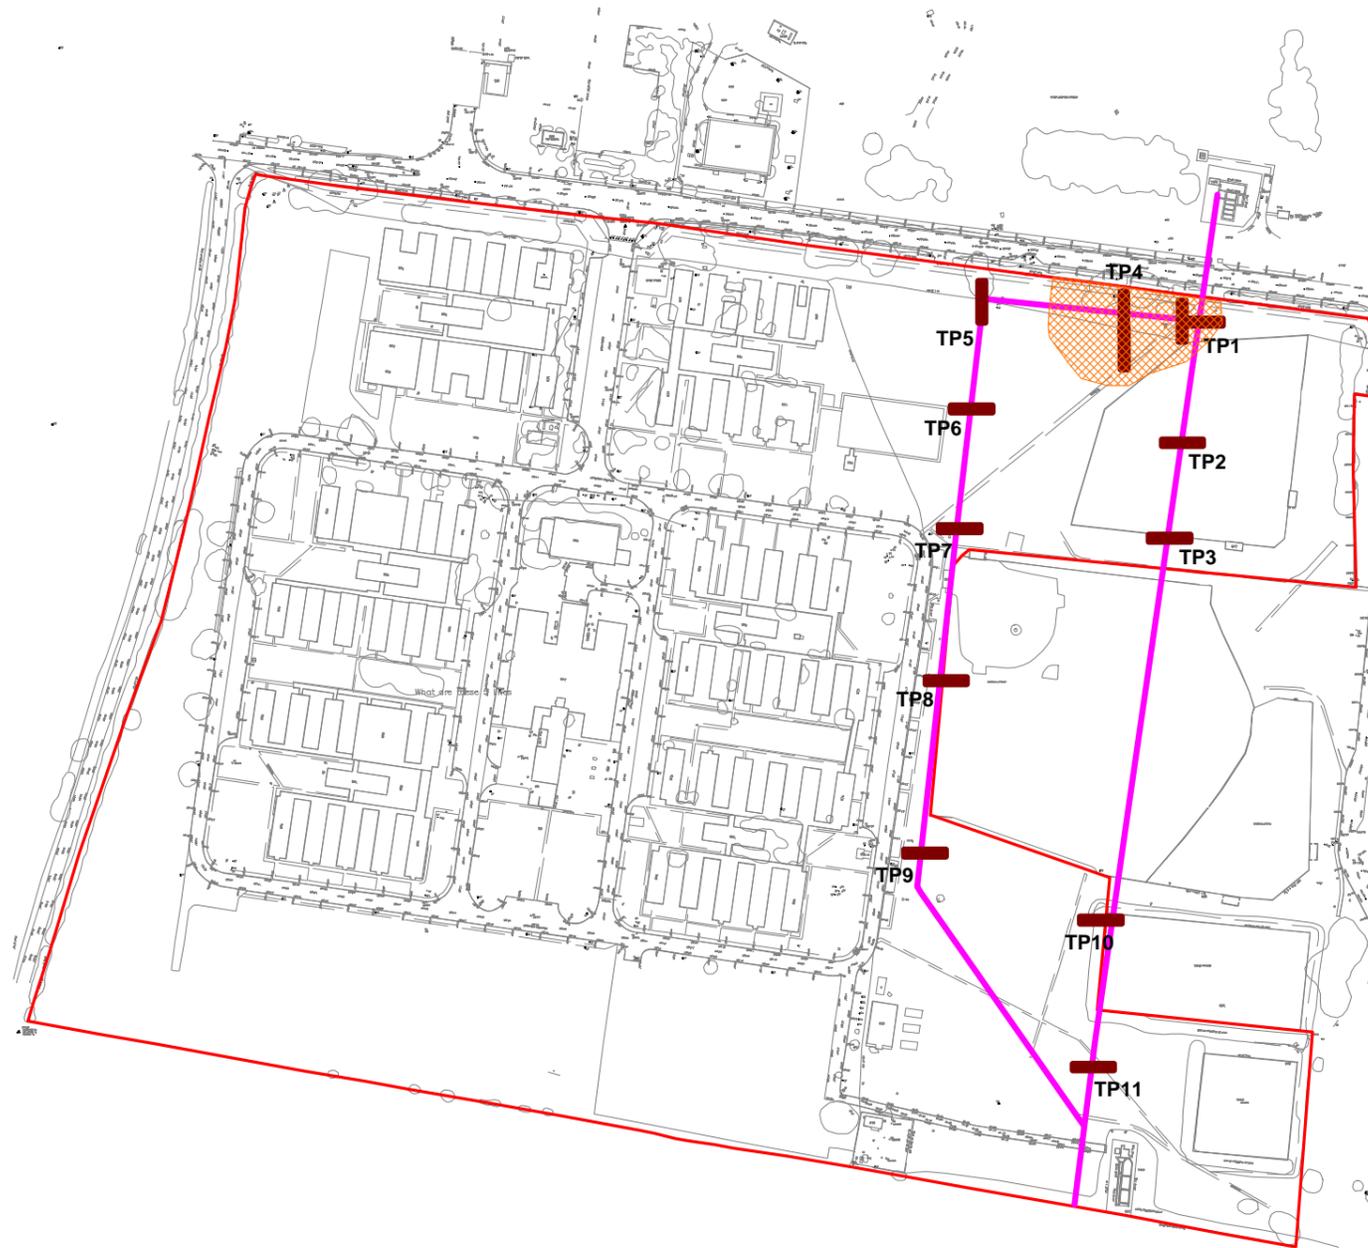
— Approx Line of POL pipeline

— Pipeline Trench / Extended TP

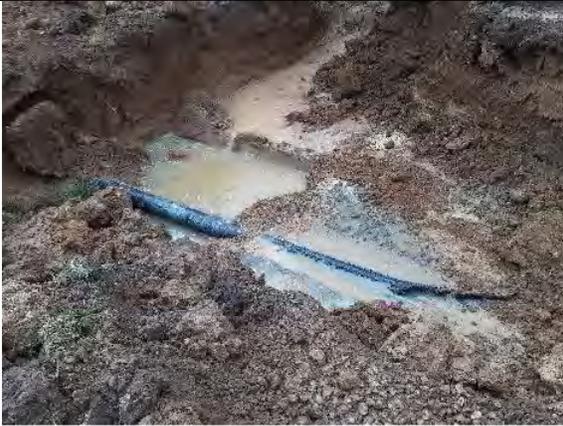
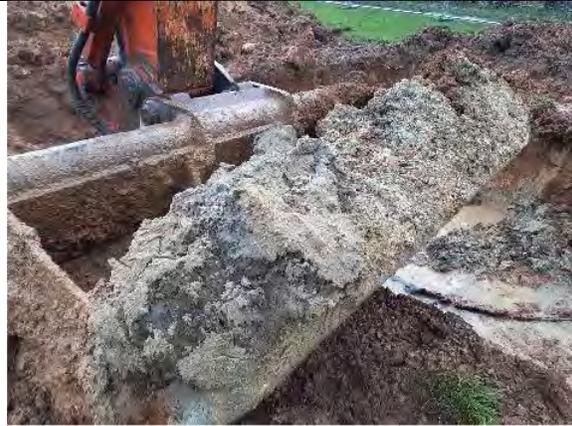
4.2.2. A slight hydrocarbon odour was reported within the soils surrounding the pipeline at approximately 1.5m bgl. Soil arisings were screened with a PID with a maximum of 6.3 ppm recorded at 1.5m bgl.

4.2.3. During the excavation of TP1 a relict manhole chamber was encountered and damaged, this resulted in the rapid ingress of perched water from the chamber into the excavation. No sheen or floating product was observed on the water. The vertical extent of the contamination could not be confirmed within this location due to ingress of water from the chamber flooding the excavation.

Sidewalls stable; no sheens or staining. Slight hydrocarbon odour at 1.5m bgl  
Max 6.3ppm at 1.5m bgl; 2x pipes at 1.5m bgl

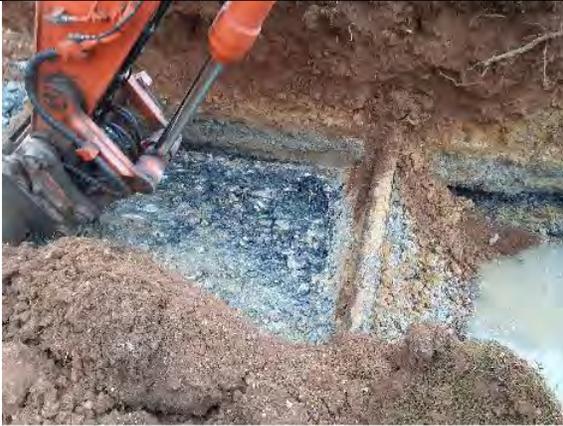
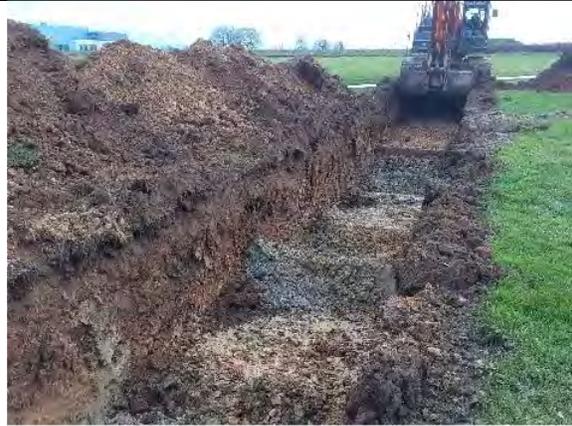
4.2.4. TP4 was excavated approximately 25m to the west of TP1 and encountered the pipeline at 1.3m bgl. Strong fuel odours were observed within the soils immediately below the pipeline with a maximum of 990 ppm recorded on the PID at 1.8m bgl. Black stained gravel was present from 1.8m to 2.3m bgl above the bedrock at 2.5m bgl.

Sidewalls stable; Light grey / silvery sand with strong fuel odour at 1.6-2.5m bgl. Black staining at 1.9-2.3m bgl  
PID 990ppm at 1.8m; 1x pipe at 1.3m bgl

6.2.1. It is recommended that this contamination hotspot is remediated at an early stage of the remedial works within Phase 9 in accordance with the revised Remediation Strategy and that a copy of this reported is submitted to the Local Authority.

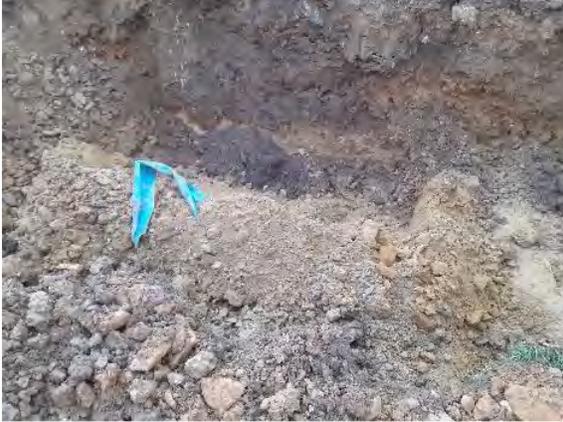
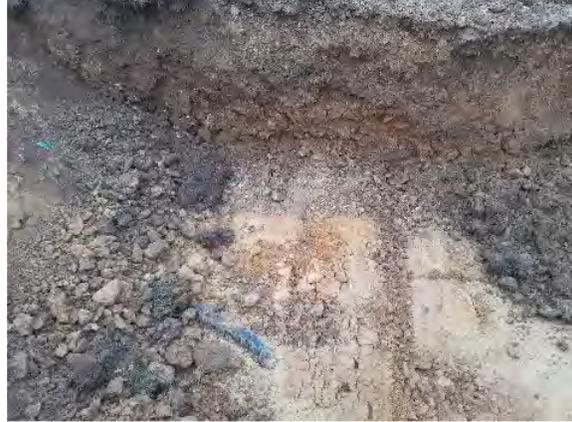
TP5

Sidewalls stable; no sheens, staining or odours  
PID <0.1 ppm; 2x pipes at 1.1m bgl

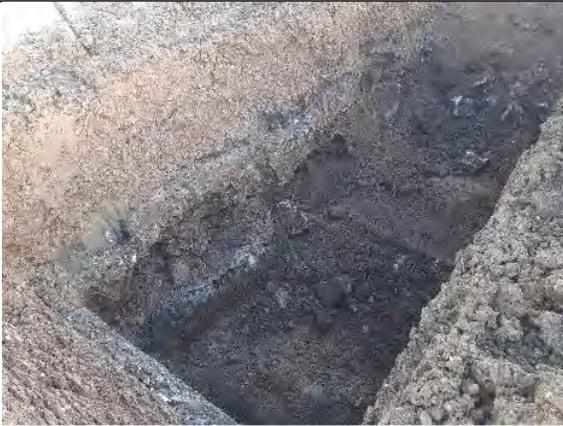
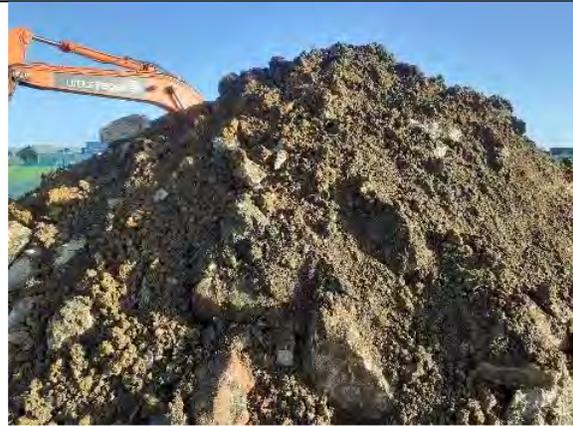
TP11

- 4.1.14. No evidence of the fuel pipeline was identified within TP11, which was excavated in line with TP10 where the pipe was located. The Vertase reporting suggests the pipeline extended in a north to south direction within this part of the site down to the southern boundary. It was observed that the made ground was particularly deep (2.5m bgl) in this location with cobbles of concrete and rebar which may suggest previous ground disturbance / preparatory works and could have also included the removal of the pipe.
- 4.1.15. The above evidence of stratigraphy is taken from discrete locations. Given the broadly similar ground conditions between many of the entries, it appears reasonable to infer that similar conditions may extend between these locations across the majority of the site, although caution should always be exercised as the nature of the ground does vary between some entries.

Sidewalls stable; no sheens, staining or odours  
PID <0.1 ppm; pipe not encountered
