**Ecological and Bat Survey Report for  
Shortlands Park Stud, Hook Norton Road,  
Sibford Ferris, Oxfordshire, OX15 5QR**

**Cotswold Wildlife Surveys**

**16<sup>th</sup> June 2021**

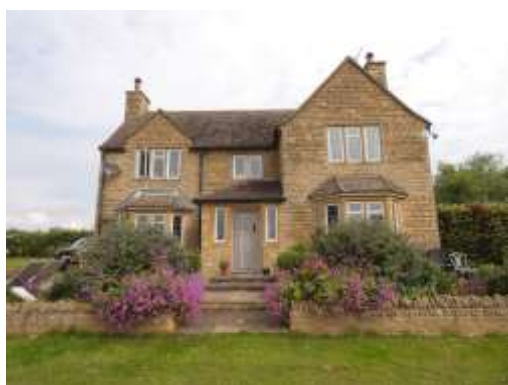
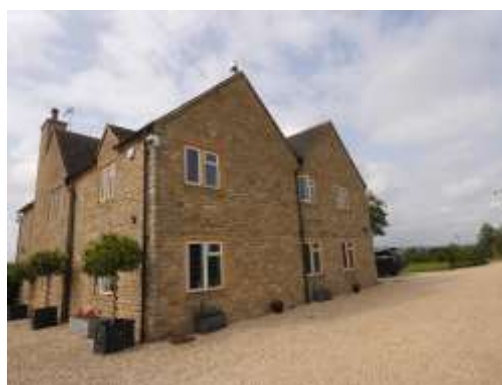
**Figs. 1 & 2 House – south elevation (L) and west elevation (R)**

The survey site comprised a two storey detached stone house with a multiple pitched clay tiled roof (Figs. 1 and 2).

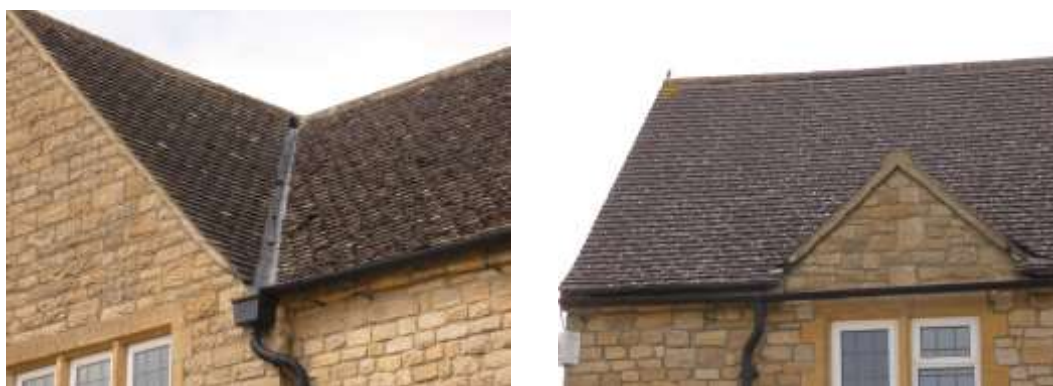
**Figs. 5 & 6 Roof tight**

The roof of the house comprised a series of interconnected pitched sections, these covered by clay tiles. All the tiles were tightly overlapping, with none raised, broken, dislodged or missing (Figs. 5 and 6).

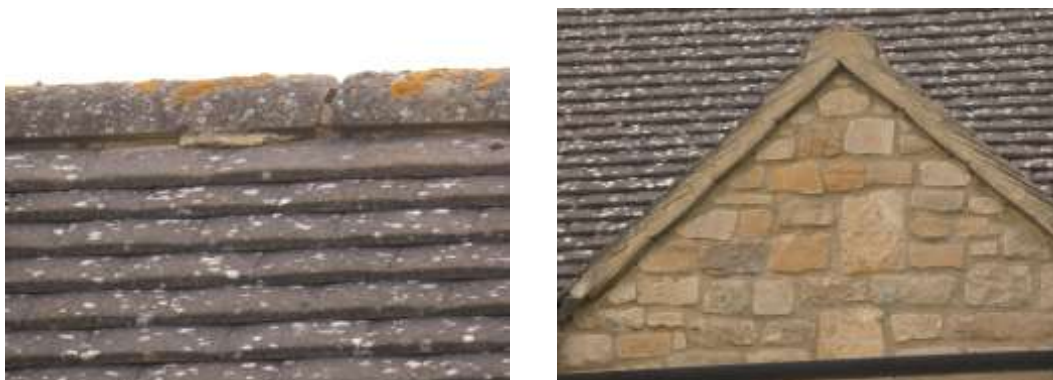
**Figs. 7 & 8 Mortar crumbling at the ridge but verge fully pointed**

Some mortar had dropped out from the bottom of the ridge tiles, but this did not create a gap leading under the ridge (Fig. 7). The roof verges were fully pointed with no gaps (Figs. 8 and 9).

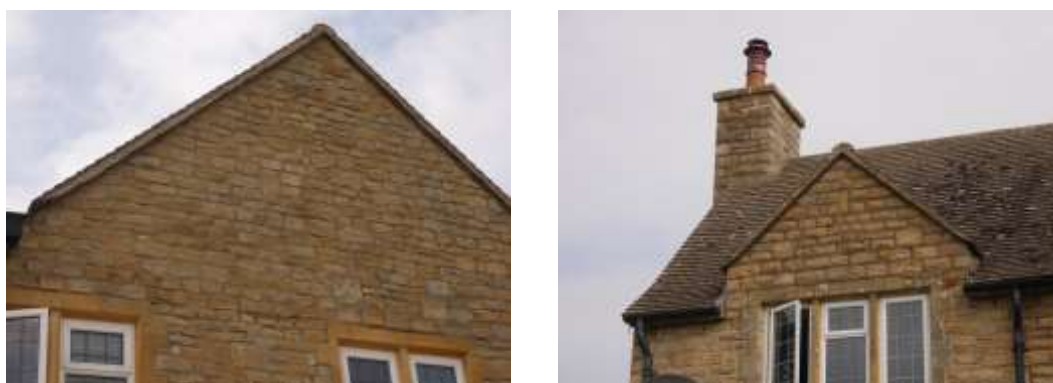
**Figs. 9 & 10 Verge and chimney base fully pointed**

The eaves were clipped and the chimney base was sealed to the tiles by cement with no cracks (Fig. 10).

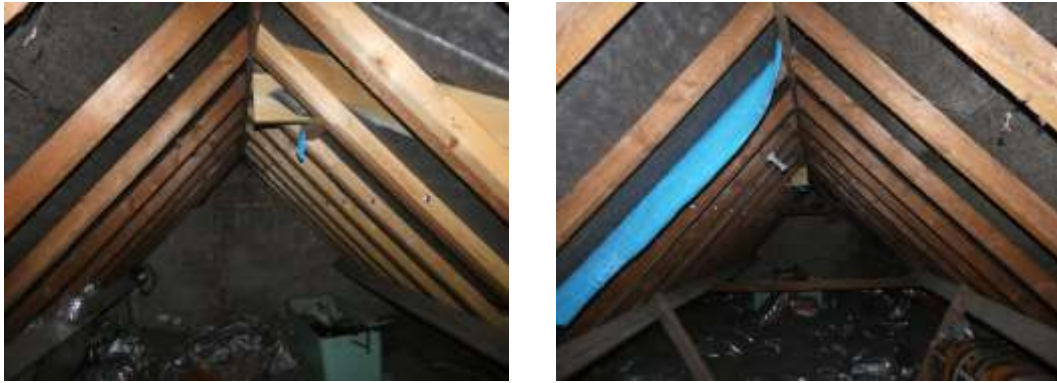
**Figs. 11 & 12 Roof voids**

Internally the house had several roof voids, these all lined with either tarred felt or modern membranes (Figs. 11 and 12 overleaf).

No evidence of bat occupation was discovered inside the house, and the roof voids were considered to be inaccessible to bats.

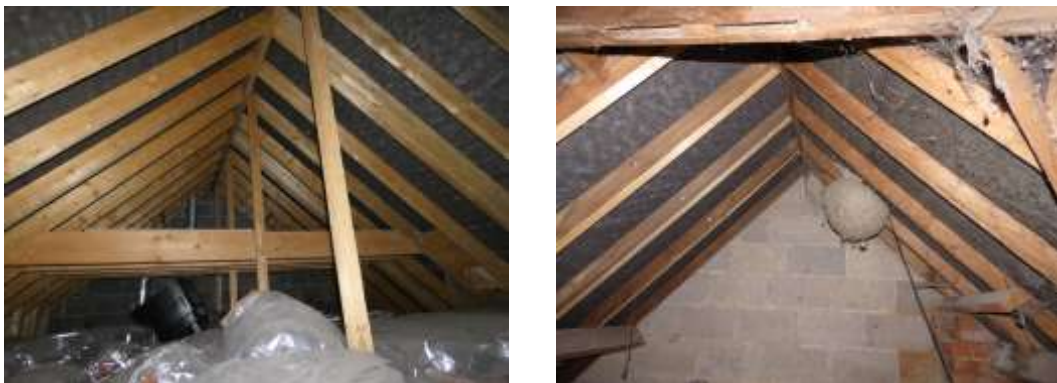
**Fig. 13 & 14 Roof voids**

There was no light penetration and quite heavy cobwebbing in places (Fig. 13 and 14 overleaf).

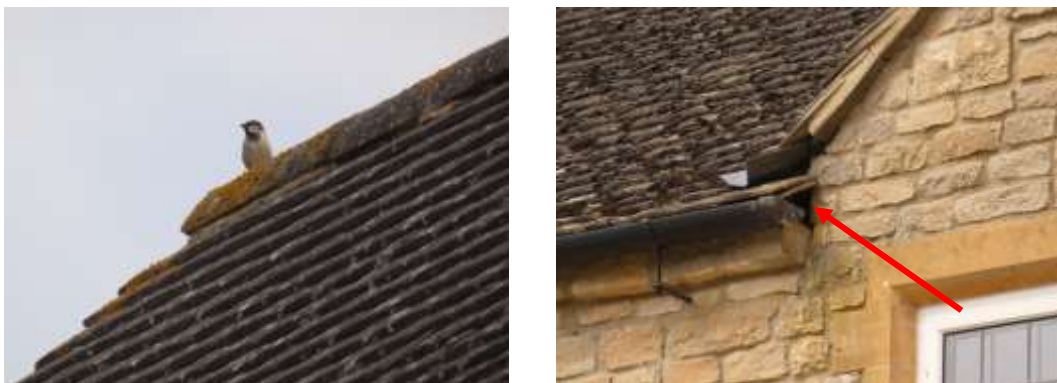
**Figs. 15 & 16 Male House Sparrow (L) and nest site (R)**

A pair of House Sparrows were nesting in a gap where the verge met the eaves (Figs. 15 and 16). This did not open into the roof void, so there was no internal bat access.

This was considered to be negligible, as the house contained no suitable crevices or cavities. The gap at the verge was blocked with a House Sparrow nest, and there was no access into the roof structure at this point.

Since all in-use bird's nests and their contents are protected from damage or destruction, any works which affect buildings should ideally be undertaken outside the period March to August inclusive. If this time frame cannot be avoided, a close inspection of the buildings affected will be undertaken prior to clearance. Work will not be carried out in close proximity to any in-use nest, and a minimum buffer of 5.0 metres will be established, although this could be more depending on the sensitivity of the species. Any in-use nest will be allowed to fledge before it is disturbed.
