INFILTRATION TESTING REPORT

***LAND AT NORTH WEST BICESTER
BUCKNELL ROAD
OXFORDSHIRE
OX27 7HN***

REPORT TITLE: INFILTRATION TESTING REPORT

Project Reference: GEG-21-678

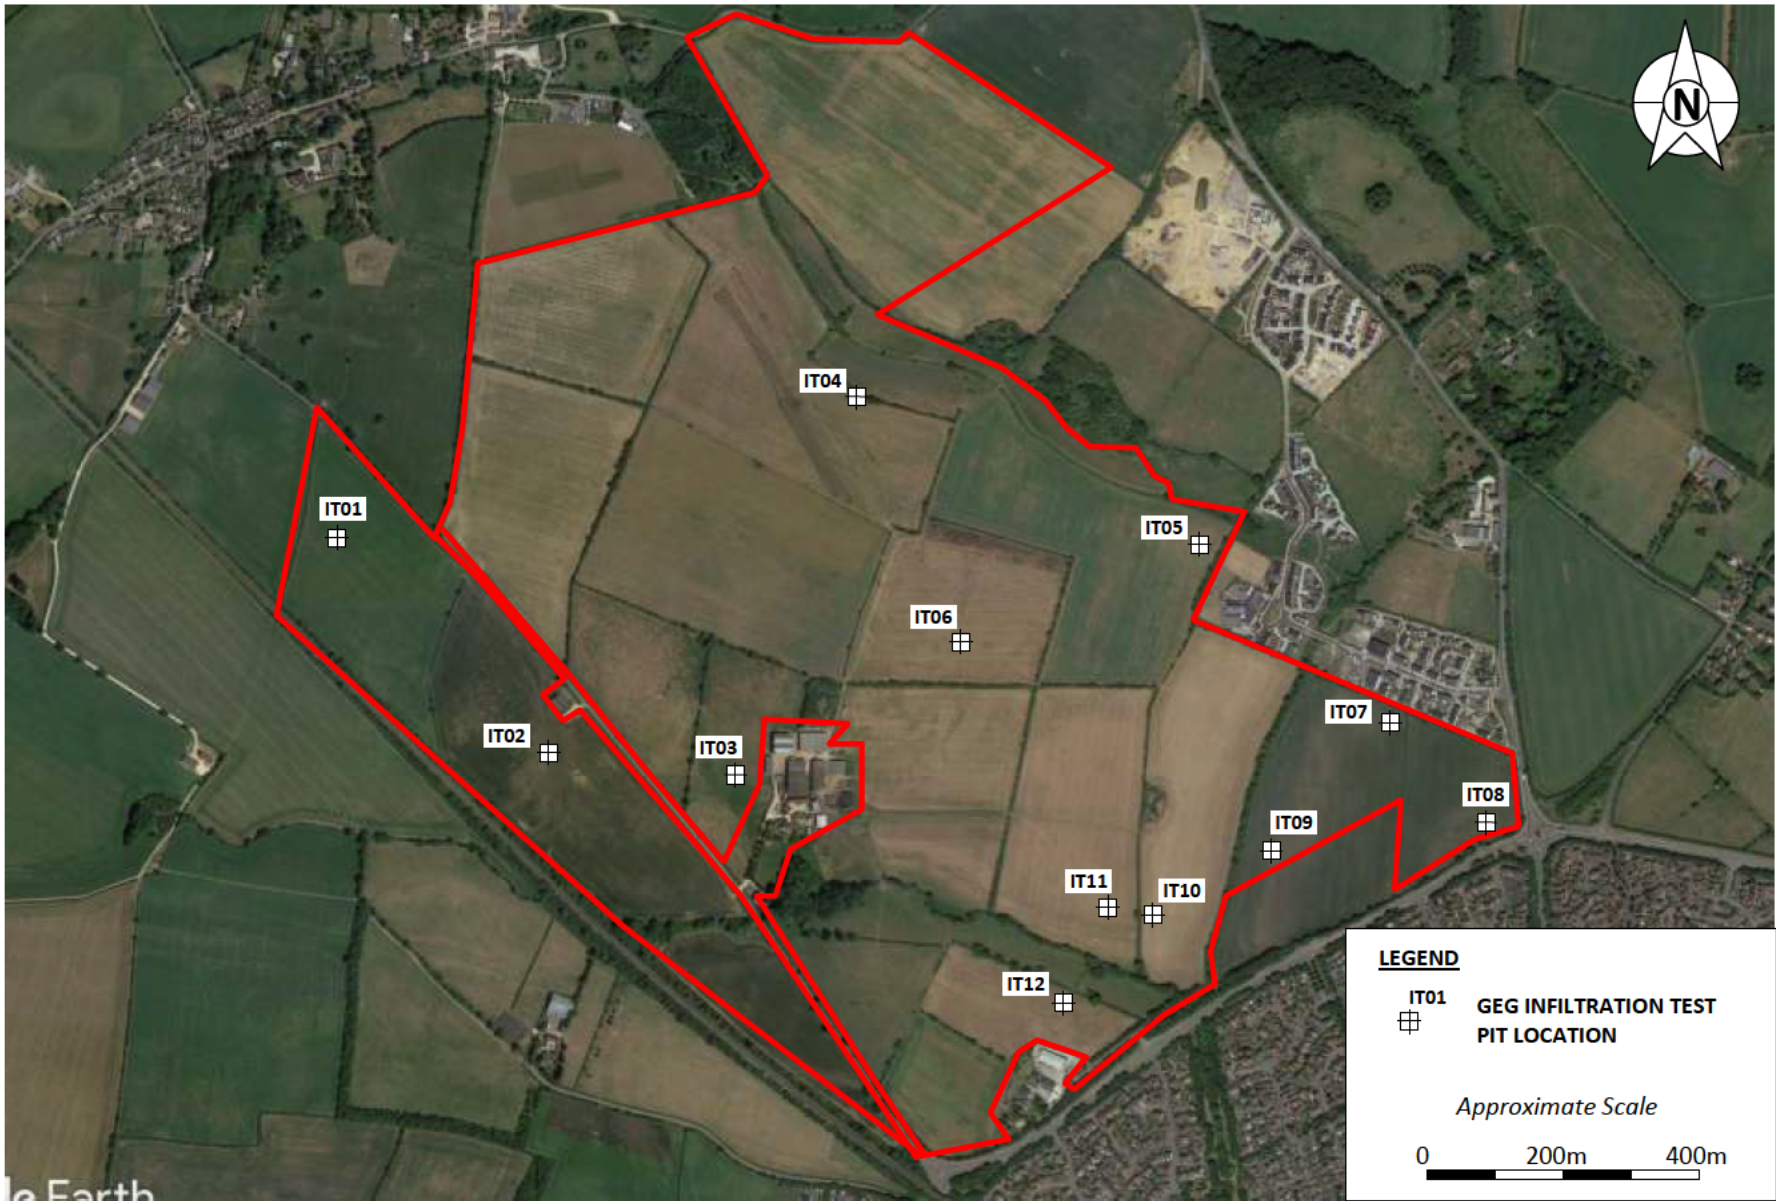
TITLE: FIGURE 2: EXPLORATORY HOLE LOCATION PLAN		CLIENT: BROOKBANKS / HLM		DRAWN/CHECKED: MP / MR		GEG House, 17 Graham Road Malvern, WR14 2HR Tel. 01684 212526 Fax 01684 576917 admin@g-eg.co.uk, www.g-eg.co.uk		Geo Environmental Group

The intrusive investigation was undertaken from 6th to 9th April 2021 and comprised the excavation of 12 No. infiltration test trial pits (IT01-IT12) at the locations determined by Brookbanks (as shown on Figure 2).

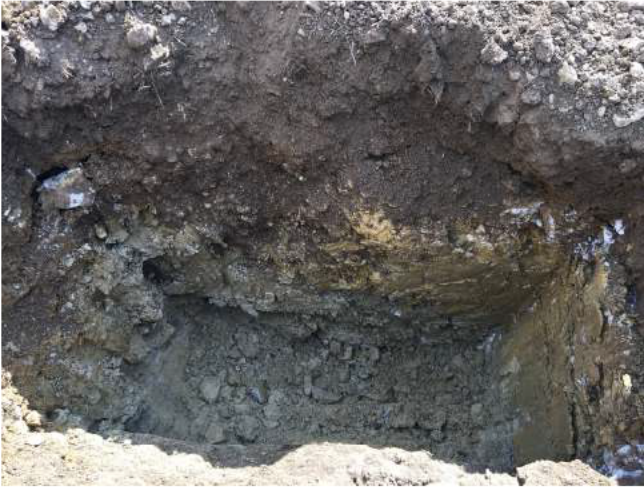
Photo 1: Excavation of trial pit IT01.

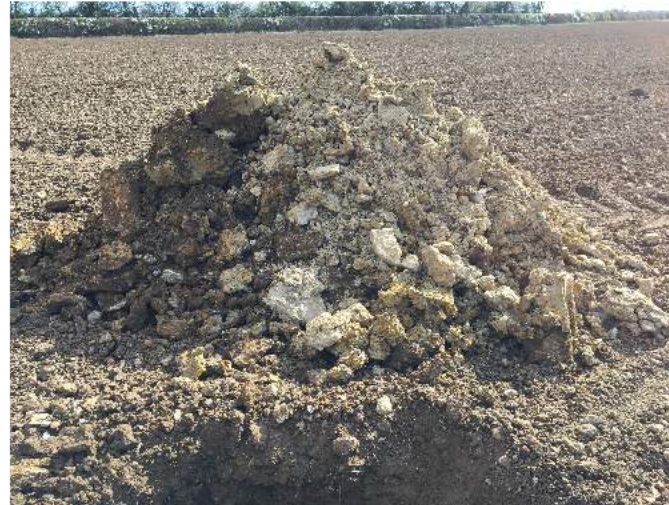
Photo 2: Arisings from trial pit IT01.

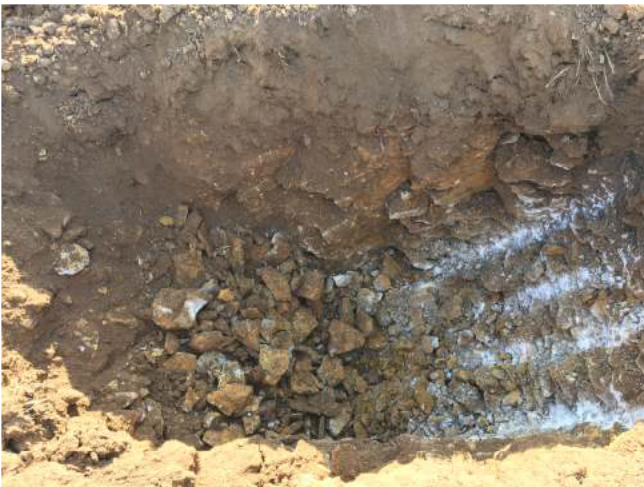
Photo 3: Excavation of trial pit IT02.

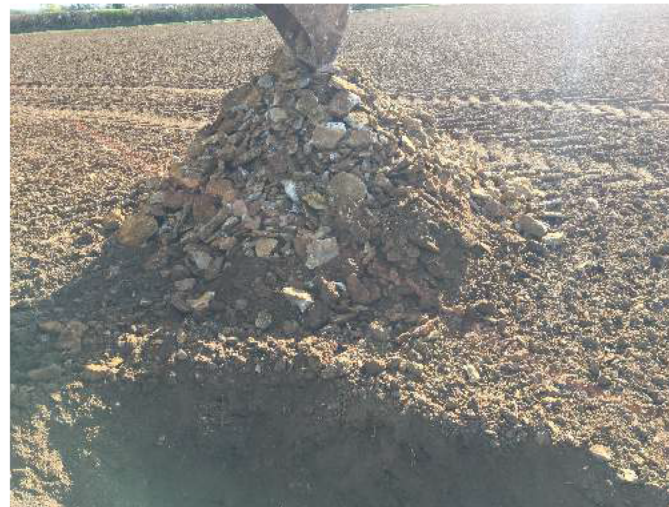
Photo 4: Arisings from trial pit IT02.

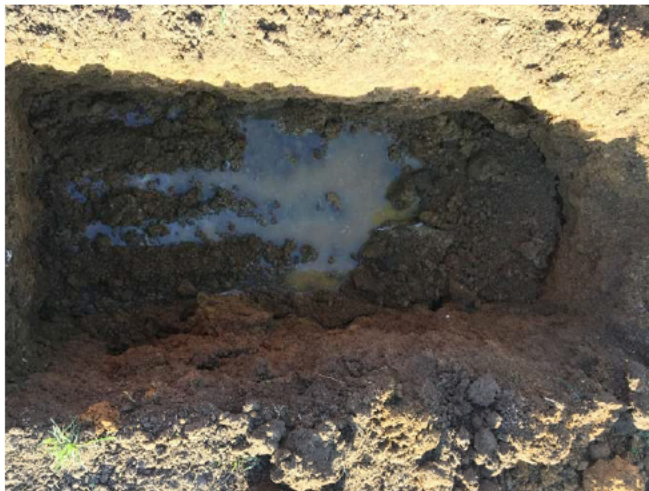
Photo 5: Excavation of trial pit IT03.

Groundwater was not encountered in the majority of the exploratory holes during the intrusive investigation with the exception of a slow inflow at 0.70m in IT03.

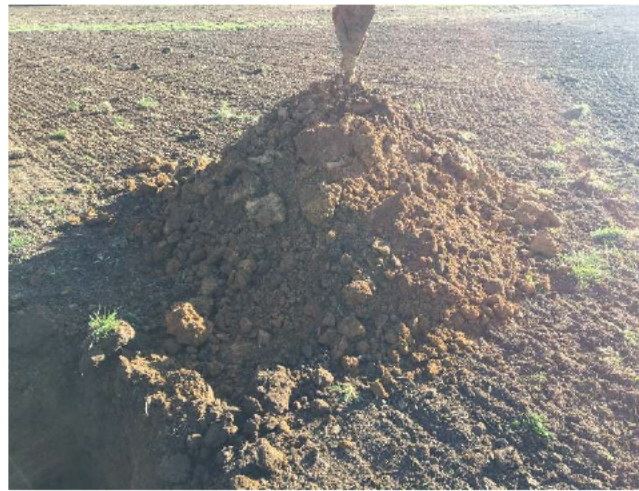
Photo 6: Arisings from trial pit IT03.

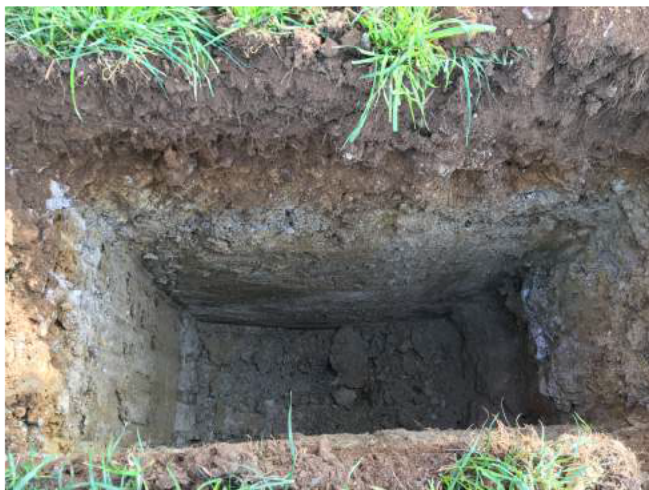
Photo 7: Excavation of trial pit IT04.

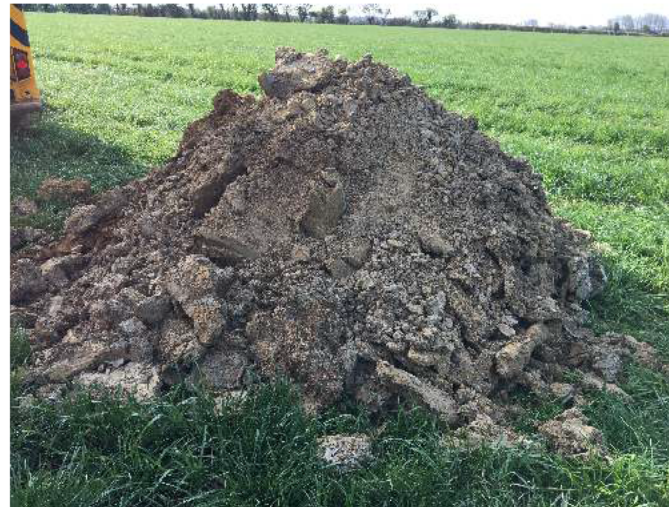
Photo 8: Arisings from trial pit IT04.

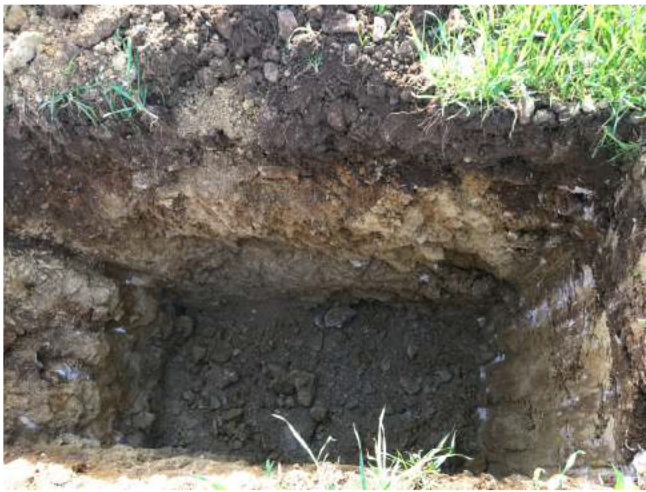
Photo 9: Excavation of trial pit IT05.

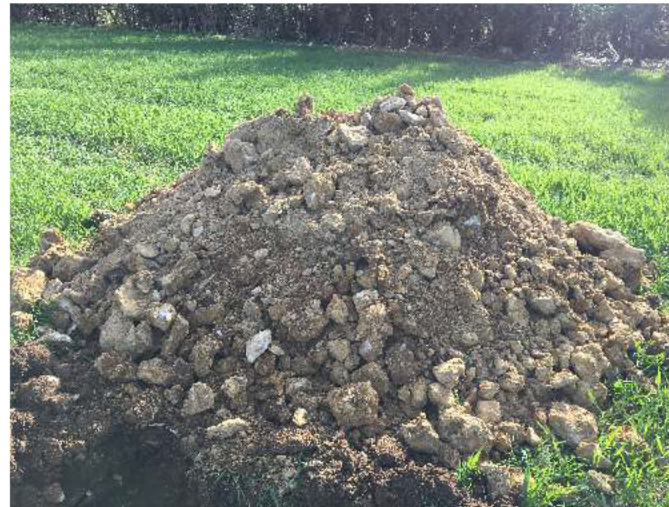
Photo 10: Arisings from trial pit IT05.

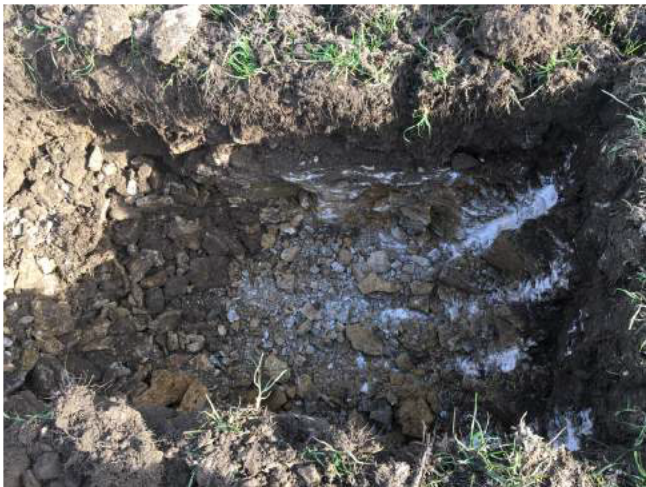
Photo 11: Excavation of trial pit IT06.

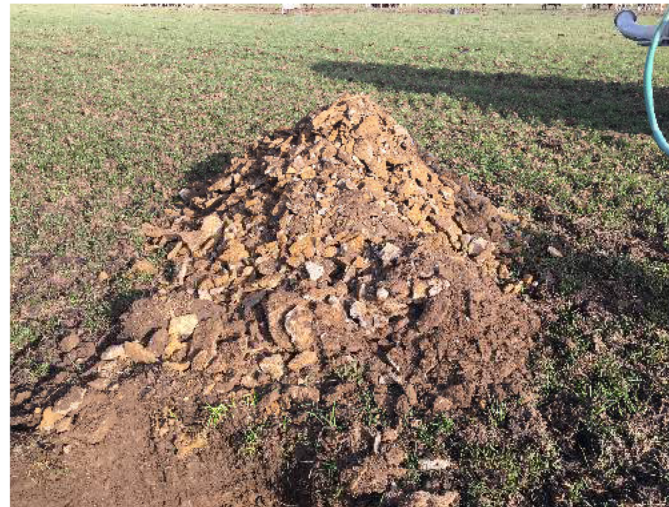
Photo 12: Arisings from trial pit IT06.

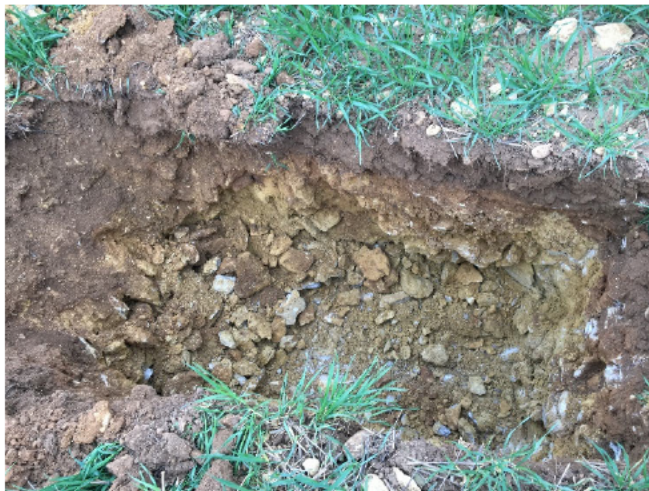
Photo 13: Excavation of trial pit IT07.

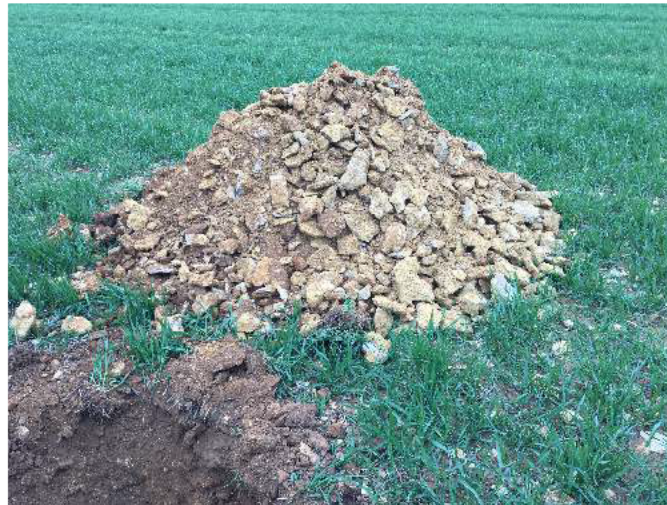
Photo 14: Arisings from trial pit IT07.

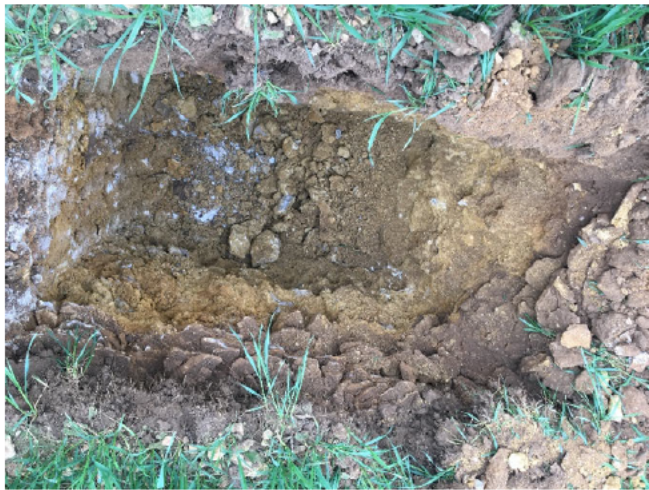
Photo 15: Excavation of trial pit IT08.

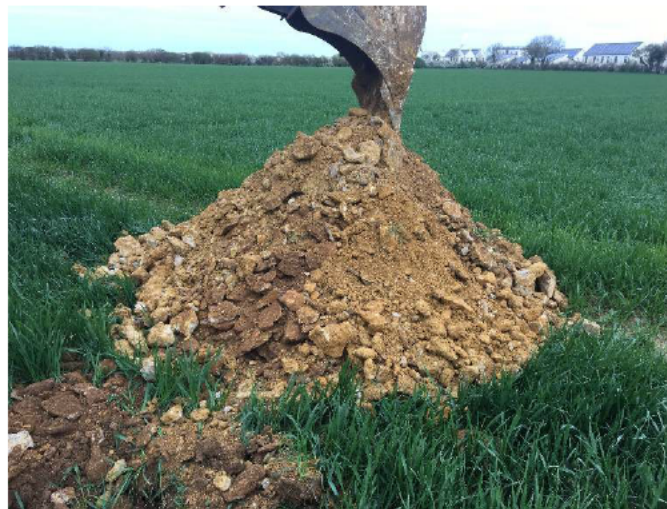
Photo 16: Arisings from trial pit IT08.

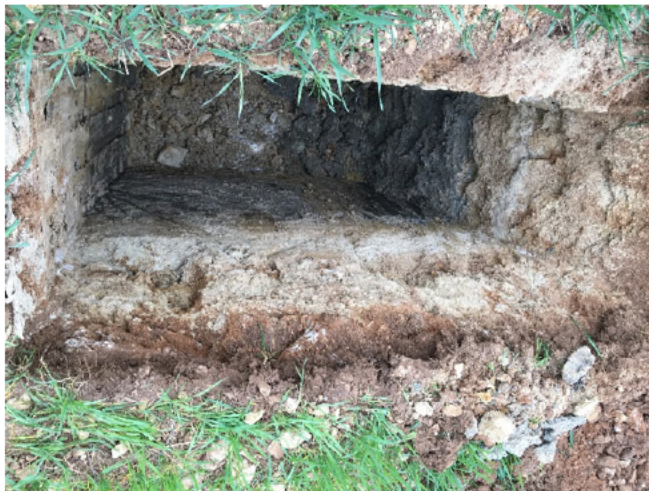
Photo 17: Excavation of trial pit IT09.

Alluvium was encountered underlying the topsoil in 1 No. exploratory hole (IT09) adjacent to a watercourse to a depth of 1.20m. It comprised medium dense silty gravelly (limestone and quartzite) SAND.

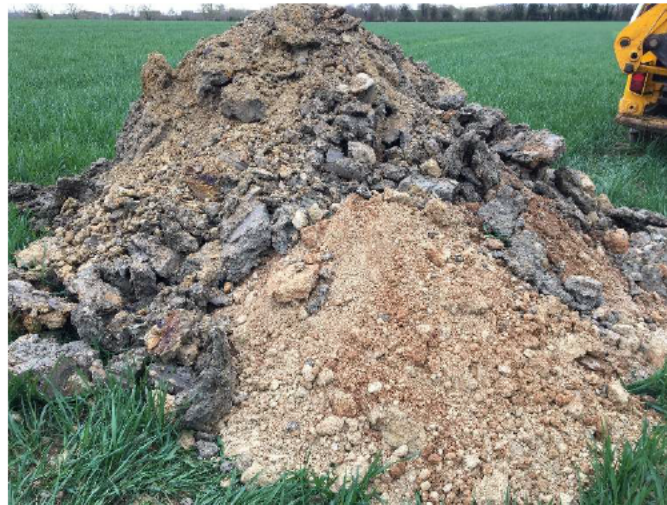
Photo 18: Arisings from trial pit IT09.

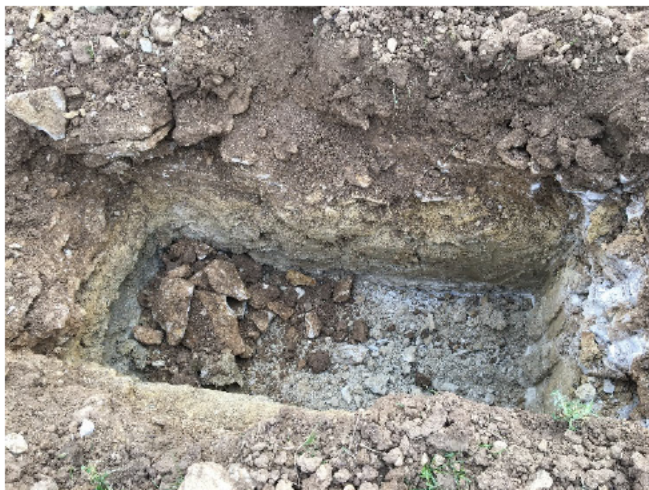
Photo 19: Excavation of trial pit IT10.

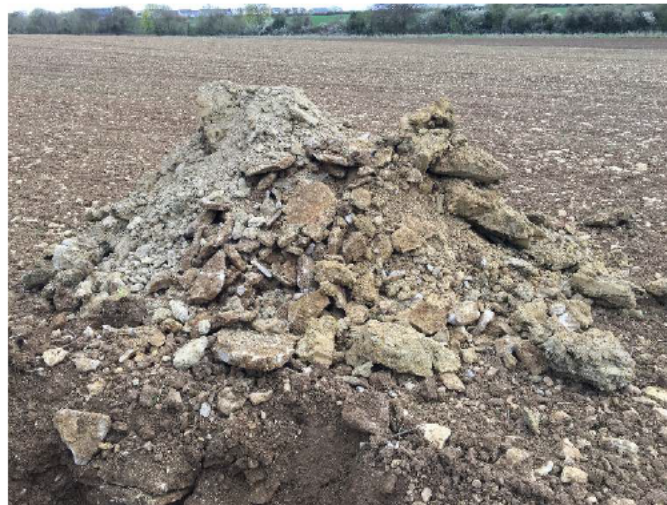
Photo 20: Arisings from trial pit IT10.

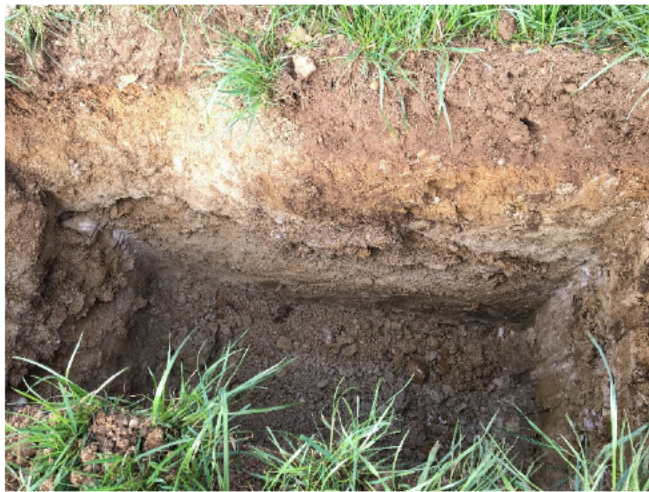
Photo 21: Excavation of trial pit IT11.

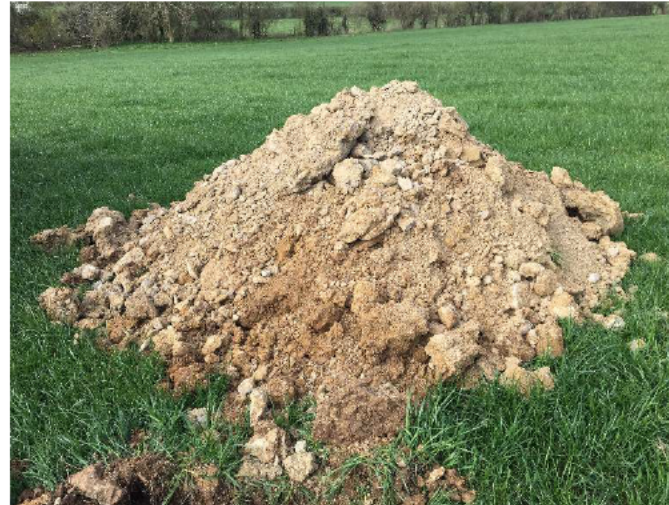
Photo 22: Arisings from trial pit IT11.

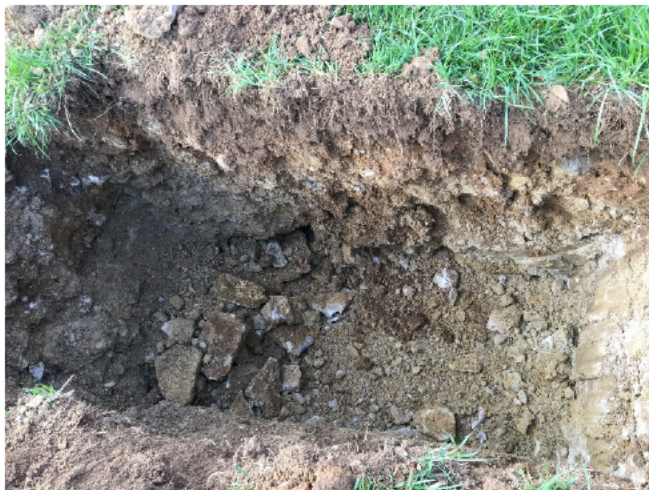
Photo 23: Excavation of trial pit IT12.

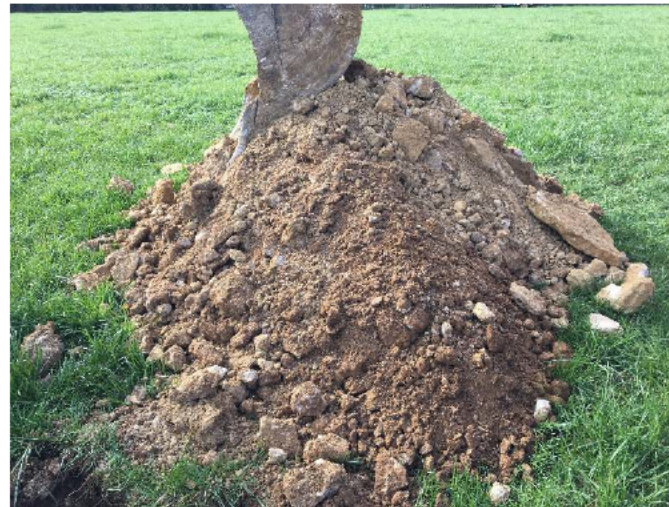
Photo 24: Arisings from trial pit IT12.

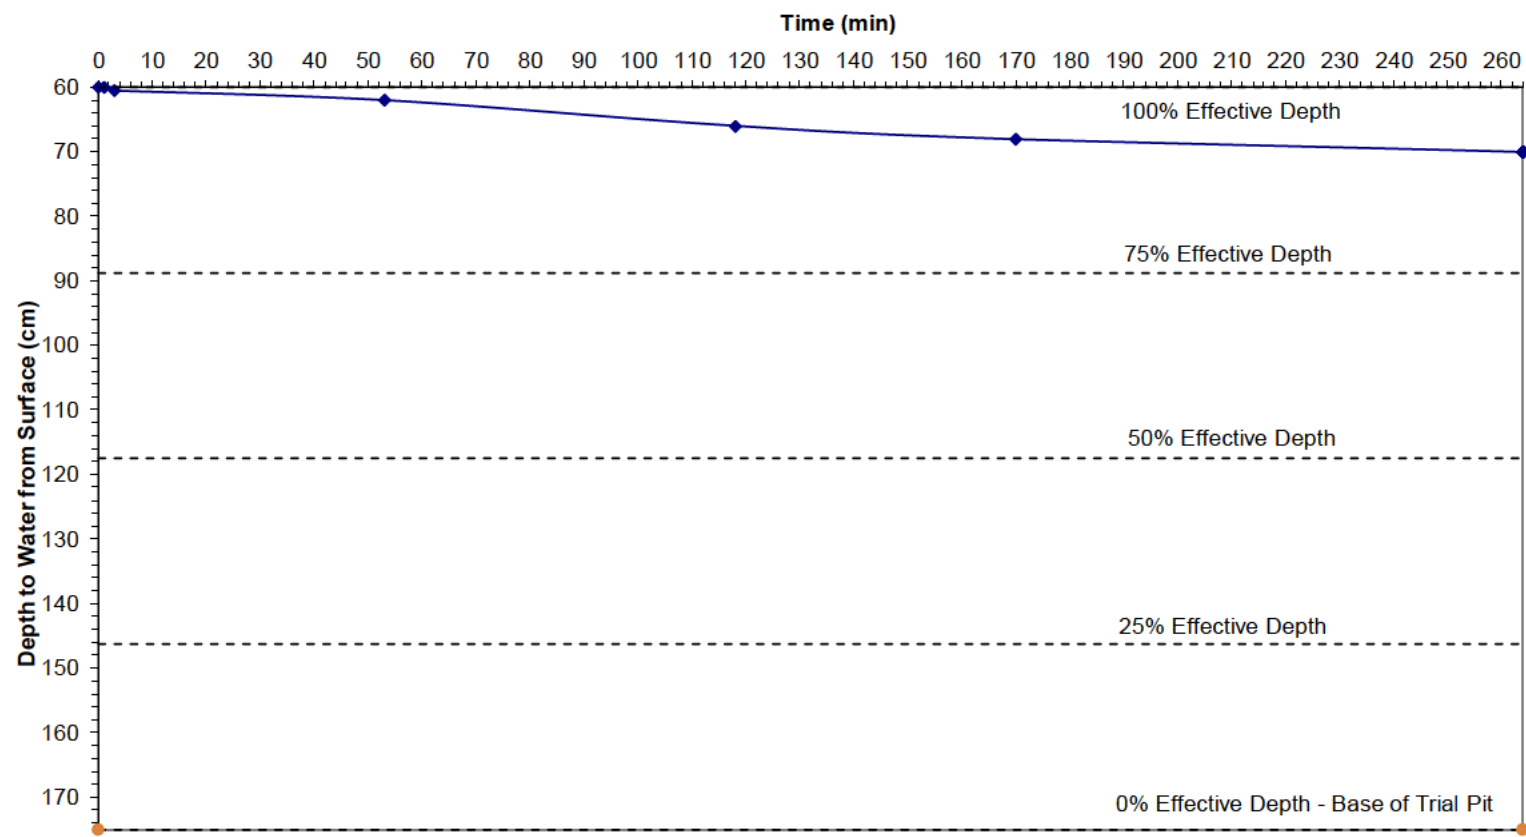
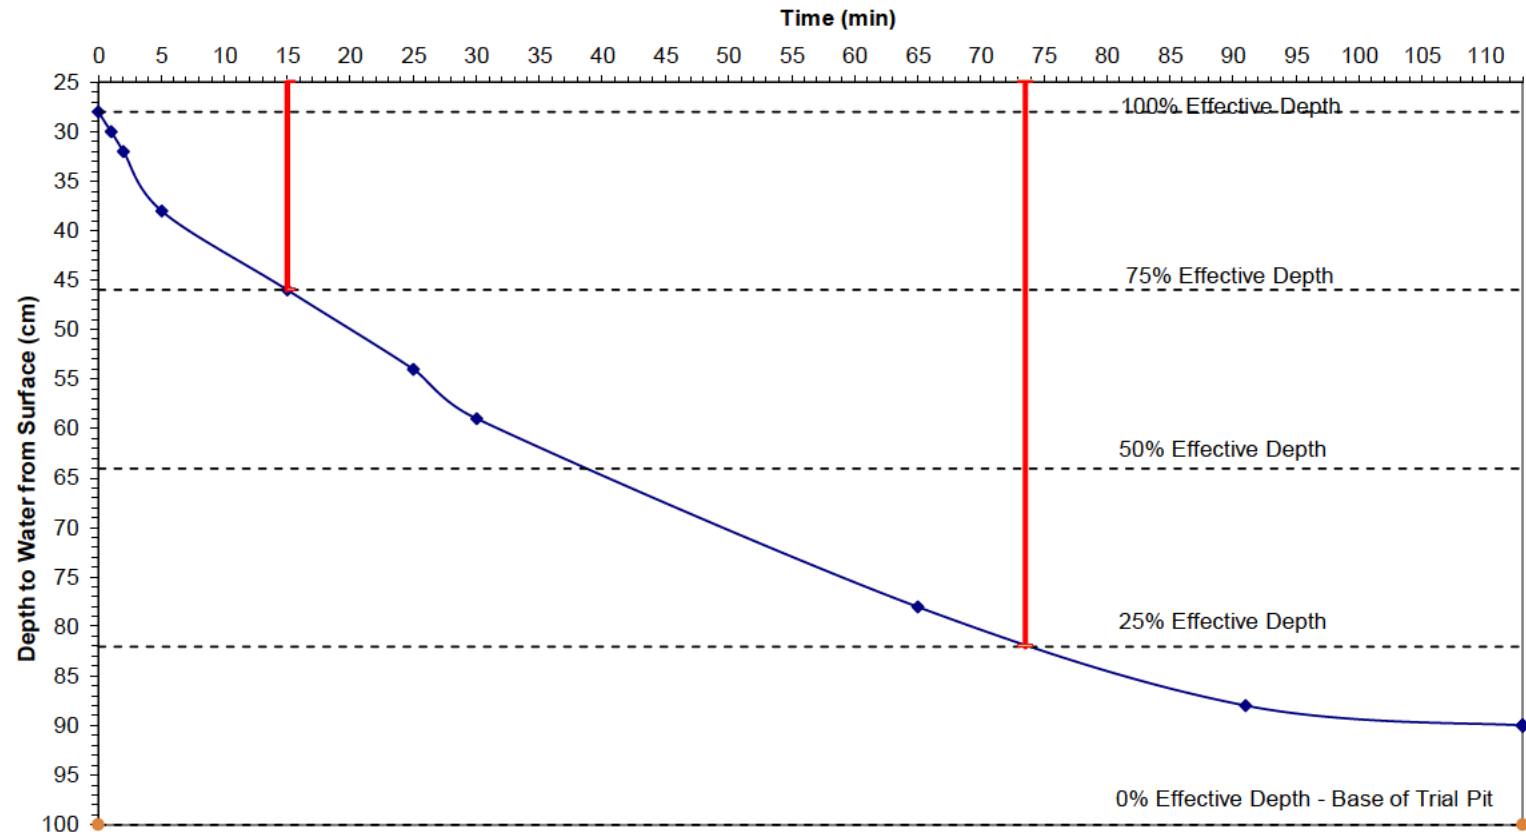
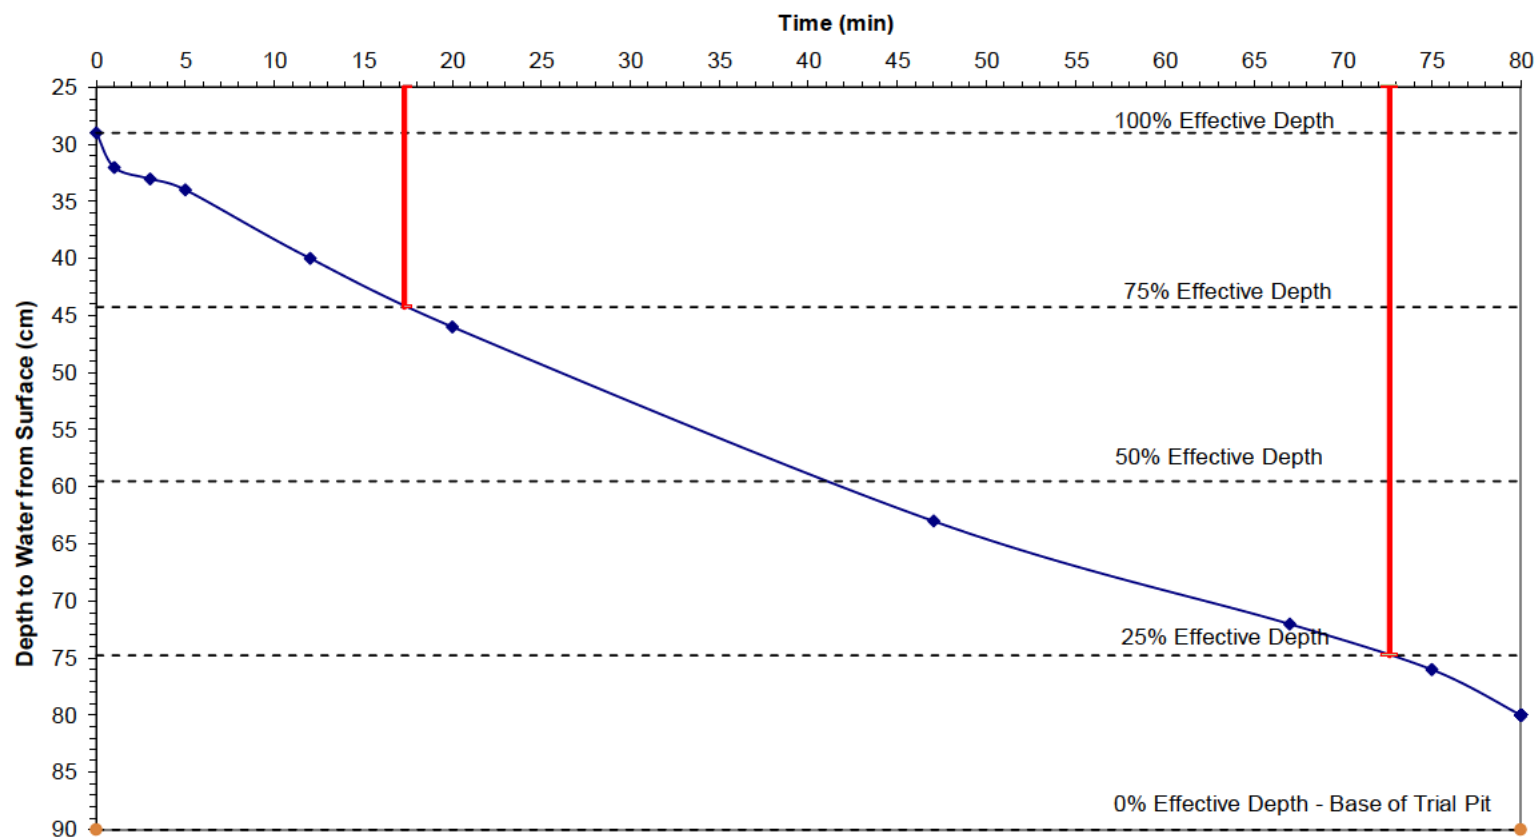
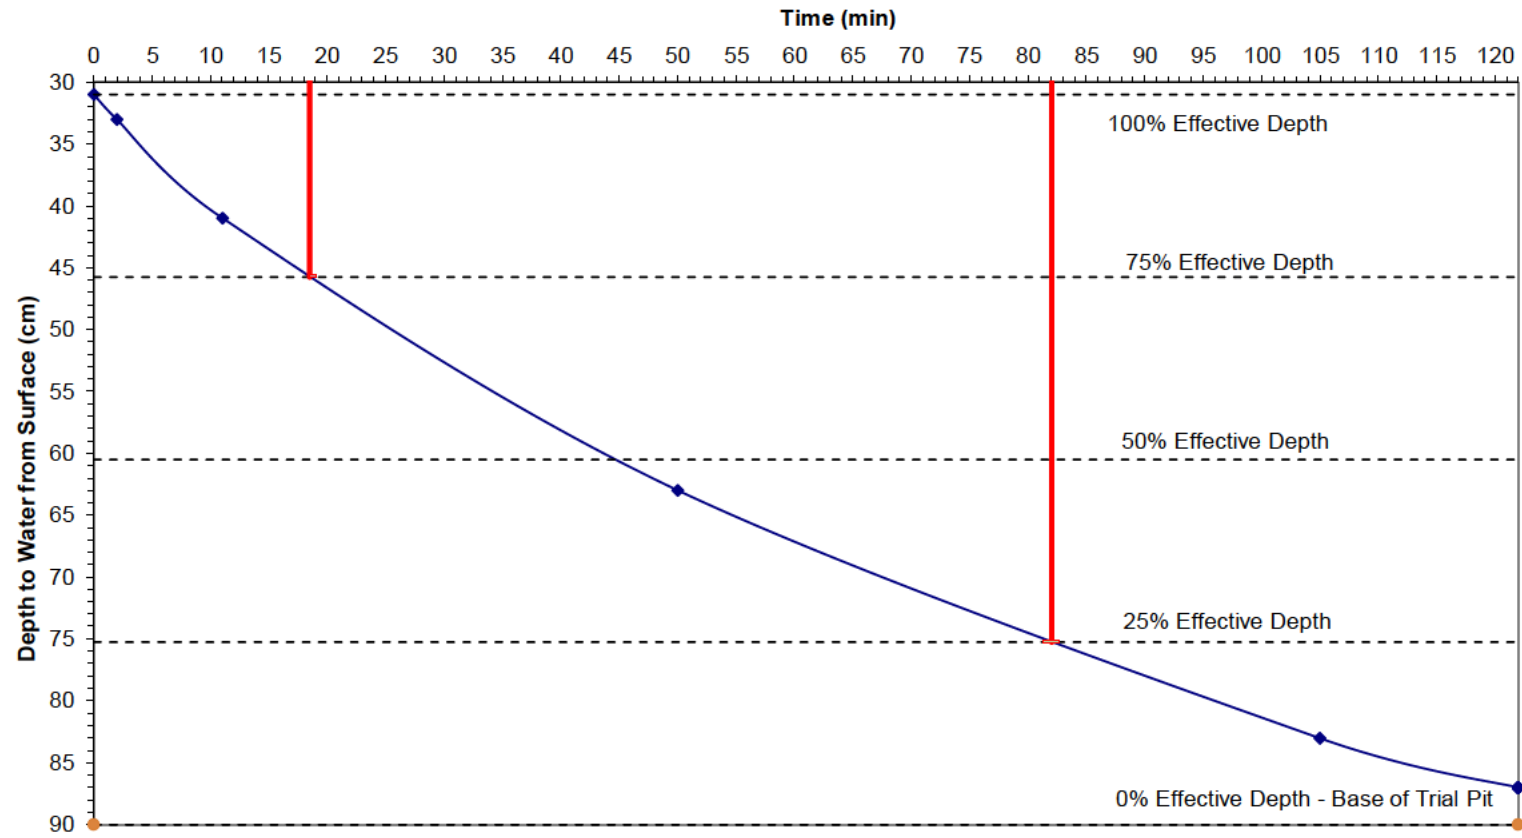
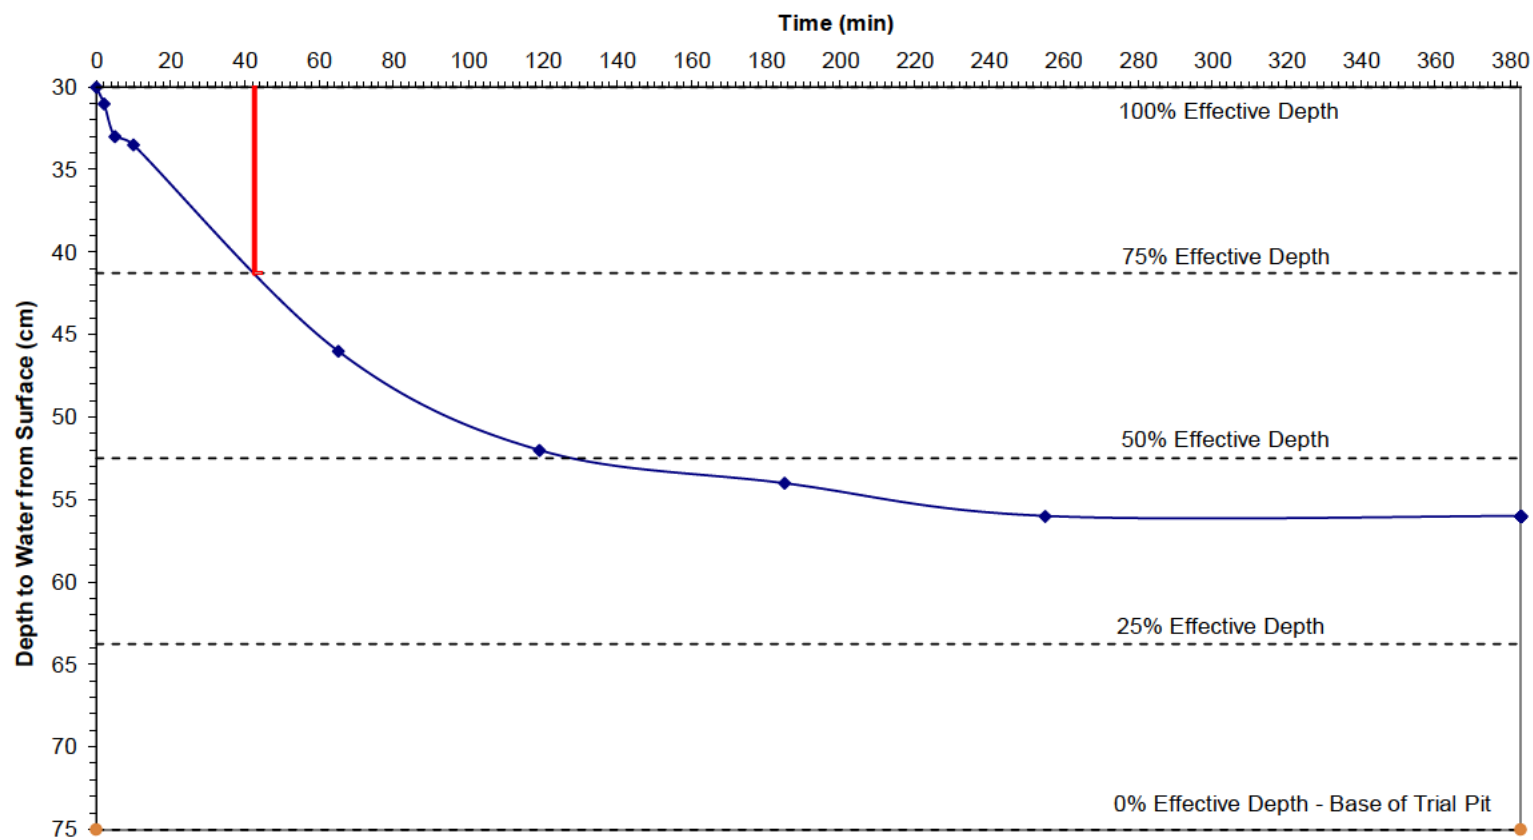
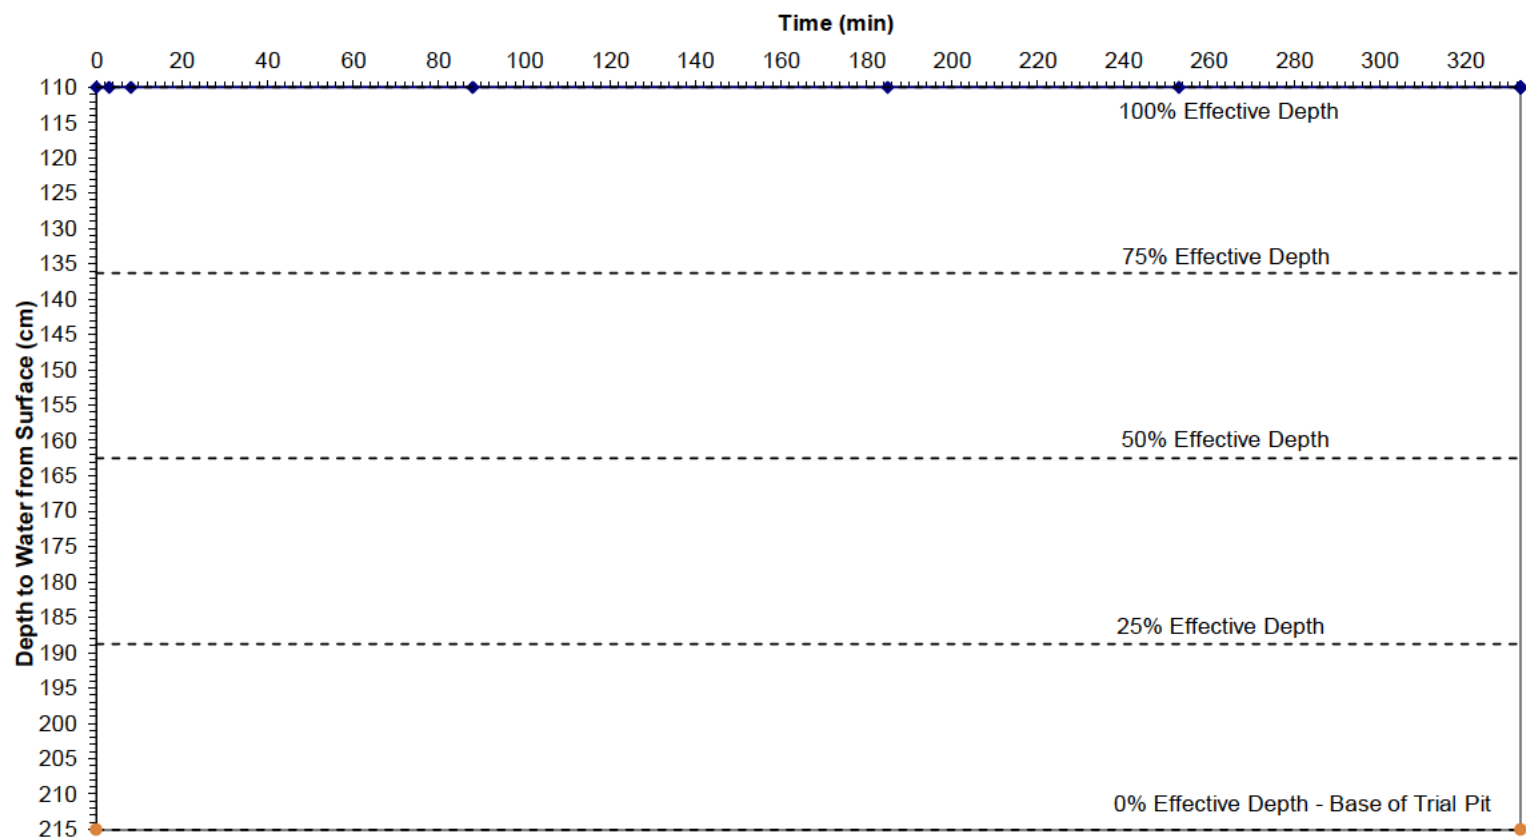
The water level measurements from the infiltration tests are tabulated and graphically depicted on Figures D-1 to D-21 in Appendix D.

Location	Test No.	Strata*	Effective Depth Reached	Time (mins)	Infiltration Rate (m/s)
IT01	1	CF	91%	264	N/A
IT02	1	CF	25%	74	3.66×10^{-5}
	2			73	3.64×10^{-5}
	3			82	3.13×10^{-5}
IT03	1	CF	42%	383	N/A**
IT04	1	FMF	100%	333	N/A
IT05	1	FMF	25%	402	7.20×10^{-6} [1]
IT06	1	CF	25%	141	1.45×10^{-5}
	2			92	2.06×10^{-5}
IT07	1	CF	25%	193	1.34×10^{-5}
	2			227	1.08×10^{-5} [2]
IT08	1	FMF	25%	343	8.87×10^{-6}
IT09	1	ALL/FMF	25%	20	1.45×10^{-4}
	2			18	1.81×10^{-4}
	3			19	2.03×10^{-4}
IT10	1	CF	25%	500	6.16×10^{-6} [1]
IT11	1	CF	25%	158	1.93×10^{-5}
	2			142	2.21×10^{-5}
IT12	1	FMF	25%	27	1.09×10^{-4}
	2			27	1.08×10^{-4}
	3			29	1.06×10^{-4}

Infiltration rates could not be calculated in 3 No. of the 12 No. infiltration test pit locations (IT01, IT03 & IT04) indicating that the ground conditions are unsuitable for traditional soakaway drainage in these locations.

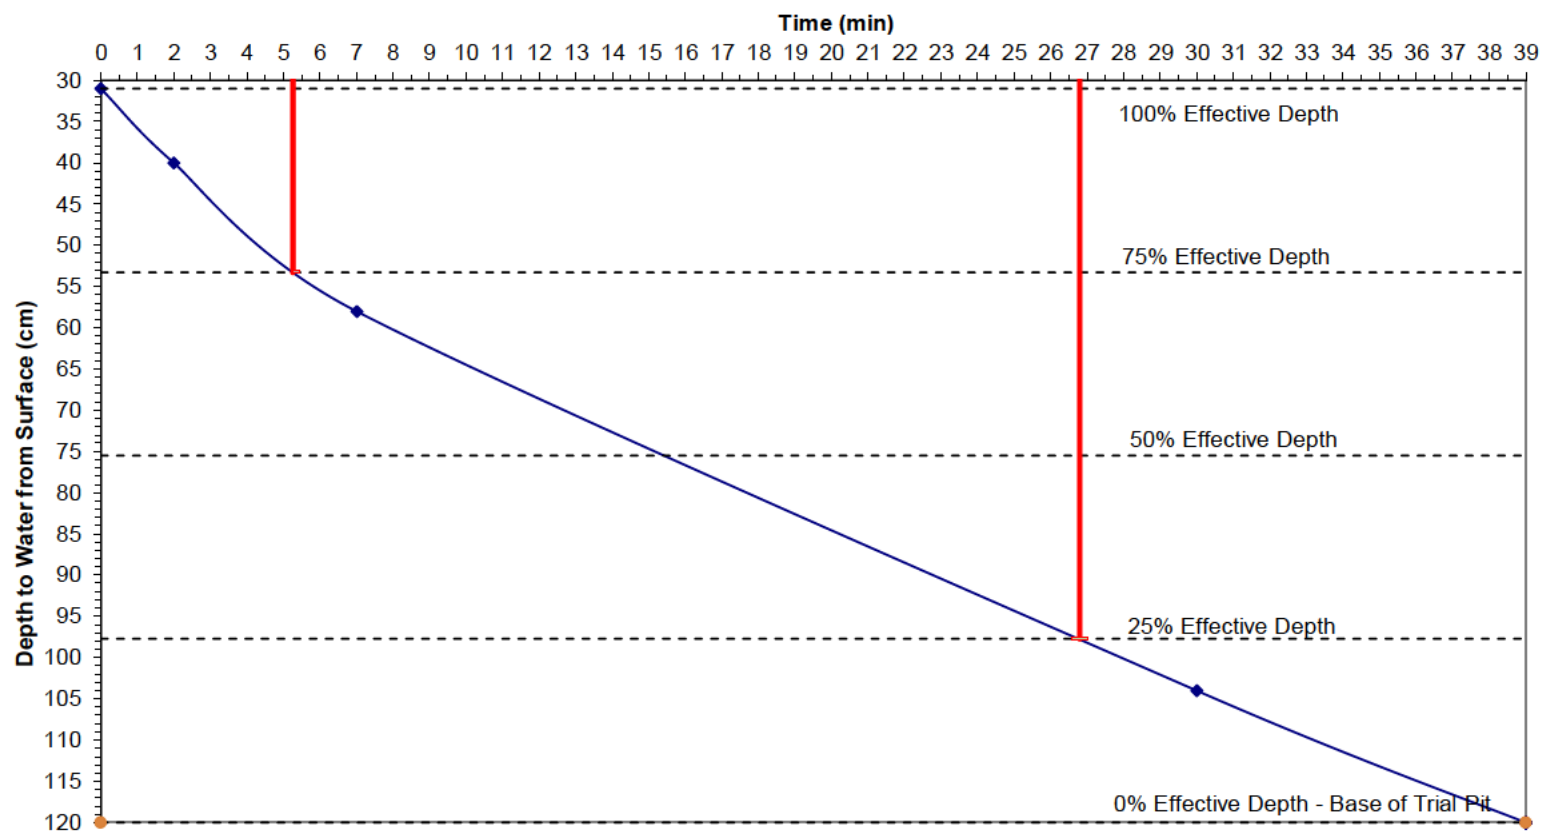
Parameter	Symbol	Calculation	Units	IT12
Effective Depth of Trial Pit	d_p		m	0.89
Width of Trial Pit	w		m	0.60
Length of Trial Pit	l		m	1.30
Volume of Trial Pit	V	$= d_p \times w \times l$	m ³	0.69
Volume of Trial Pit at 50% Effective Depth	V _{50%}	$= V \times 0.5$	m ³	0.3471
Internal Surface Area of Trial Pit*	a _{p50%}	$= l \times w + d_p \times (w + l)$	m ²	2.47
Time to reach 75% Effective Depth	T _{p75%}		min	5.25
Time to reach 25% Effective Depth	T _{p25%}		min	26.80
Time 25% - 75%	T _{p75%-25%}	$= T_{p25\%} - T_{p75\%}$	min	21.55
Infiltration Rate	f	$= V_{50\%} / a_{p50\%} \times (T_{p75\%-25\%})$	m/s	1.09E-04

Note: Infiltration test pit refused at 1.20m on weak grey LIMESTONE.
