**Phase 1 Desk Study**

**Phase 2a Preliminary Ground Investigation**

**Land off Woodbury Road, Sibford Ferris, Oxfordshire**

**Report: GCE01141/R1v2**

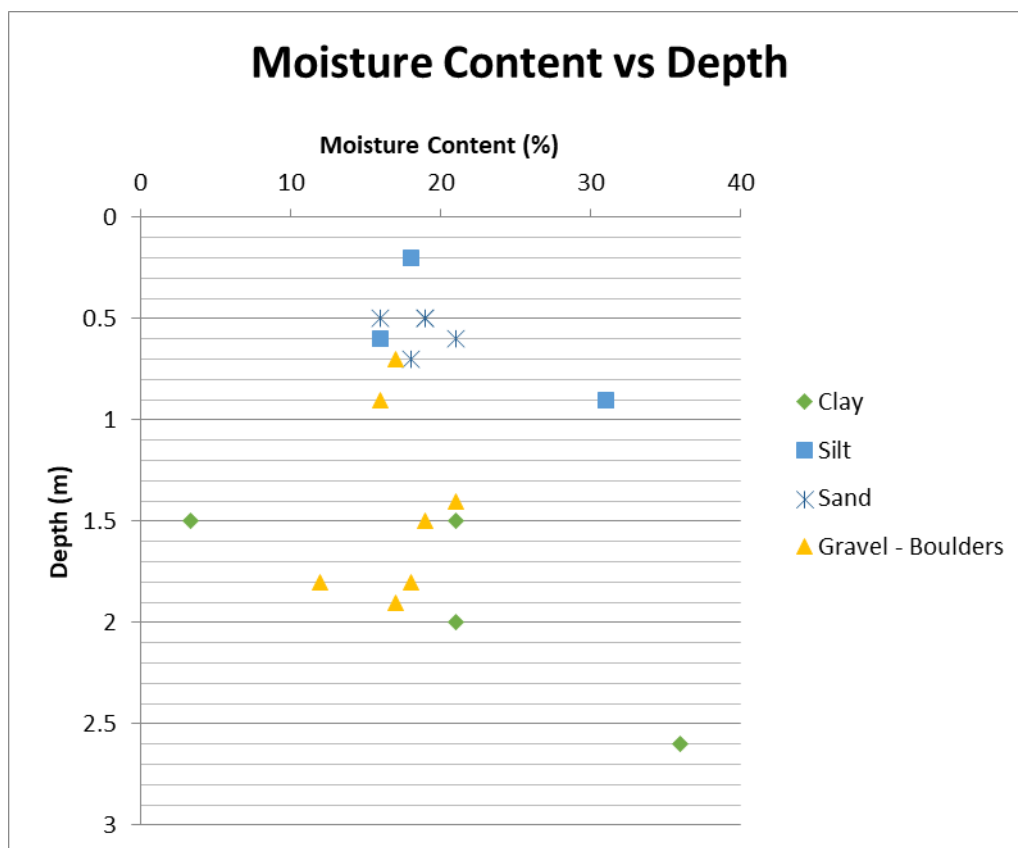
Nineteen soil samples were tested to determine their moisture content (W<sub>n</sub>). The moisture content results are shown in the plot below which shows depth versus moisture content by stratum:

The above plot shows moisture content percentages ranged from 3.3% to 36%.

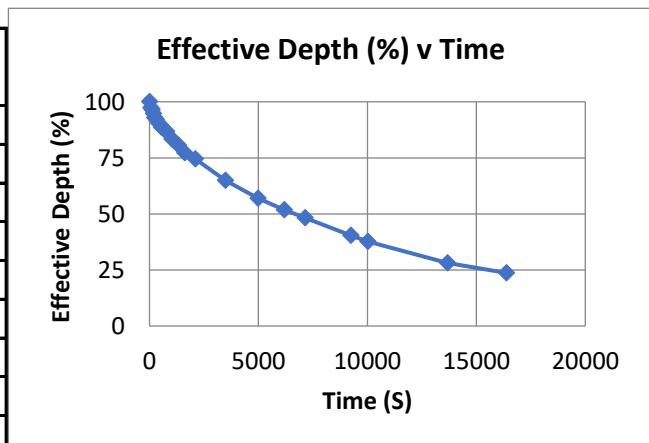
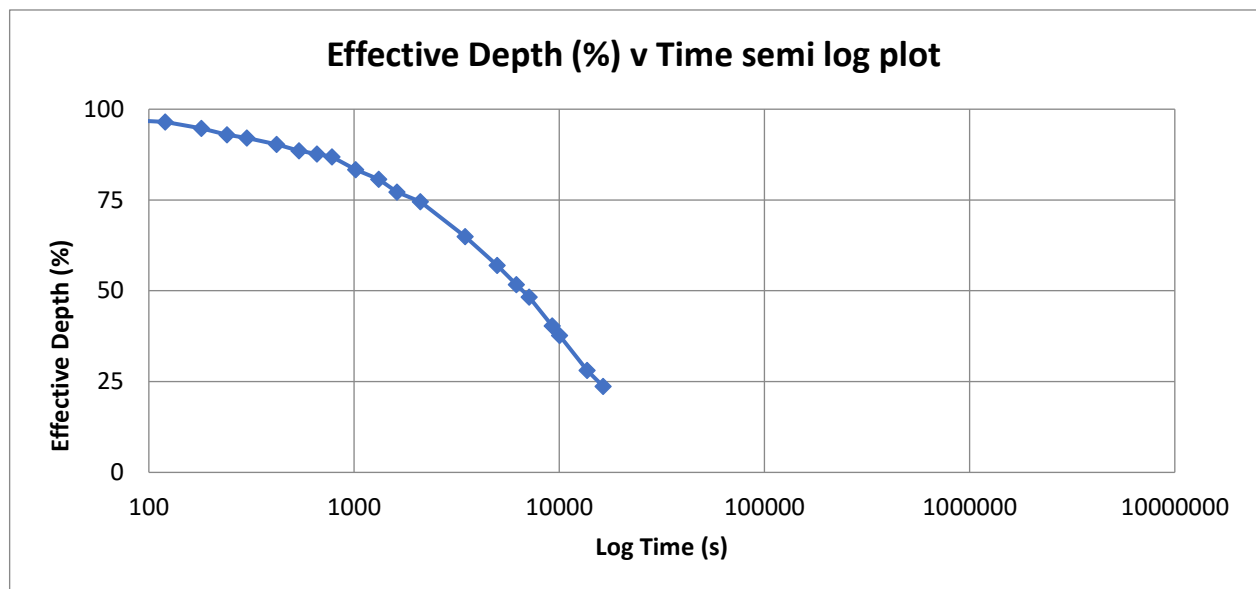
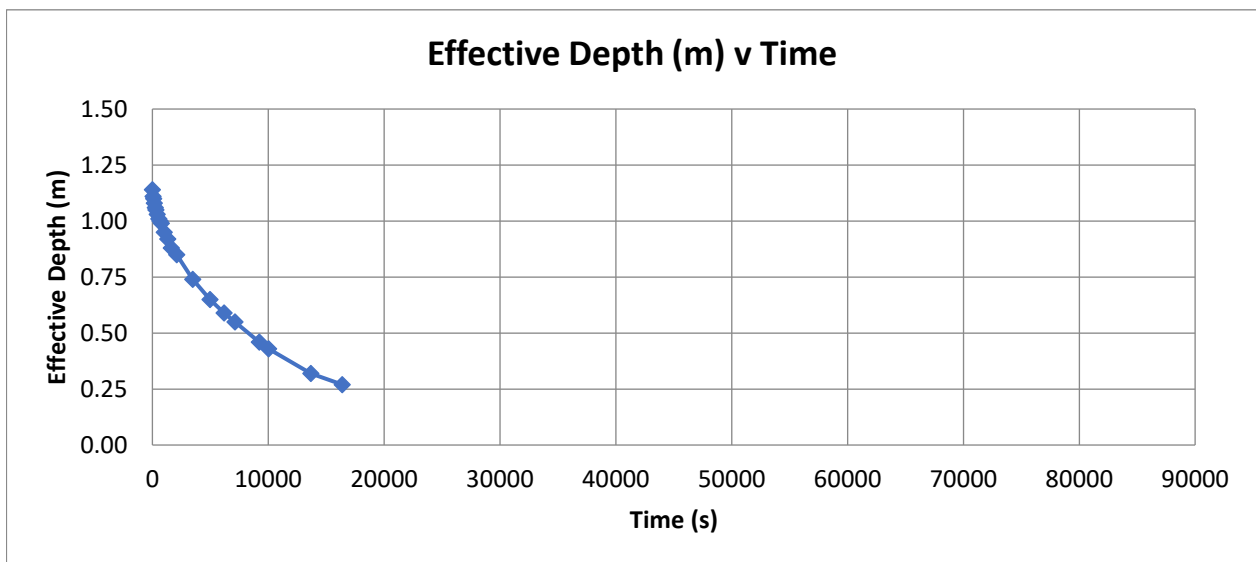
| Effective Depth % | Depth<br>(m) | Time<br>(s) |
|---|---|---|
| <b>Soil Infiltration Rate</b> | <b>1.29E-05</b> | <b>m/s</b> |

| Features | Summary |
|---|---|
| Infiltration Testing | Rapid rates of infiltration were encountered within two locations, anticipated to be as a result of water discharge into weathered limestone bedrock. Careful consideration should be given to the use and design of soakaway drainage within the weathered limestone at this site to ensure significant settlement does not occur.<br>The local drainage authority should be contacted for advice/ guidance on the use of soakaway drainage at this site. |

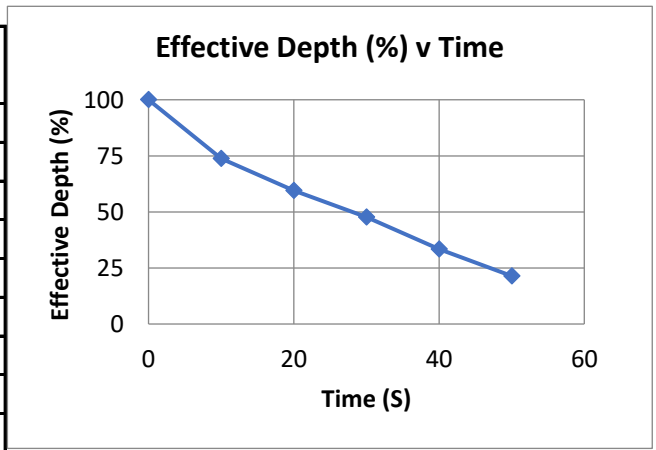
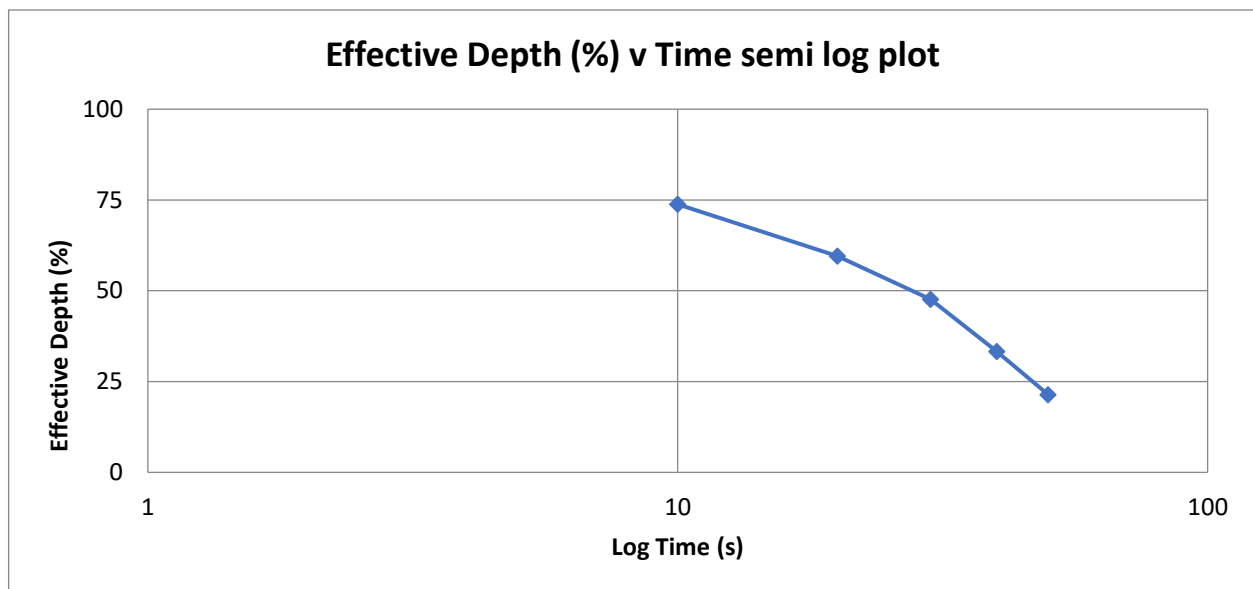
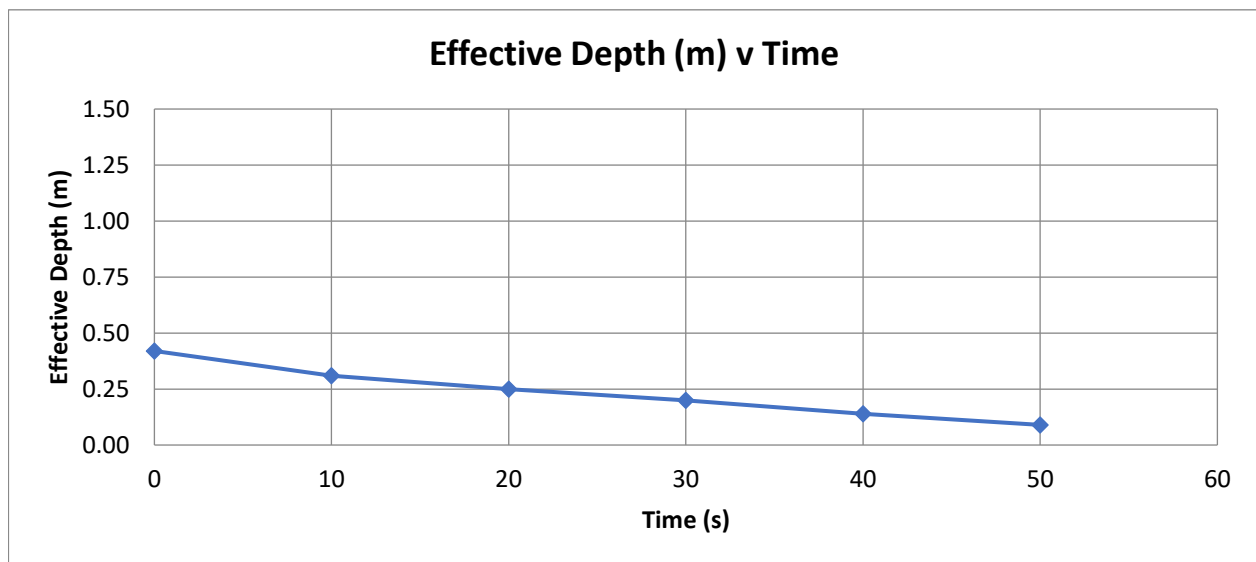
| | Depth (m) | Time (s) |
|---|---|---|
| <b>Soil Infiltration Rate</b> | <b>3.05E-03</b> | <b>m/s</b> |

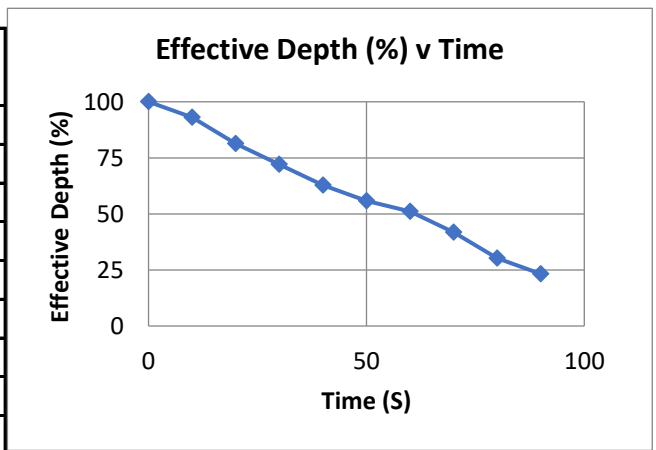
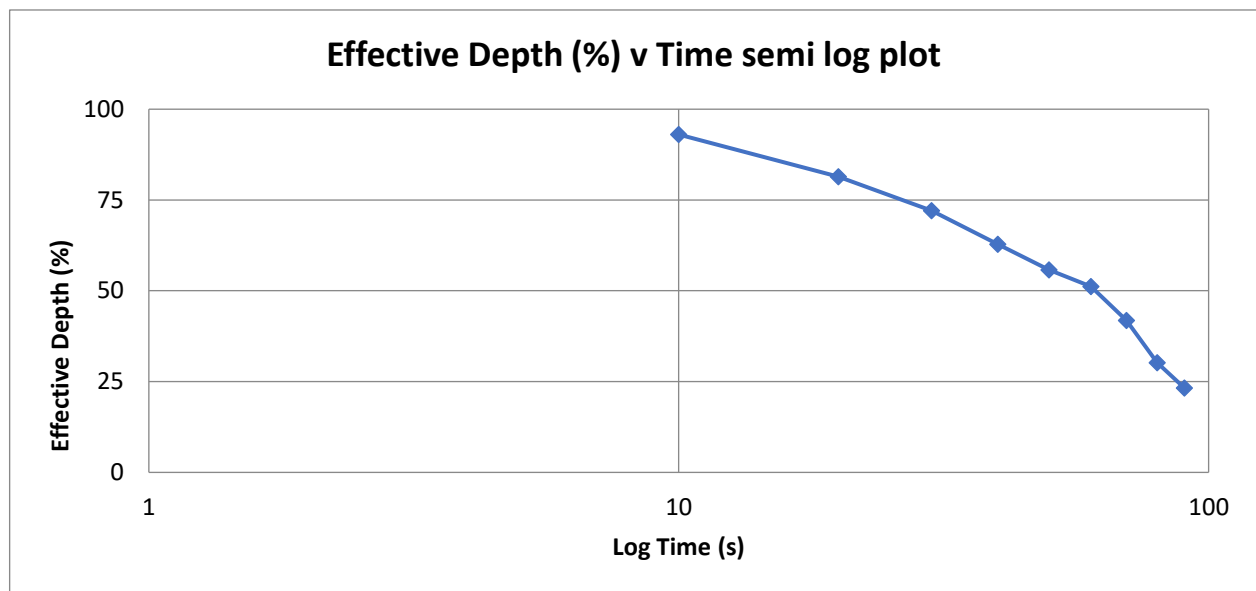
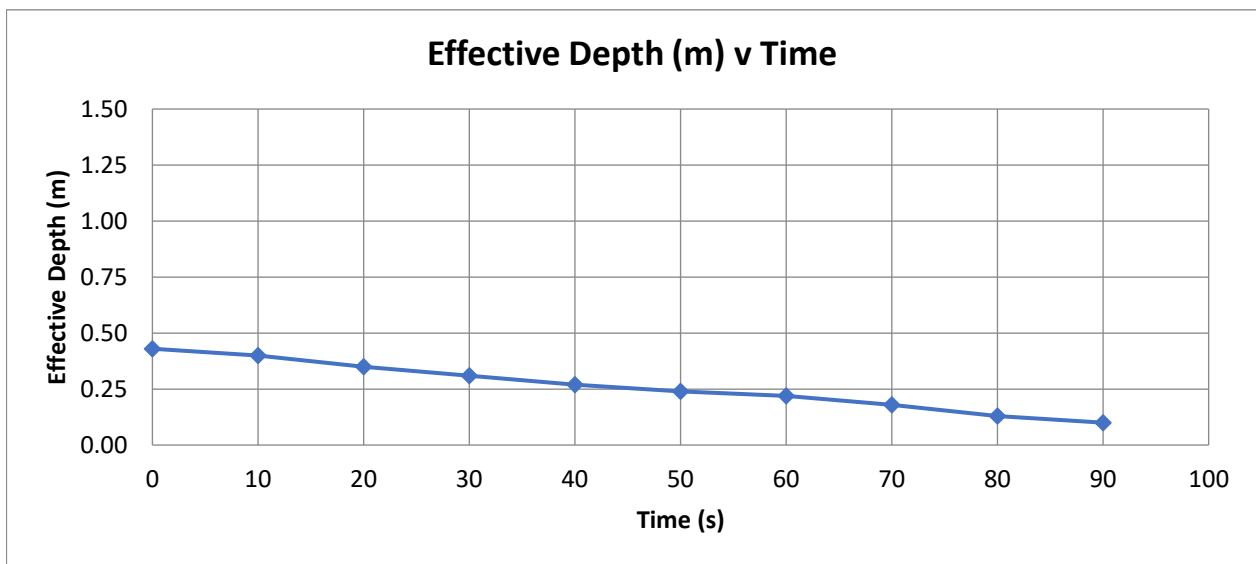
| | Depth<br>(m) | Time<br>(s) |
|---|---|---|
| <b>Soil Infiltration Rate</b> | <b>1.87E-03</b> | <b>m/s</b> |

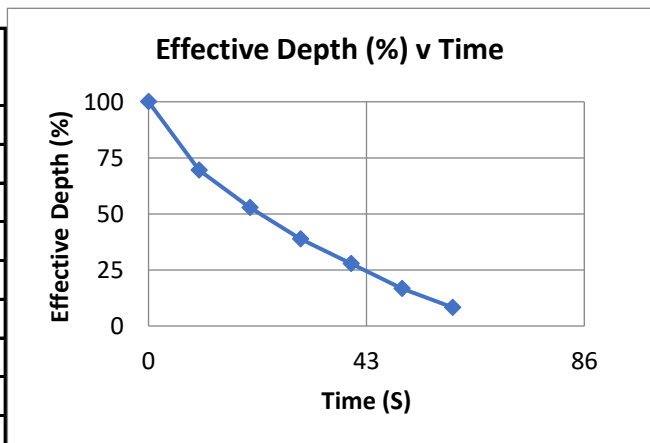
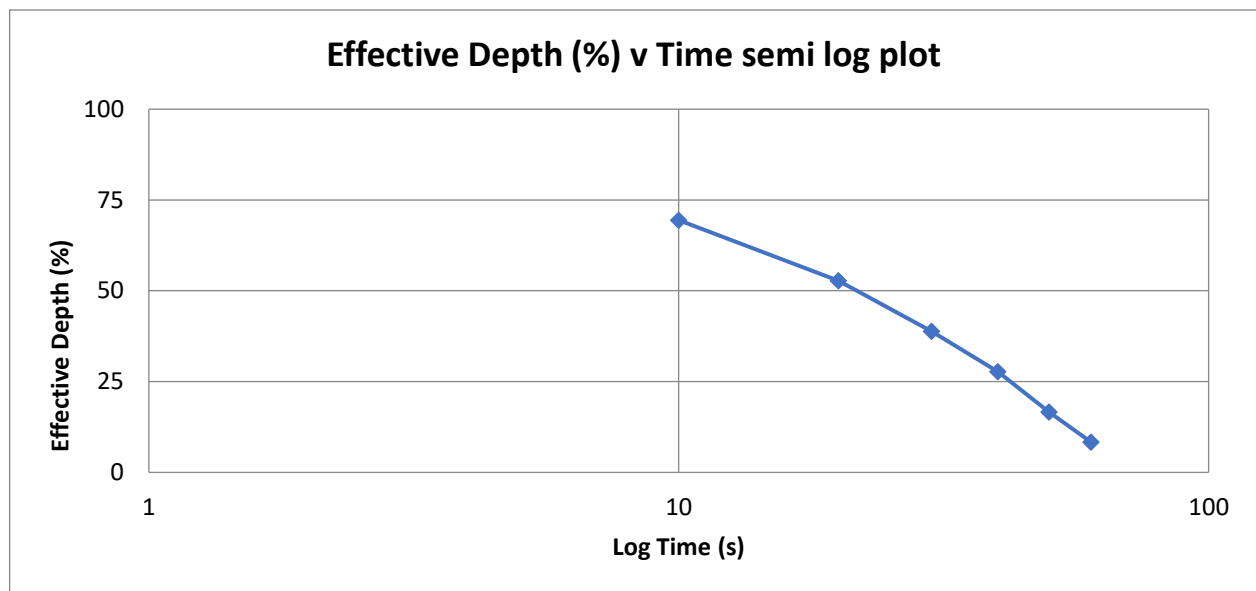
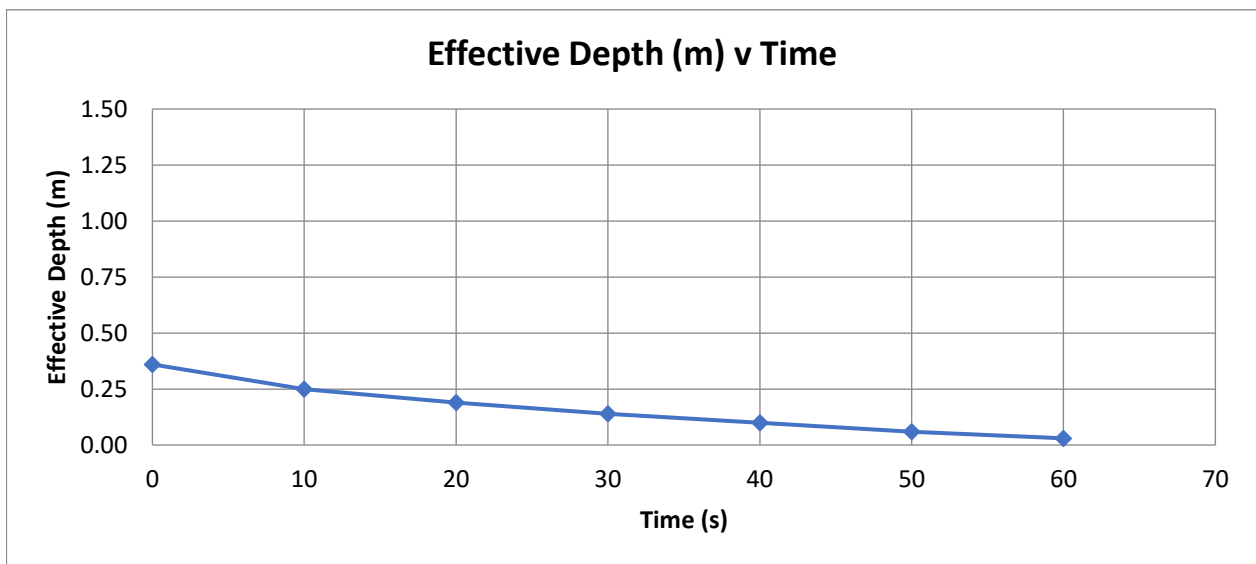
| | Depth<br>(m) | Time<br>(s) |
|---|---|---|
| <b>Soil Infiltration Rate</b> | <b>3.31E-03</b> | <b>m/s</b> |
