Phase 1 Desk Study

Phase 2a Preliminary Ground Investigation

Land off Woodbury Road, Sibford Ferris, Oxfordshire

Report: GCE01141/R1v2

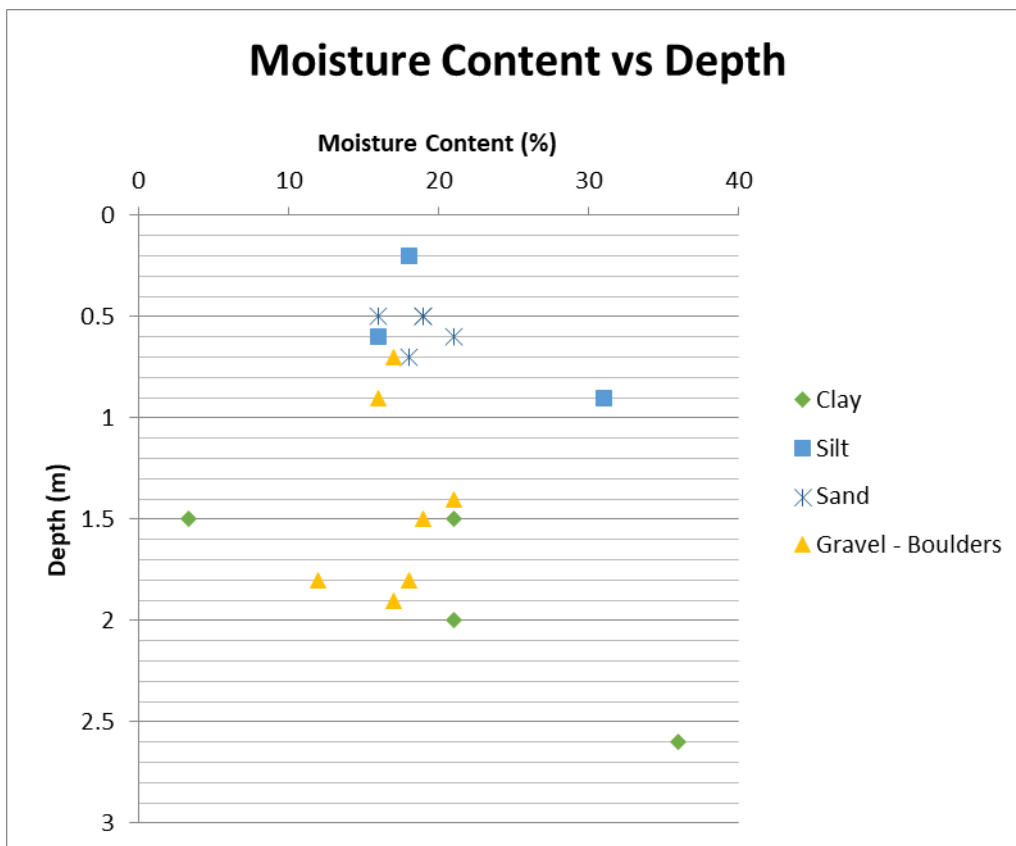
Moisture Content

Nineteen soil samples were tested to determine their moisture content (W_n). The moisture content results are shown in the plot below which shows depth versus moisture content by stratum:

The above plot shows moisture content percentages ranged from 3.3% to 36%.

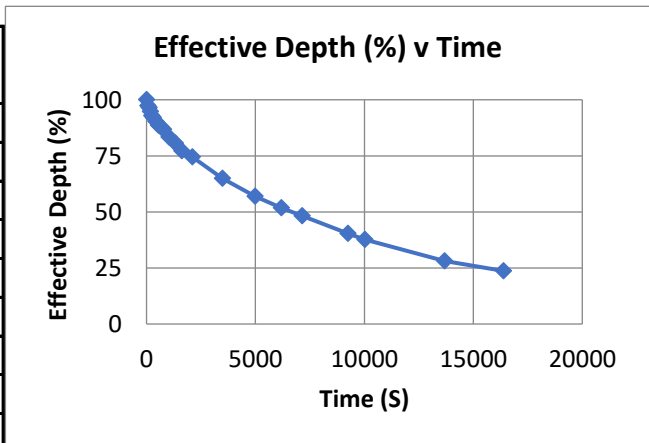
Effective Depth %	Depth (m)	Time (s)
75	0.855	2100
25	0.285	16000
	Vp75-25	tp75-25
Sum	0.8379	13900
Base	1.47	m ²
Side long	1.197	m
Side short	0.399	m
ap50	4.662	m ²
Soil Infiltration Rate	1.29E-05	m/s

Infiltration Testing	Rapid rates of infiltration were encountered within two locations, anticipated to be as a result of water discharge into weathered limestone bedrock. Careful consideration should be given to the use and design of soakaway drainage within the weathered limestone at this site to ensure significant settlement does not occur. The local drainage authority should be contacted for advice/ guidance on the use of soakaway drainage at this site.
