Sibford School
The Hill, Back Lane,
Sibford Ferris

Biodiversity Enhancement Strategy

Prepared by
Griffin Ecology Ltd.

Project No. GE0314

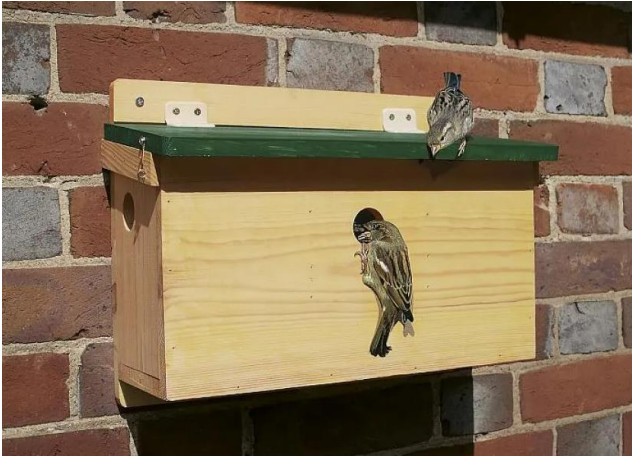
Boxes will include 2x House Sparrow Terrace FSC Nest Box and 3x Vivara Pro Barcelona WoodStone Open Nest Box or similar.

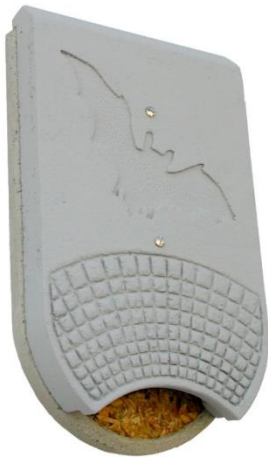
A total of 4 bat boxes will be provided as part of the development in an effort to secure additional bat roosting opportunities post works. The boxes will include 1x 1FQ Schwegler Bat Roost to be mounted on the new pavilion building and 3x 2F Schwegler Bat Boxes to be mounted on retained trees.

The 1FQ box will be sited on south eastern gable end of the new pavilion at the gable apex to a height of at least 4m from ground level. This southerly elevation is chosen to ensure maximum chance of occupation success.

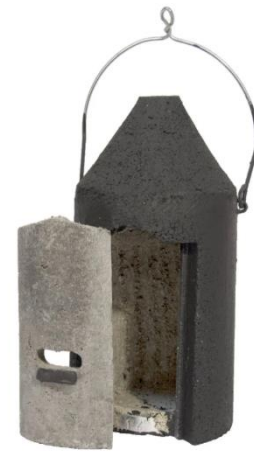
2F Schwegler Bat Box

The 3x 2F general purpose, tree mounted bat boxes will be sited to the southern side of the three retained and protected trees on site at a height of between 4m and 6m from ground level.
