Document Title Geo-Environmental Phase 1 Desk Study

Document Ref 10669 DS01 Rv1

Project Name Land at Gosford

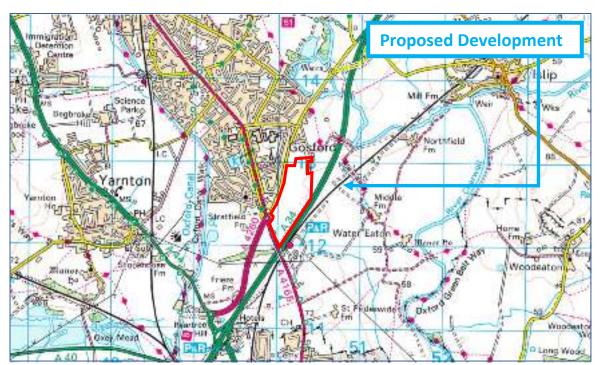
Figure 2-1: Site Location

- 2.1 The proposed development lies to the south east of the village of Kidlington and is approximately 27.75ha.
- 2.2 The Site is bound to the north by existing agricultural land/fields and to the east by agricultural fields, Water Eaton Lane and the A34. The south of the Site is bound by Oxford Road and the west to Bicester Road. A cemetery is situated adjacent to the north-west of the Site, off Bicester Road.
- 2.3 The site is currently undeveloped agricultural land and the land is not thought to have been historically subject to any significant built development. The Site location and boundary is shown indicatively on **Figure 2-1**, below:

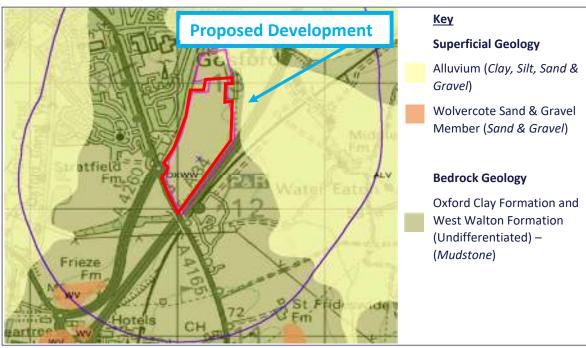
Figure 5-1: BGS Published Combined Geology

5.1 With reference to the BGS map, the entire Site is shown to be underlain by mudstone of the Oxford Clay Formation and West Walton Formation (Undifferentiated). The north-eastern corner of the Site includes for superficial Alluvium deposits, comprising clay, silt, sand and gravel. This is illustrated in **Figure 5-1**:

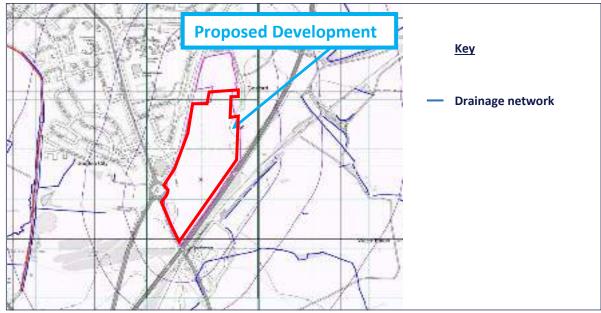
Figure 6-1: FEH web service - Urban Extent 2000 and BGS Hydrology and Drainage Network

- 6.3 The River Cherwell is located approximately 550m north-east of the Site and the Oxford Canal is situated approximately 800m west of the Site.
- The site is shown to have limited development on site but located on the outskirts of the currently developed Kidlington. **Figure 6-1** illustrates the watercourse and feature described above.

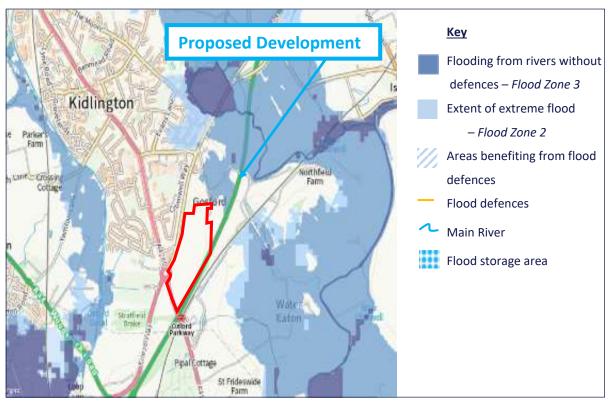
Figure 6-2: EA Flood Zone Plan showing 1 in 100 & 1 in 1,000 year floodplains

6.5 The EA mapping shows that almost the entire Site lies within Flood Zone (FZ) 1; being an area of Low Probability of flooding and outside both the 1 in 100 (1% AEP) and 1 in 1,000 (0.1% AEP) year flood events. However, a small area in the north-eastern corner of the Site potentially lies within FZ2 and FZ3. These are areas assessed as having between a 1 in 100 and 1 in 1,000 annual probability of river flooding (1% – 0.1%) and a 1 in 100 or greater annual probability of river flooding (>1%). This is illustrated on **Figure 6-2**.

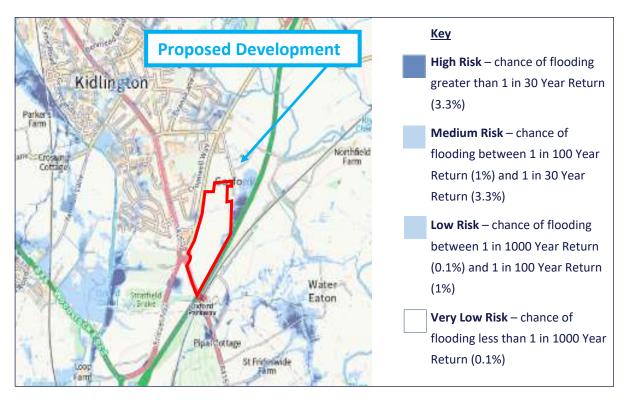
Figure 6-3: EA Long Term Flood Risk Maps – Flood risk from Surface Water (Gov.Uk website)

6.6 **Figure 6-3** illustrates areas the Site has a very low risk of surface water flooding. However, a small area in the east is shown to have a medium to high risk from surface water flooding.

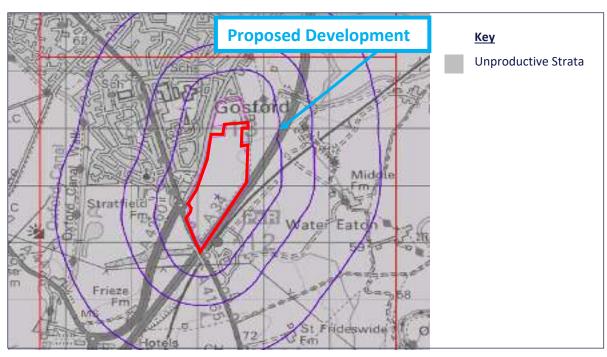
Figure 7-1: BGS Bedrock Geology Aquifer Designation

7.1 The underlying mudstone bedrock is shown to form an Unproductive Strata, whilst the superficial Alluvium deposits on and off Site are shown to form a Secondary A Aquifer, as illustrated below in **Figure 7-1** and **Figure 7-2**:

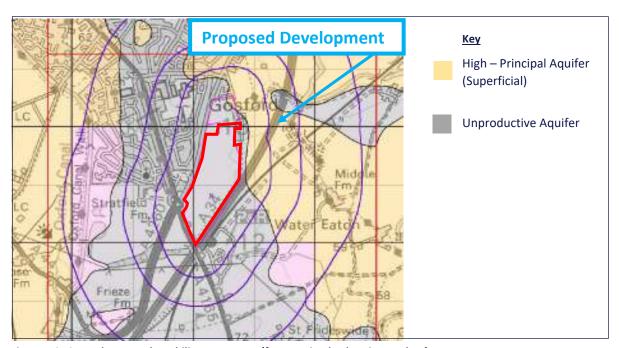
Figure 7-3: Groundwater Vulnerability Zones Map (from Envirocheck, using EA data)

- 7.3 The EA has recently updated their Groundwater Vulnerability Zones (GVZ) Map, this now includes 5 risk categories (High, Medium High, Medium Low and Low). The Map summarises the overall risk to groundwater, taking into account groundwater vulnerability, the types of aquifer present (superficial and/or bedrock) and their designation status.
- 7.4 **Figure 7-3** is an extract of their simplified GVZ map from the Envirocheck, which assesses the groundwater vulnerability risk for both Bedrock Geology and Superficial Deposits. The risk to the Site. The indicative risk on Site is shown to be 'Unproductive'. Areas to the east adjacent to the Site are shown to be of high vulnerability, from the Superficial Deposits.

- 7.5 It should therefore be noted, that the EA maps provide an overall groundwater vulnerability. The area identified as "high" risk, is shown in EA mapping, incorporating the Bedrock Geology and Superficial Deposits as "medium-low" vulnerability.
- 7.6 The EA provides the following definitions for the five GVZs:
