20th December 2018
314228 L01 (00)

FACTUAL INFILTRATION TESTING REPORT, LAND SOUTH OF CASTLE STREET, DEDDINGTON

This letter presents the results of infiltration testing undertaken for the Land South of Castle Street, Deddington. RSK's service constraints are presented within **Appendix A**.

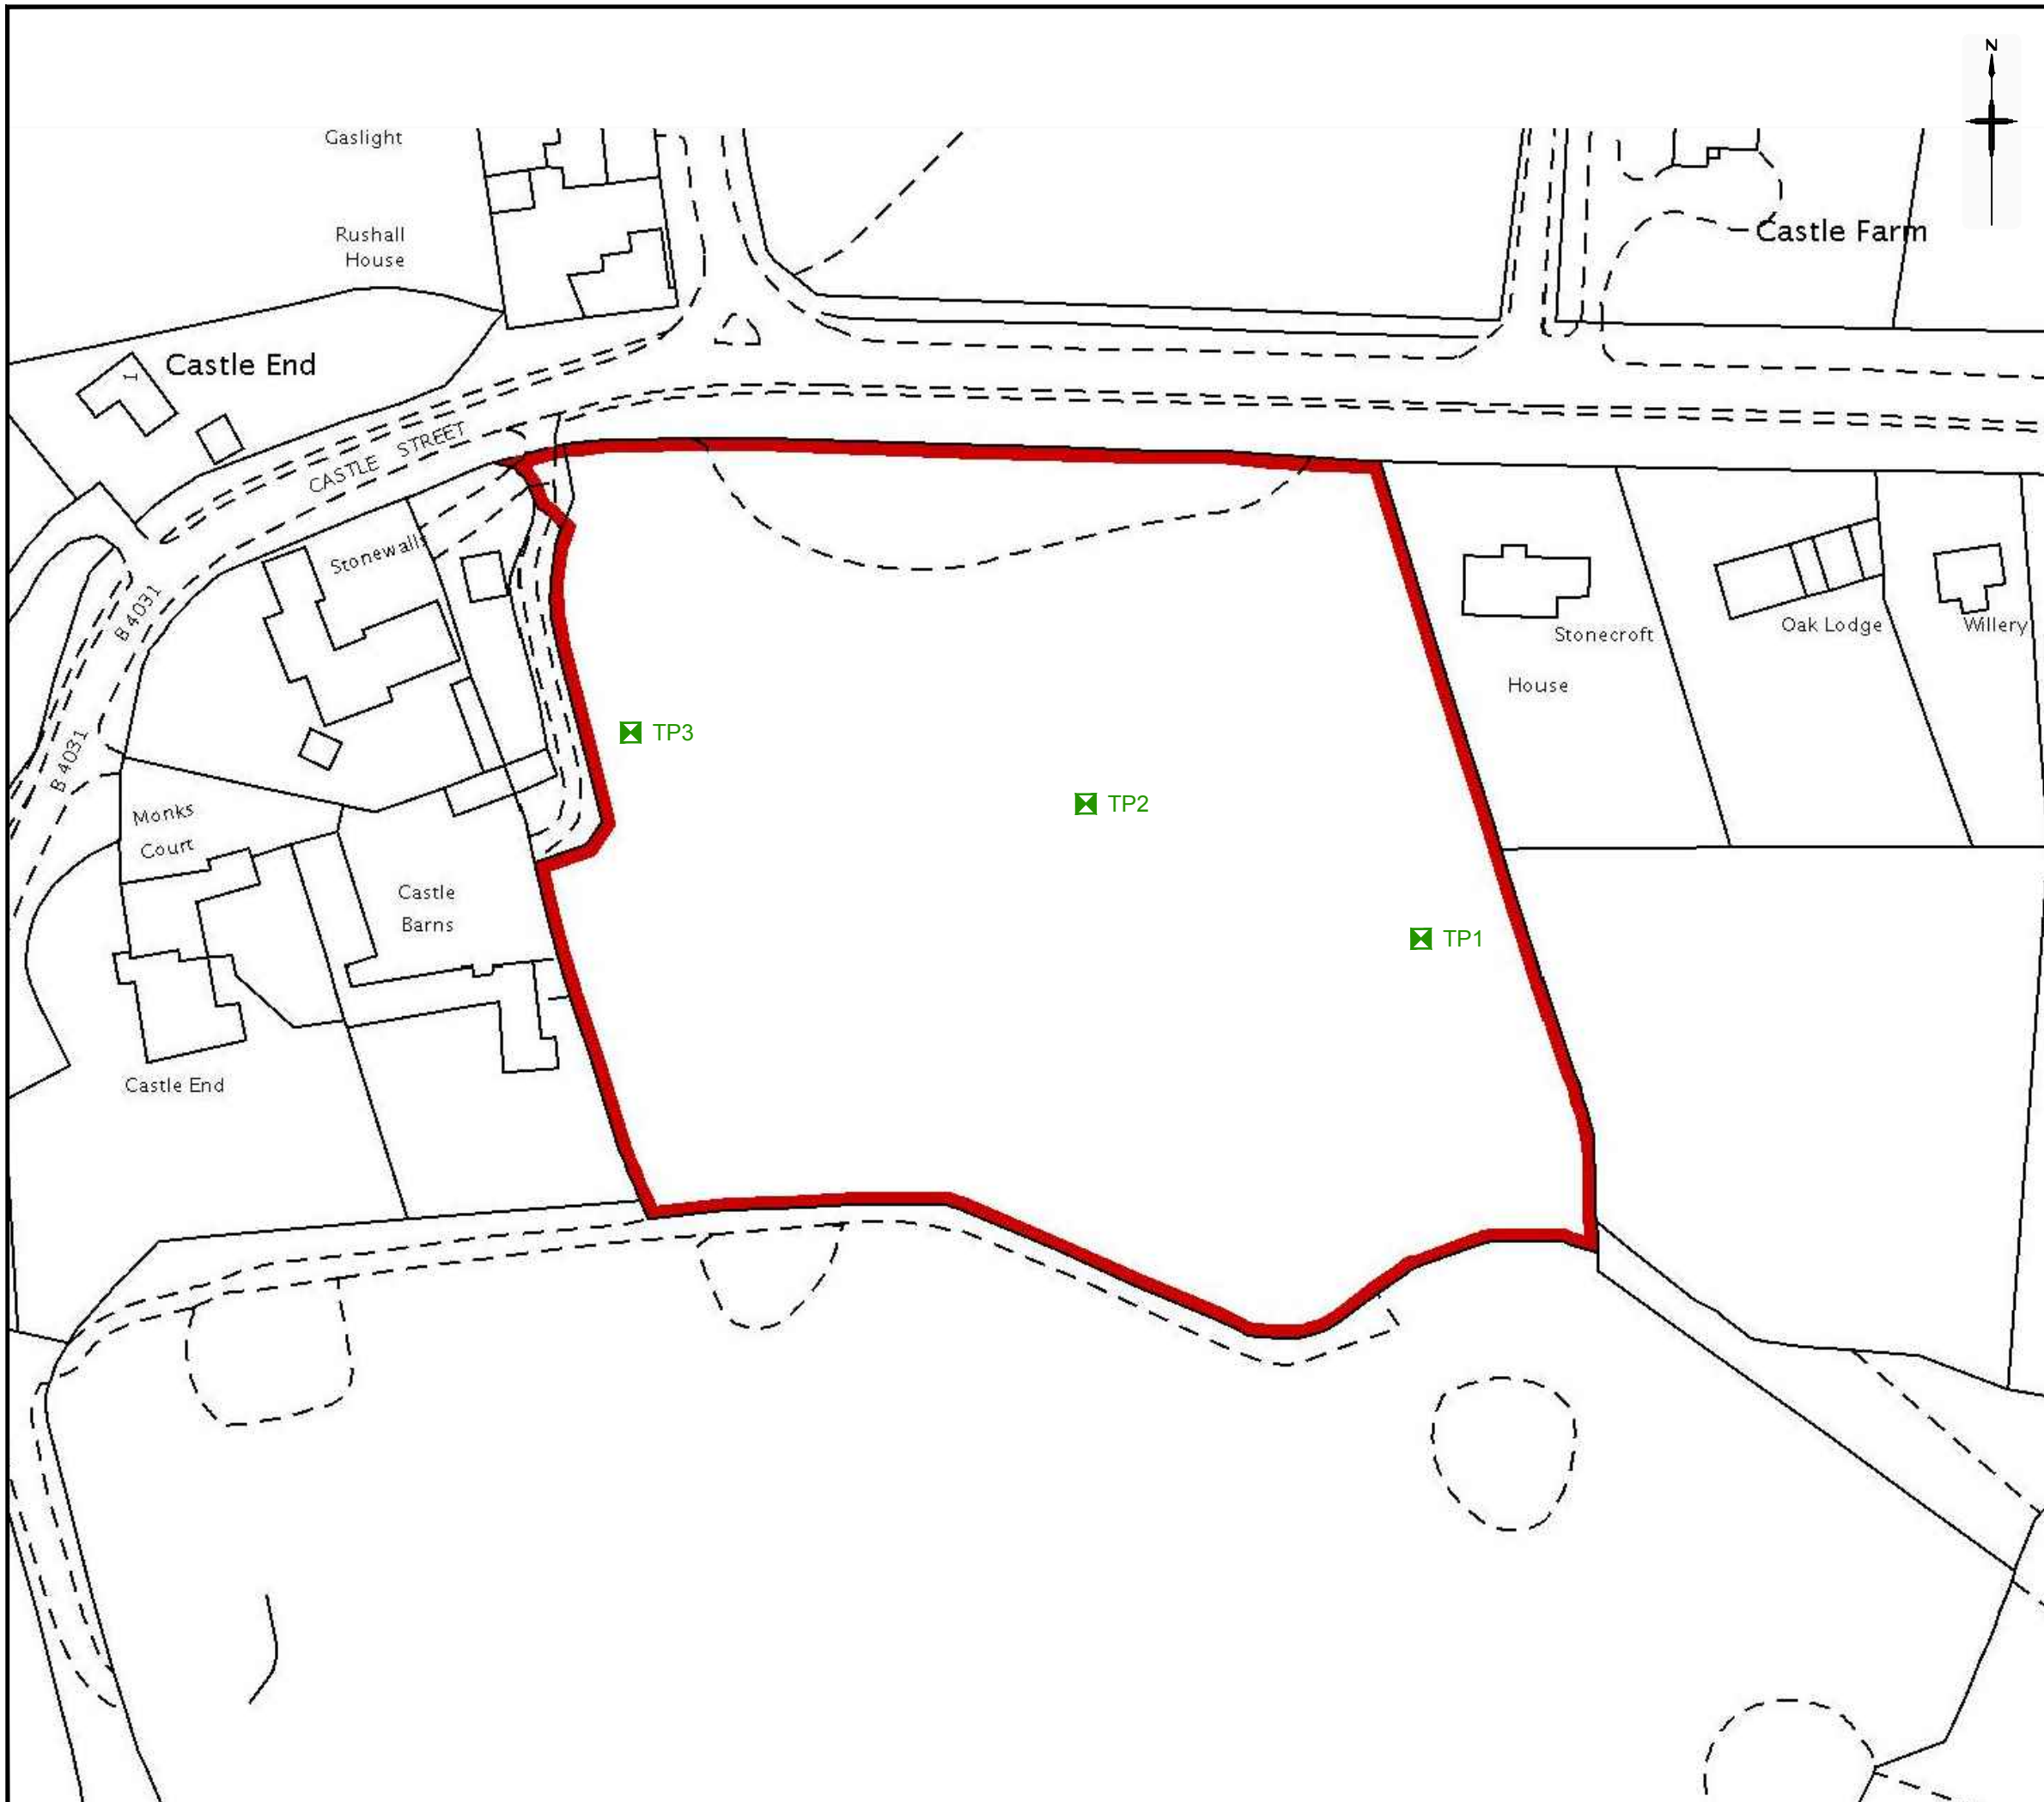
Drawing No.	Rev.
FIGURE 2	P1

The locations of the intrusive investigations are shown in **Figure 2**.

The exploratory logs are summarised in **Table 1** and reported in detail in **Appendix C**. Exploratory hole locations are shown on the site plan in **Figure 2**.

Drawing Title
EXPLORATORY HOLE LOCATION PLAN

The 3 No. trial pits were excavated (TP1 - TP3) using mechanical excavation techniques. The locations and depths of the soakaway test pits were chosen by RSK, in order to provide a general spread across the site.

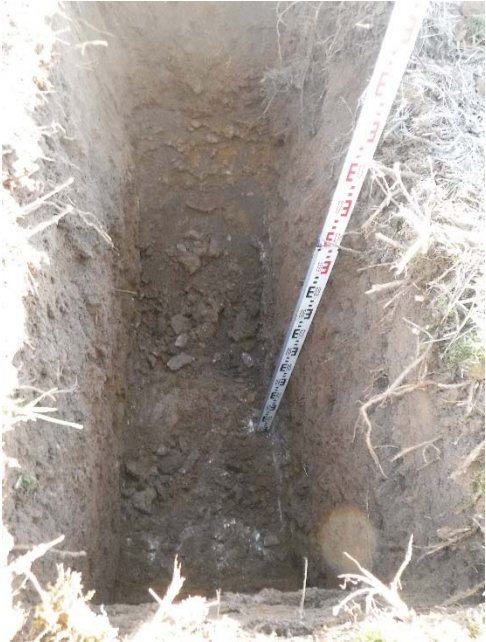
Photo no. 5	Date: 04/12/18

Description: View showing the full extent of TP3 with limestone gravel at the base.

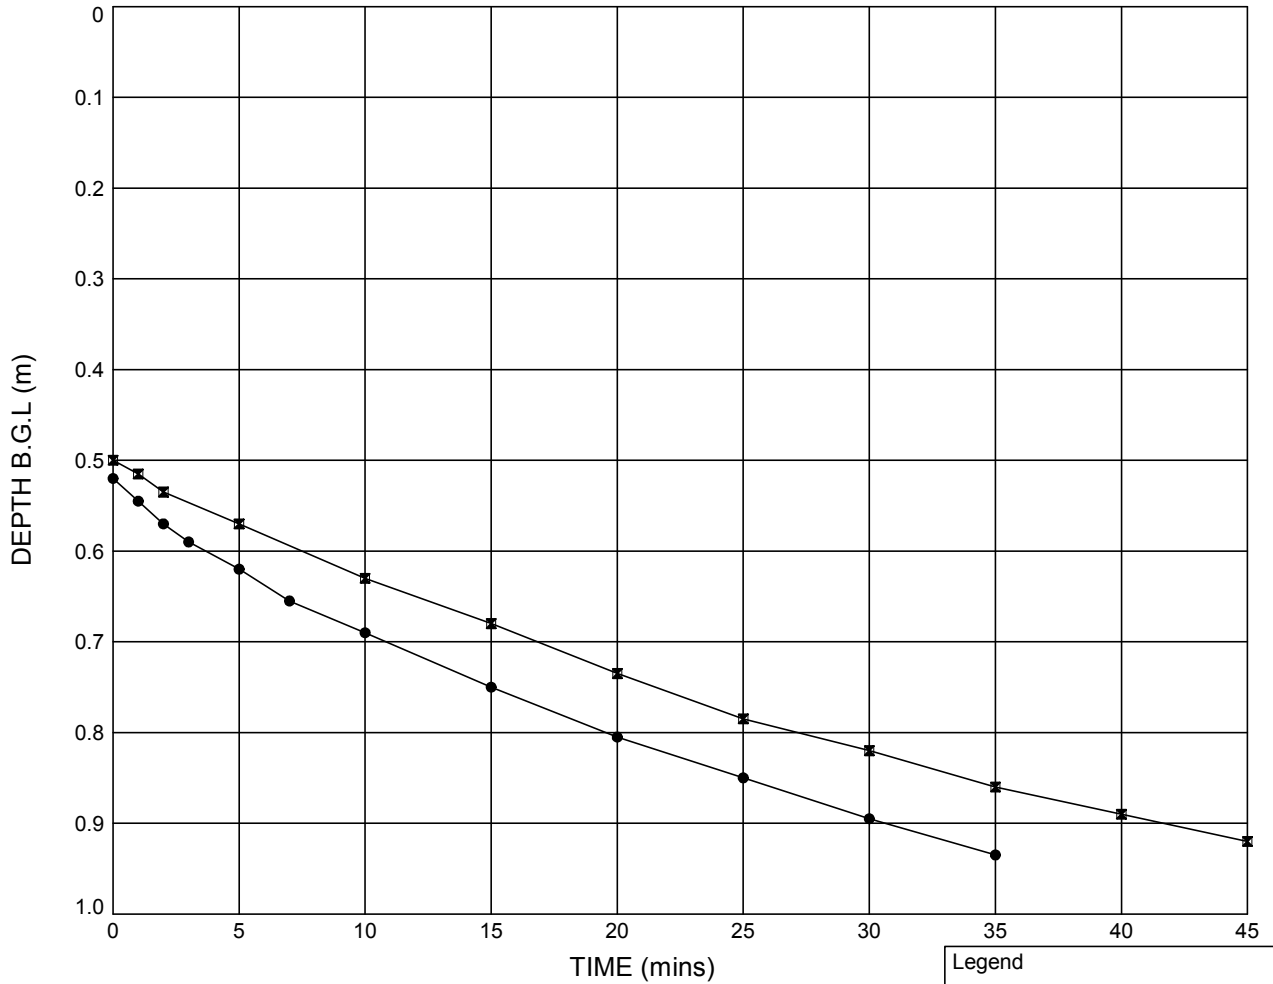
Soakaway Test - Position ID : TP1

Plot of Depth of Water Below Ground Level Against Time

Test 1	Test 2	
Pit start depth:	= 1.05	1.05	m
Pit final depth:	= 1.05	1.04	m
Effective depth, D_e	= 0.53	0.54	m
Effective storage volume, V_{p75-25}	= 0.3101	0.3159	m^3
Surface area, a_{p50}	= 2.5215	2.5470	m^2
Time, t_{p75-25}	= 1558	1920	secs
Infiltration rate, f	= 7.89×10^{-5}	6.46×10^{-5}	m/s

Trial Pit	Test base depth (m bgl)			Length of test (minutes)			Infiltration rate (m/s)		
	1	2	3	1	2	3	1	2	3
TP1	1.05	1.05	-	26	32	-	7.89x10 ⁻⁵	6.46x10⁻⁵	-
TP2	1.58	1.57	-	16	16	-	1.19x10⁻⁴	1.26x10 ⁻⁴	-
TP3	1.46	1.46	1.42	9	11	12	2.36x10 ⁻⁴	2.11x10 ⁻⁴	1.91x10⁻⁴

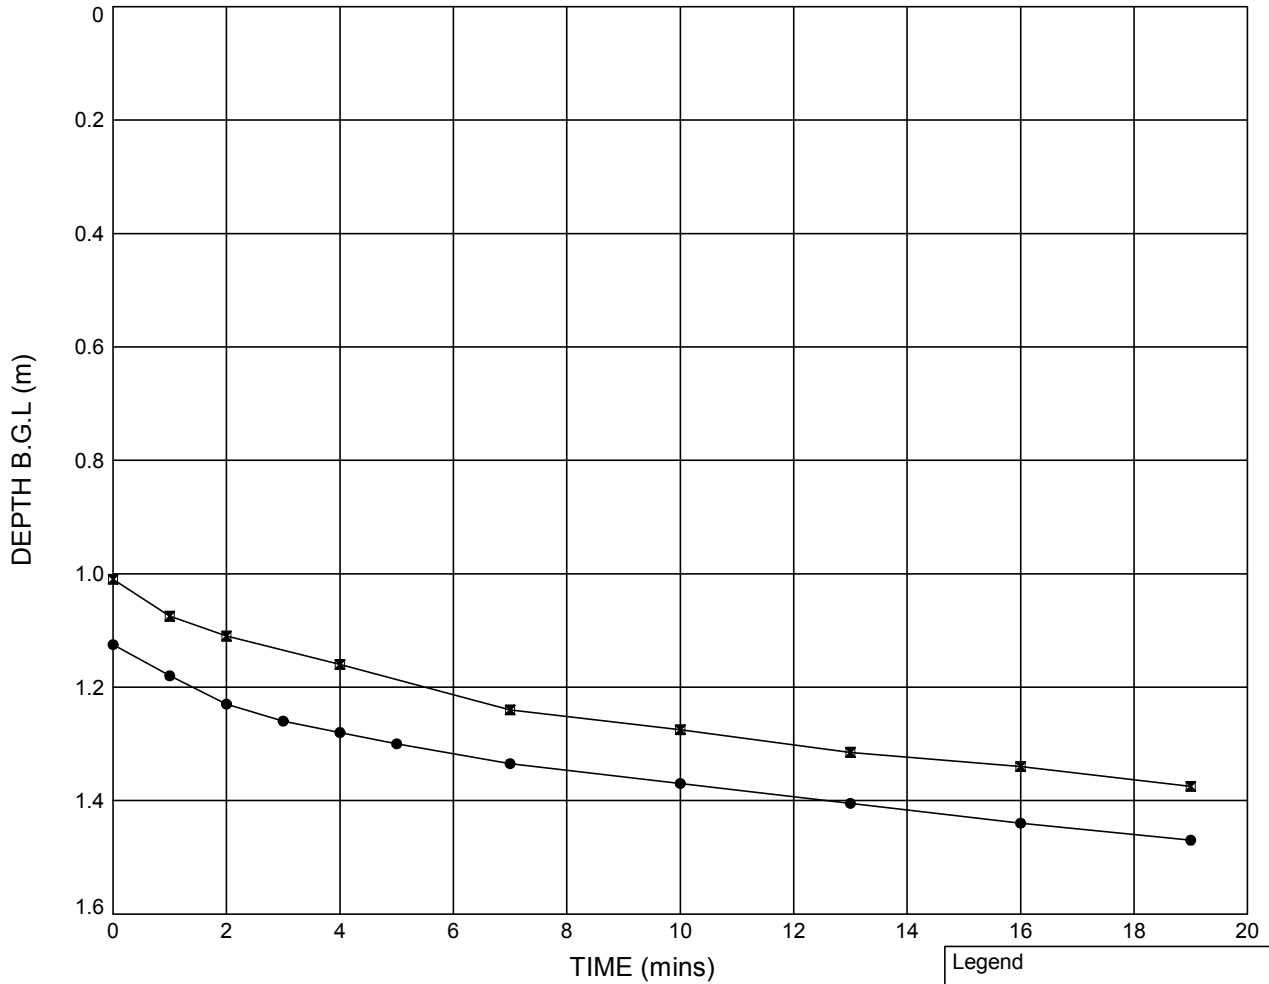
Soakaway Test - Position ID : TP2

PLOT OF DEPTH OF WATER BELOW GROUND LEVEL AGAINST TIME

Test 1	Test 2	
Pit start depth:	= 1.58	1.58	m
Pit final depth:	= 1.57	1.48	m
Effective depth, D_e	= 0.45	0.47	m
Effective storage volume, V_{p75-25}	= 0.2470	0.2609	m ³
Surface area, a_{p50}	= 2.2003	2.2615	m ²
Time, t_{p75-25}	= 940	914	secs
Infiltration rate, f	= 1.19×10^{-4}	1.26×10^{-4}	m/s

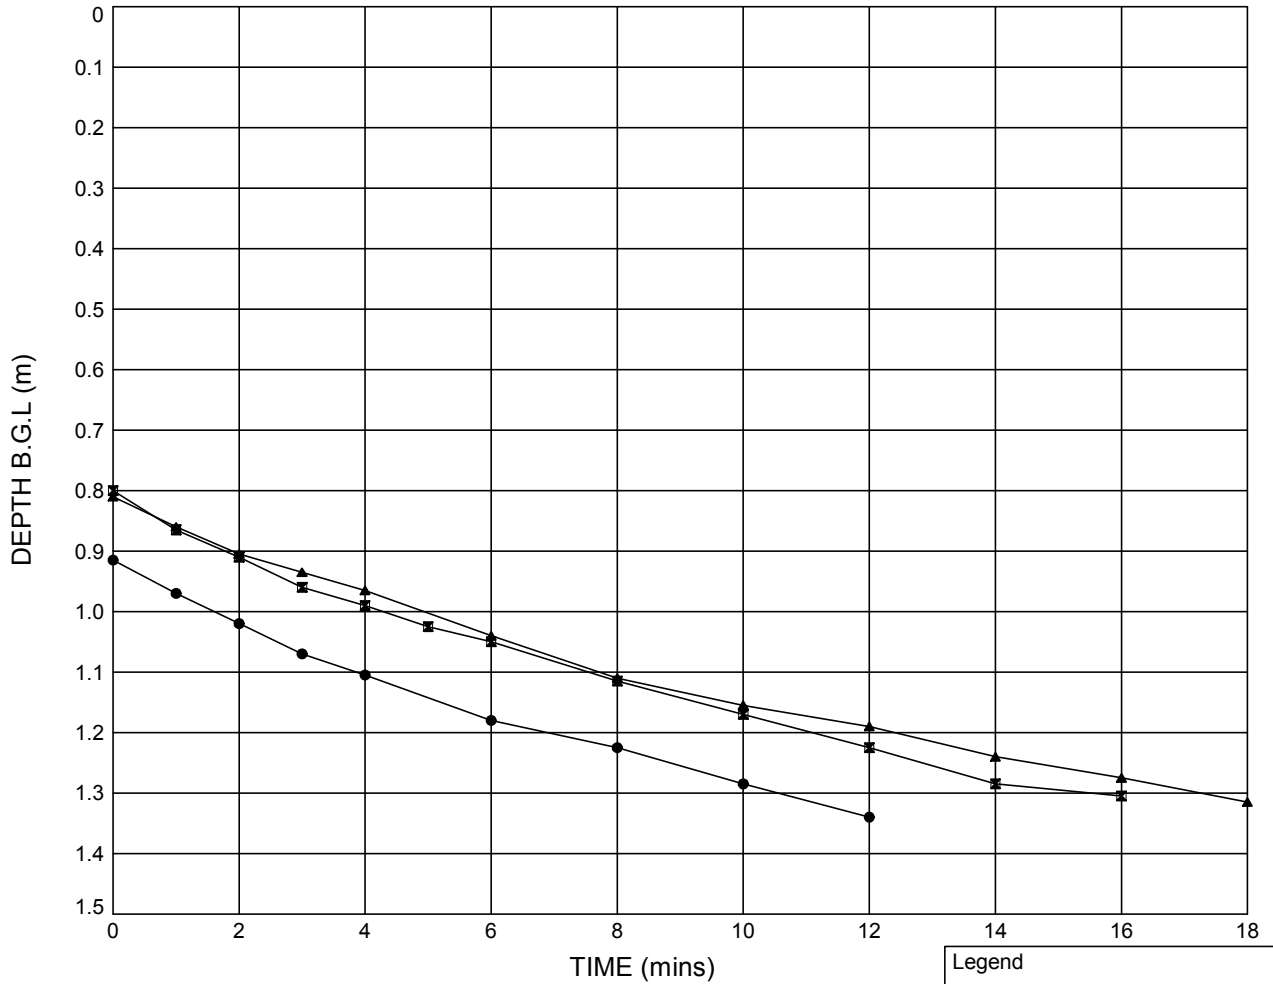
Soakaway Test - Position ID : TP3

Plot of Depth of Water Below Ground Level Against Time

Test 1	Test 2	Test 3	
Pit start depth:	= 1.46	1.46	1.42	m
Pit final depth:	= 1.46	1.42	1.41	m
Effective depth, D_e	= 0.55	0.62	0.60	m
Effective storage volume, V_{p75-25}	= 0.3188	0.3627	0.3510	m^3
Surface area, a_{p50}	= 2.5598	2.7510	2.7000	m^2
Time, t_{p75-25}	= 527	626	679	secs
Infiltration rate, f	= 2.36×10^{-4}	2.11×10^{-4}	1.91×10^{-4}	m/s
