# Preliminary Geo-Environmental Risk Assessment

Banbury Logistics Park, Oxford

Presented to: **Greystoke Land**

Delta-Simons Project No: 21-2141.02

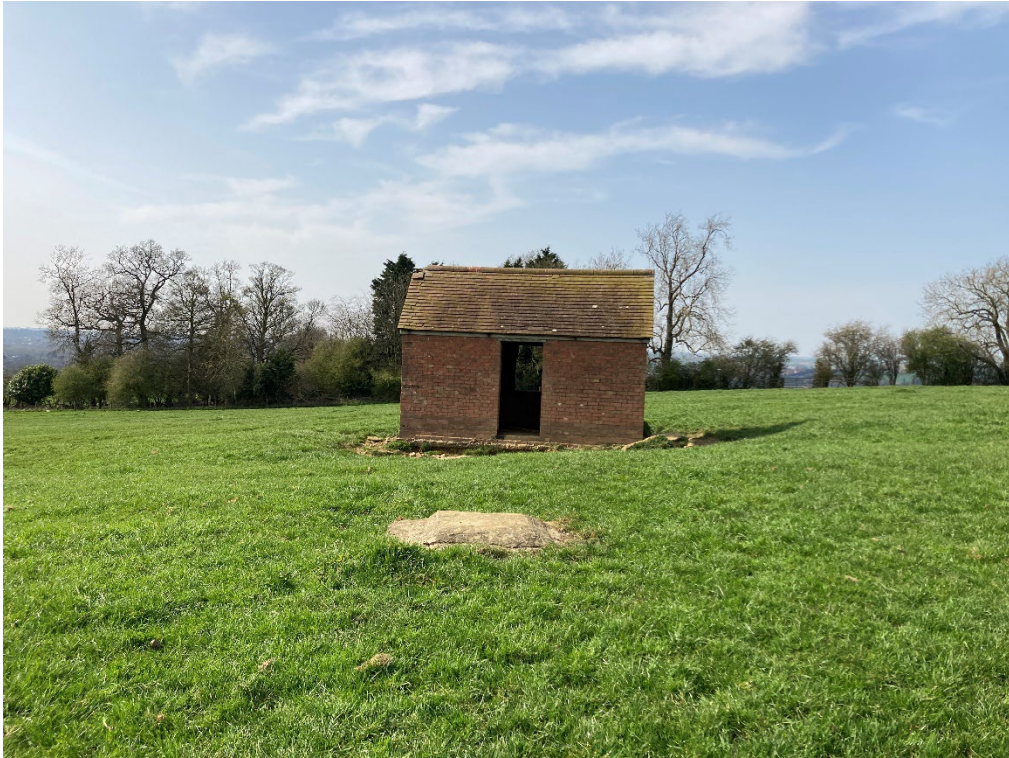
**Photograph 5 - Small brick outhouse located in easternmost field**

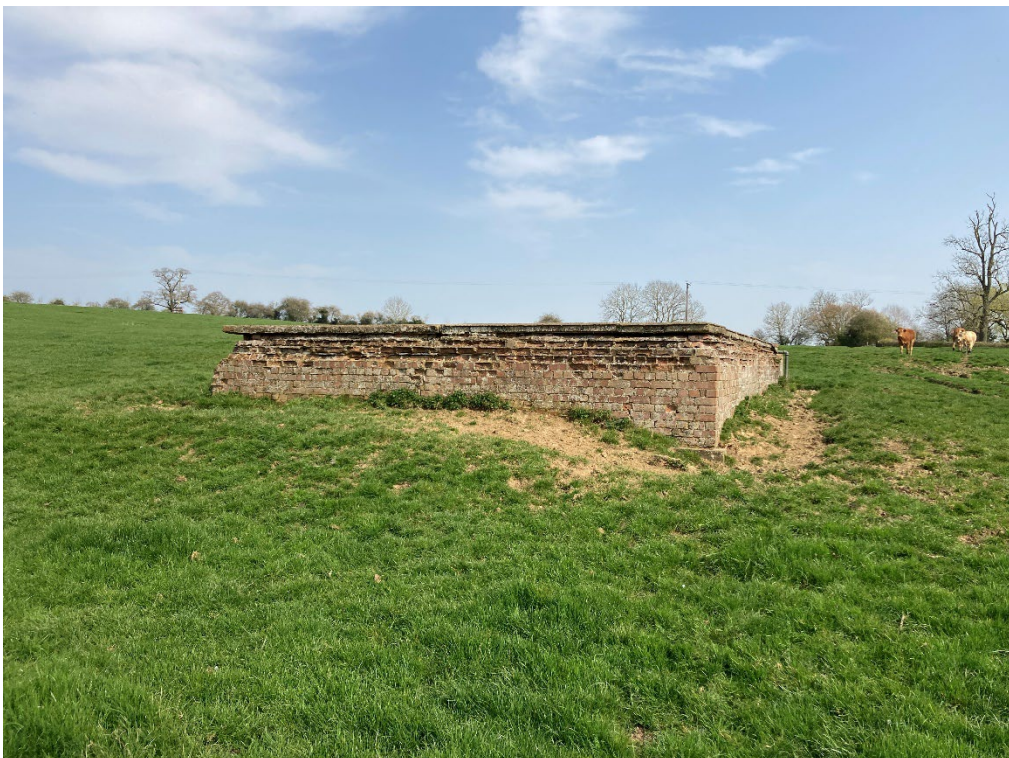
**Photograph 6 - Relict structures considered to relate to a former water tank in the easternmost field**
