Phase I & II Geo-Environmental Report

Project: Hook Norton Road, Sibford
Ferris, Banbury,
OX15 5BP

Reference: C85855-JNP-XX-XX-RP-G-0001 P02

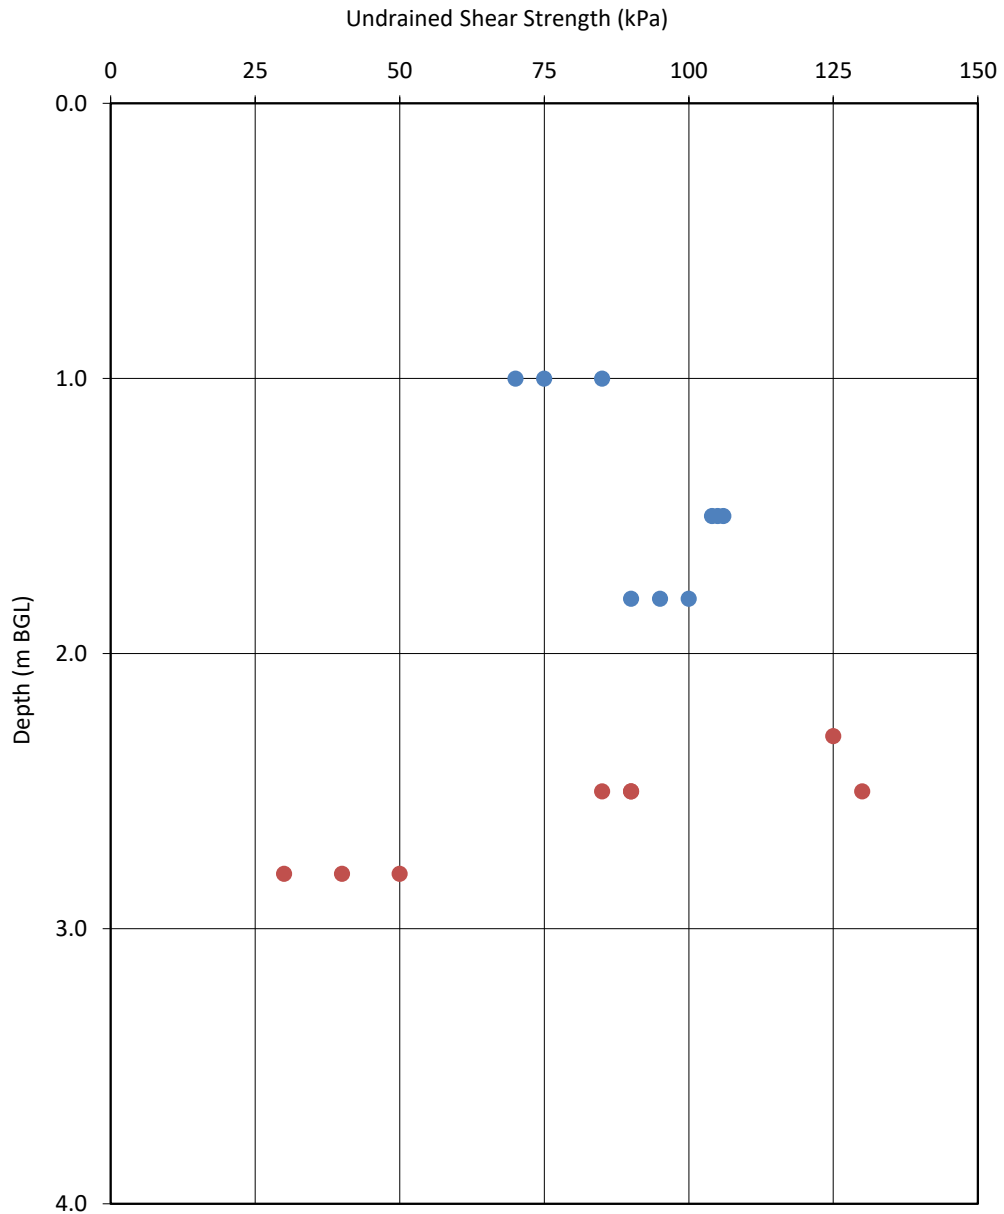
Figure 4

● Northampton Sands Formation (Hand Shear Vane) ● Whitby Mudstone Formation (Hand Shear Vane)

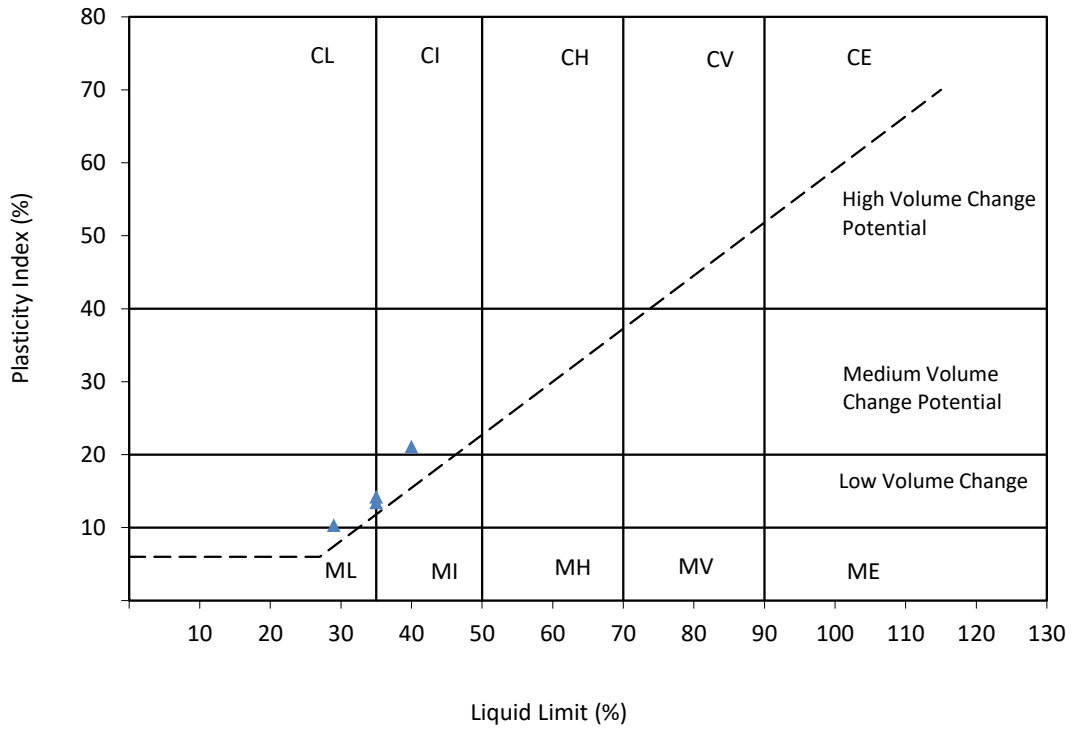
Figure 5

Moisture Content / Depth Relationship

- 15.3.6 When the natural moisture content of a soil lies close or less than the value of the plastic limit, the soil can be considered desiccated. In addition, Driscoll (1983) suggested that desiccation is assumed to be present when the moisture content falls below a level of 40% of the liquid limit. The index tests indicate that the two samples of Northampton Sand Formation are possibly marginally desiccated.
