Bat Assessment
Preliminary Roost Assessment
&
Roost Characterisation Surveys

Land at The Beeches
Steeple Ashton
Oxfordshire

2019-01(03)

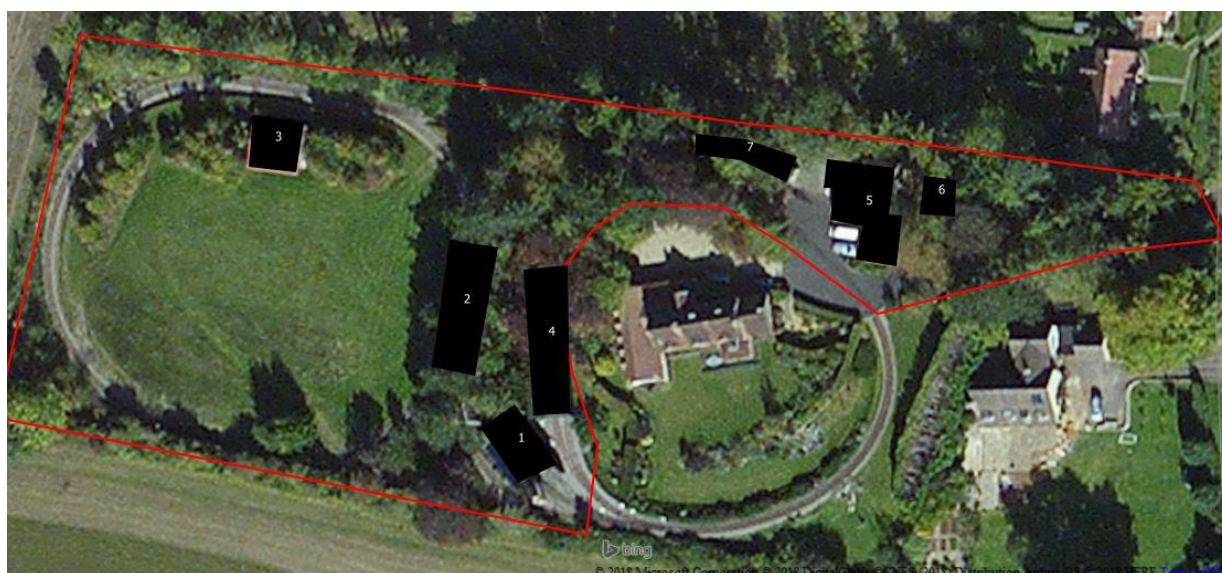
Figure 1: Survey boundary (including building numbers)

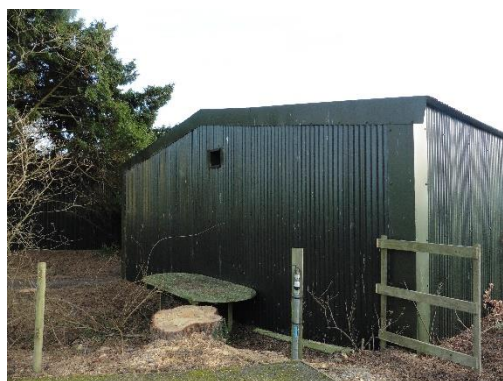
This was a large metal ‘shed’ (Photo 1) used for the storage of train carriages. Its walls and roof were constructed from corrugated metal sheeting, with bat access available at the eaves. The finish of the metal was considered to be too smooth for bats to land and crawl on, hence access to the inside of the building for bats was considered highly unlikely. Internally, the building was constructed from a steel frame with no timber trusses or ridgeboard present. Consequently, there was not considered to be any roosting potential for bats.

Photo 1: Building 1

Suitability for roosting bats: NEGLIGIBLE

No further survey work in respect of buildings 1, 2, 3, 4, 6 or 7 is recommended at this stage. It should be noted that buildings can deteriorate over time, creating additional access points for bats. As bats are very mobile, they can occupy a building with suitable features at any time. If in doubt as to whether bats may have moved onto the site in the period since the writing of this report, the advice of an appropriately licensed and experienced ecologist should be sought on how best to proceed.

Due vigilance should be maintained during the course of works to buildings 1, 2, 3, 4, 6, and 7 (particularly any works at roof level) and should evidence of bats (such as individuals or droppings) be found, then works must cease whilst advice is sought from Natural England or a licensed ecologist.

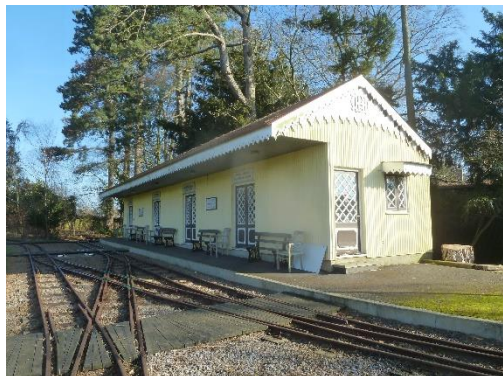
Building 2 was a single storey train station building (Photo 2). Its walls and gabled roof were constructed from corrugated metal, which was very smooth and unsuitable for bats to cling to. Whilst access was possible for bats behind signs fixed to the external walls or via gaps at the corner of a soffit on the southern elevation (Photo 3), these would only permit bats access to roost against the corrugated metal, which would heat and cool too rapidly

Photo 2: Building 2 exterior

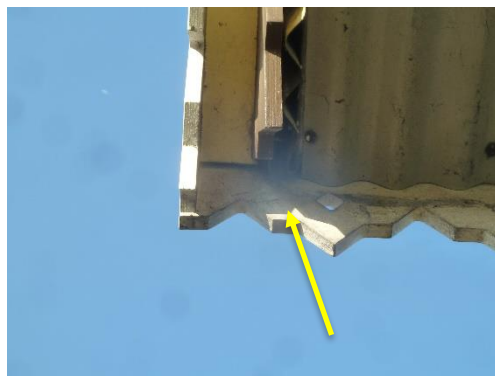
Photo 3: Potential bat access but poor roosting suitability

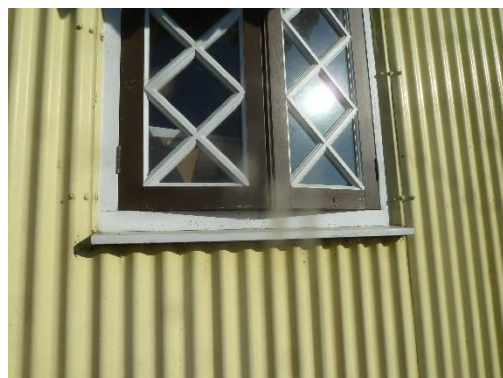
to support sustained roosting. A window was left slightly ajar at the southern elevation of the building (Photo 4) and it is possible that bats could have landed on the external window ledge and gained access to the inside of the building.

Photo 4: Open window providing access into interior of building 2

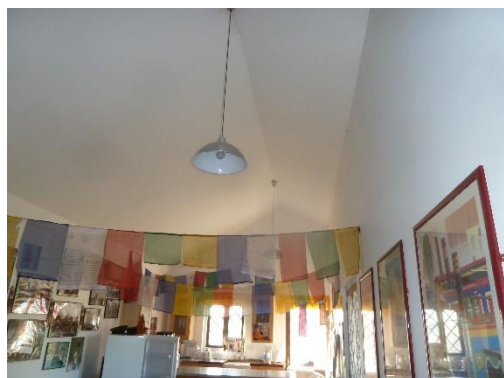
Internally, all of the walls and ceiling of building 2 had been plastered, with no exposed roof structure and nothing for bats to cling to. Equally, the room was vaulted, offering no roof void above for roosting bats (Photo 5). No evidence of bats using the building was recorded during the inspection.

Photo 5: Building 2 internal, plastered ceiling

Suitability for roosting bats: NEGLIGIBLE

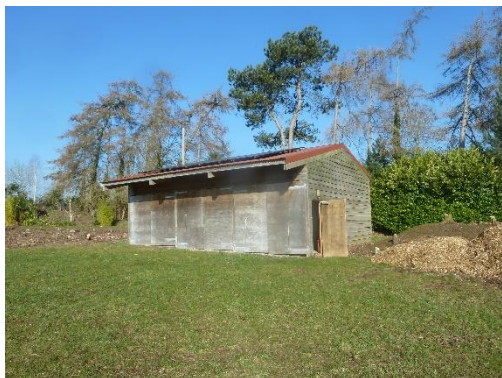
Building 3 was a timber clad and timber framed stable building overlooking the garden (Photo 6). Its gabled roof was finished with corrugated metal sheeting and did not benefit from any sarking to the underside. The roof overhung the southern elevation to create a porch, although no access for bats was possible at the eaves in this location. A walk around the building revealed occasional gaps between timber panels as well as a gap between roof timbers on the north elevation (Photo 7), which would permit bats access to the inside of the building.

Photo 6: Building 3 exterior

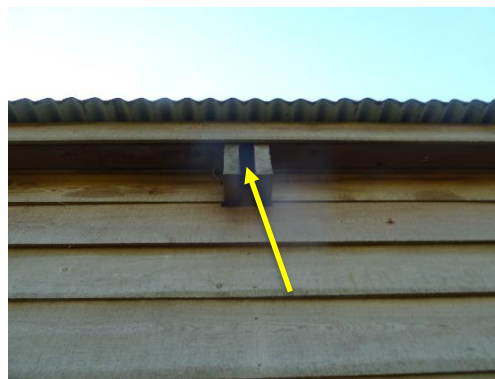
Photo 7: Potential bat access to interior of building 3

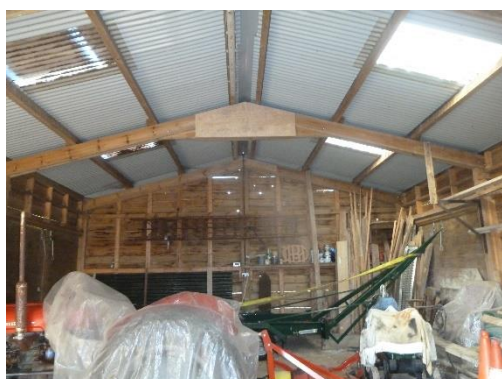
Internally, roof lights of translucent corrugated plastic were visible in the roof (Photo 8), resulting in moderate light levels internally. A lack of ridgeboard or rafters severely limited any bat roosting opportunities, although plyboard baffles at the ridgeboard did create a dark tunnel potentially suitable for bats (as seen in Photo 9). However, upon detailed inspection, these areas were found to be densely cobwebbed with no evidence of bats.

Photo 8: Building 3 interior

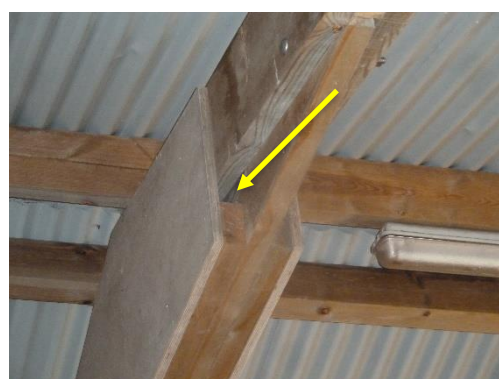
Photo 9: Plyboard 'baffle' at ridgeboard, full of cobwebs

Suitability for roosting bats: NEGLIGIBLE

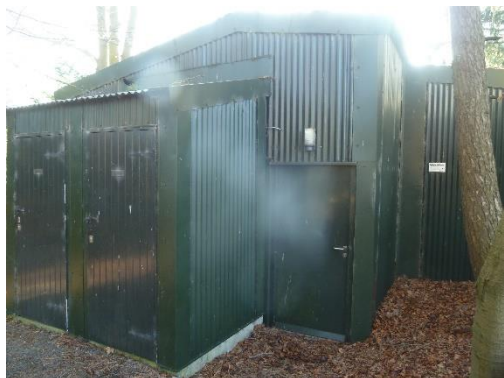
Building 4 was a large metal 'shed' (Photo 10) used for the storage of train carriages. Its roof and walls were constructed from corrugated metal sheeting, with bat access available at the eaves. However, the finish of the

metal was considered to be too smooth for bats to land and crawl on, hence access to the inside the building for bats was highly unlikely. An inspection pit was present towards the southern end of the building, but this was concrete lined with no gaps, cracks or crevices in which bats could roost. Internally, the building was constructed with a steel frame with no timber trusses or ridgeboard present (Photo 11), consequently, there was not considered to be any roosting potential for bats.

Photo 10: Building 4 exterior

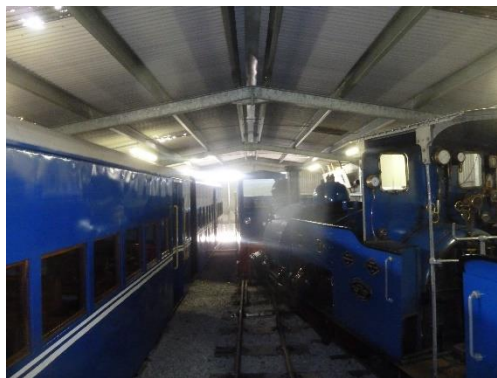
Photo 11: Railway carriages inside building 4

Suitability for roosting bats: NEGLIGIBLE

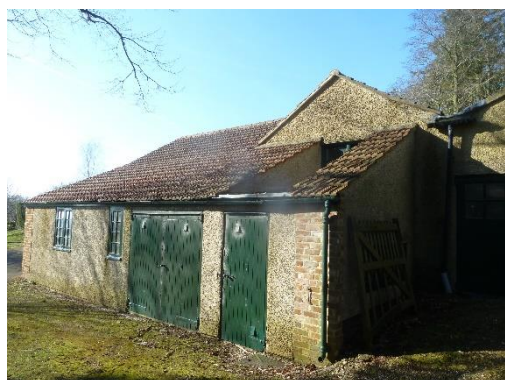
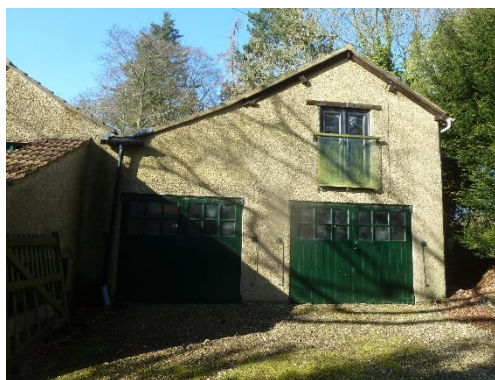
Photo 12: Building 5 garages – eastern elevation Photo 13: To storey section of building 5, eastern elevation

While no evidence of roosting bats was identified in building 5, due to the mobile nature of bats the following measures are recommended to minimise any risk of encountering bats during the demolition works of building 5. If works are delayed past June 2021, it is advised that an updated preliminary roost assessment of the Site be undertaken to assess the suitability of the building for bats at that time, as buildings are known to deteriorate and potentially become more suitable for bats over time. This updated survey would inform the proposed works and any further survey work that may be required at that time.

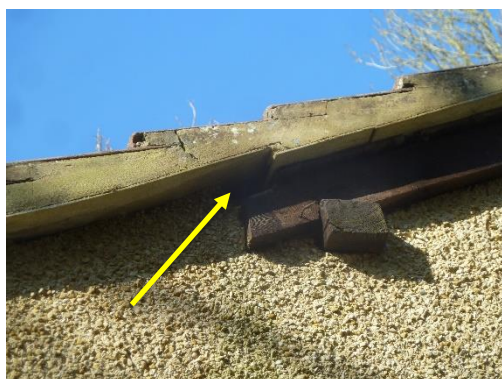
Access for bats was possible on the eastern elevation where a barge board was flush with the external wall but finished short along the slope of the roof and a large gap was present at its southern end (Photo 14). A close inspection did not reveal any bat evidence by way of droppings or staining; neither did it reveal any evidence of bird nesting.

Photo 14: Potential bat access at eastern elevation

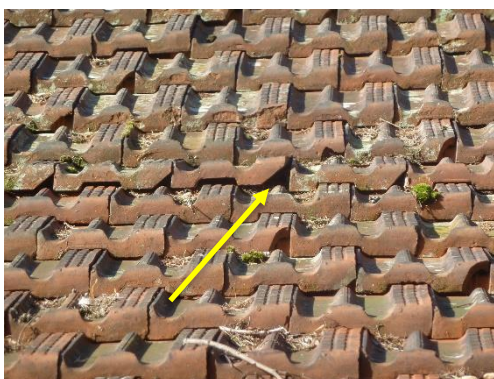
Other potential bat access points were noted under lifted tiles across all elevations of the building, via an open window on the southern elevation and via a gap where the bitumen felt was visible at the roof valley on the eastern elevation.

Photo 15: Potential bat access point under tiles

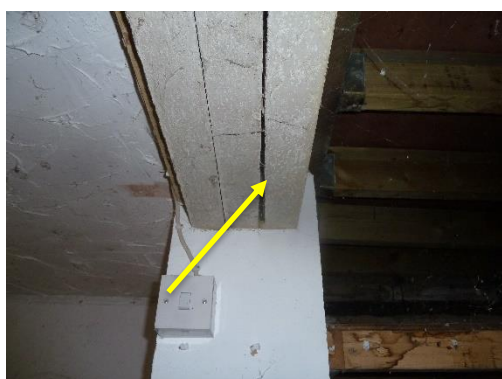
The other southern section of garage was vaulted and plasterboarded (Photo 18) with no exposed timbers and no roosting opportunities for bats. A gap was present in the lintel by the window on the southern elevation but upon closer inspection this was only 1 inch deep and not suitable for roosting bats.

Photo 16: Gap in lintel by lean-to, full of cobwebs

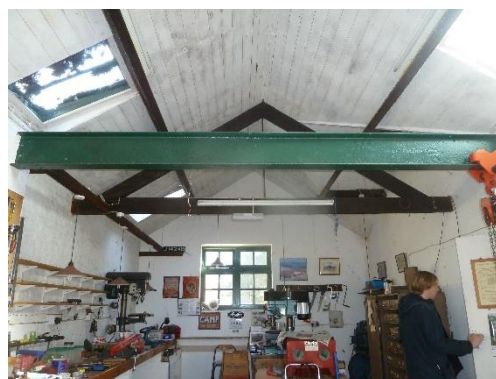
The single-storey garages present at the southern half of this building (one of which was in use as a workshop) were both vaulted with no exposed ridgeboard. The workshop had rooflights resulting in a light internal environment unsuitable for bat roosting, but the underside of the roof here benefited from timber sarking (Photo 17), which could provide suitable crevice-roosting opportunities for pipistrelle bats or similar, between the sarking and the tiles above.

Photo 17: Building 5 interior - workshop

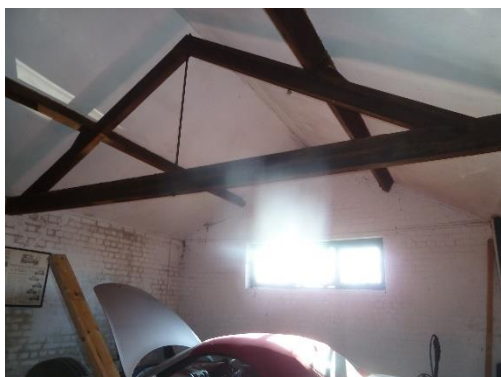
Photo 18: Building 5 interior - vaulted and plaster-boarded garage

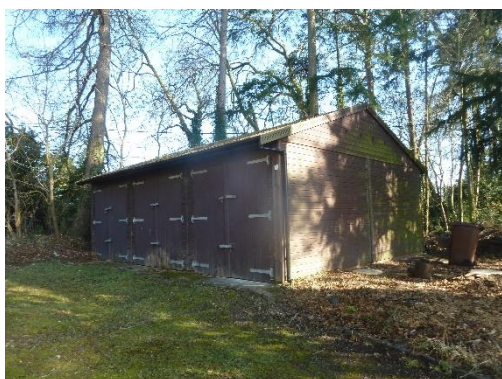
This was a timber-framed and timber-clad garage with a gabled roof finished with tight-fitting felt shingles (Photo 19). Overhanging eaves were present to the western elevation, but these were well-sealed, offering no internal access to bats. An internal inspection revealed that the felt shingles were fitted directly onto the chipboard sarking below (Photo 20), offering no gaps and hence no roosting opportunities for bats. The internal structure of the garage included king post timber trusses in a vaulted roof, but the joints of the timbers were all well-sealed and no crevices existed for bats to conceal themselves; consequently, any bat roosting opportunity was considered to be too exposed. Furthermore, bat access inside the building was not possible unless the garage door was frequently left open, and this was understood not to be the case.

Photo 19: Building 6 west and south elevations

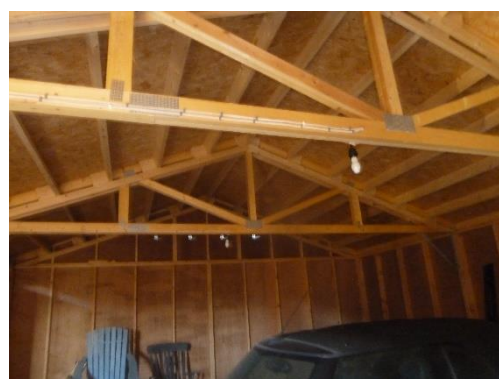
Photo 20: Building 6 interior

Suitability for roosting bats: NEGLIGIBLE

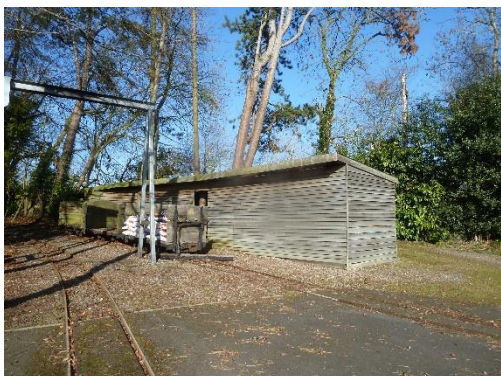
Building 7 was a long, low level timber shed building, measuring approximately 2.5m from floor to ridge, which was open along part of its southern elevation (Photo 21) and along its western elevation (Photo 22). It was timber-clad and timber-framed with a mono-pitch roof finished with corrugated metal sheeting. It was used as a log store and

the open nature of the building resulted in very light and draughty internal conditions unsuitable for roosting bats. There was potential for it to be used occasionally by bats as a feeding perch, given it was a covered area next to mature trees and with exposed timber rafters, but a close inspection of the building revealed no such evidence. Furthermore, no gaps or crevices were noted anywhere in the building, in which bats could conceal themselves.

Photo 21: Building 7, southern elevation

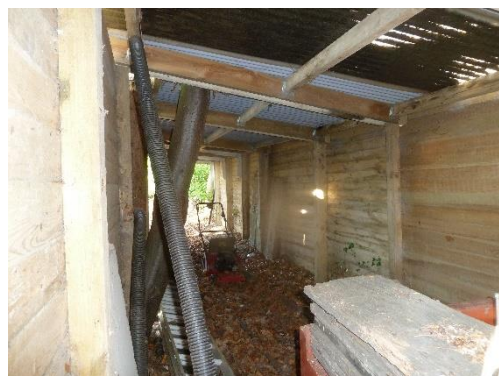
Photo 22: Interior of building 7, looking west

Suitability for roosting bats: NEGLIGIBLE
