PROJECT Stratfield Farm
OX5 1DL Kidlington

DWG TITLE Block F
Existing Elevations and LBC

STATUS Planning and LBC

JOB/DWG No. 219-115

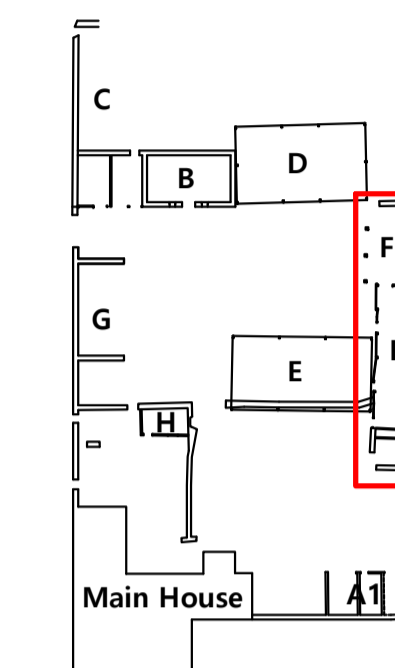
Key

R1 Roof structure of Block F appears to be raking east. Remaining 3 bays of the roof (from north) are in fair condition and are proposed to be preserved and reused. Structural engineer will be required to advise.

Generally, remove all vegetation. Retain limestone rubble walling stone from demolished walls to be reused for new walls.
