Client Great Wolf Resorts Ltd.	Project Bicester Golf Club	Job No CG39017

Title Core Runs from BH01	Appendix G

<p>Client Elliott Wood Partnership Ltd.</p>	<p>Project Bicester Golf Club</p>	<p>Job No CG39017</p>

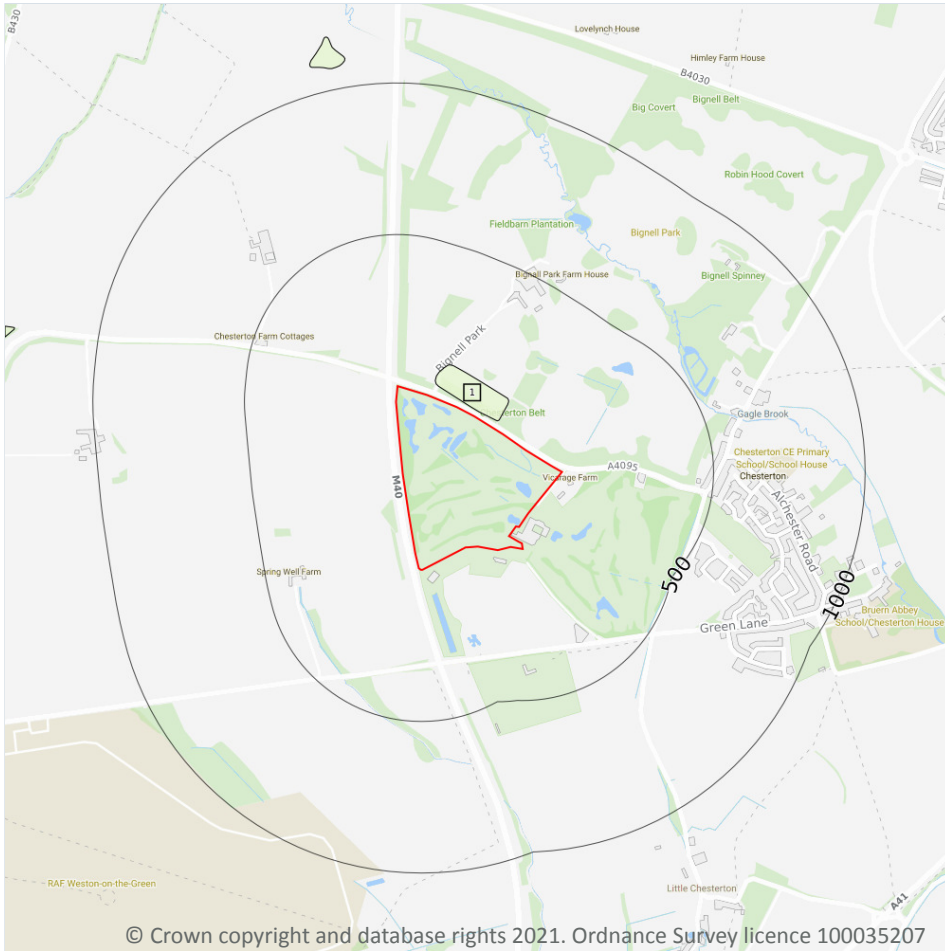
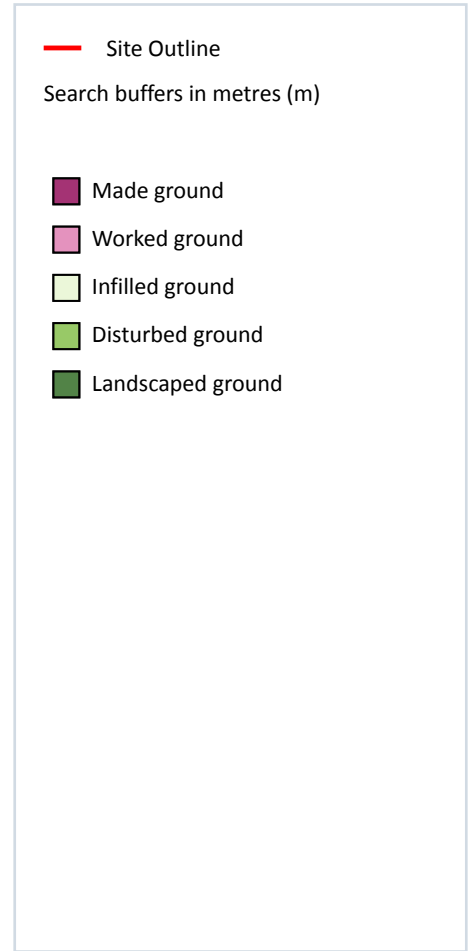
Geology 1:50,000 scale - Artificial and made ground

Details of made, worked, infilled, disturbed and landscaped ground at 1:50,000 scale. Artificial ground can be associated with potentially contaminated material, unpredictable engineering conditions and instability.

ID	Location	LEX Code	Description	Rock description
1	21m NE	WMGR-ARTDP	INFILLED GROUND	ARTIFICIAL DEPOSIT

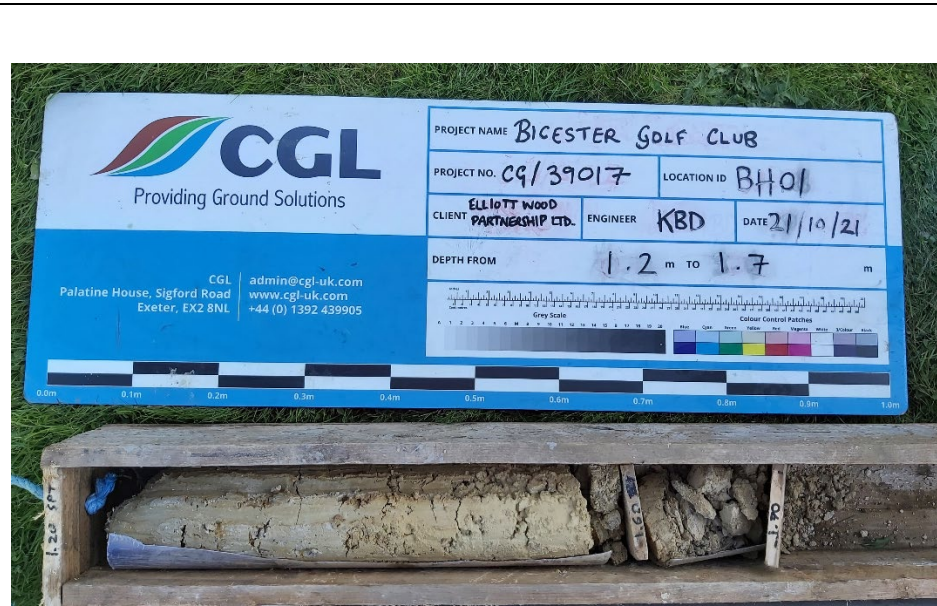
Photograph 1: Core run of sandy gravelly clay between 1.2 – 1.7 m bgl in BH01.

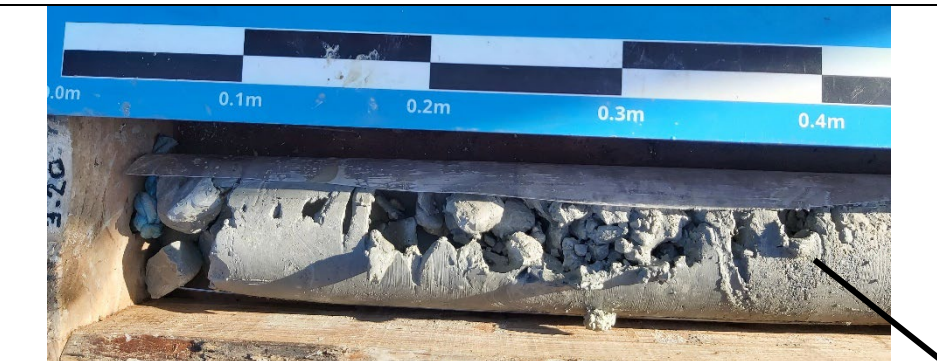
Photograph 3a: Weak mudstone recovered as gravel of stiff grey clay between 3.2 and 3.6 m bgl.

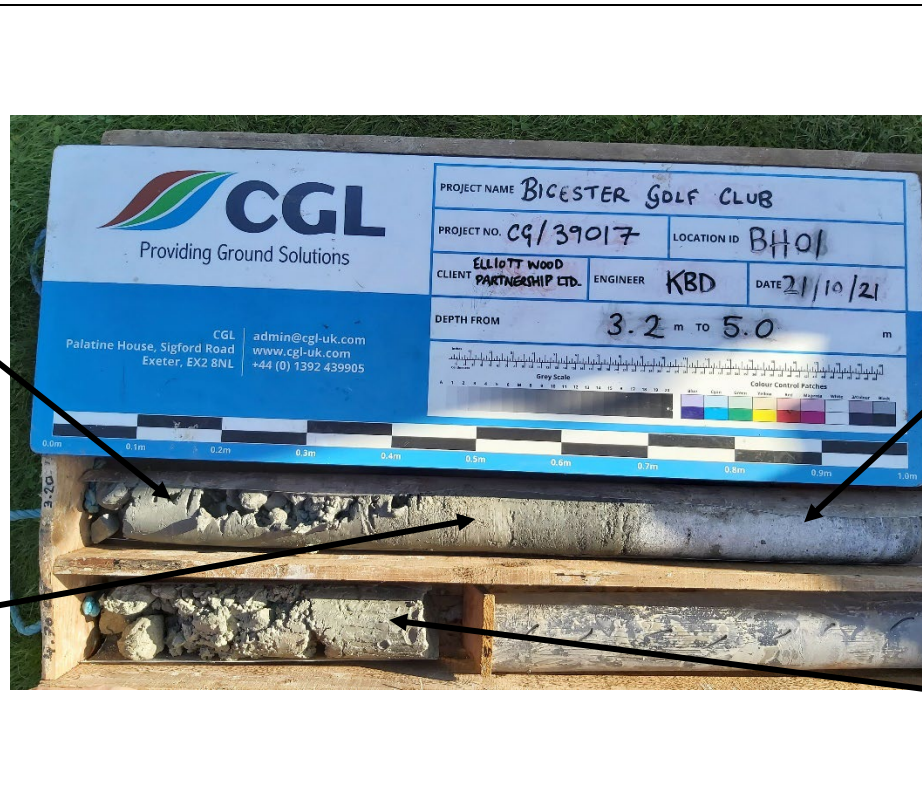
Photograph 3: Core runs between 3.2 – 4.7 and 4.7 – 5.0 in BH01

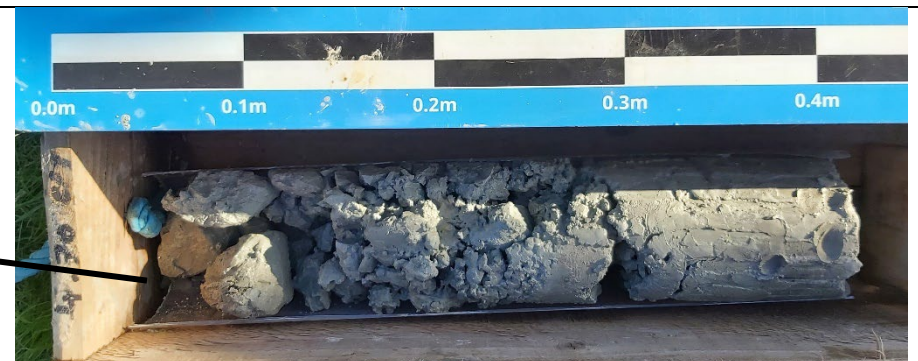
Photograph 3d: Stiff dark grey clay between 4.7 – 5.0 m bgl.

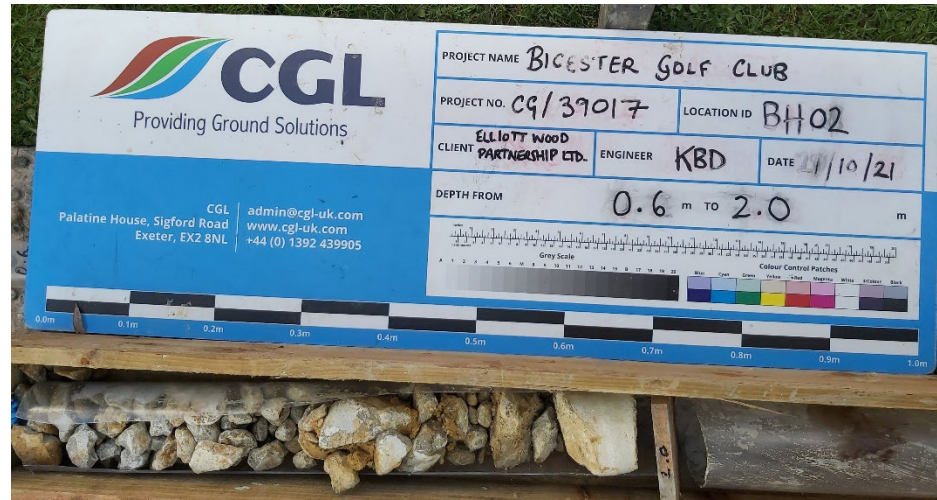
Photograph 4: Limestone gravel between 1.34 and 2.00 m bgl in BH02.

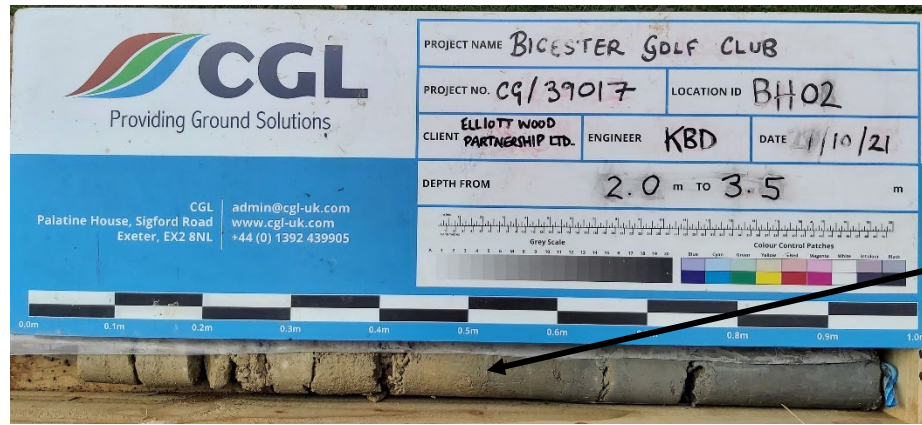
Photograph 5: Core run between 2.0 -3.5 m bgl. No recovery between 2.0 and 2.55. Limestone between 2.55 m and 3.05. Mudstone from 3.05 to 3.50 m bgl.

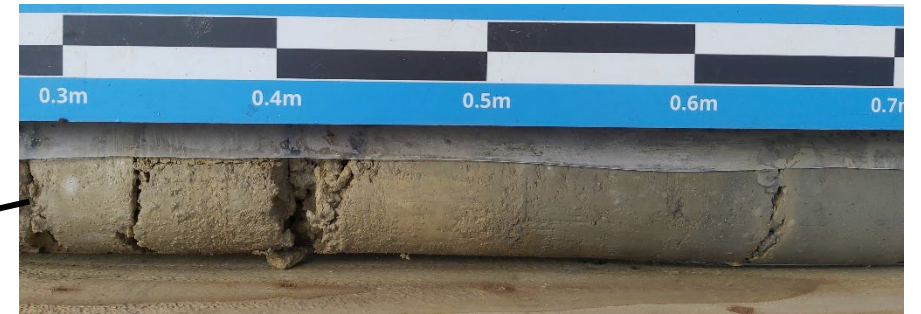
Photograph 5a: boundary between the limestone and the mudstone at ~3.00 m bgl.

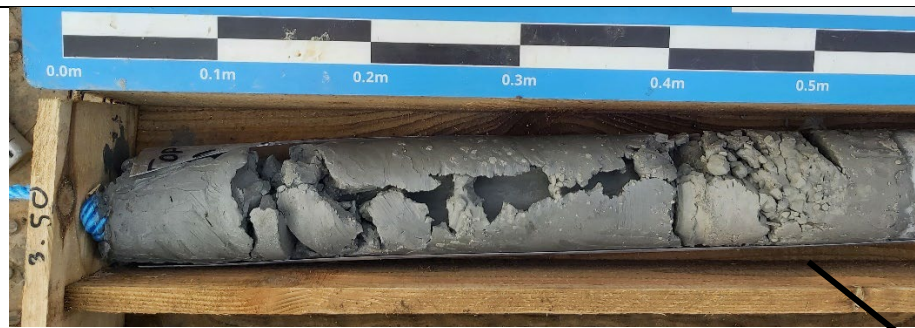
Photograph 6a: Stiff dark grey clay between 3.5 and 3.9 m bgl.

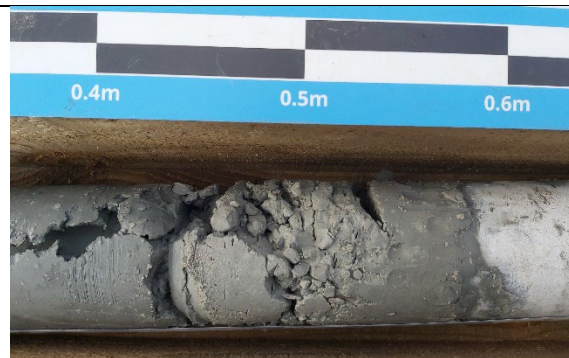
Photograph 6b: Weak mudstone recovered as gravel between 3.9 and 4.1 m bgl.

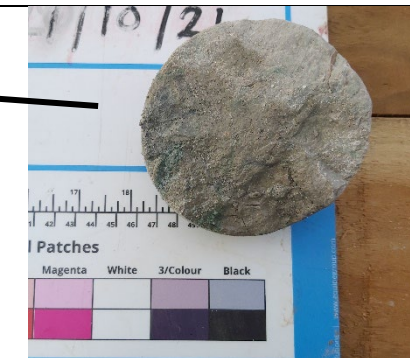
Photograph 6d: Fracture surface at 4.54 m bgl.

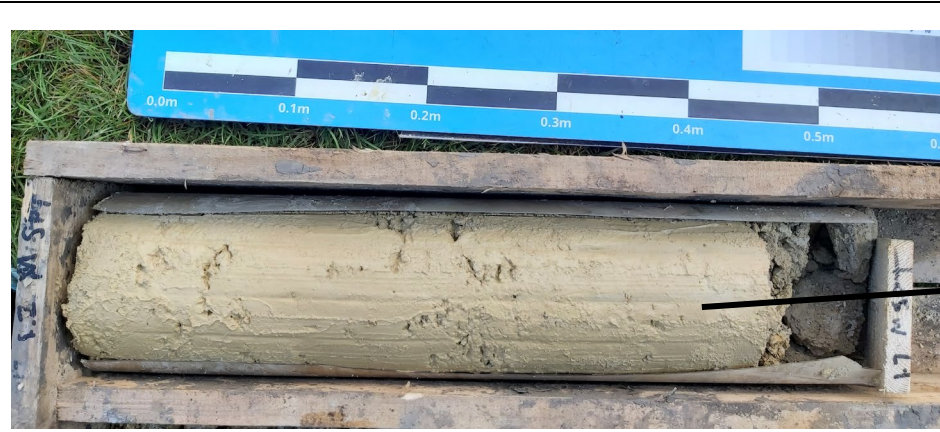
Photograph 7a: Core run between 1.2 and 1.70 m bgl of stiff slightly gravelly clay.

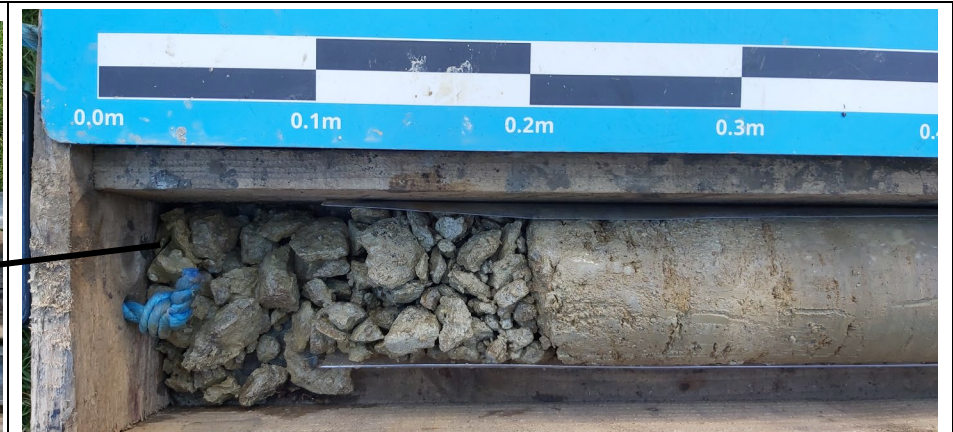
Photograph 7b: limestone recovered as gravel between 1.70 and 1.85 m bgl.

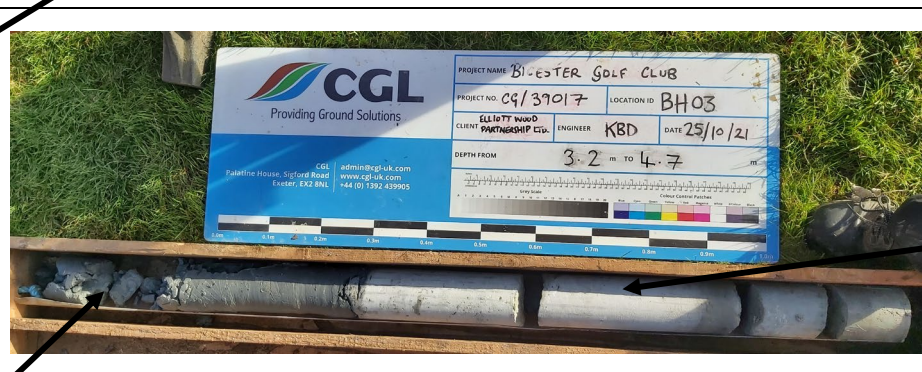
Photograph 8: Core run between 3.20 and 4.70 m bgl in BH03.

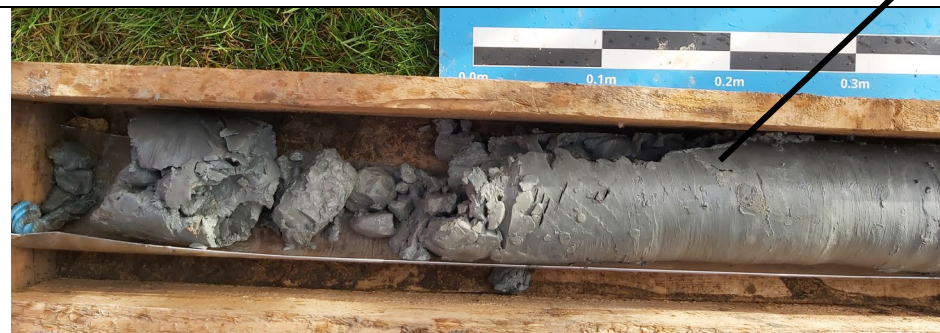
Photograph 8a: Weak dark grey mudstone between 3.9 and 4.1 m bgl.

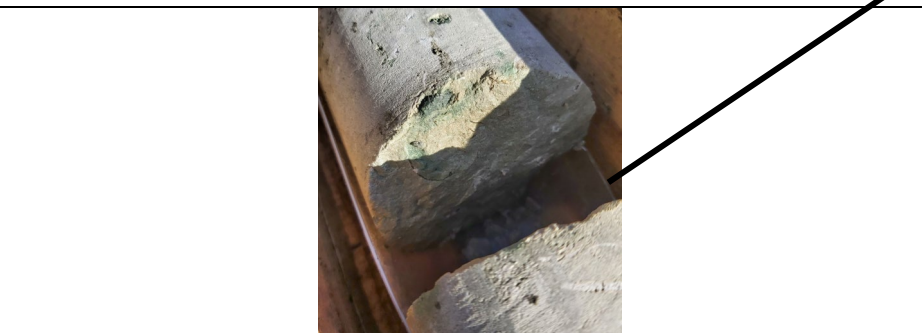
Photograph 8c: Green staining on the limestone

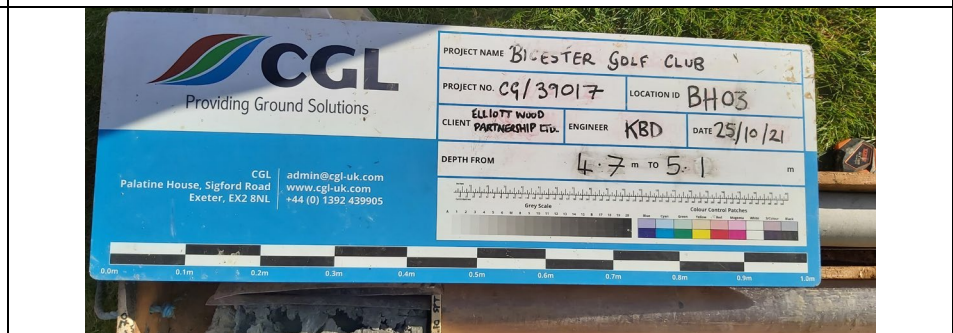
Photograph 9: Core run of dark grey mudstone between 4.70 m and 5.00 bgl.

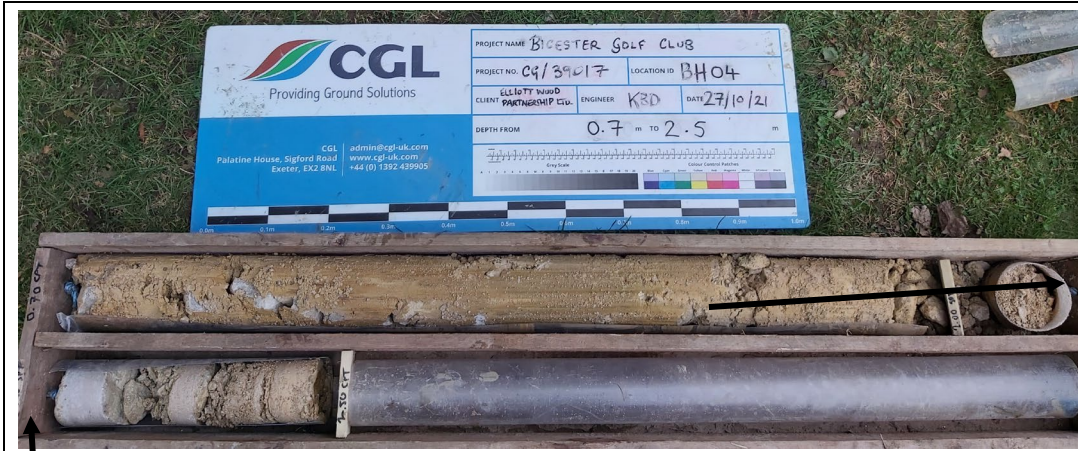
Photograph 10: Core runs between 0.70 and 2.50 m bgl of marl and limestone of the Cornbrash Formation in BH04.

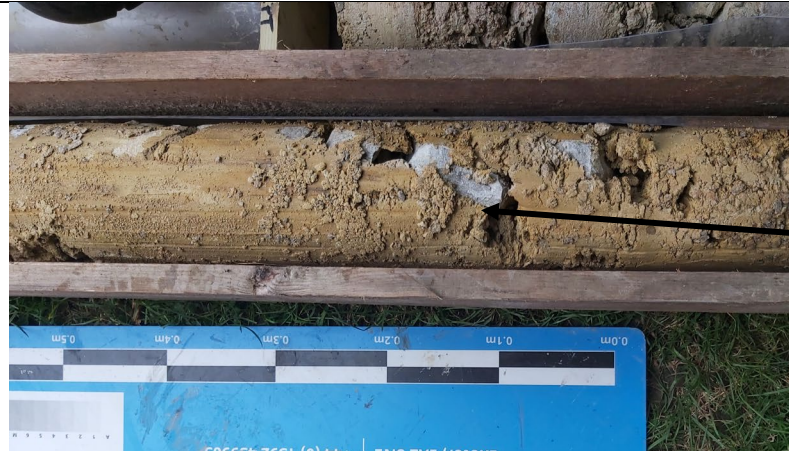
Photograph 10a: Marl as recovered - described as firm to stiff sandy gravelly clay between 0.70 and 1.5 m bgl.

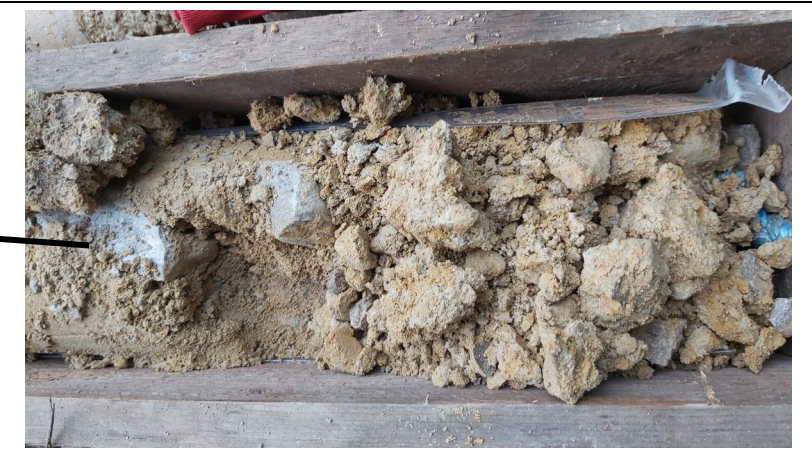
Photograph 10b: Marl when broken open. Gravel is fine to coarse sub-angular to angular grey limestone.

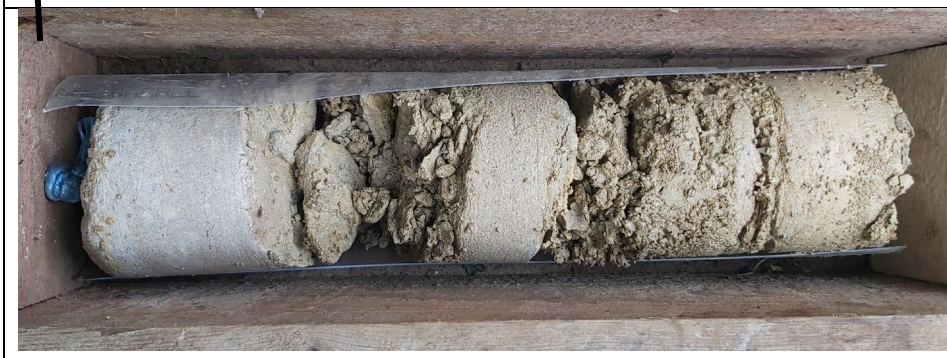
Photograph 10c: Intact light brown to pinkish orange mottled grey medium grained limestone – the base of the Cornbrash Formation. Between 2.10 and 2.55 m bgl.

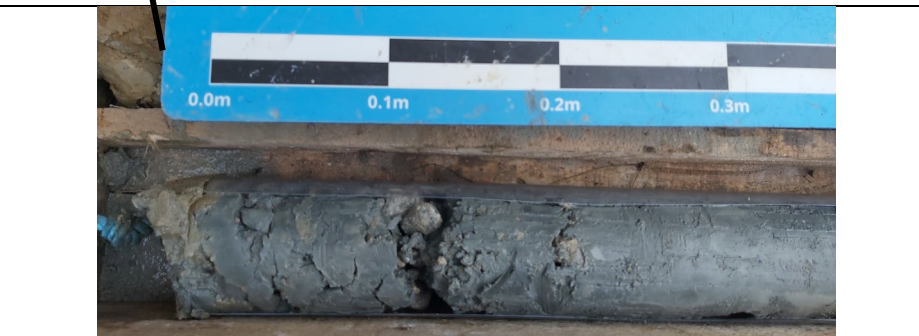
Photograph 11c: Firm slightly sandy slightly gravelly clay between 4.00 and 4.30 m bgl.

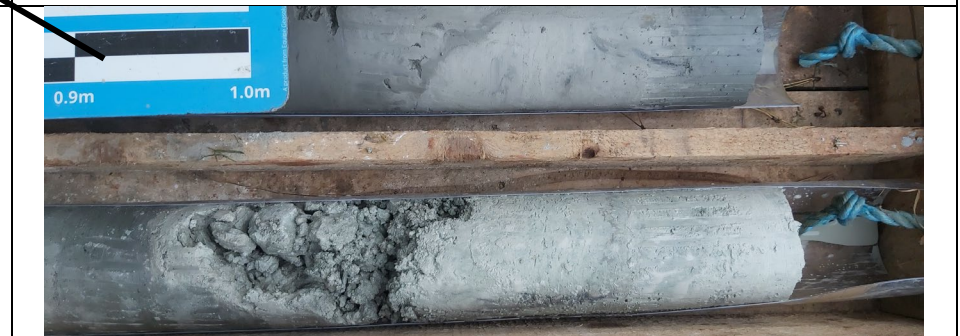
Photograph 11d: Weak greenish grey mudstone between 4.90 and 5.50 m bgl, recovered as gravel between 4.90 and 5.10 m bgl.

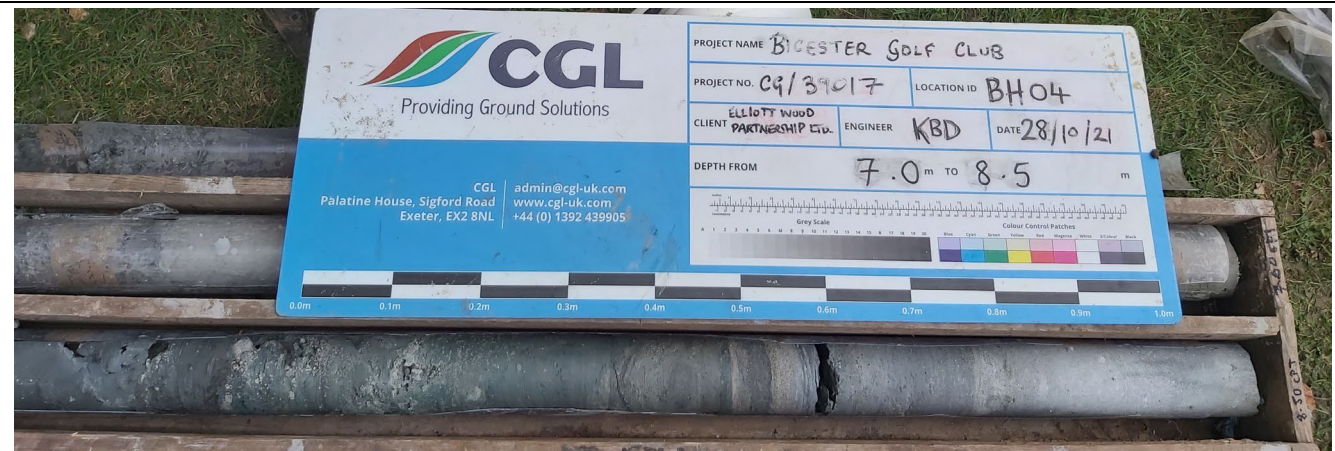
Photograph 13: Core run between 7.0 and 8.5 m bgl of mudstone, clay, and limestone of the Forest Marble Formation in BH04.

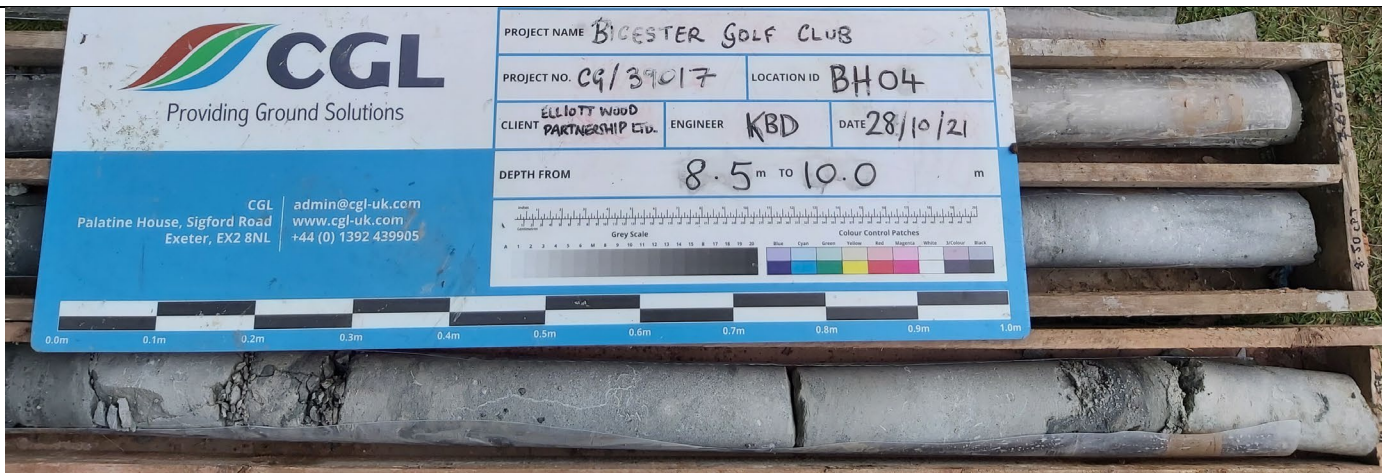
Photograph 14: Core run between 8.5 and 10.0 m bgl of mudstone of the Forest Marble Formation in BH04.

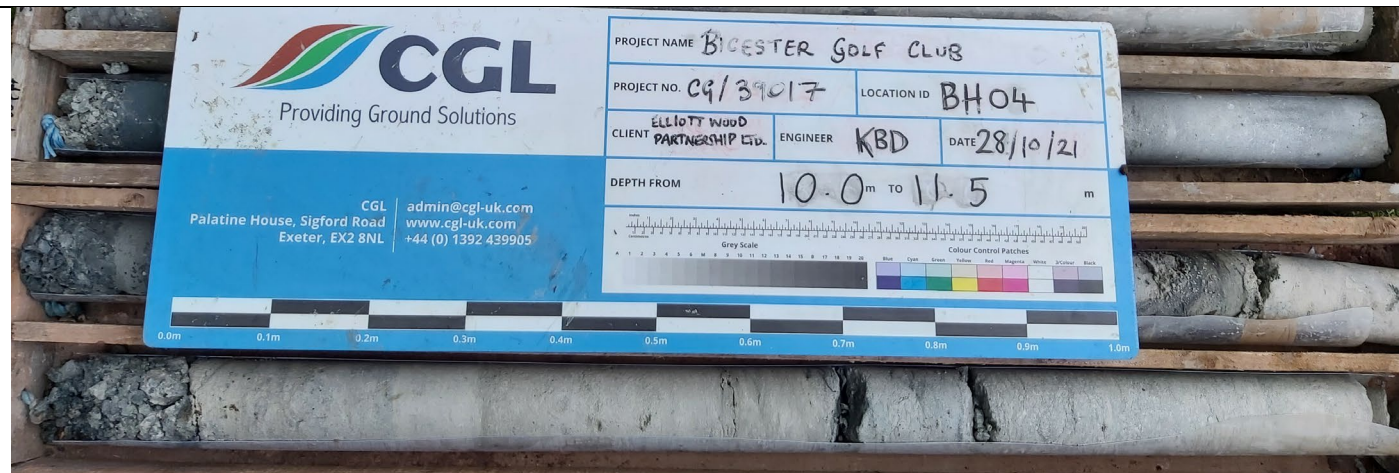
Photograph 15: Core run between 10.0 and 11.5 m bgl of mudstone of the Forest Marble Formation in BH04.
