# **Ground Investigation (Interpretative) Report**

Project D1 Employment Land, Graven Hill, Bicester

November 2020

**Client Name:** Graven Hill Village Development Company Limited  
**Document Reference:** WIE11386-159-1.1.2-GIR  
**Project Number:** WIE11386-159

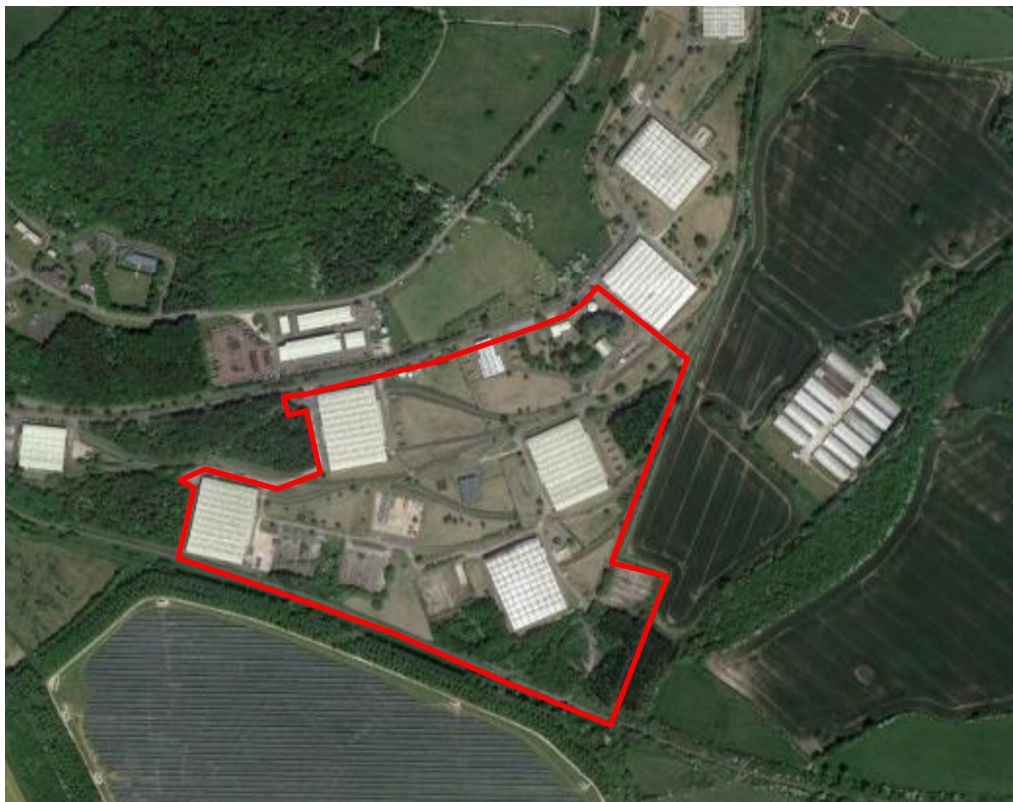
Figure 2: Site Boundary

The total Site area covers approximately 28.6 hectares and is located within the administrative boundary of Cherwell District Council. The current site layout is shown in Figure 2 below.

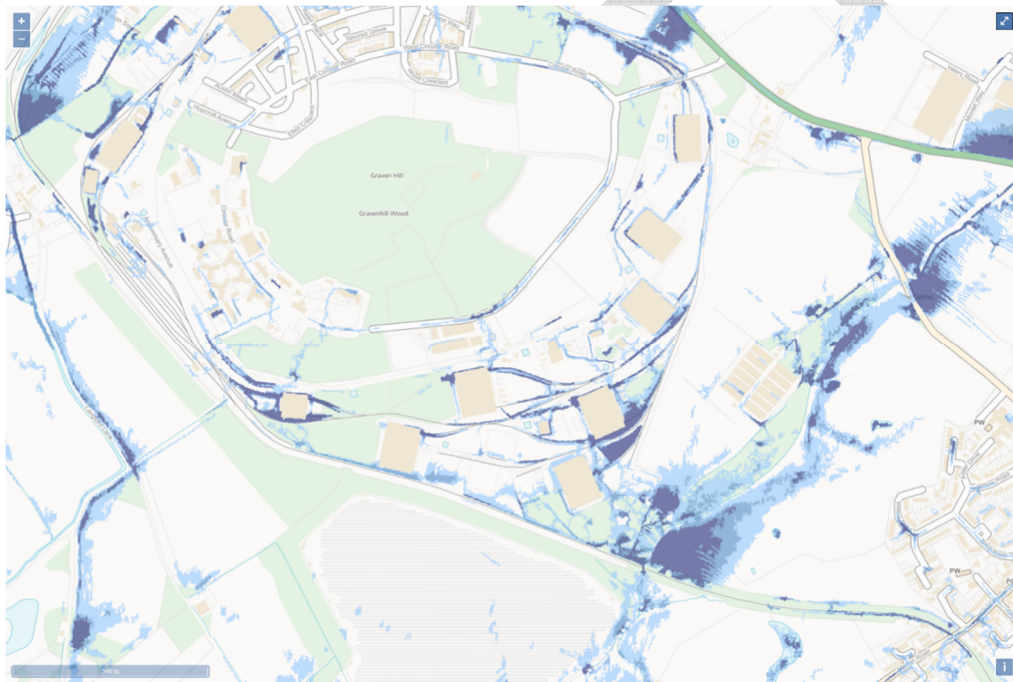
Figure 3: Environment Agency Flood Risk Mapping

Data accessed from the Environment Agency's Flood Warning Information Service indicates the Site is generally at low risk from surface water flooding. However, some areas are recorded as high risk. An extract from the Environment Agency flood risk map is shown in Figure 3 below:

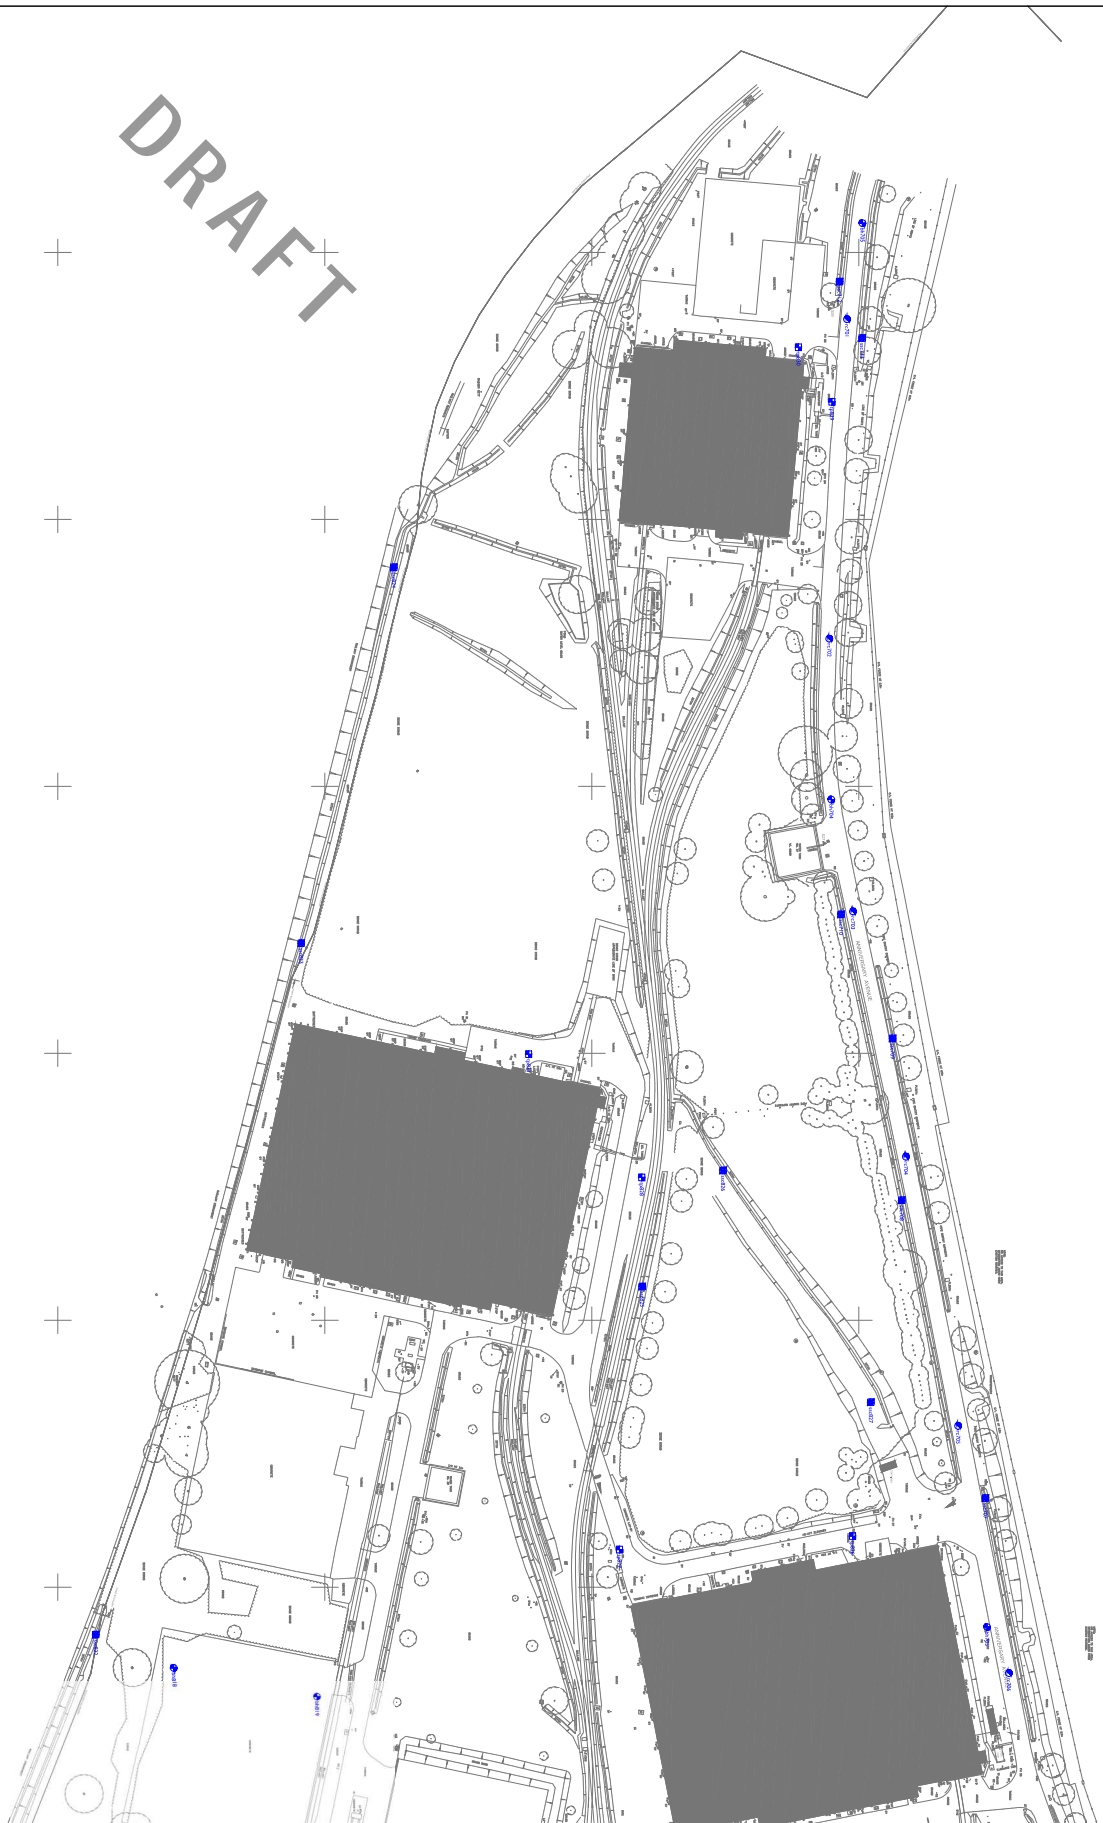
## **B. Exploratory Hole Records**

Scale: 1:1000@A1 Date: August 2020
