# GRAVEN HILL, D1 SITE, BICESTER

## Ecological Assessment

ECO01318  
Graven Hill, D Site, Bicester:  
Ecological Assessment  
Final v4  
June 2022

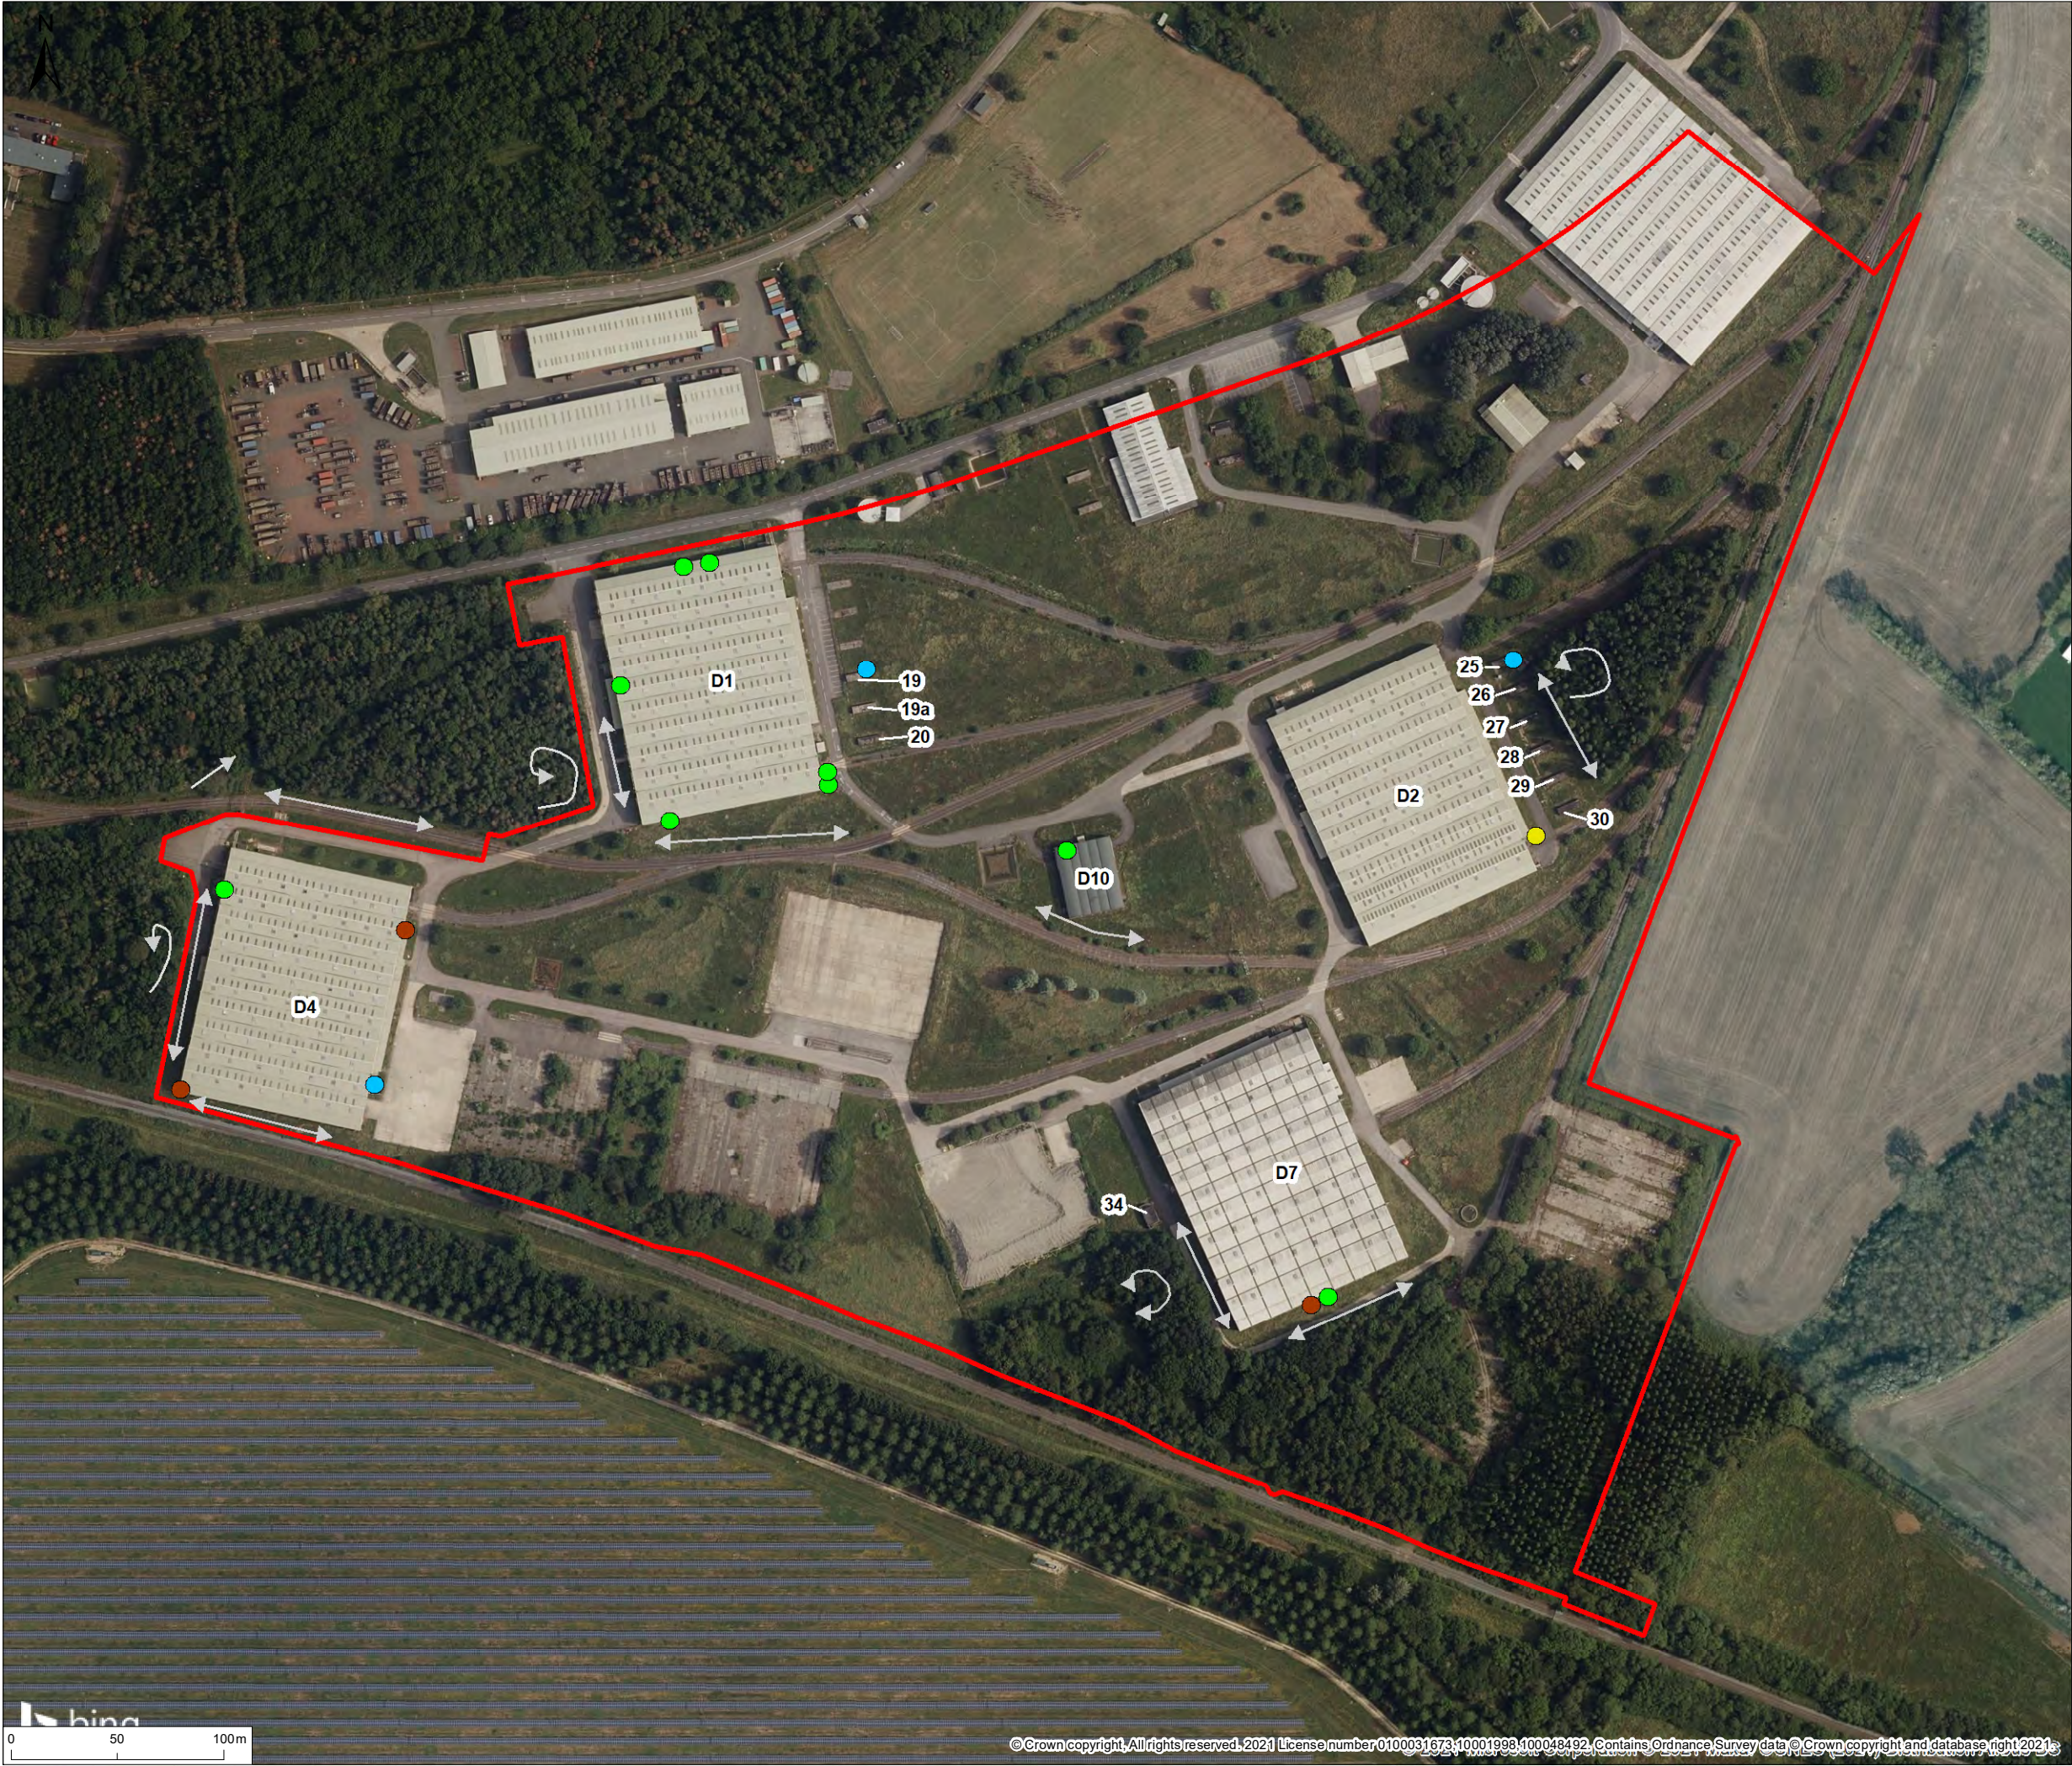
**Figure 4.2: Confirmed bat roost locations – D Site only (emergence and re-entry surveys)**

- 4.6.5 The locations of the confirmed roosts identified during the emergence / re-entry surveys are shown on Figure 4.2.

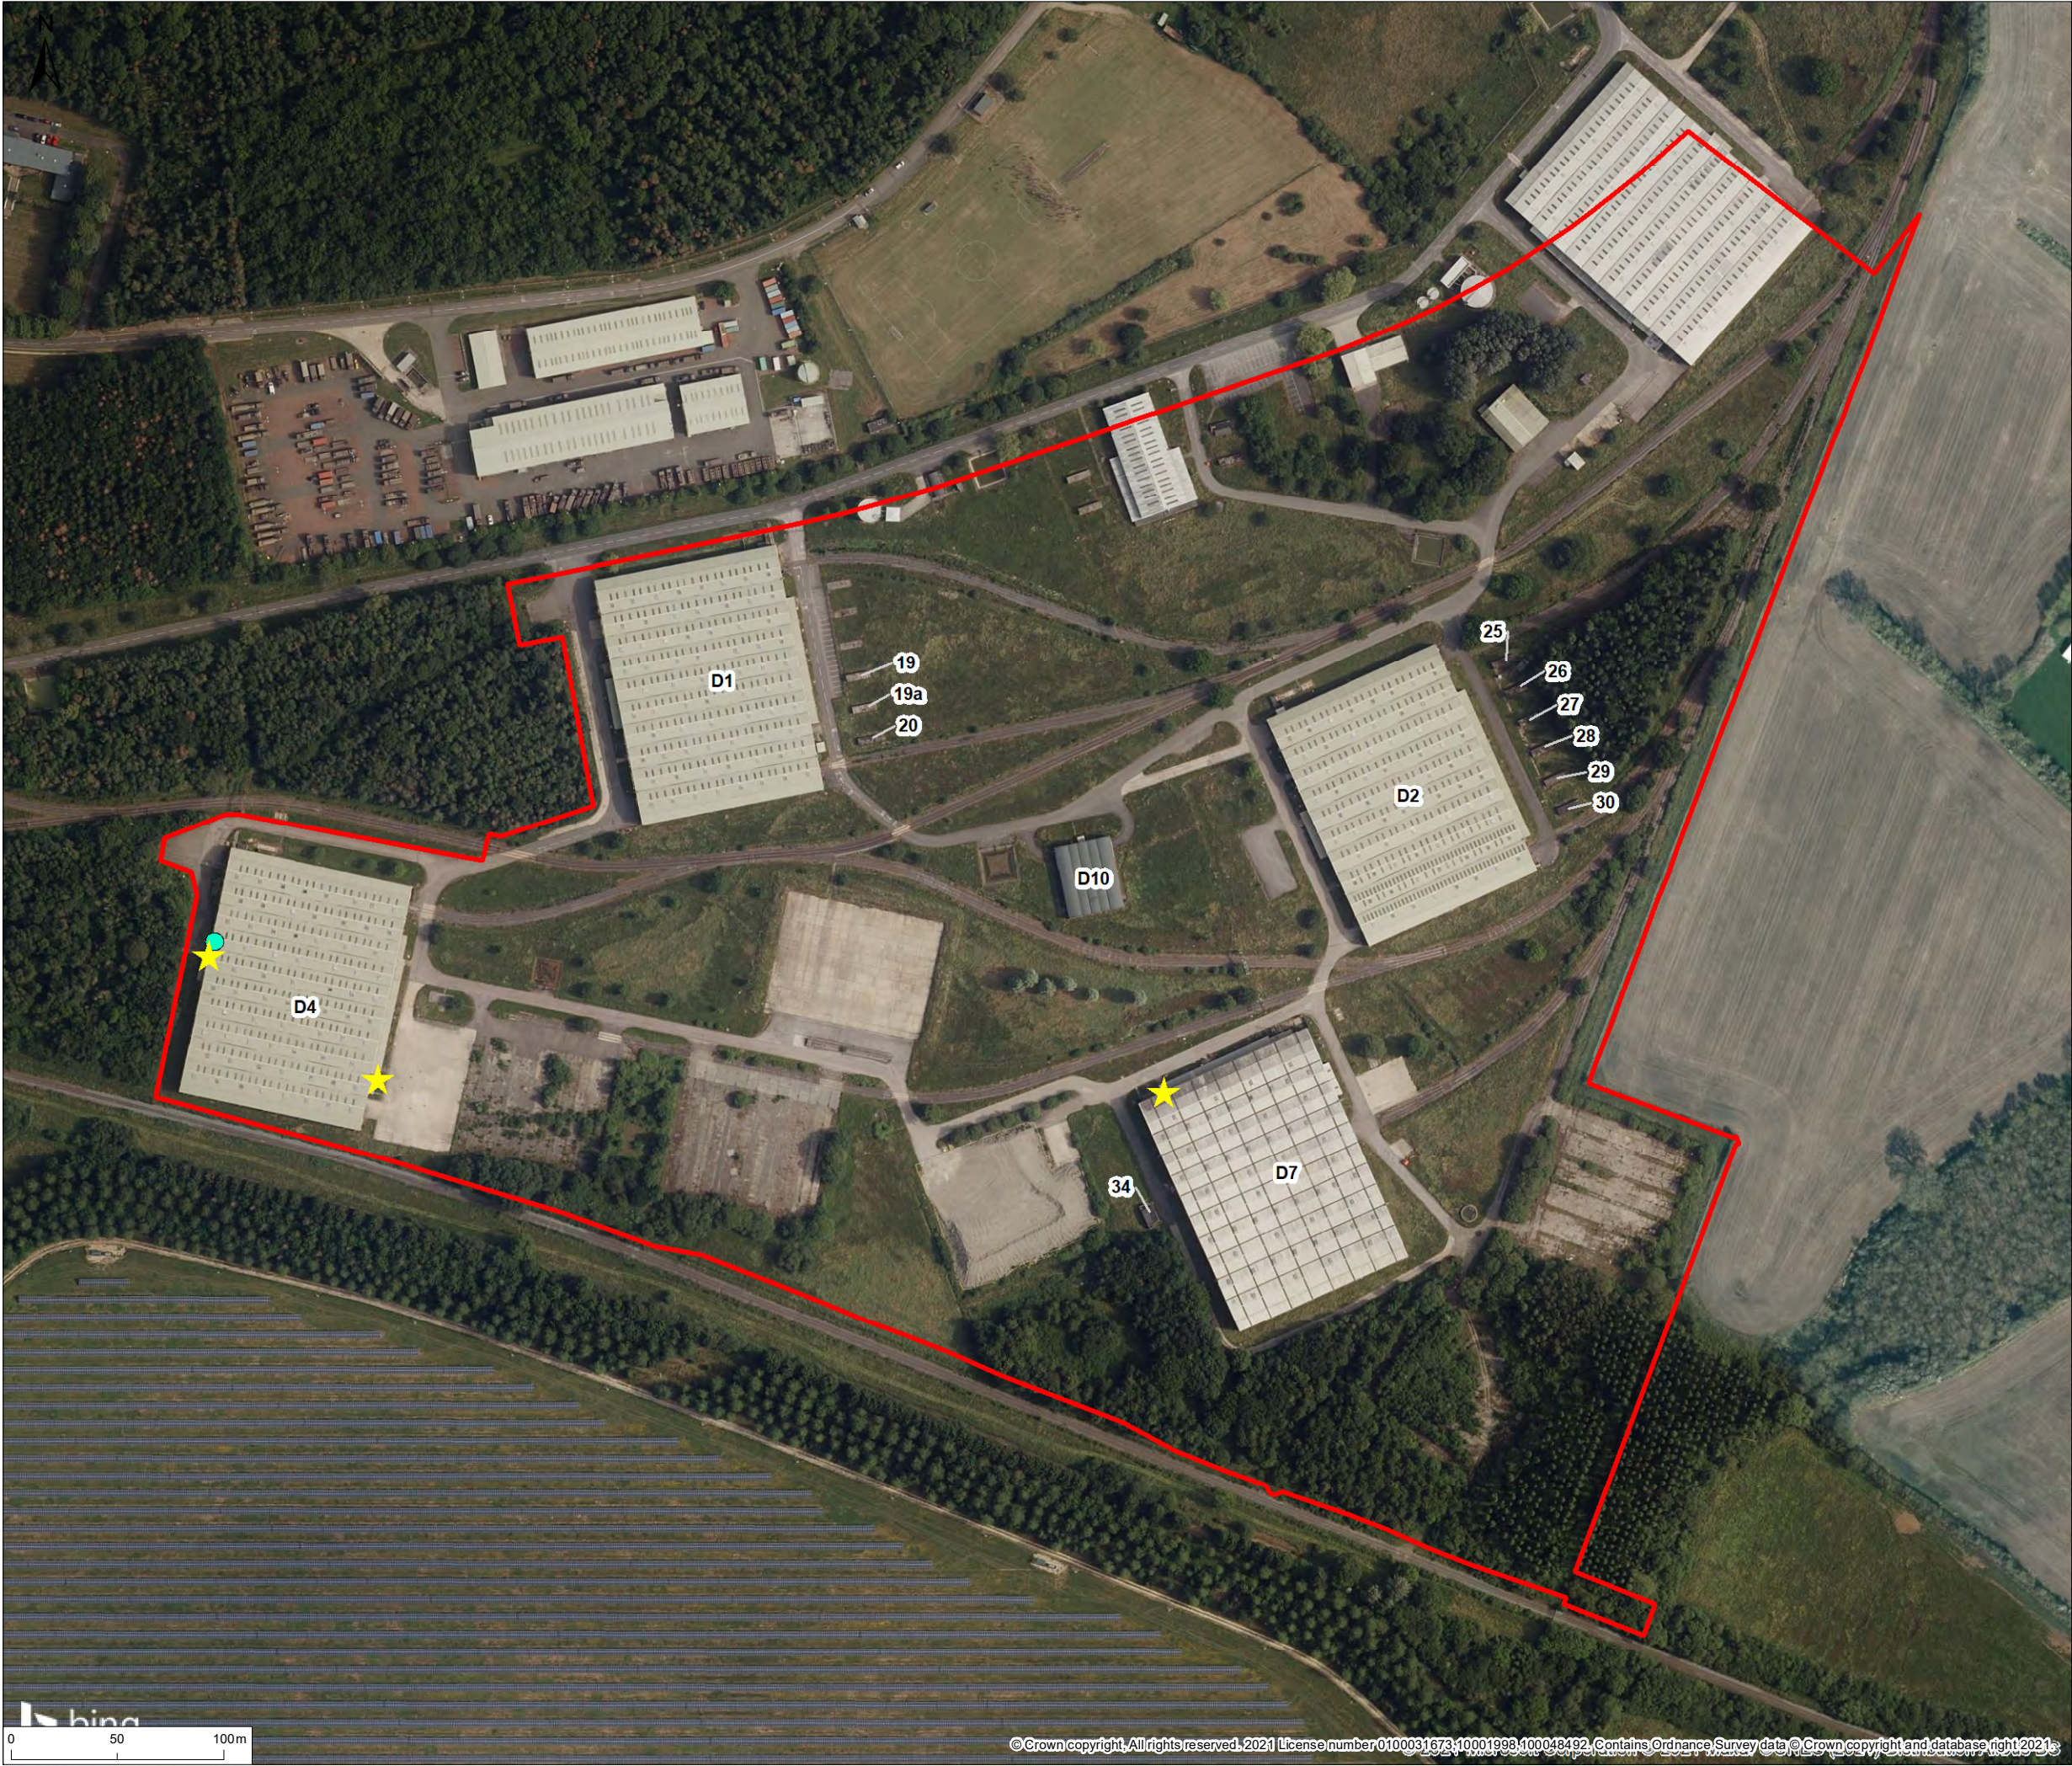
**Figure 4.3: Confirmed bat roost locations – D Site only (hibernation surveys)**

- 4.7.1 One brown long-eared bat was found during the hibernation survey undertaken in January 2021. The bat was found in the outbuilding on the north west side of Building D4, tucked away between the top of the brick wall and flat concrete roof. No other bats were seen during the hibernation checks in either January or February 2021.

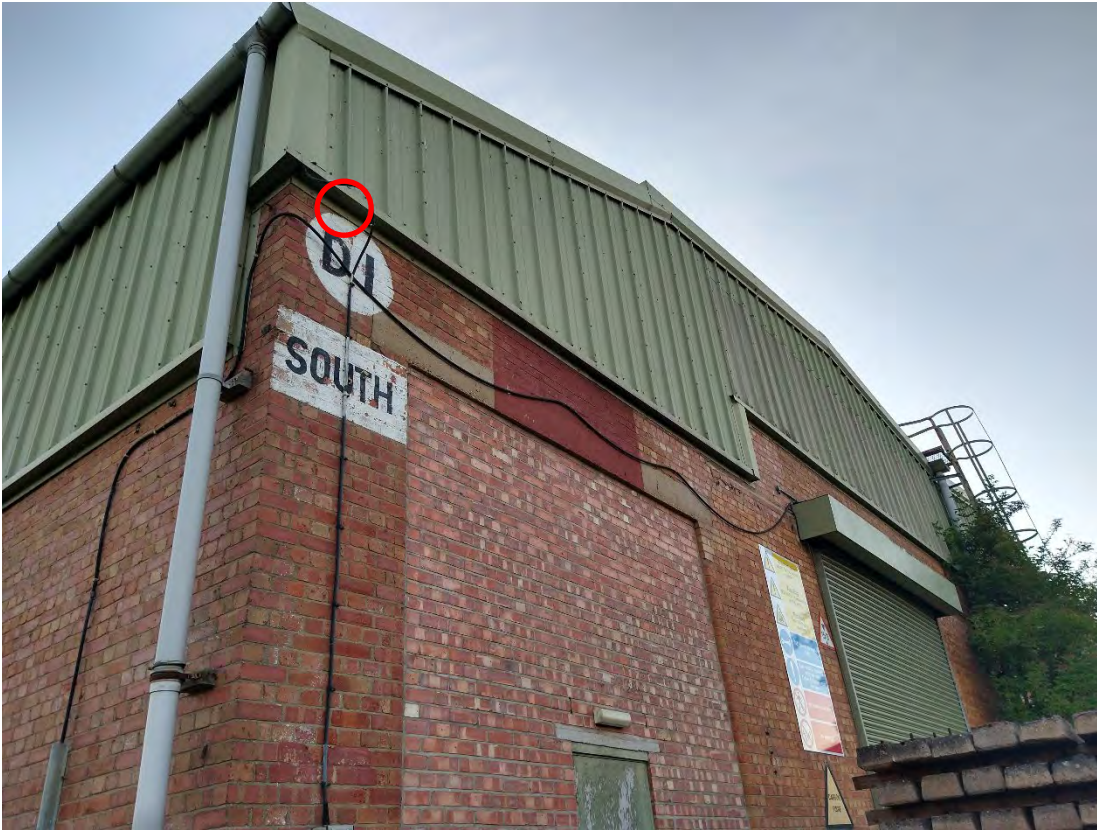
**Photograph 1:** Eastern elevation of Building D1 showing common pipistrelle emergence point.

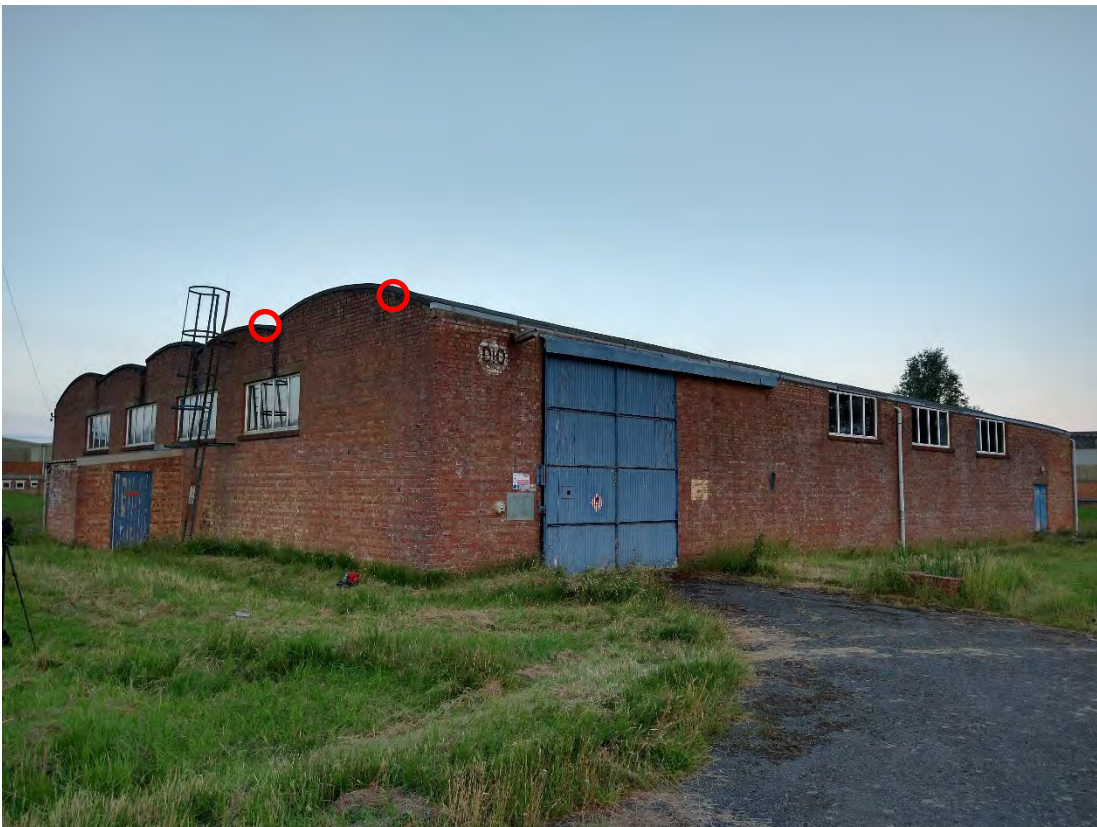
**Photograph 2:** Building D10 showing entry points for the common pipistrelle maternity colony.

- 5.3.13 The common pipistrelle maternity roost in Building D10 was surveyed once in September in 2020 and twice in July 2021. At least 38 bats were recorded re-entering the building at two points on the northern elevation during the survey in early July. However, there were no bats recorded emerging / re-entering the building during any other survey; the colony could have been using a different maternity roost Site on that night, or it is even possible that the colony had already broken up by the final survey in late July 2021. Maternity colonies are known to start breaking up once the

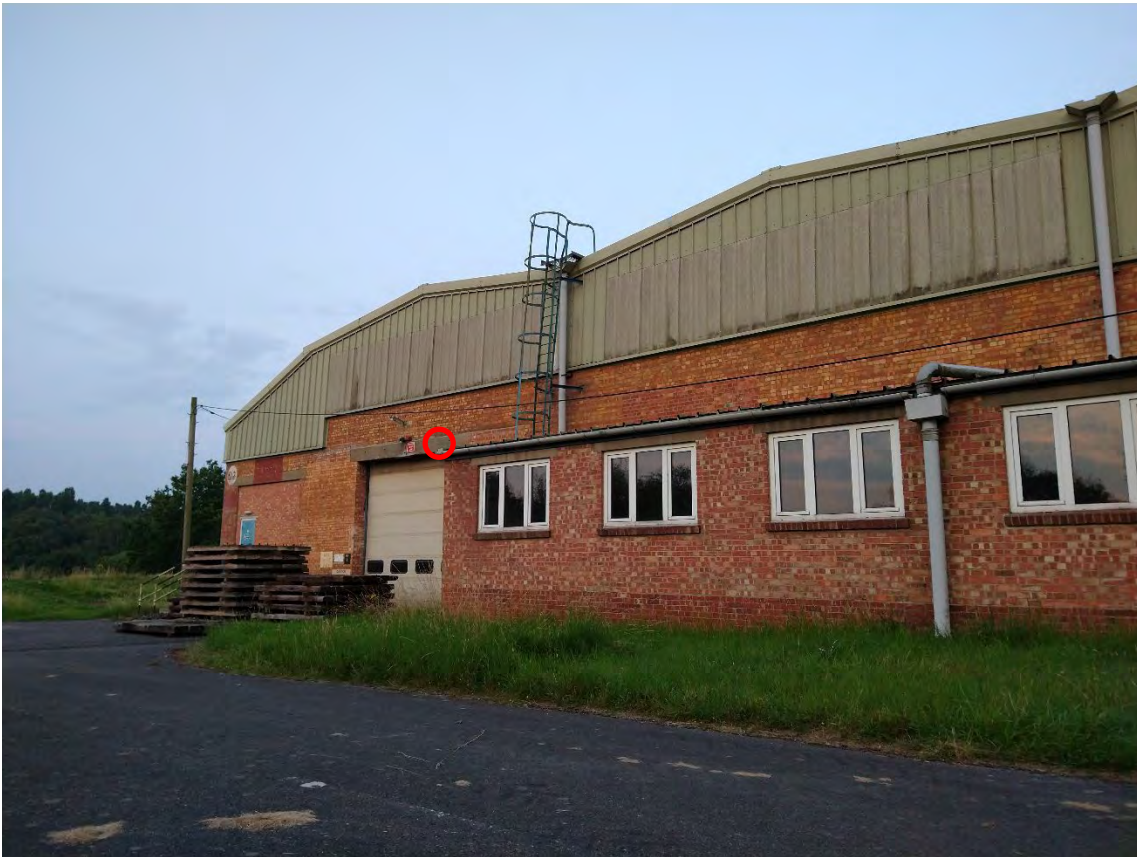
**Photograph 3:** North eastern elevation of Building D2 showing soprano pipistrelle re-entry point.

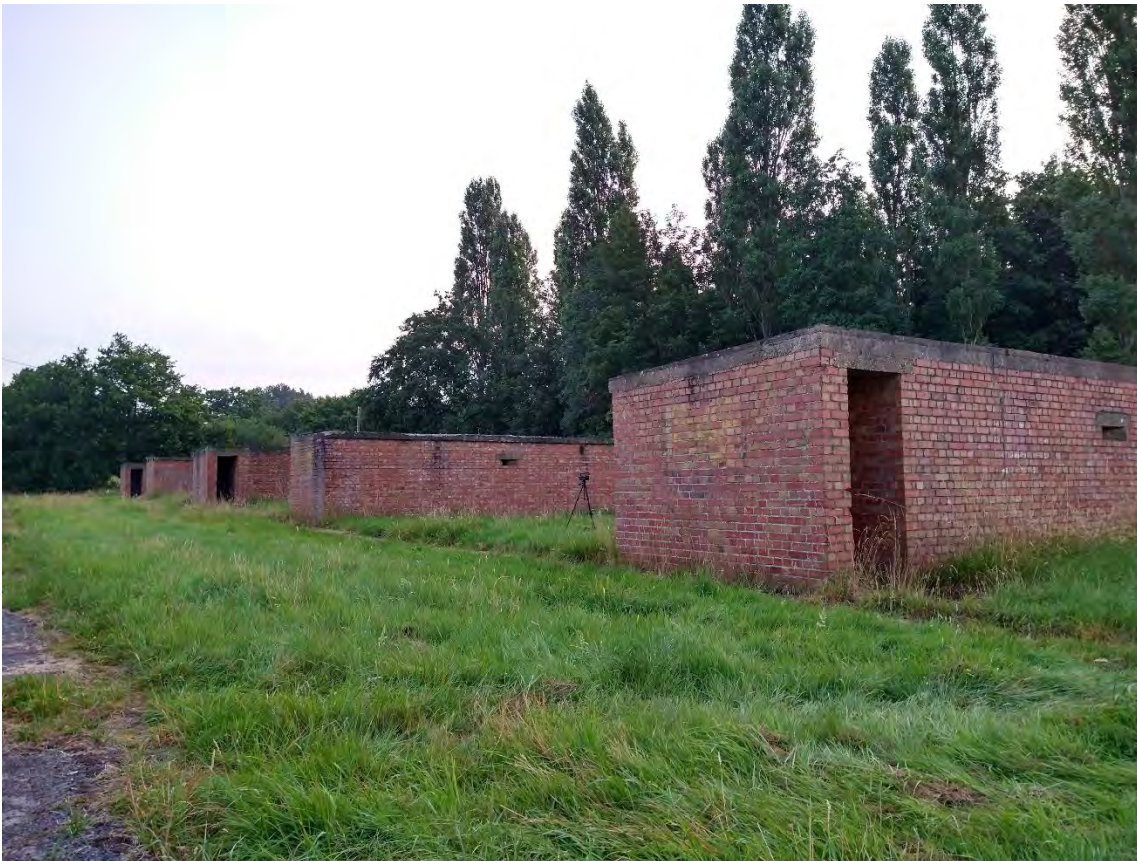
**Photograph 4:** Showing Buildings 25-29.

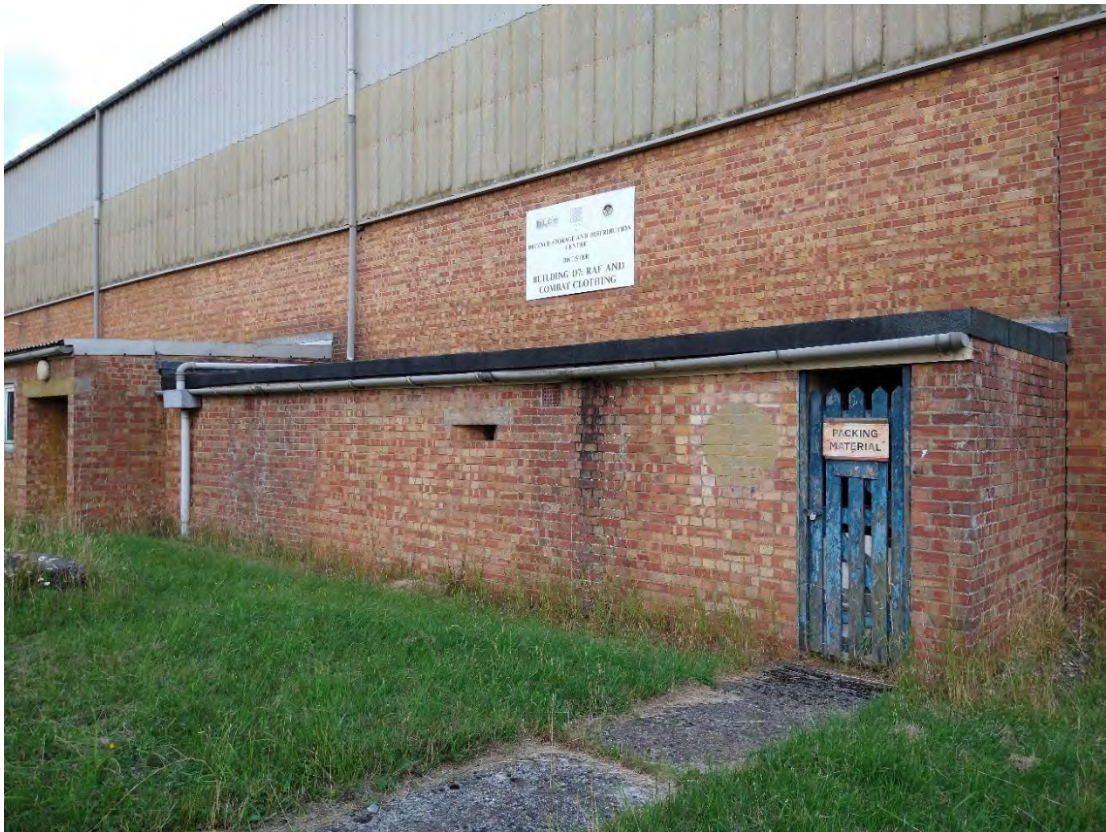
**Photograph 5:** North western elevation of Building D7 showing the brick outbuilding and potential bat access points.

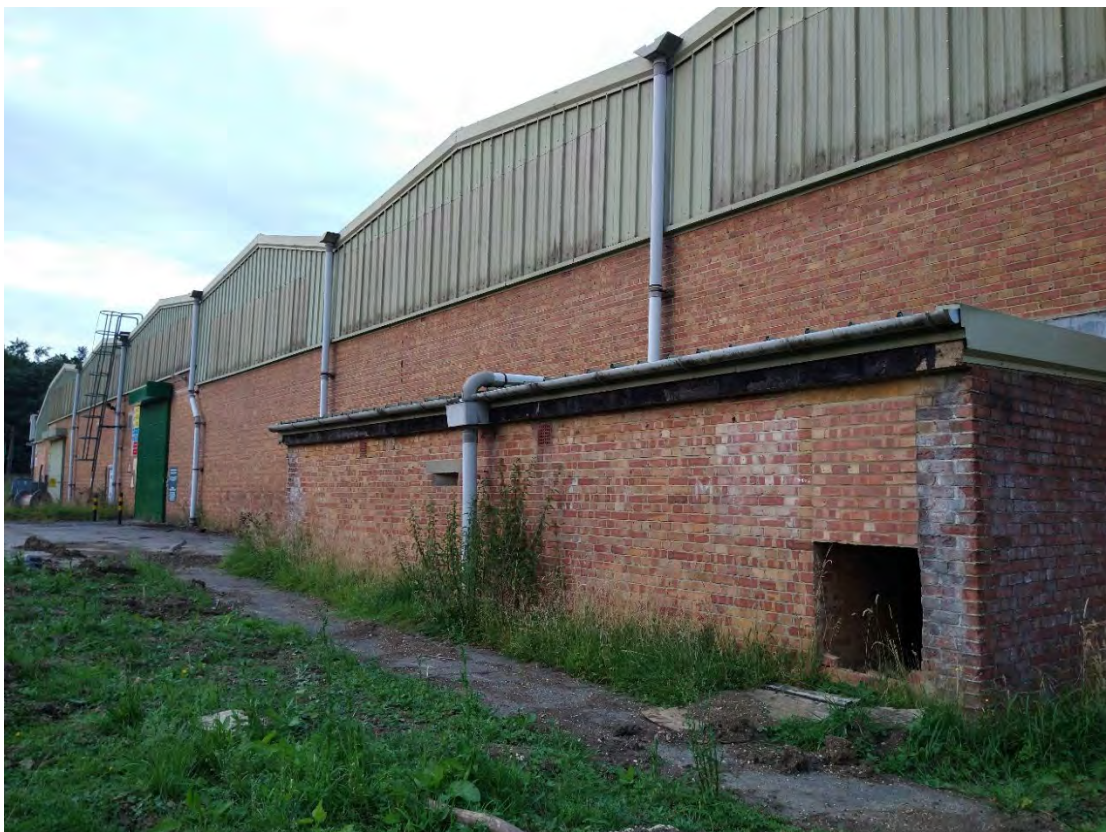
**Photograph 6:** Single-storey brick outbuilding on north western aspect of Building D4 – confirmed hibernation roost for a single brown long-eared bat.

- 5.3.16 One brown long-eared bat was found during the hibernation survey undertaken in January 2021, in the outbuilding on the north west side of Building D4.

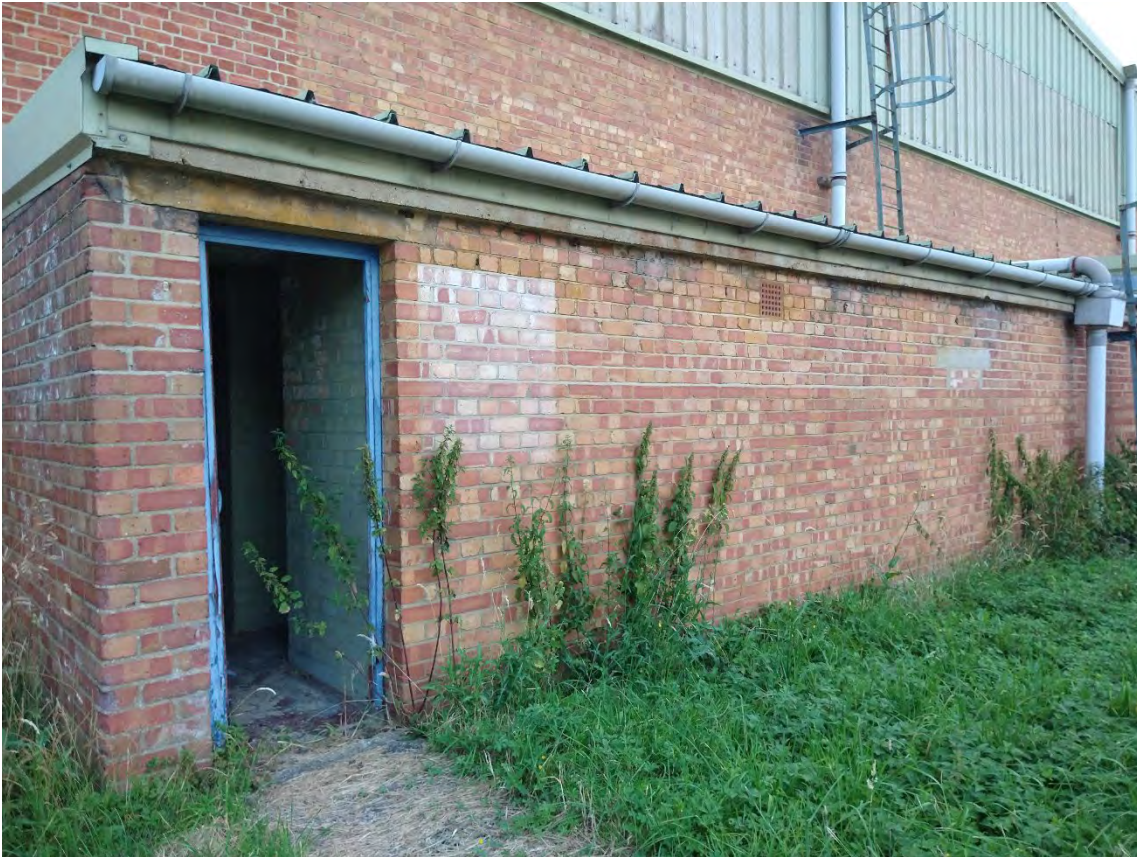
**Photograph 7:** Single-storey outbuilding on south eastern aspect of Building D4 with confirmed brown long-eared and natterer's bat roosts (access point into cavity wall shown on Photograph 8).

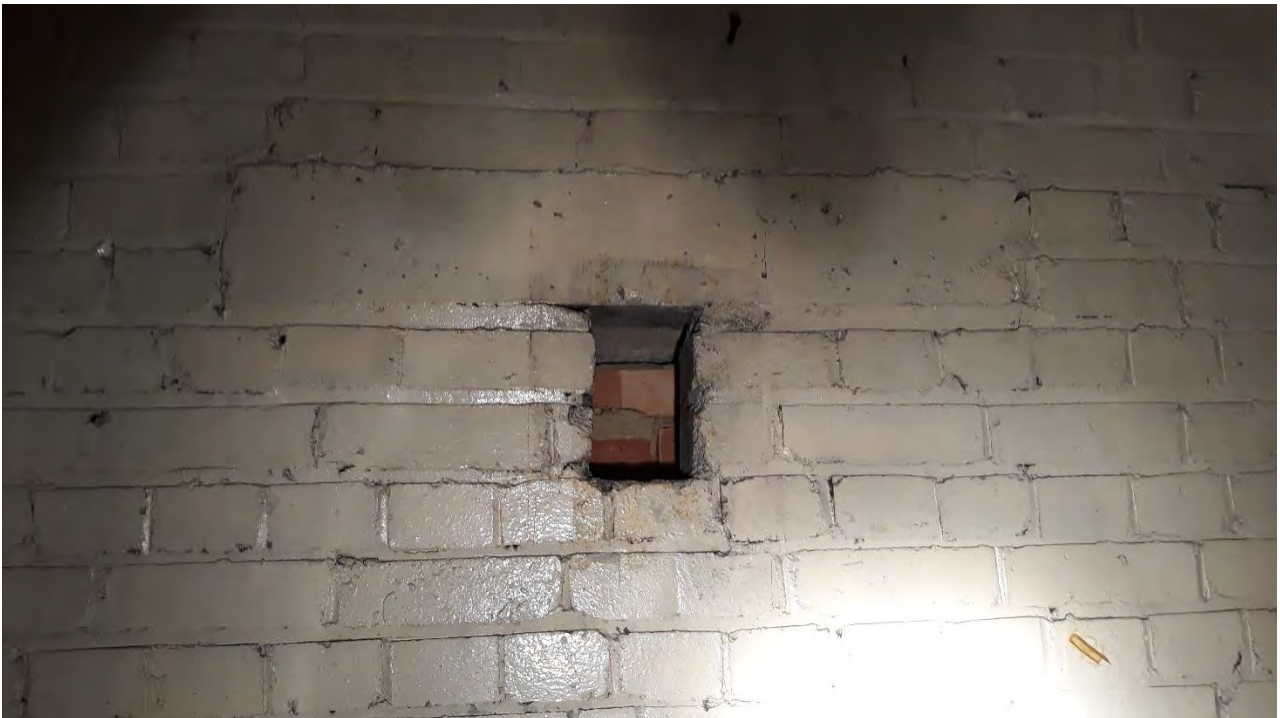
**Photograph 8:** One of two access points leading into the cavity wall of Building D4 outbuilding. Bat droppings were found at the entrance to the cavity, on the walls and on the door leading into the building.

side comprised an L-shaped entrance hall, one large room and two chemical closet areas. Two large holes on either side of the room which led to a void within the cavity wall; old bat droppings were present in both voids. Fresh droppings were found throughout the bunker and at the entrance. Samples were taken to be analysed which confirmed the presence of brown long-eared and natterer's bat *Myotis nattereri*.
