DARLING ASSOCIATES  
ARCHITECTS

Landscaping

**PLANNING CONDITION 10**

Site 2 - JDE

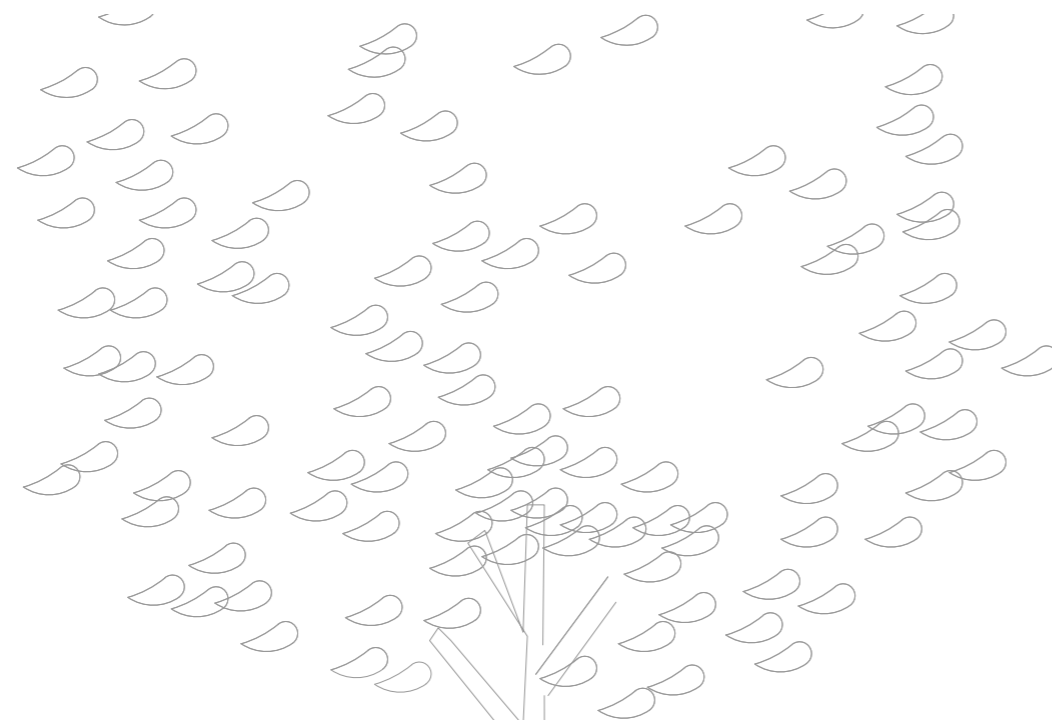
**Tree Pit Details**

Applicable for use on trees with stem girths from between 12cm and 20cm inclusive.

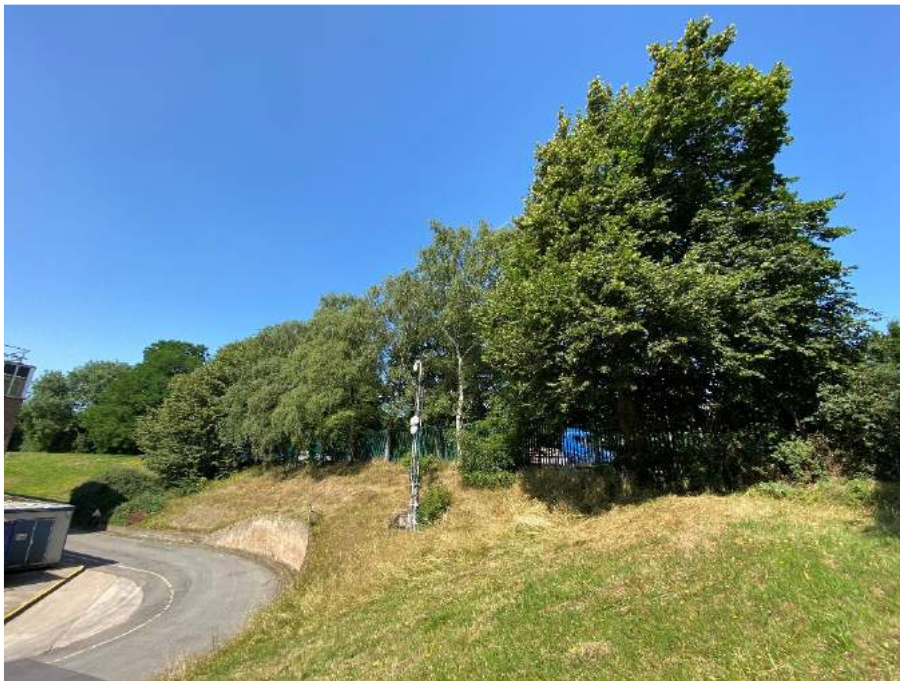
Photograph 1: Boundary trees on top of embankment viewed from the east.

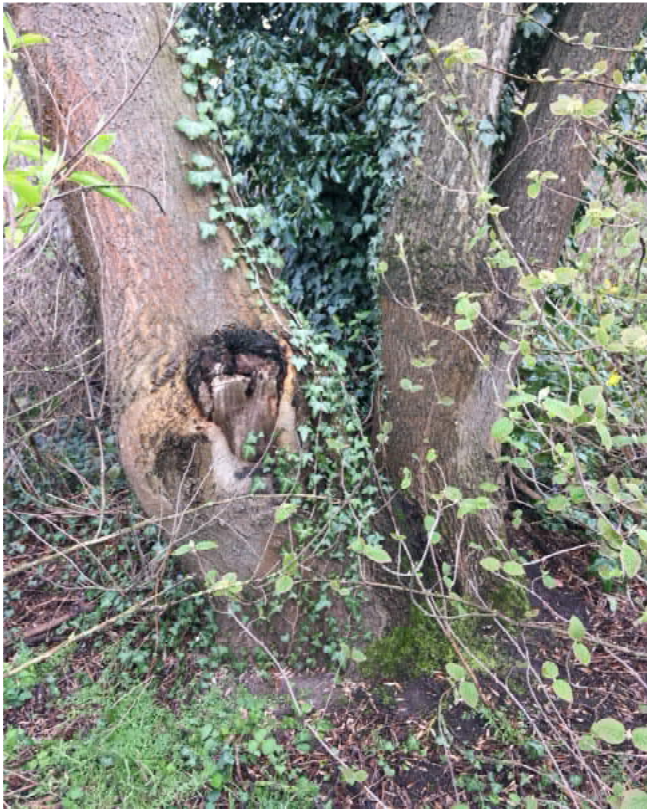
- 2.7 Tree 8 is coppice regeneration from a previously felled ash tree and grows amongst an outgrown shrubbery surveyed as group G9, for which the arboricultural elements are mainly restricted to younger self-sown trees of mediocre only form.

Photograph 2: Showing coppiced base of ash tree 8 (photograph taken in May 2019 when more visible).

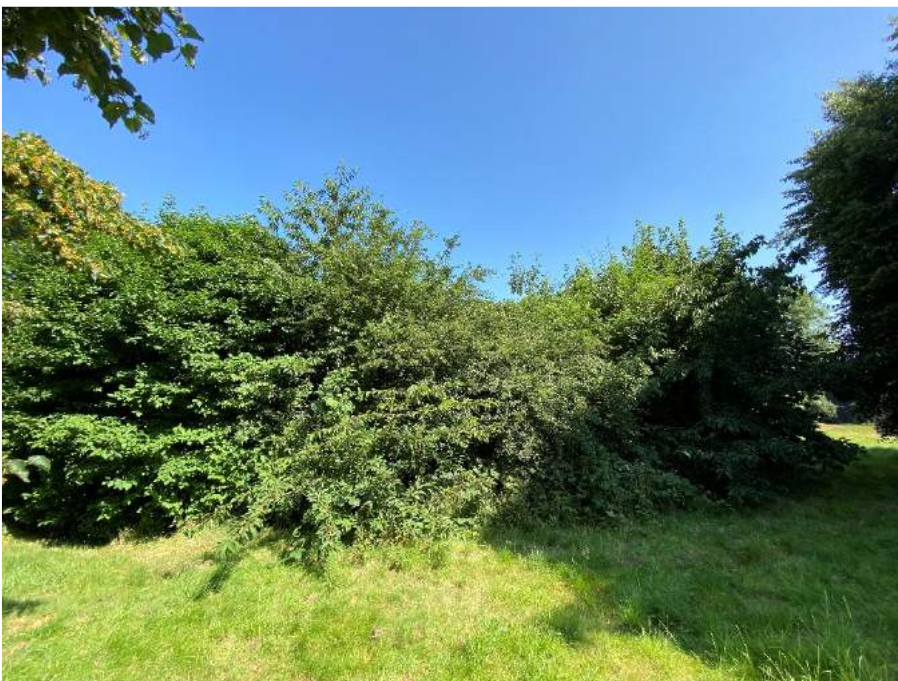
Photograph 3: Part of group G9 viewed from the south.

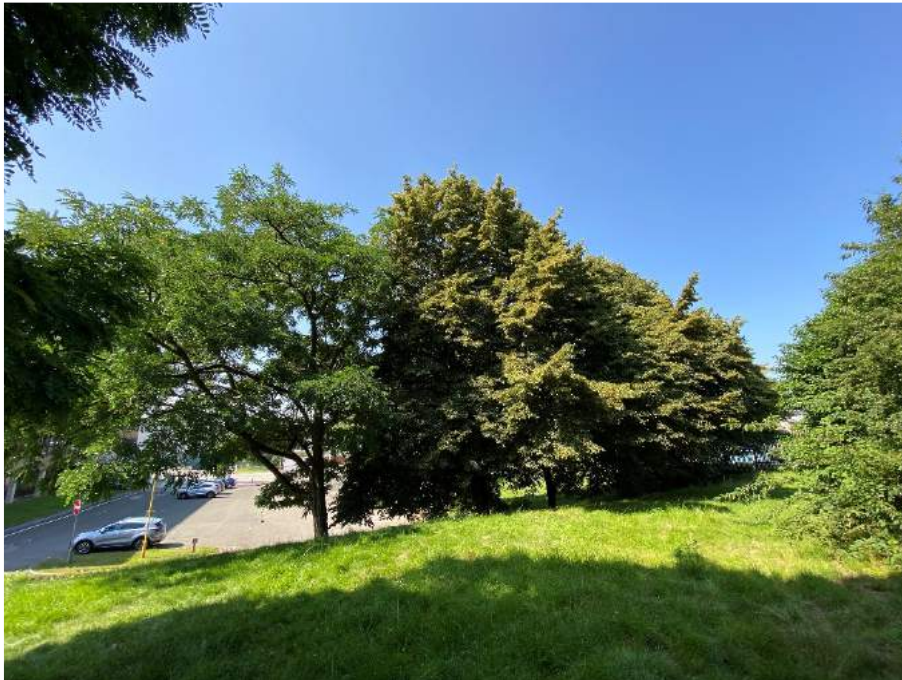
- 2.8 Trees 10 to 19 have a collective impact growing upon either the sloping embankments or the upper level of the landscaping mound.

Photograph 4: Showing trees 10 to 12 viewed from the north.

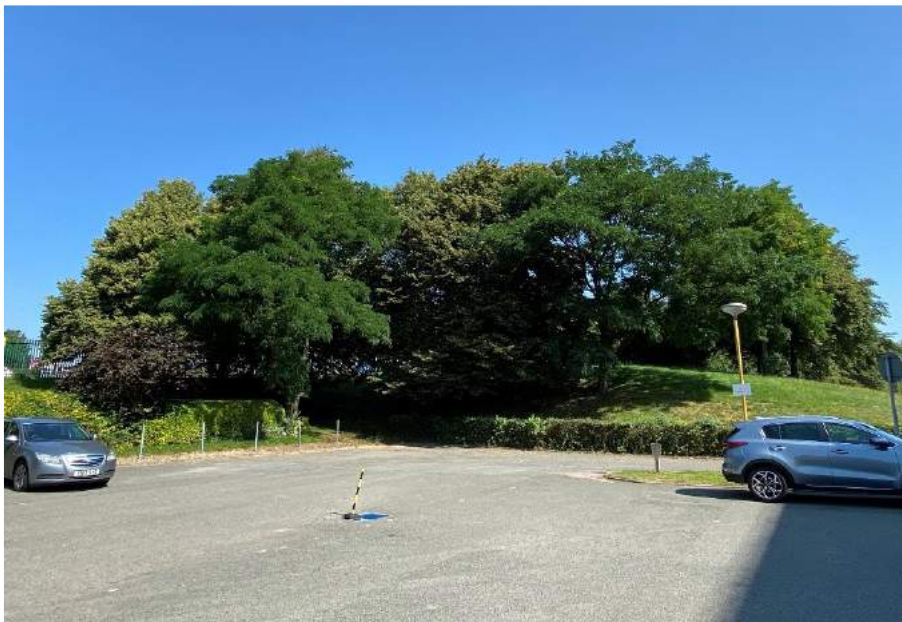
Photograph 5: Showing trees 10 to 19 inclusive viewed from the south.

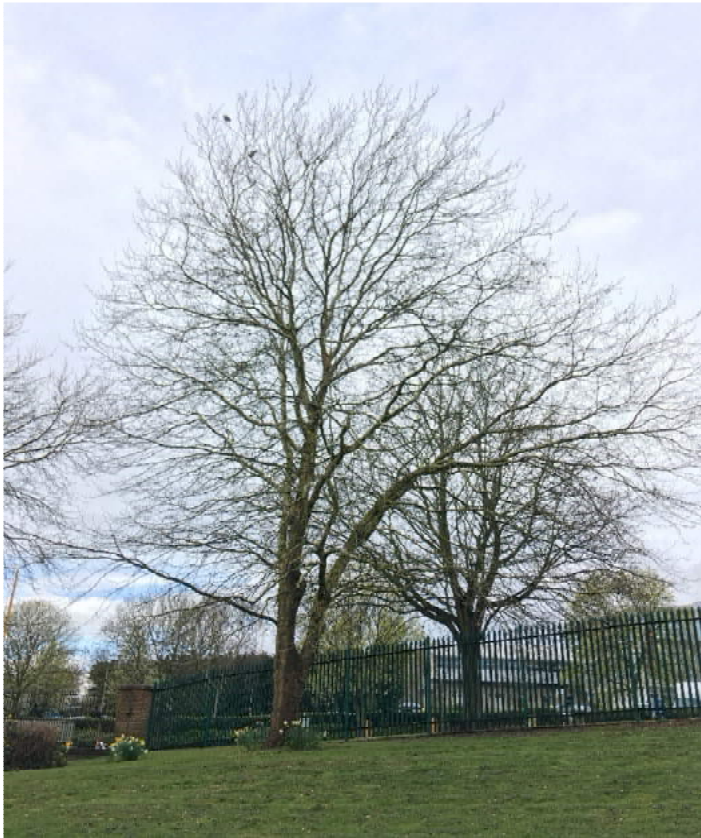
- 2.9 Tree 20 is a prominent frontage, high value London plane tree that has co-evolved with Norway maple tree G growing in the public verge.

Photograph 6: London plane tree 20 viewed from the south east with Norway maple tree G visible in the background (photograph taken in May 2019).

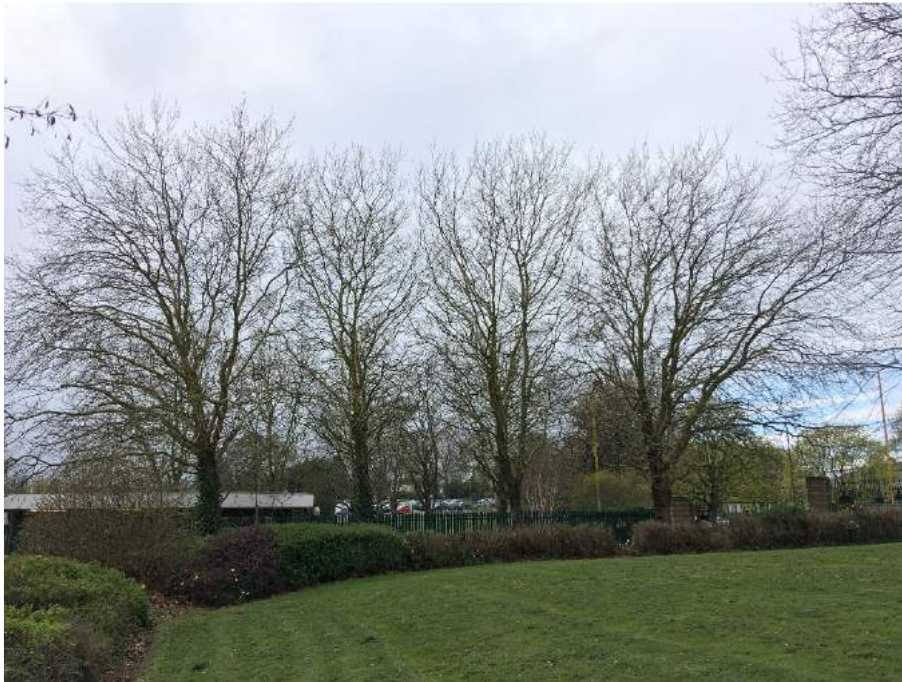
2.10 Plane trees 21 to 24 inclusive form one half of an avenue feature to either side of the main access into the site with the security lodge in the centre. The north western tree, tree 21, is the best developed and grows in the most conspicuous location.

Photograph 7: Plane trees 21 to 24 viewed from the east (photograph taken in May 2019).

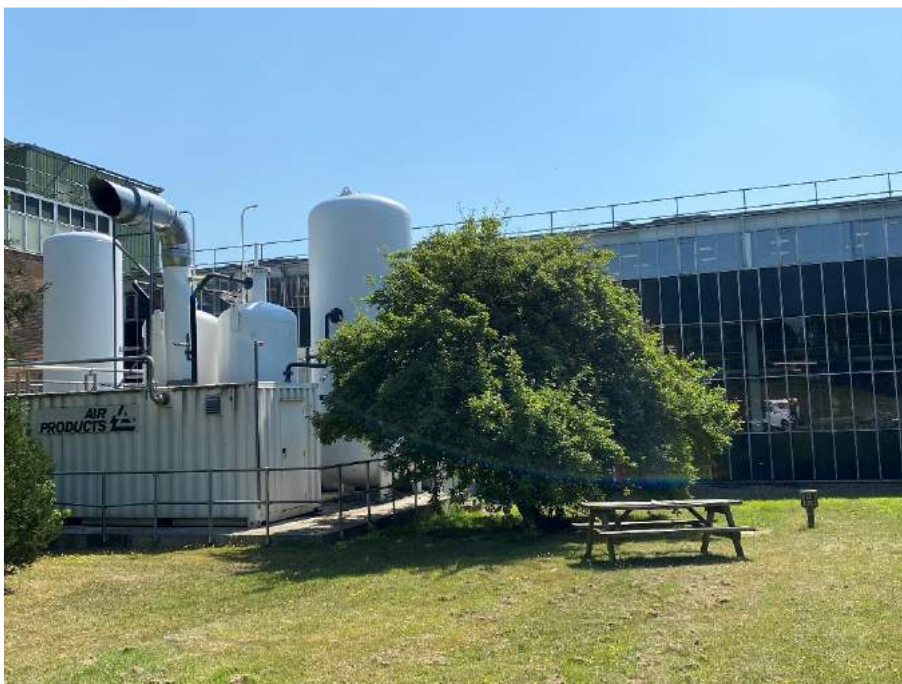
2.11 Apple tree 26 and group G27, formed from cypress and yew, are located within the amenity space set back slightly within the factory footprint close to the nitrogen production plant.

Photograph 8: Apple 26 viewed from the west.

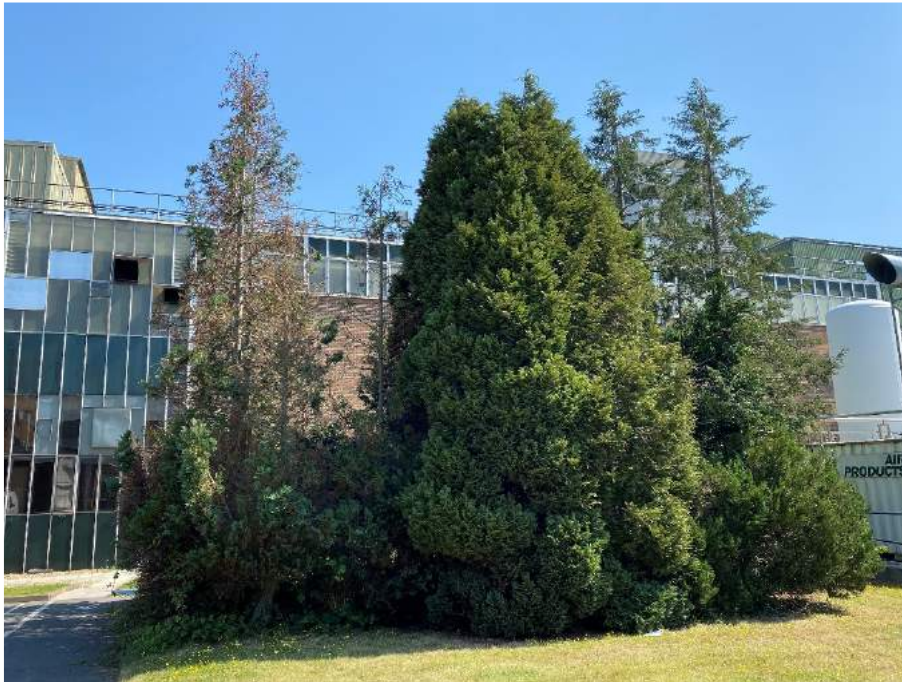
Photograph 9: Group G27 showing the declining trees within.
