Barn In OS Parcel 0545, West of Withycombe Farm, Wiggington, OX15 4LE

PRELIMINARY CONTAMINATION RISK ASSESSMENT

June 2022

P22-126pra

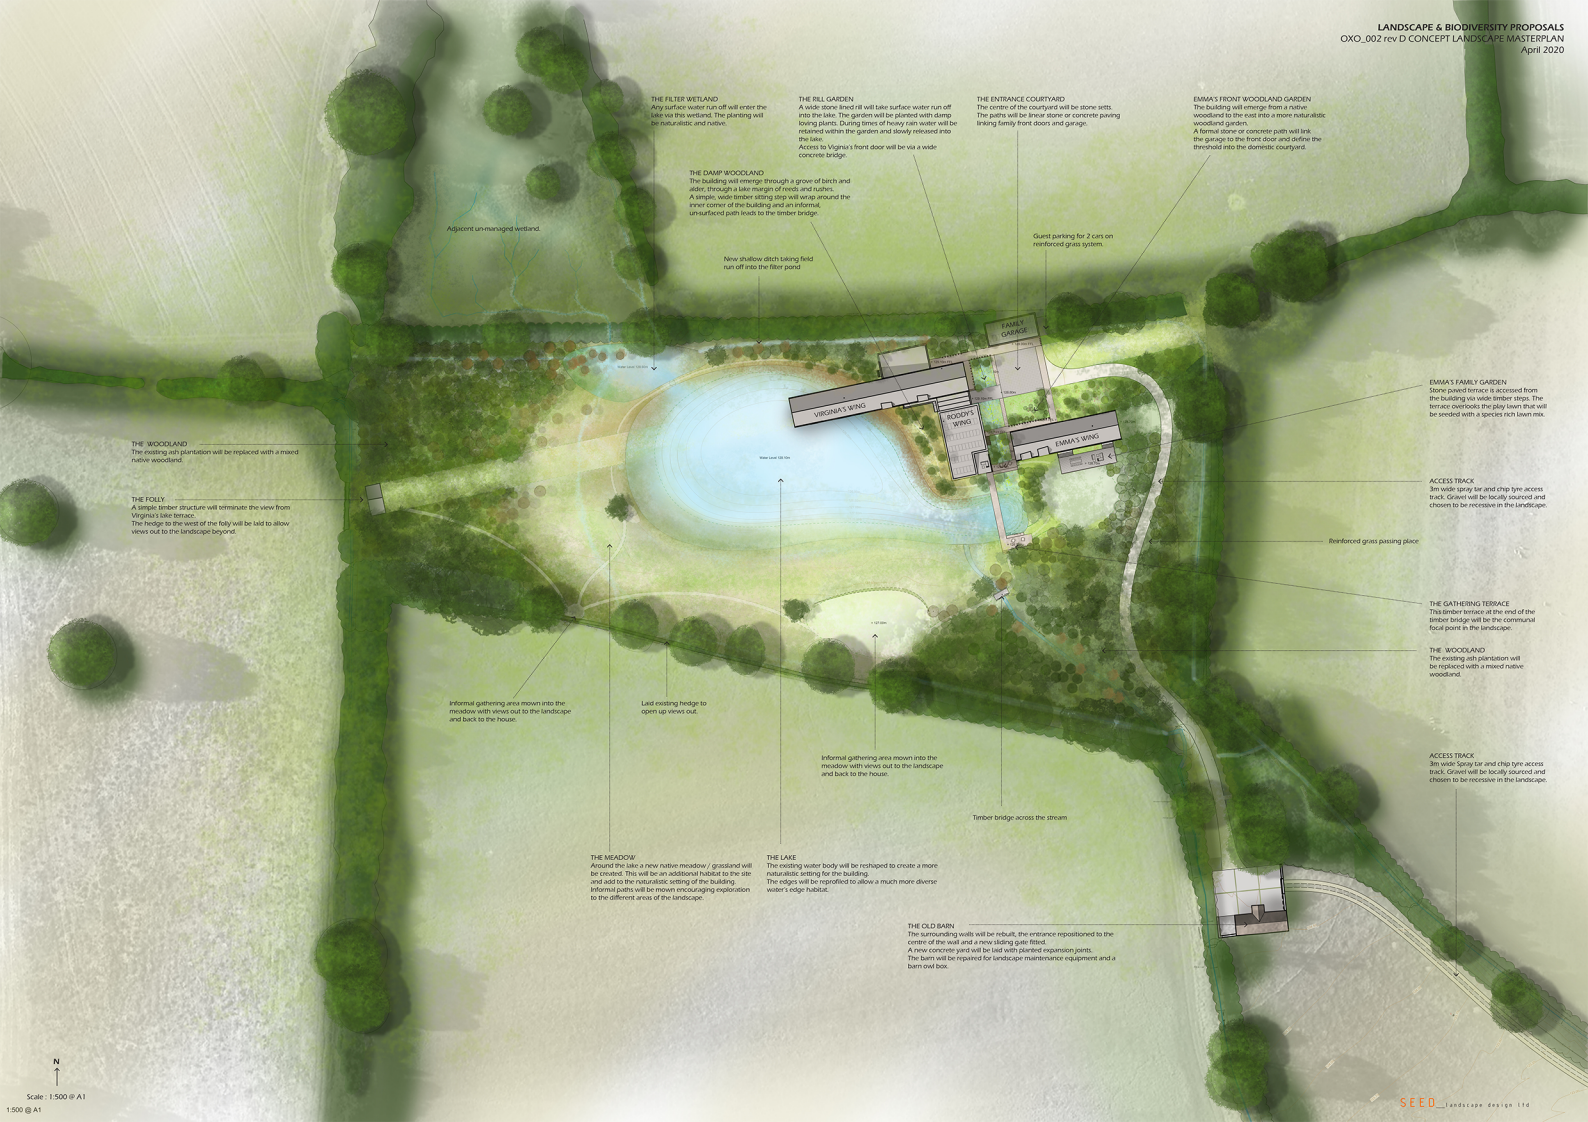
THE FILTER WETLAND
 Any surface water run off will enter the lake via this wetland. The planting will be naturalistic and native.

THE RILL GARDEN
 A wide stone lined rill will take surface water run off into the lake. The garden will be planted with clump loving plants. During times of heavy rain, water will be retained within the garden and slowly released into the lake. Access to Virginia's front door will be via a wide concrete bridge.

THE WOODLAND
 The existing soft plantation will be replaced with a mixed native woodland.

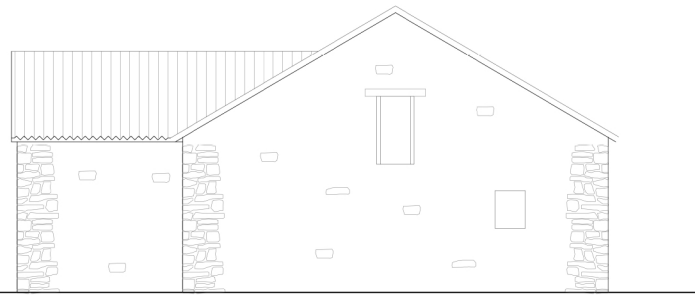
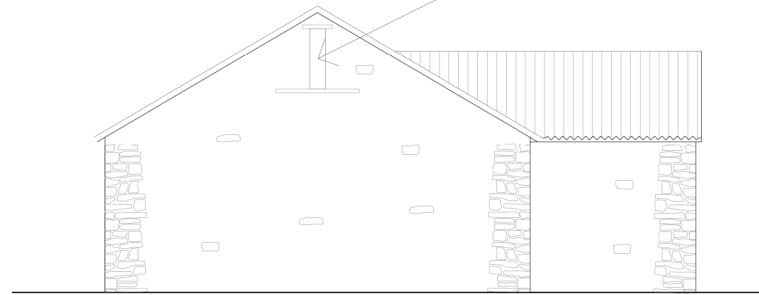
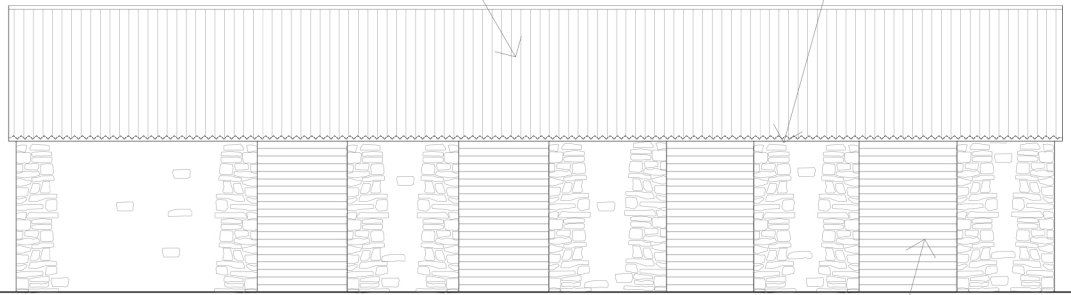
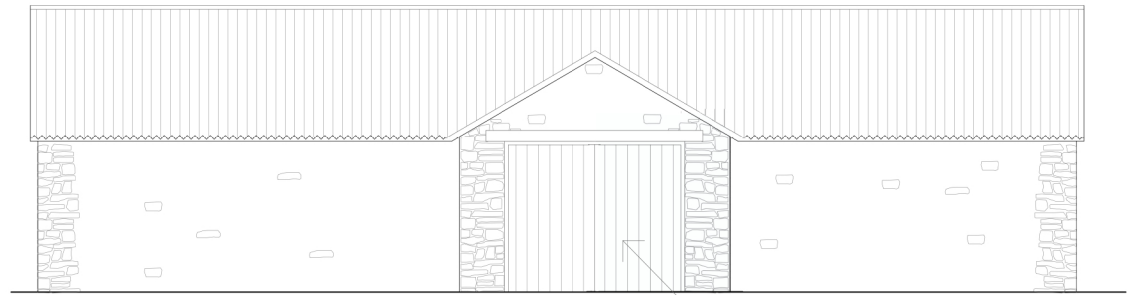
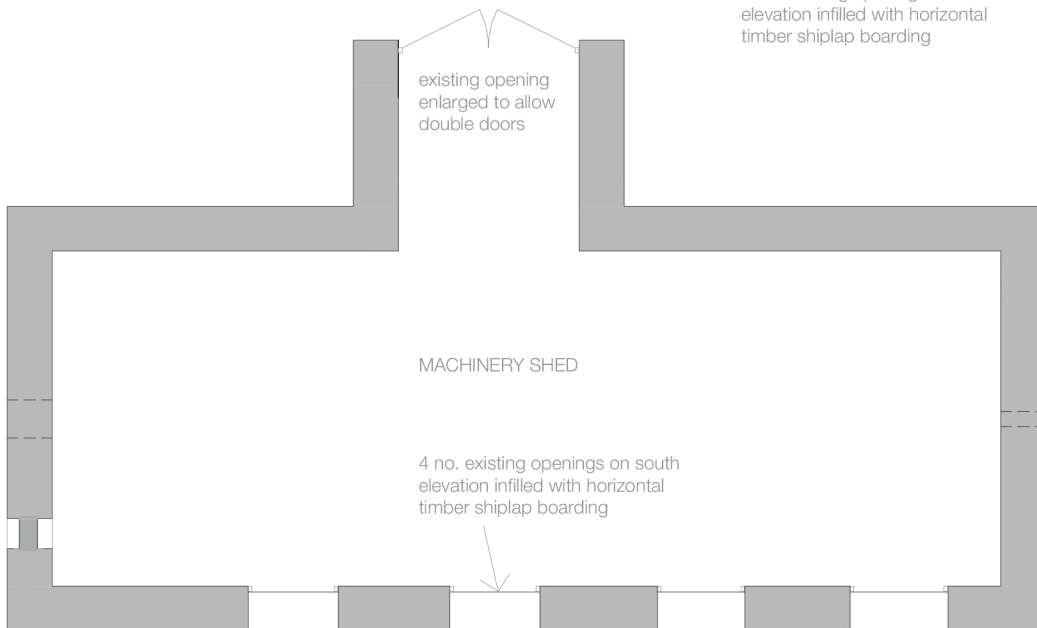
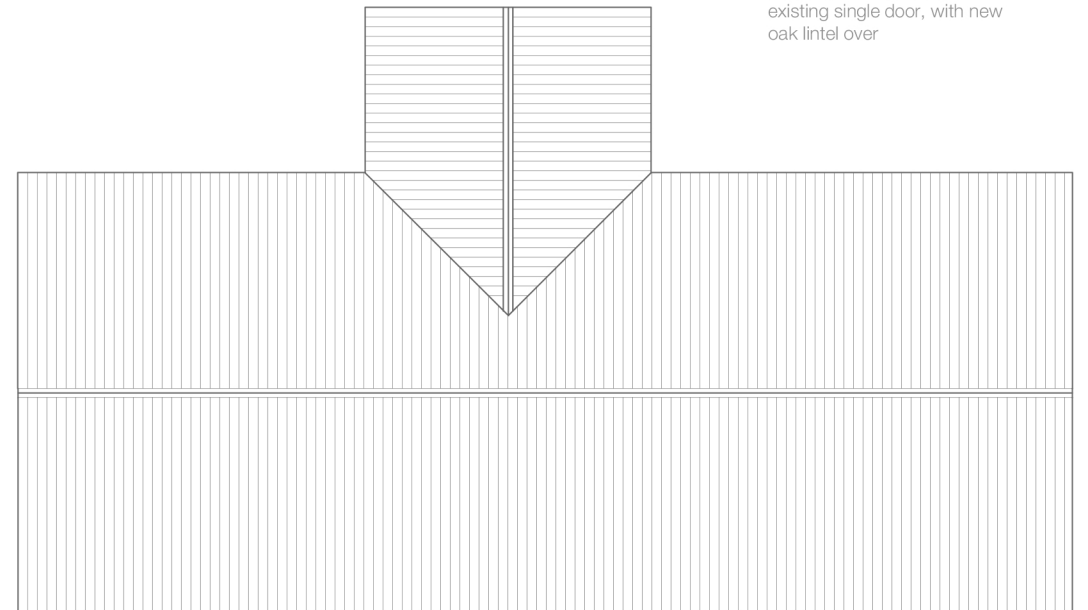
existing rusting sheet roofing all replaced with dark grey corrugated steel sheeting

bat boxes to be built in to eaves

4 no. existing openings on south elevation infilled with horizontal timber shiplap boarding

existing opening enlarged to allow double doors

The existing derelict barn will be refurbished as part of the proposals for use as a machinery and equipment shed.
