Technical Design (LI work stage 4) Mr & Mrs Fennessy LAYOUT - Hard

Landscape (barn & entrance) OXO\_103

Oxpens, Oxfordshire

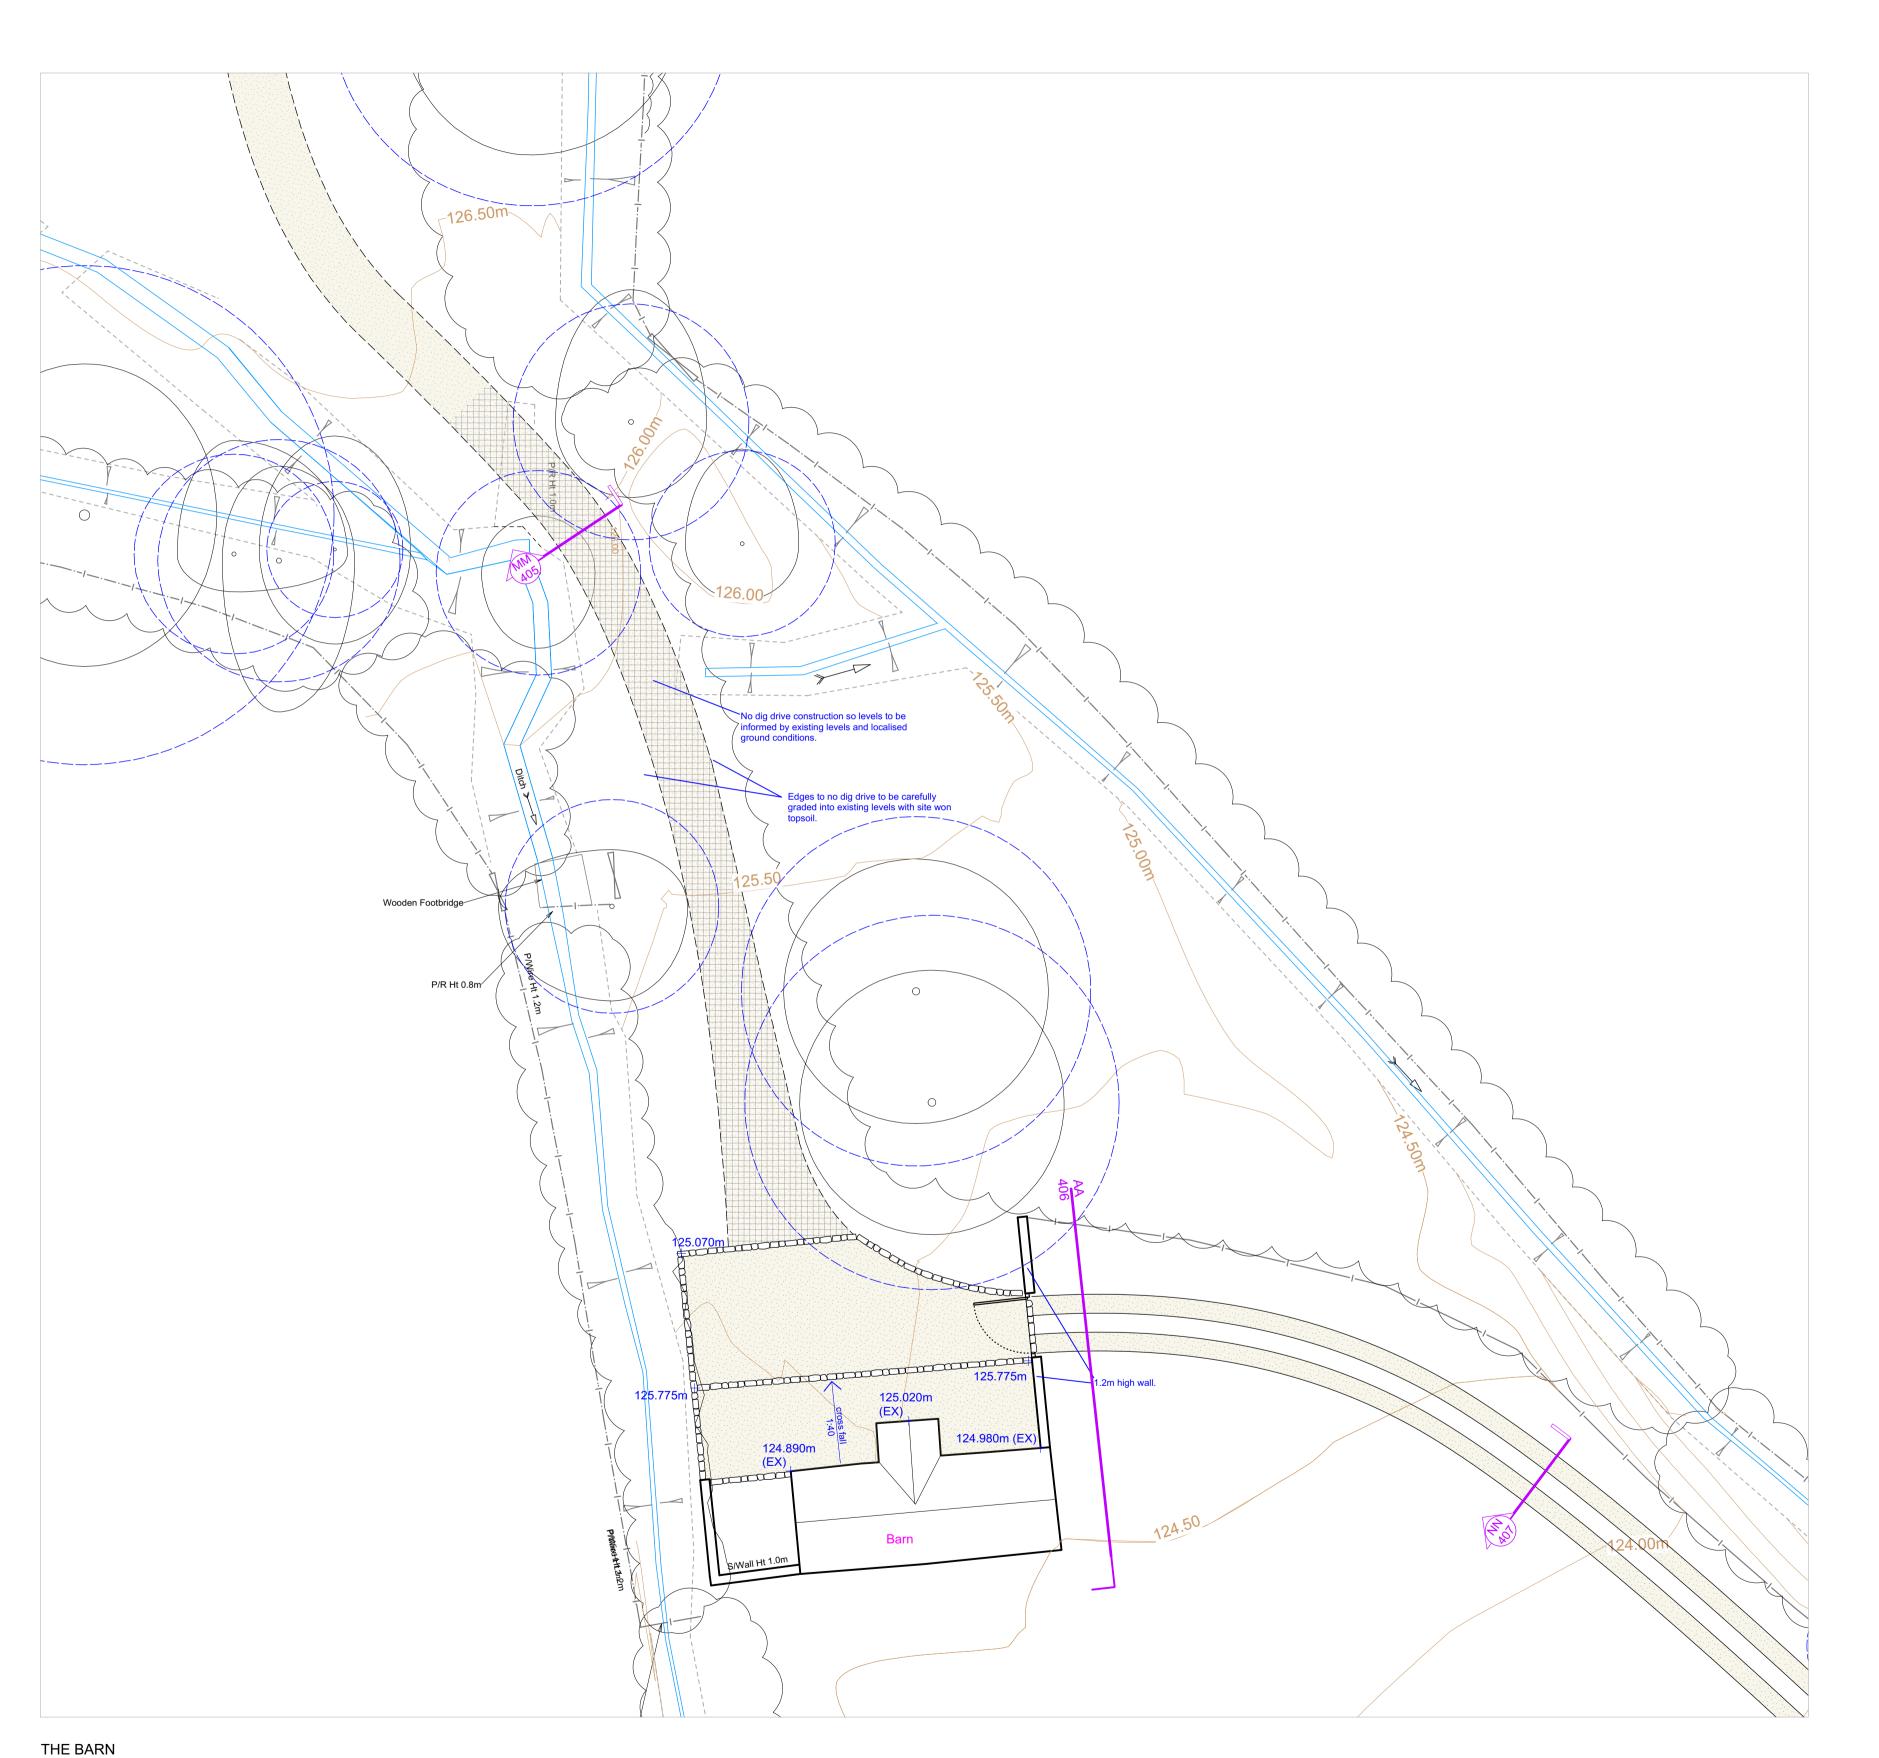
**ENTRANCE**

Bonded Aggregate 'Tier Track' Surface Limestone chippings bonded to a macadam surface. Structural buildup TBC by structural engineer.

Aggregate Surface (porous)
50mm of limestone chippings laid ontop of
200mm MOT Type 3 (sub base TBC by

engineer).

Limestone Edging (laid flat)
Limestone walling stone laid on 25mm mortar bed with 150mm concrete foundation.

TBC by structural engineer.

Limestone Edging / Drainage Channel (laid on edge to road threshold) Limestone walling stone laid on 25mm mortar bed with 150mm concrete foundation. TBC by structural engineer.

Timber Gate 5 bar agricultural timber gate. Gate post set in concrete.
