**Phase 2 Geo-  
Environmental Site  
Investigation**

**Hempton Road,  
Deddington**

**BRD3567-OR2-A**

**January 2020**

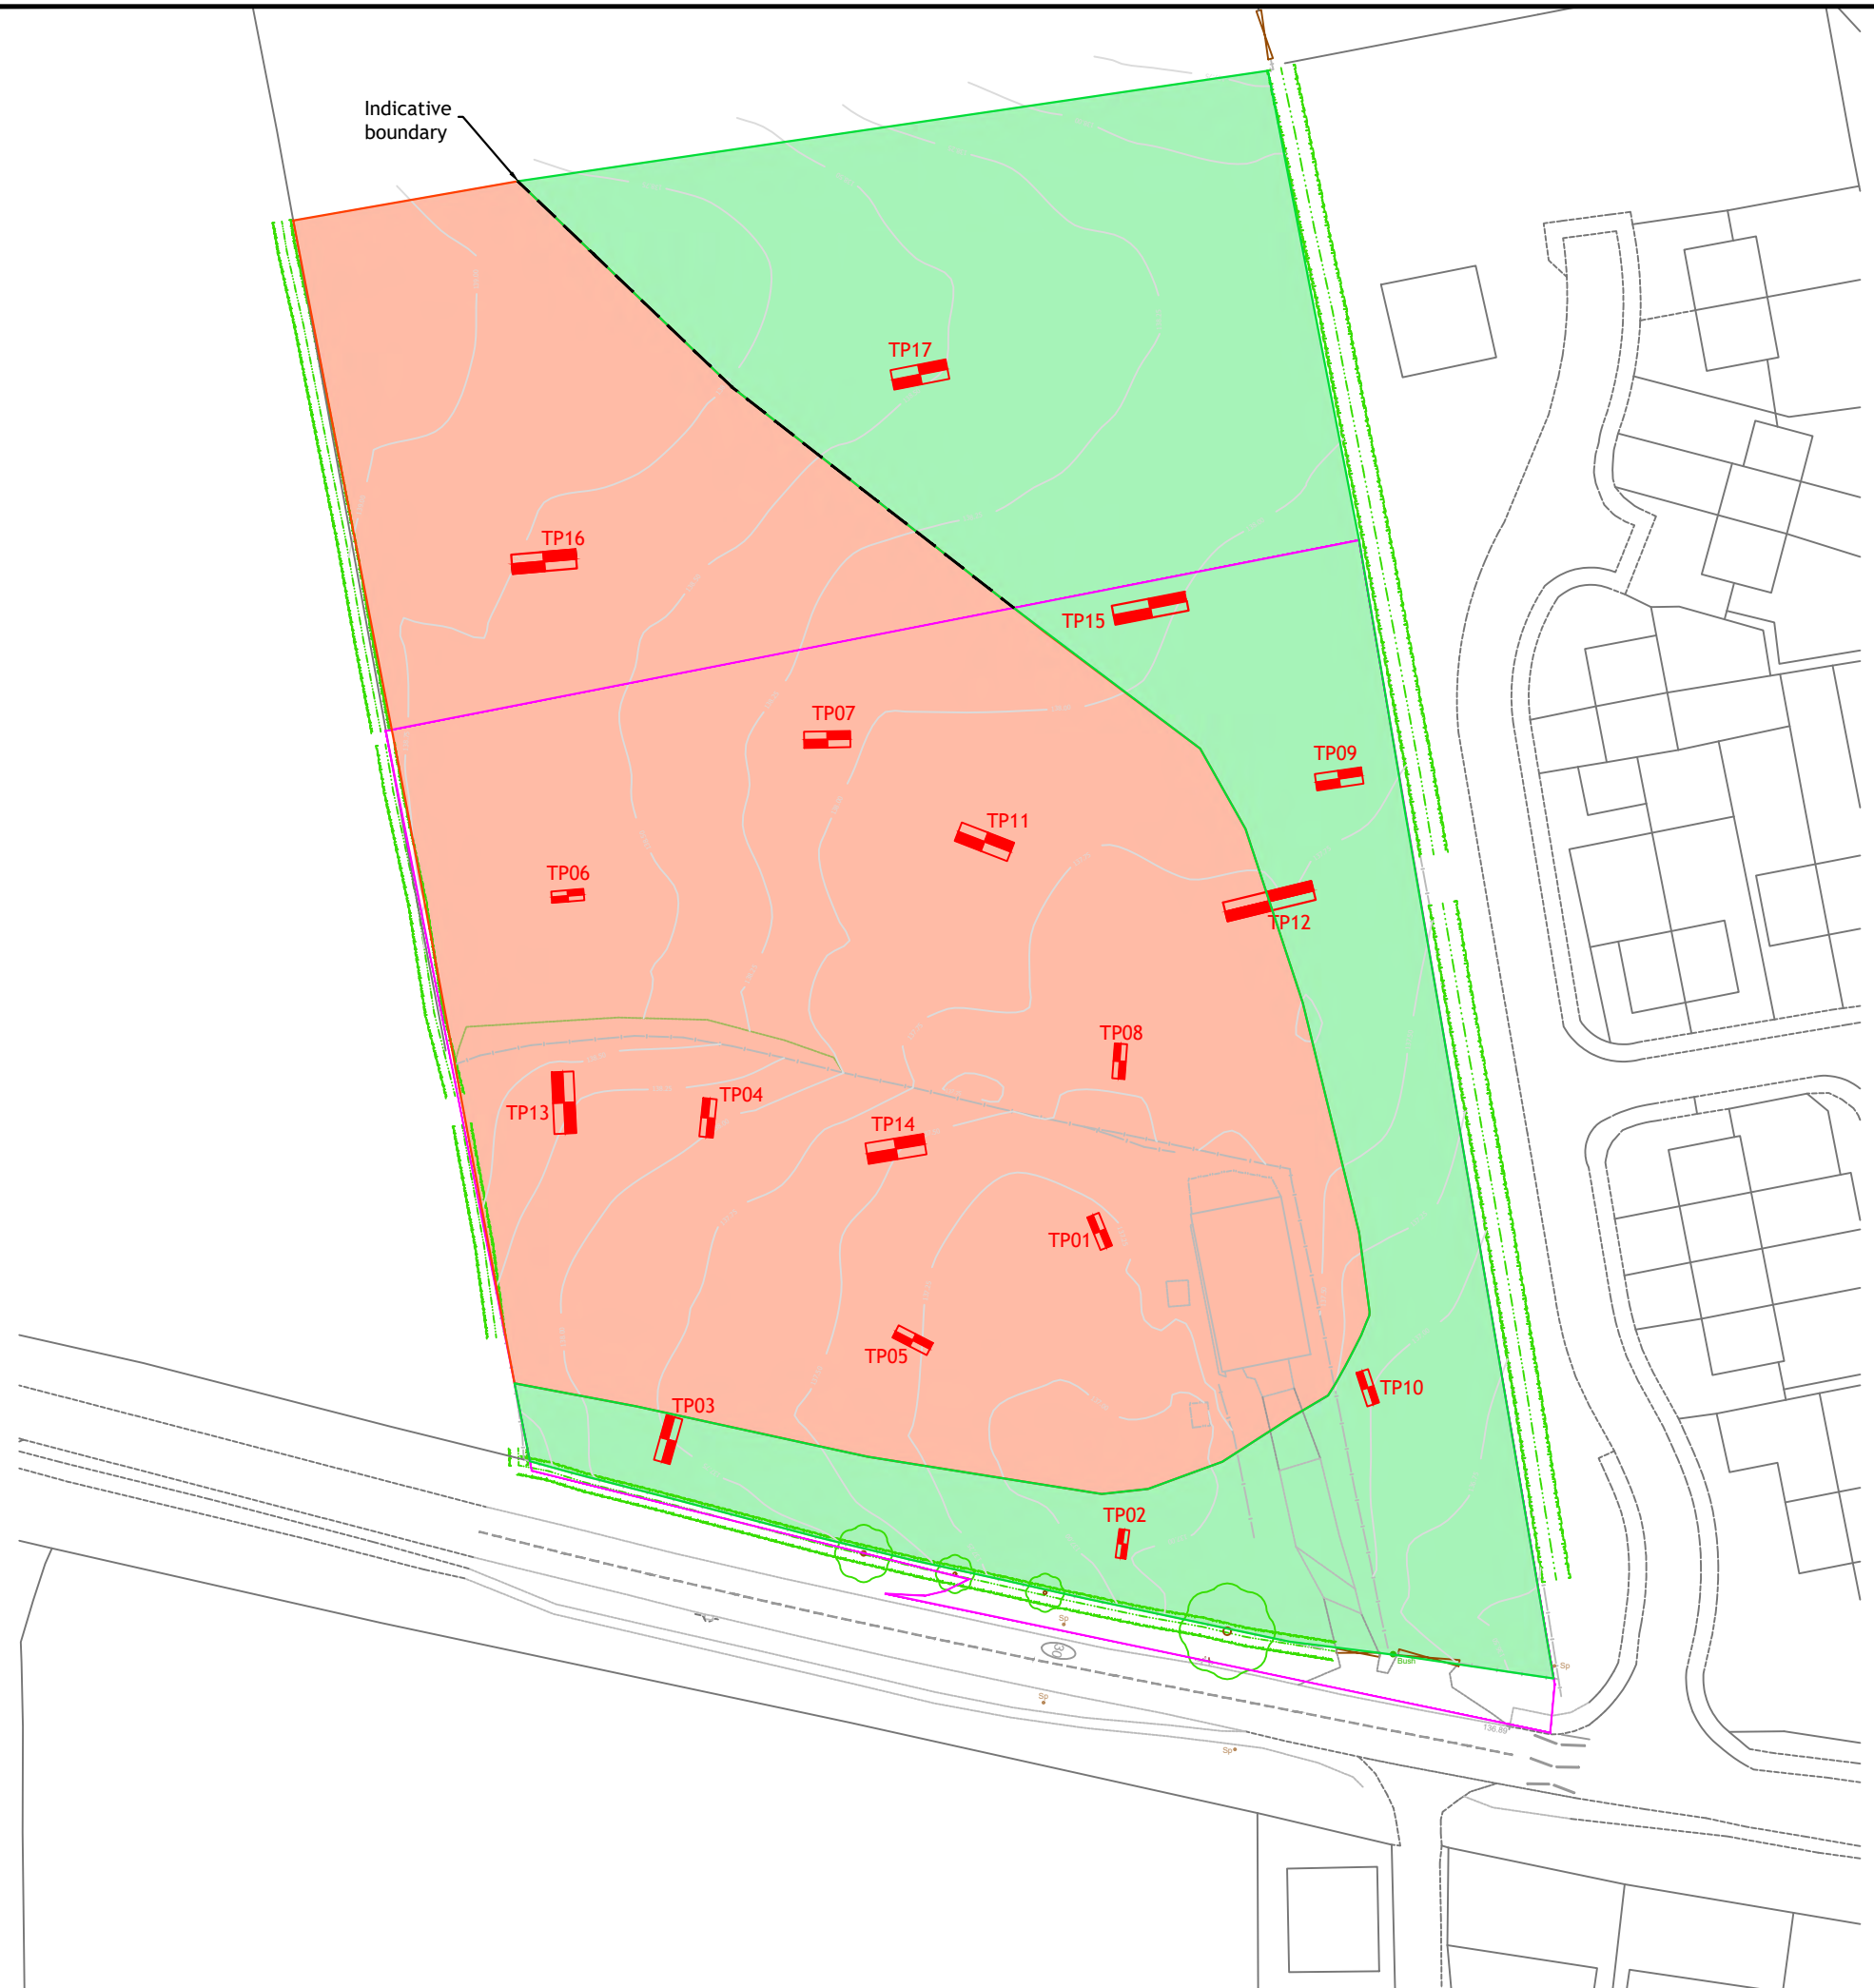
- Shallow strip/trench fill footings
- Piles or Ground Improvement
- BRD Trial Pit Locations
- BRD Site Boundary (Approximate Locations)

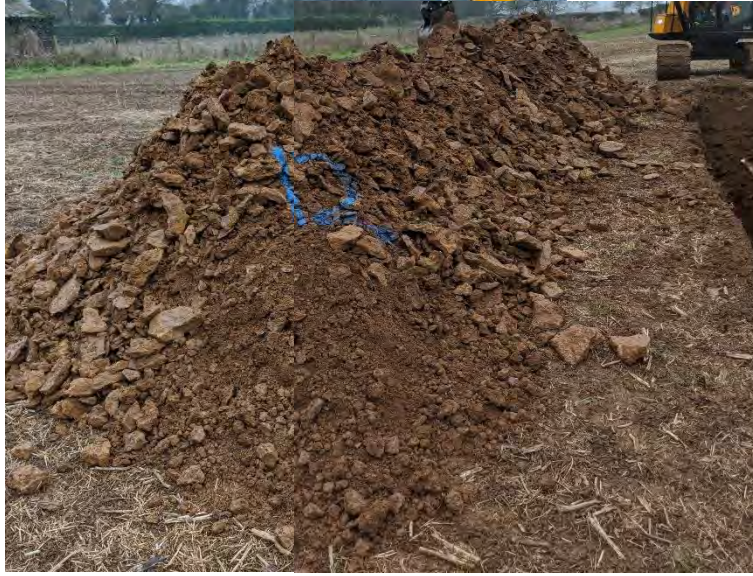
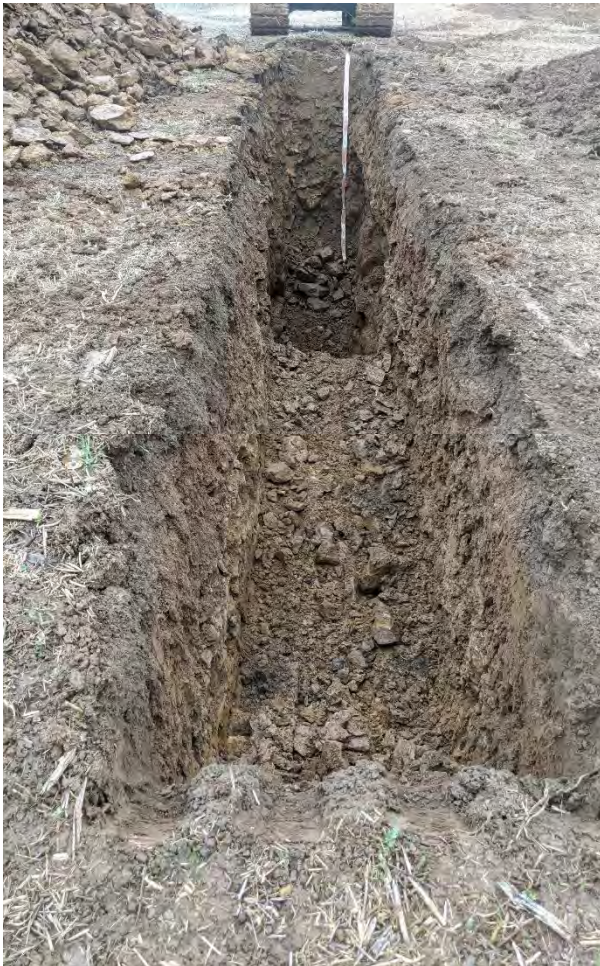
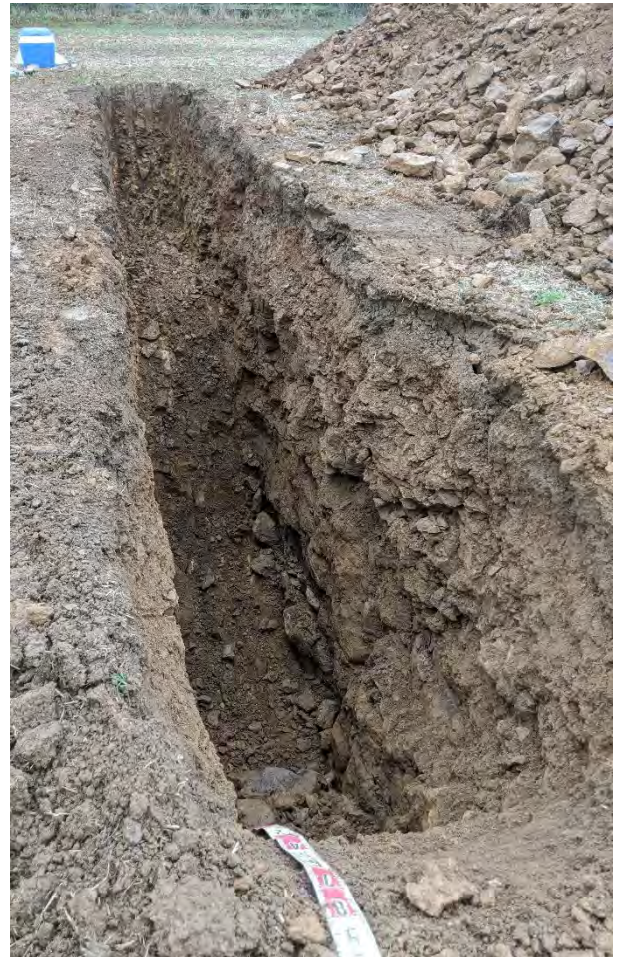
TP12

To determine the outer edge of the quarry area a long trial pit (TP12) was undertaken identifying a change from loose reworked ironstone in the west of the pit to layered natural bedrock in the eastern extent of the pit. The transition here from bedrock to the loose Made Ground indicates the edge of the former quarry or loose ground, and at this location, approximately aligns with the eastern boundary of Field A.
