GEO-ENVIRONMENTAL & GEOTECHNICAL ASSESSMENT (GROUND INVESTIGATION) REPORT

PHASE 10
HEYFORD PARK
CAMP ROAD
OX25 5BS

Report Title: Geo-environmental & Geotechnical Assessment Ground Investigation Report for Phase 10, Heyford Park, Camp Road, OX25 5BS

Job No: P4280J2513/SC

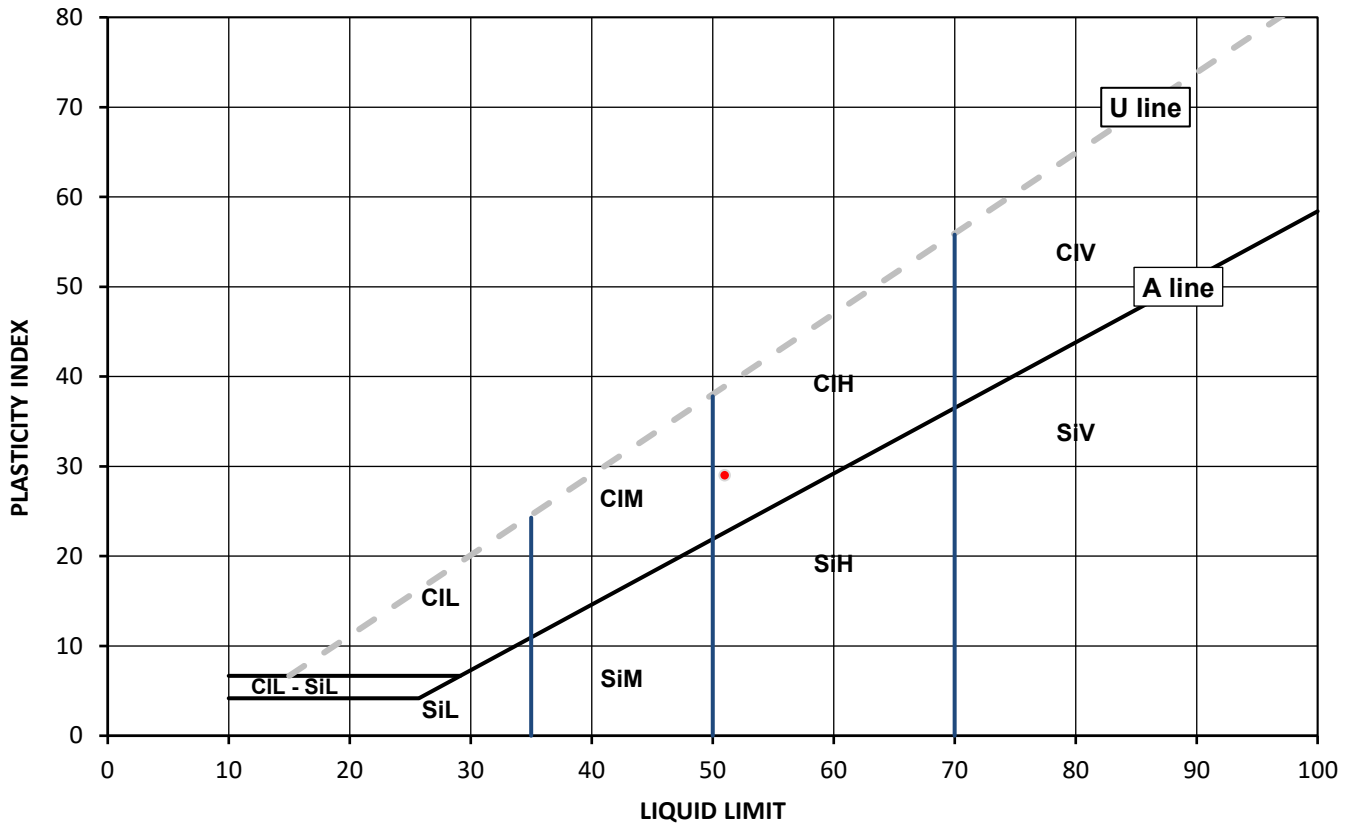
As Received Water Content [W] %	Liquid Limit [WL] %	Plastic Limit [Wp] %	Plasticity Index [Ip] %	% Passing 425µm BS Test Sieve
21	51	22	29	100
