SITE INVESTIGATION REPORT

LAND OFF BERRY HILL ROAD, ADDERBURY, BANBURY. OX17 3HF

Prepared for: **Hayfield Homes Construction Ltd and Hollins Strategic Land**

Report Reference: BC592 RE001

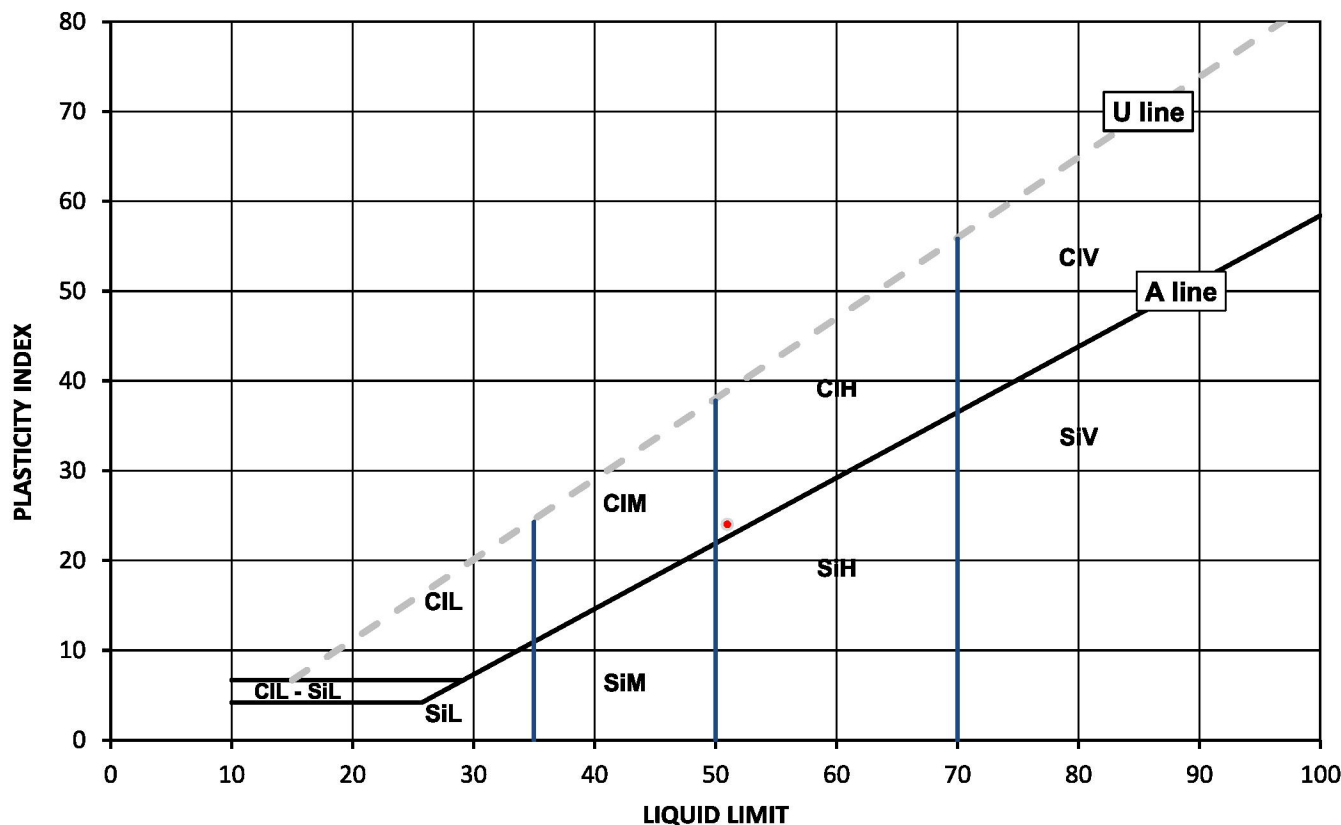
Sample Preparation: Tested in natural condition

As Received Water Content [W] %	Liquid Limit [WL] %	Plastic Limit [Wp] %	Plasticity Index [Ip] %	% Passing 425µm BS Test Sieve
24	51	27	24	100

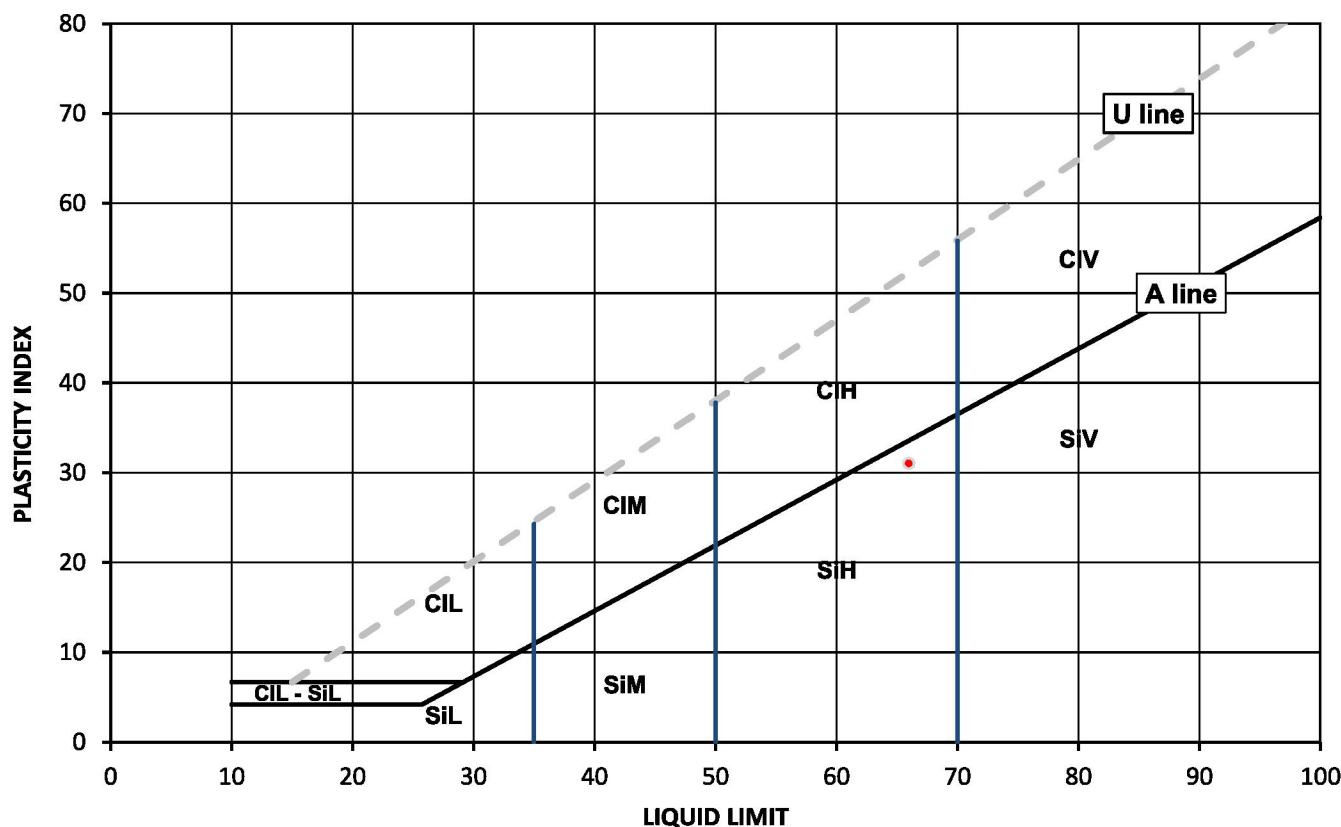
Sample Preparation: Tested after >425um removed by hand

As Received Water Content [W] %	Liquid Limit [WL] %	Plastic Limit [Wp] %	Plasticity Index [Ip] %	% Passing 425µm BS Test Sieve
39	66	35	31	82

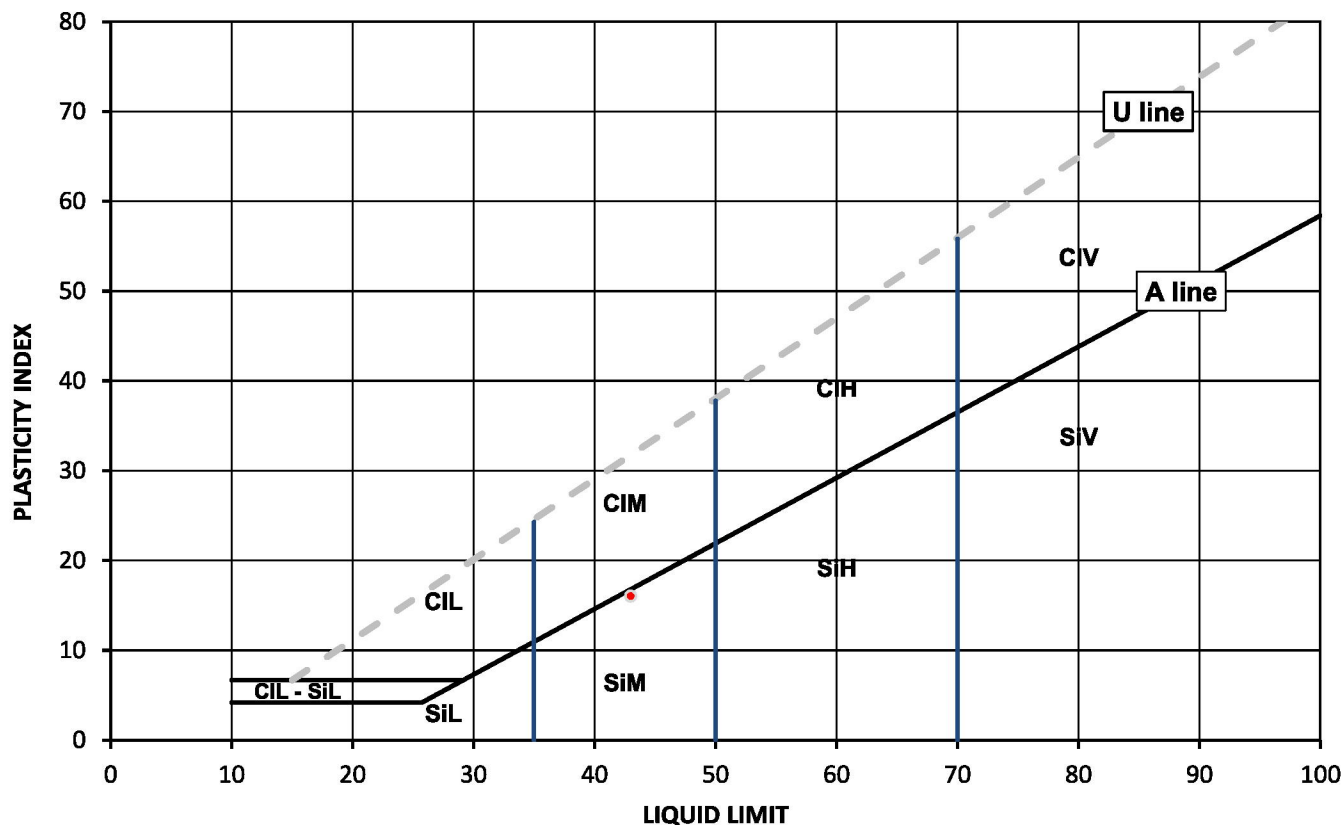
Sample Preparation: Tested in natural condition

As Received Water Content [W] %	Liquid Limit [WL] %	Plastic Limit [Wp] %	Plasticity Index [Ip] %	% Passing 425µm BS Test Sieve
22	43	27	16	100

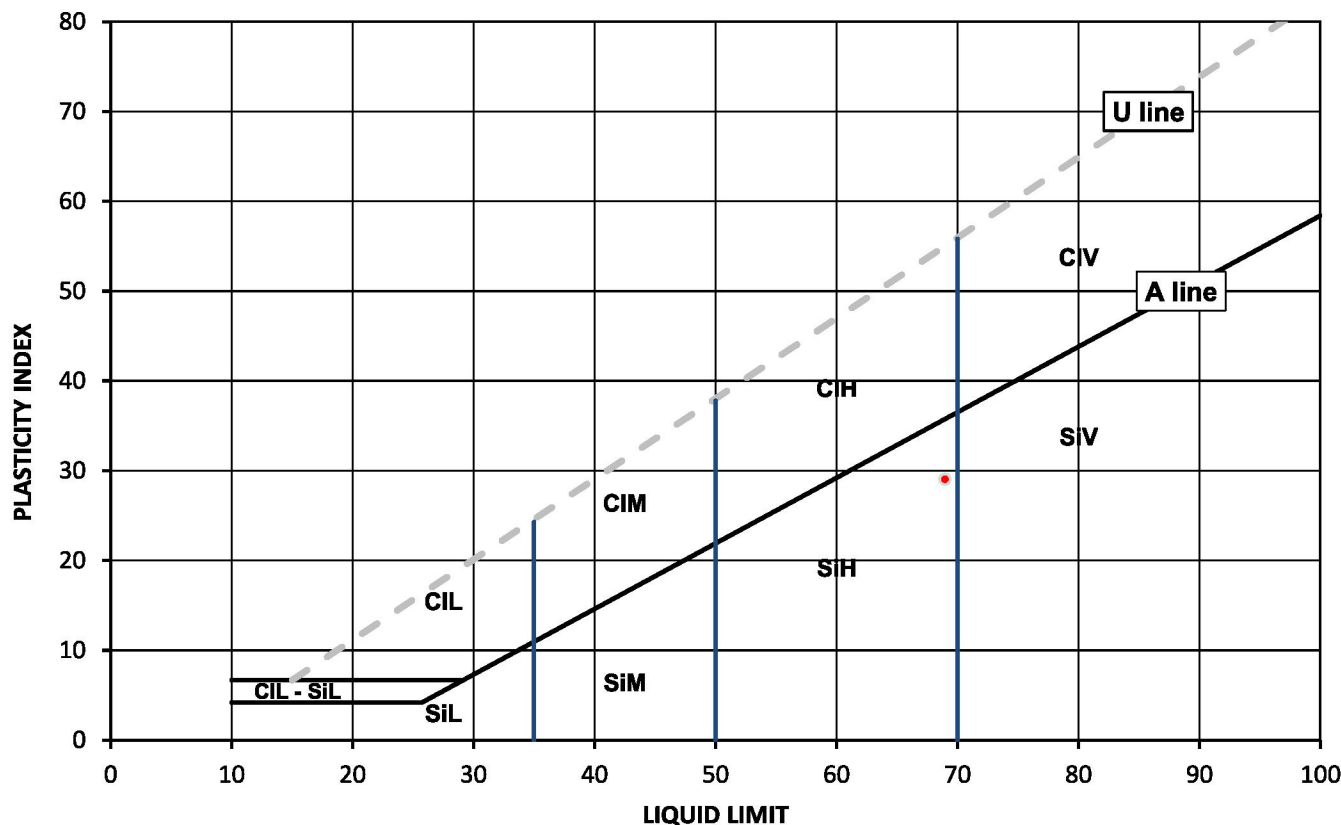
Sample Preparation: Tested after washing to remove >425um

As Received Water Content [W] %	Liquid Limit [WL] %	Plastic Limit [Wp] %	Plasticity Index [Ip] %	% Passing 425µm BS Test Sieve
38	69	40	29	79

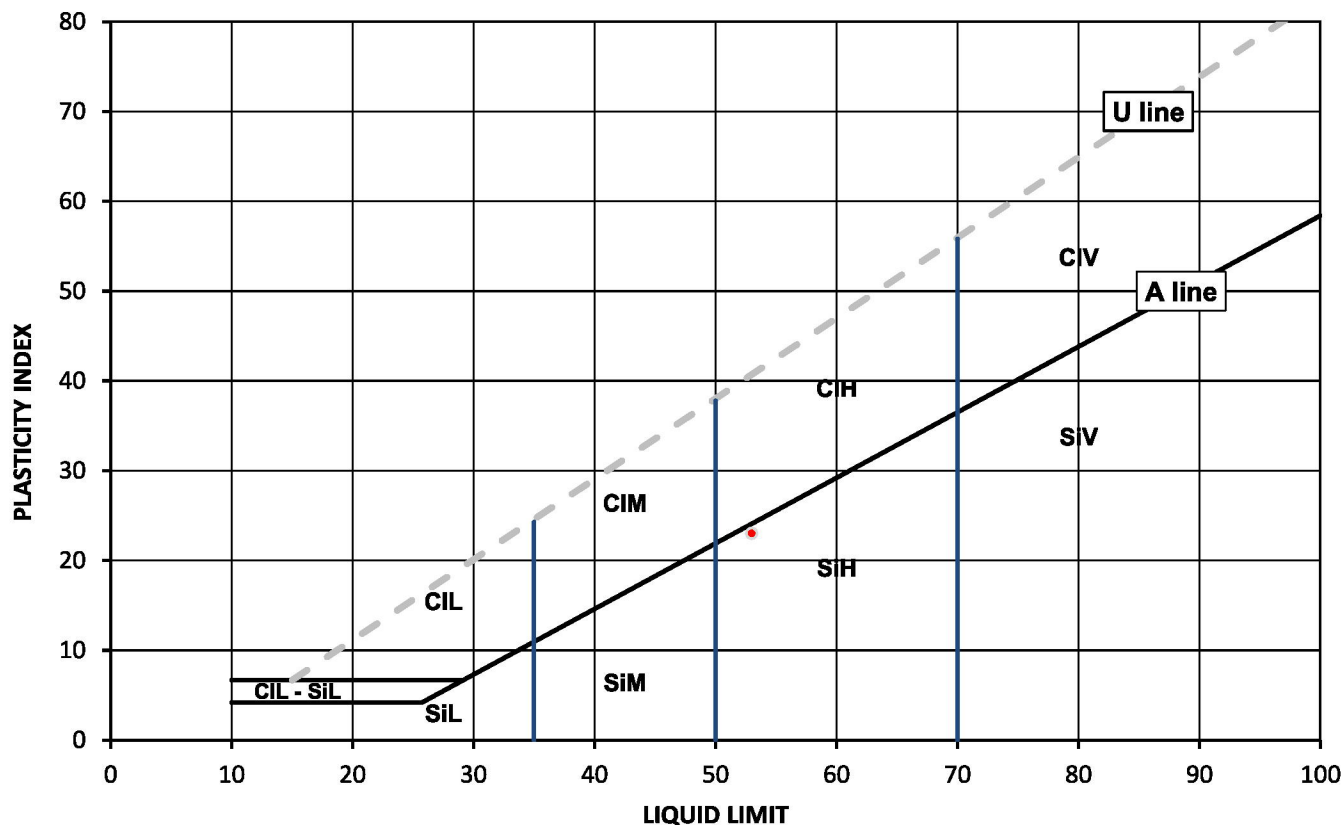
Sample Preparation: Tested after washing to remove >425um

As Received Water Content [W] %	Liquid Limit [WL] %	Plastic Limit [Wp] %	Plasticity Index [Ip] %	% Passing 425µm BS Test Sieve
37	53	30	23	52

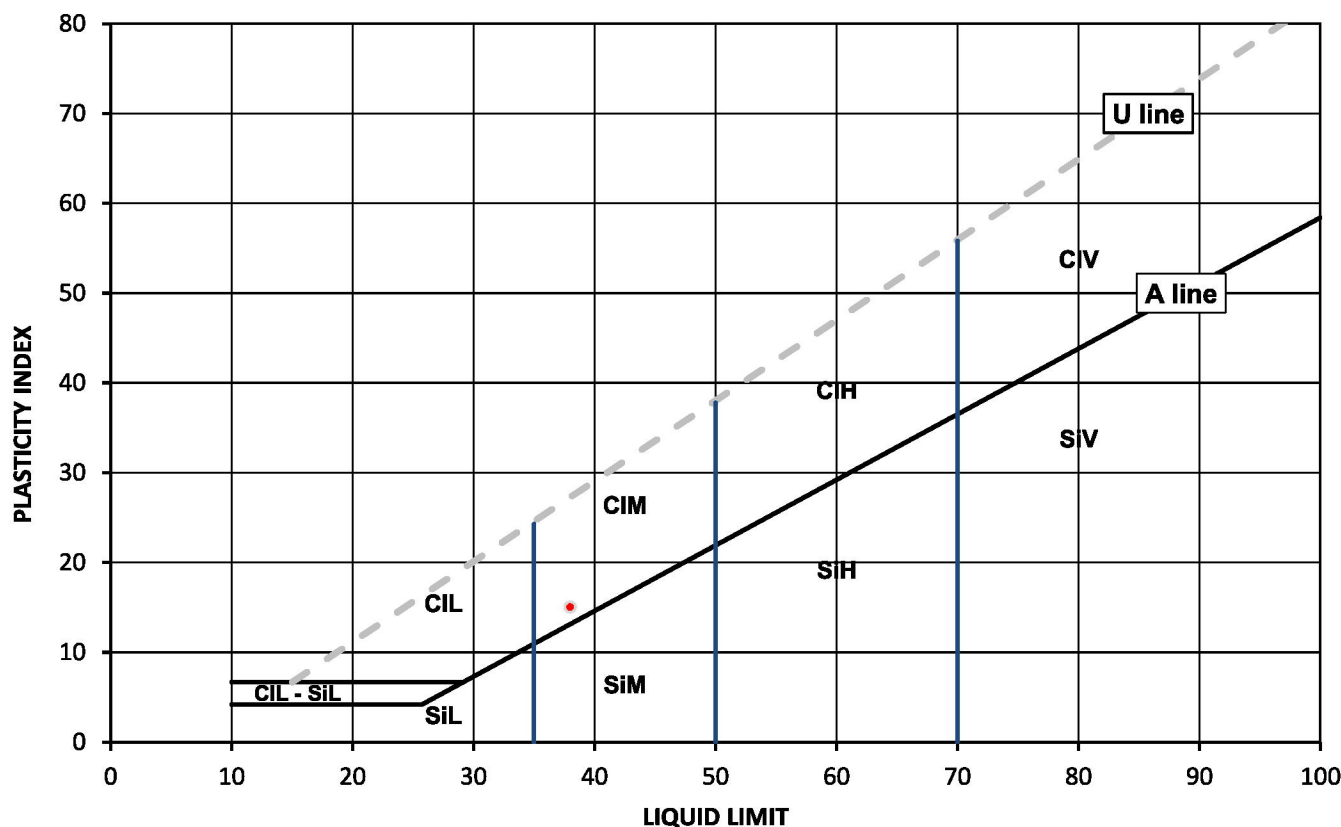
Sample Preparation: Tested after washing to remove >425um

As Received Water Content [W] %	Liquid Limit [WL] %	Plastic Limit [Wp] %	Plasticity Index [Ip] %	% Passing 425µm BS Test Sieve
24	38	23	15	72

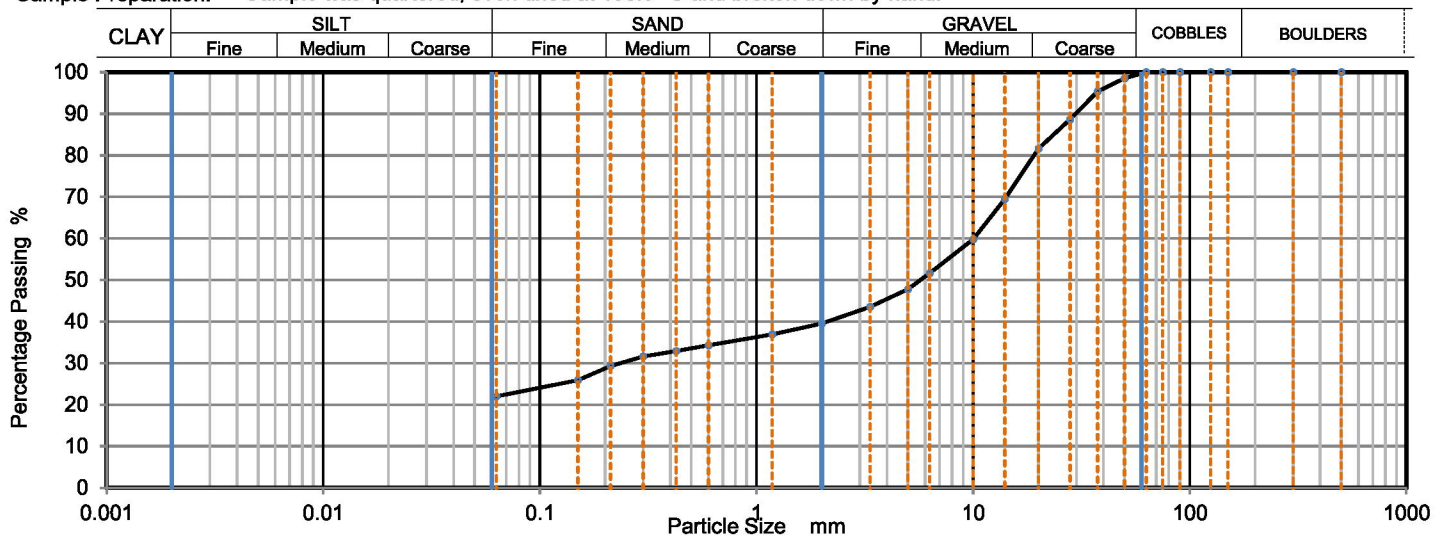
Laboratory Reference: 2126100
Hole No.: WS1
Sample Reference: Not Given
Sample Description: Brown sandy clayey GRAVEL
Sample Preparation: Sample was quartered, oven dried at 106.0 °C and broken down by hand.

Sieving		Sedimentation	
Particle Size mm	% Passing	Particle Size mm	% Passing
500	100		
300	100		
150	100		
125	100		
90	100		
75	100		
63	100		
50	99		
37.5	95		
28	89		
20	82		
14	70		
10	60		
6.3	52		
5	48		
3.35	44		
2	40		
1.18	37		
0.6	34		
0.425	33		
0.3	32		
0.212	29		
0.15	26		
0.063	23

Sample Proportions	% dry mass
Very coarse	0
Gravel	60
Sand	17
Fines <0.063mm	23

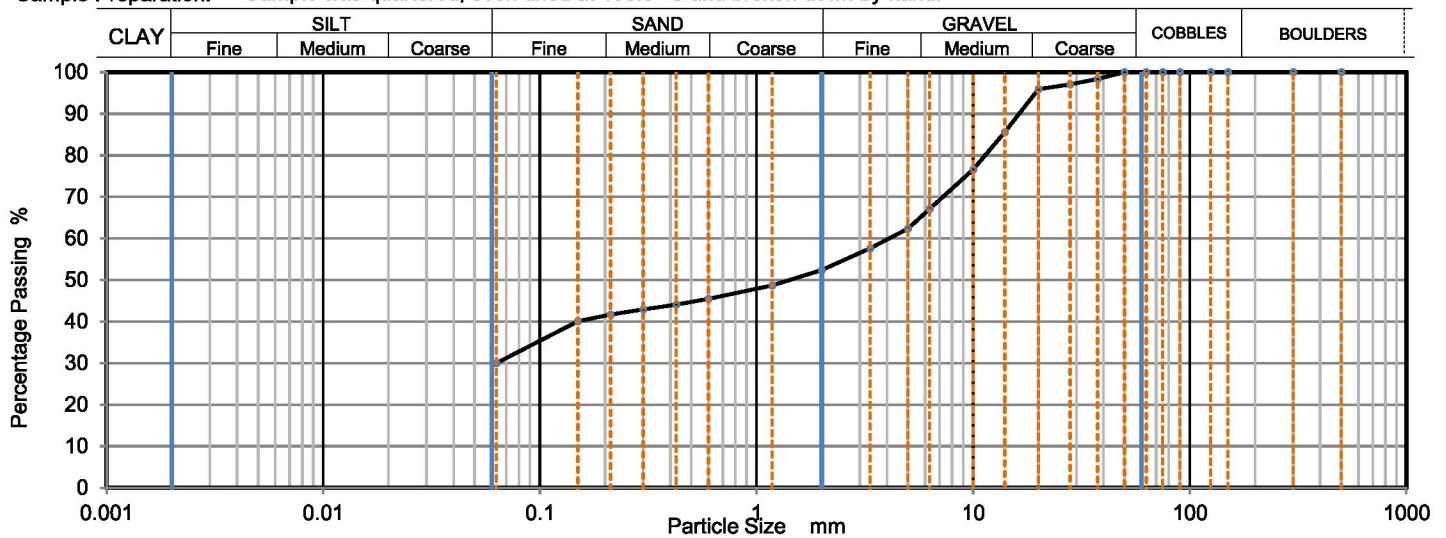
Laboratory Reference: 2126104
Hole No.: WS5
Sample Reference: Not Given
Sample Description: Yellowish brown sandy very clayey GRAVEL
Sample Preparation: Sample was quartered, oven dried at 106.5 °C and broken down by hand.

Sieving		Sedimentation	
Particle Size mm	% Passing	Particle Size mm	% Passing
500	100		
300	100		
150	100		
125	100		
90	100		
75	100		
63	100		
50	100		
37.5	98		
28	97		
20	96		
14	86		
10	77		
6.3	67		
5	62		
3.35	58		
2	52		
1.18	49		
0.6	46		
0.425	44		
0.3	43		
0.212	42		
0.15	40		
0.063	30

Sample Proportions	% dry mass
Very coarse	0
Gravel	48
Sand	22
Fines <0.063mm	30

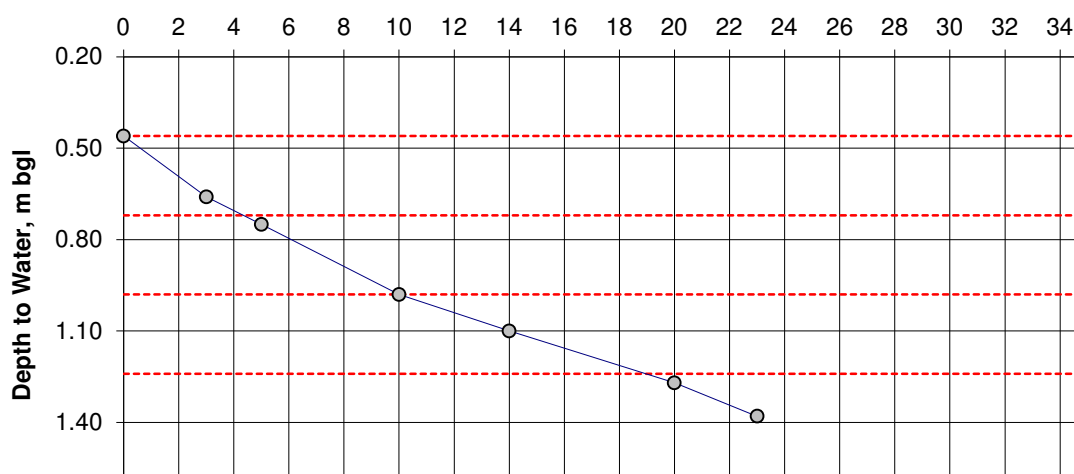
Depth to Water vs Elapsed Time
Elapsed Time, minutes

1.4E-04 m/sec

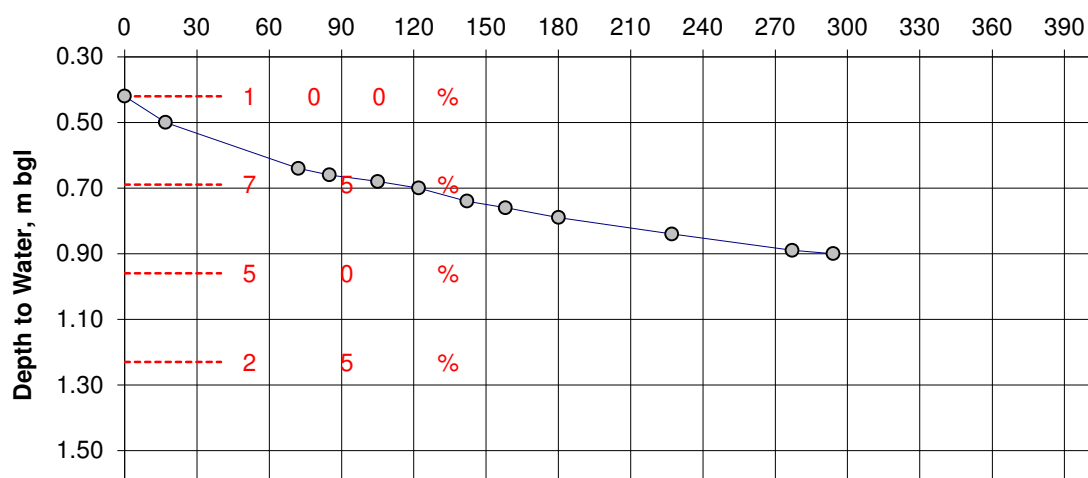
Depth to Water vs Elapsed Time
Elapsed Time, minutes

- m/sec

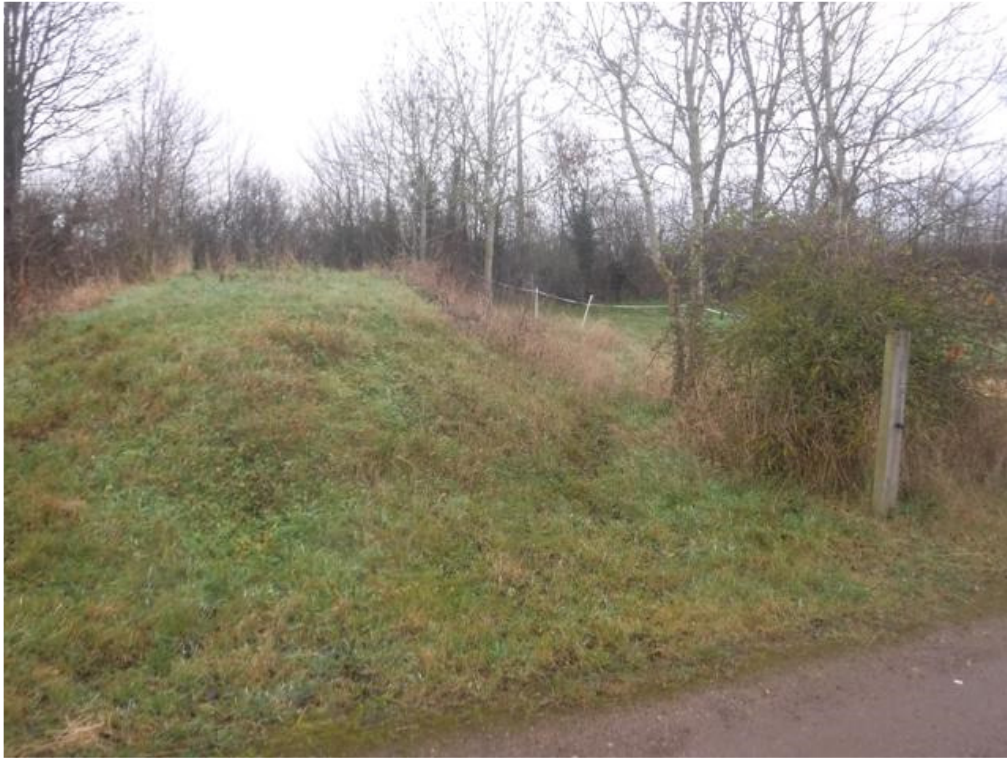
Bund immediately south of the arena.

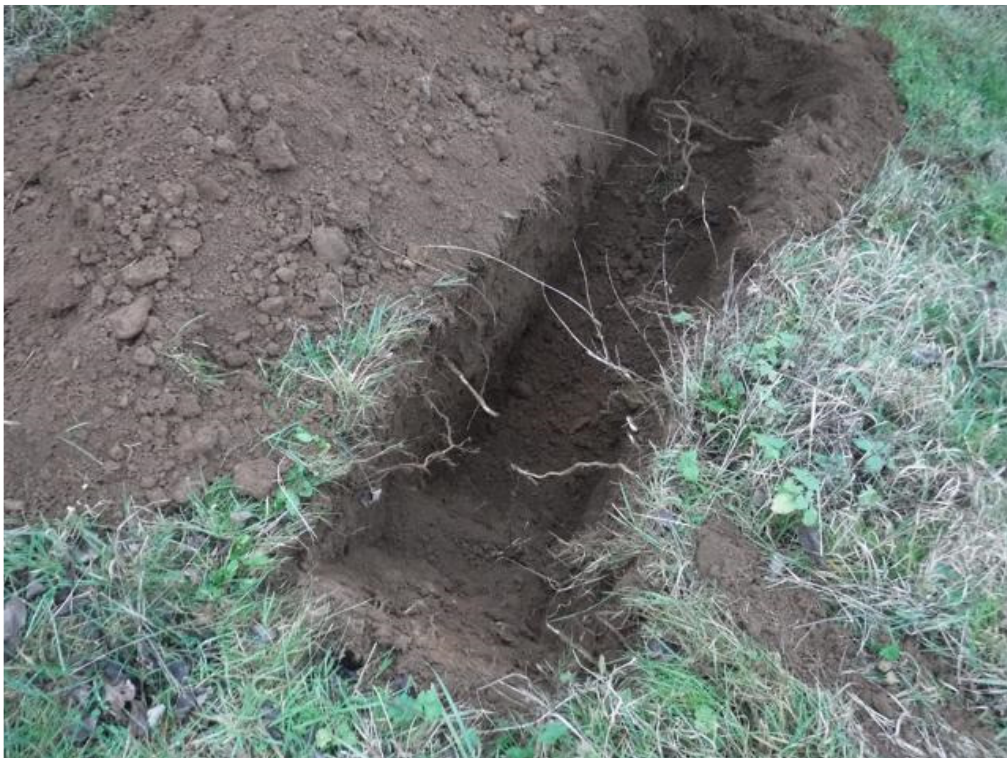
Machine excavation into the bund.

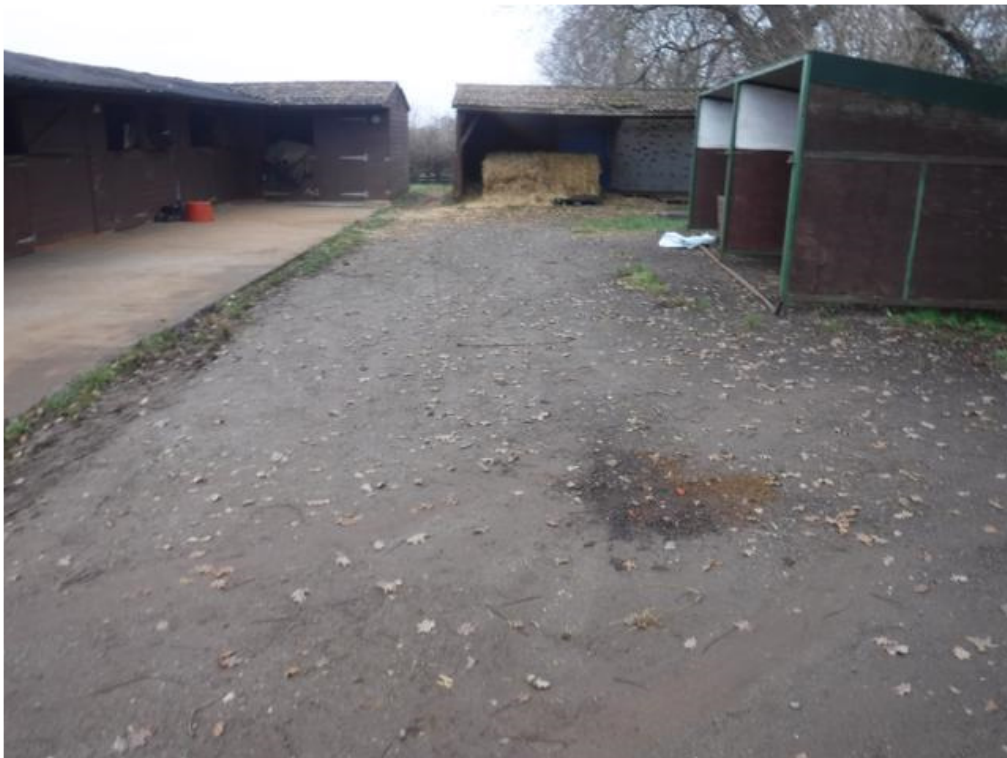
Stable Block looking Northerly. Backfilled HP3 in the foreground.

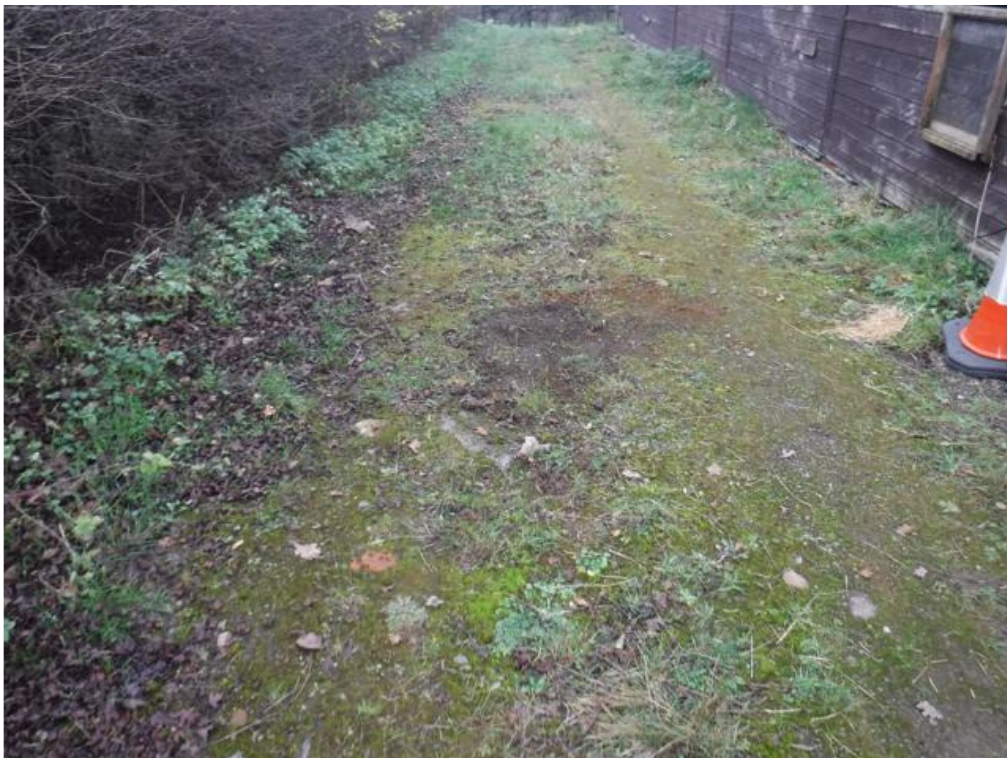
HP1 Location immediately west of the main Stable building.

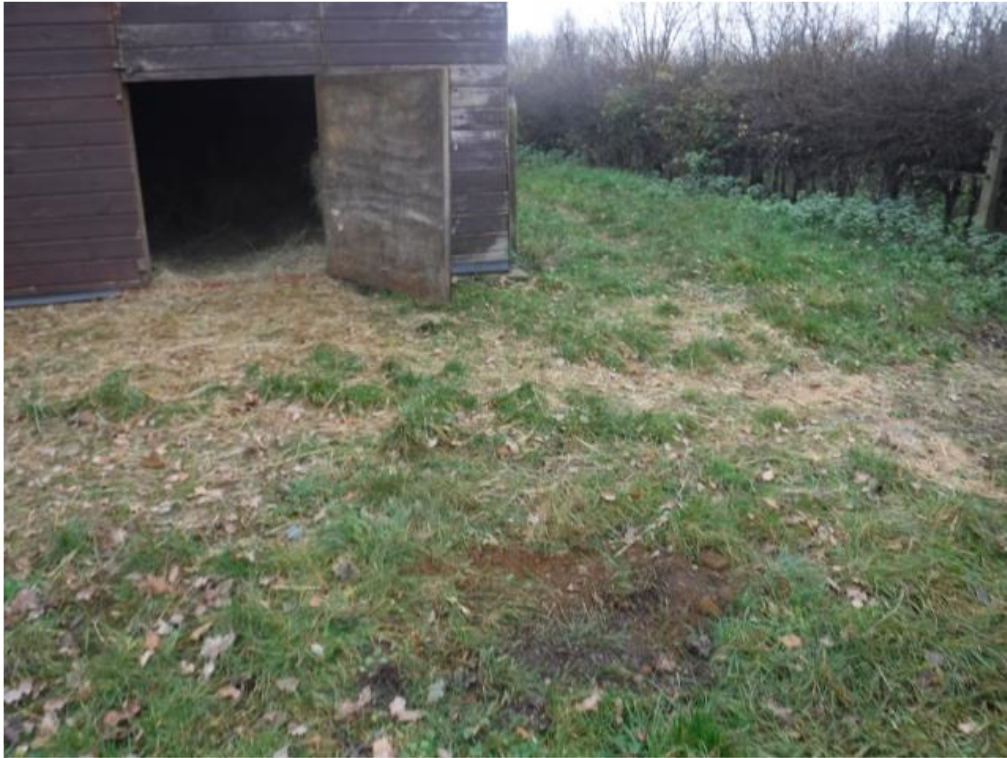
HP2 location, North of the Stable Block.

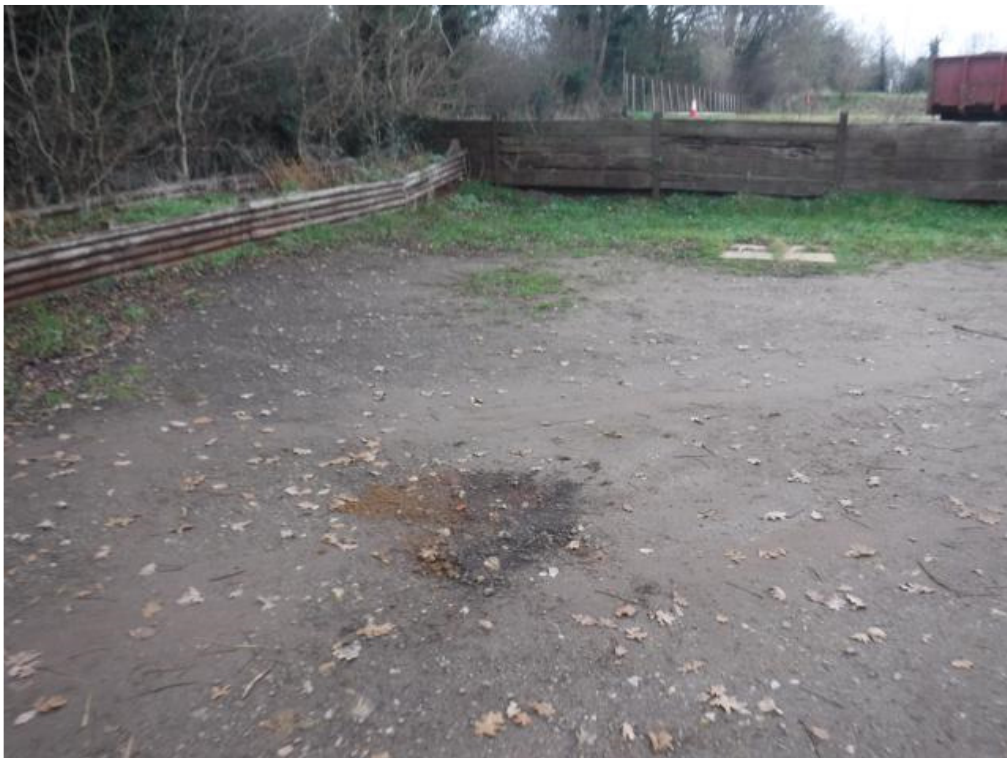
HP3 location, looking southerly.
