Appendix E Exploratory Hole Location Plan, Exploratory Hole Logs and Photographs

TITLE
PROPOSED GROUND INVESTIGATION PLAN

HYDROCK PROJECT NO. 22457
SCALE @ A3 1:2,000

PROJECT
Bicester Heritage Hotel

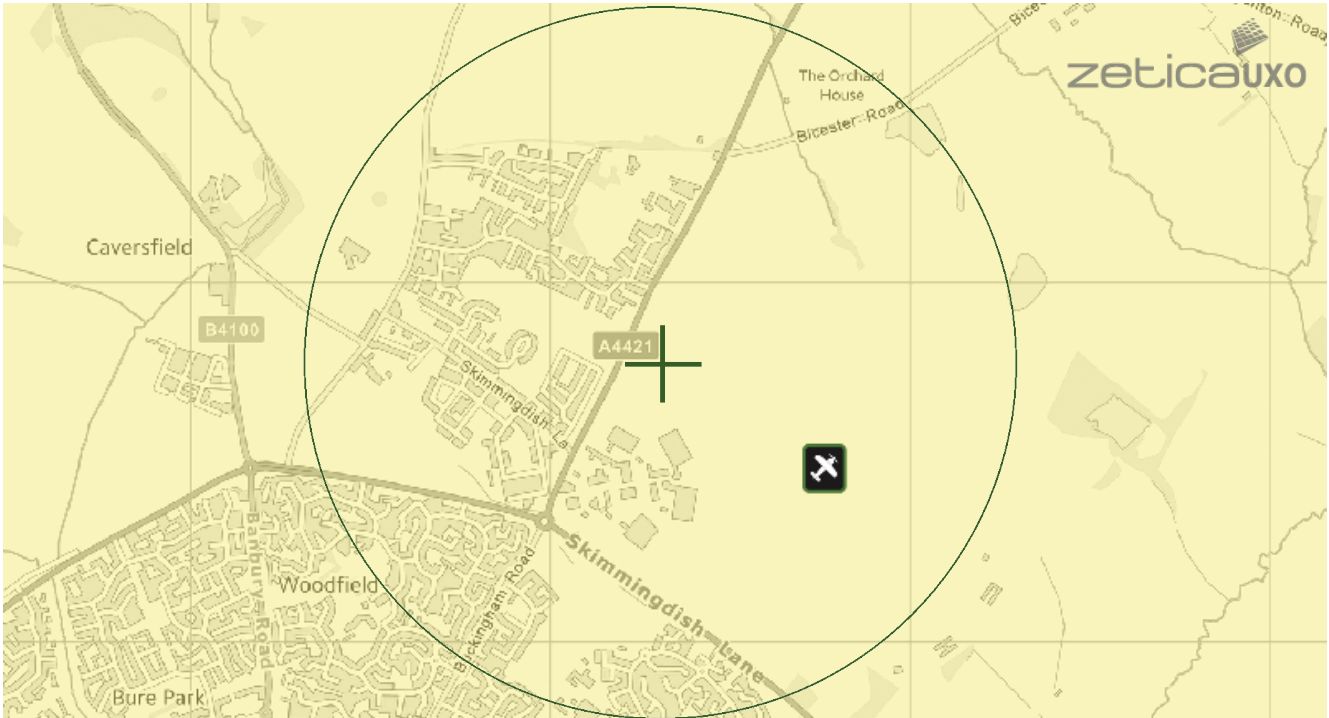
SITE LOCATION

Map Centre: 459318,224779

- High:** Areas indicated as having a bombing density of 50 bombs per 1000acre or higher.
- Moderate:** Areas indicated as having a bombing density of 15 to 49 bombs per 1000acre.
- Low:** Areas indicated as having 15 bombs per 1000acre or less.

Generally, we recommend that a detailed UXO desk study and risk assessment is undertaken for sites in a moderate or high UXB risk area.

Similarly, if your site is near to a designated Luftwaffe target or bombing decoy then additional detailed research is recommended.

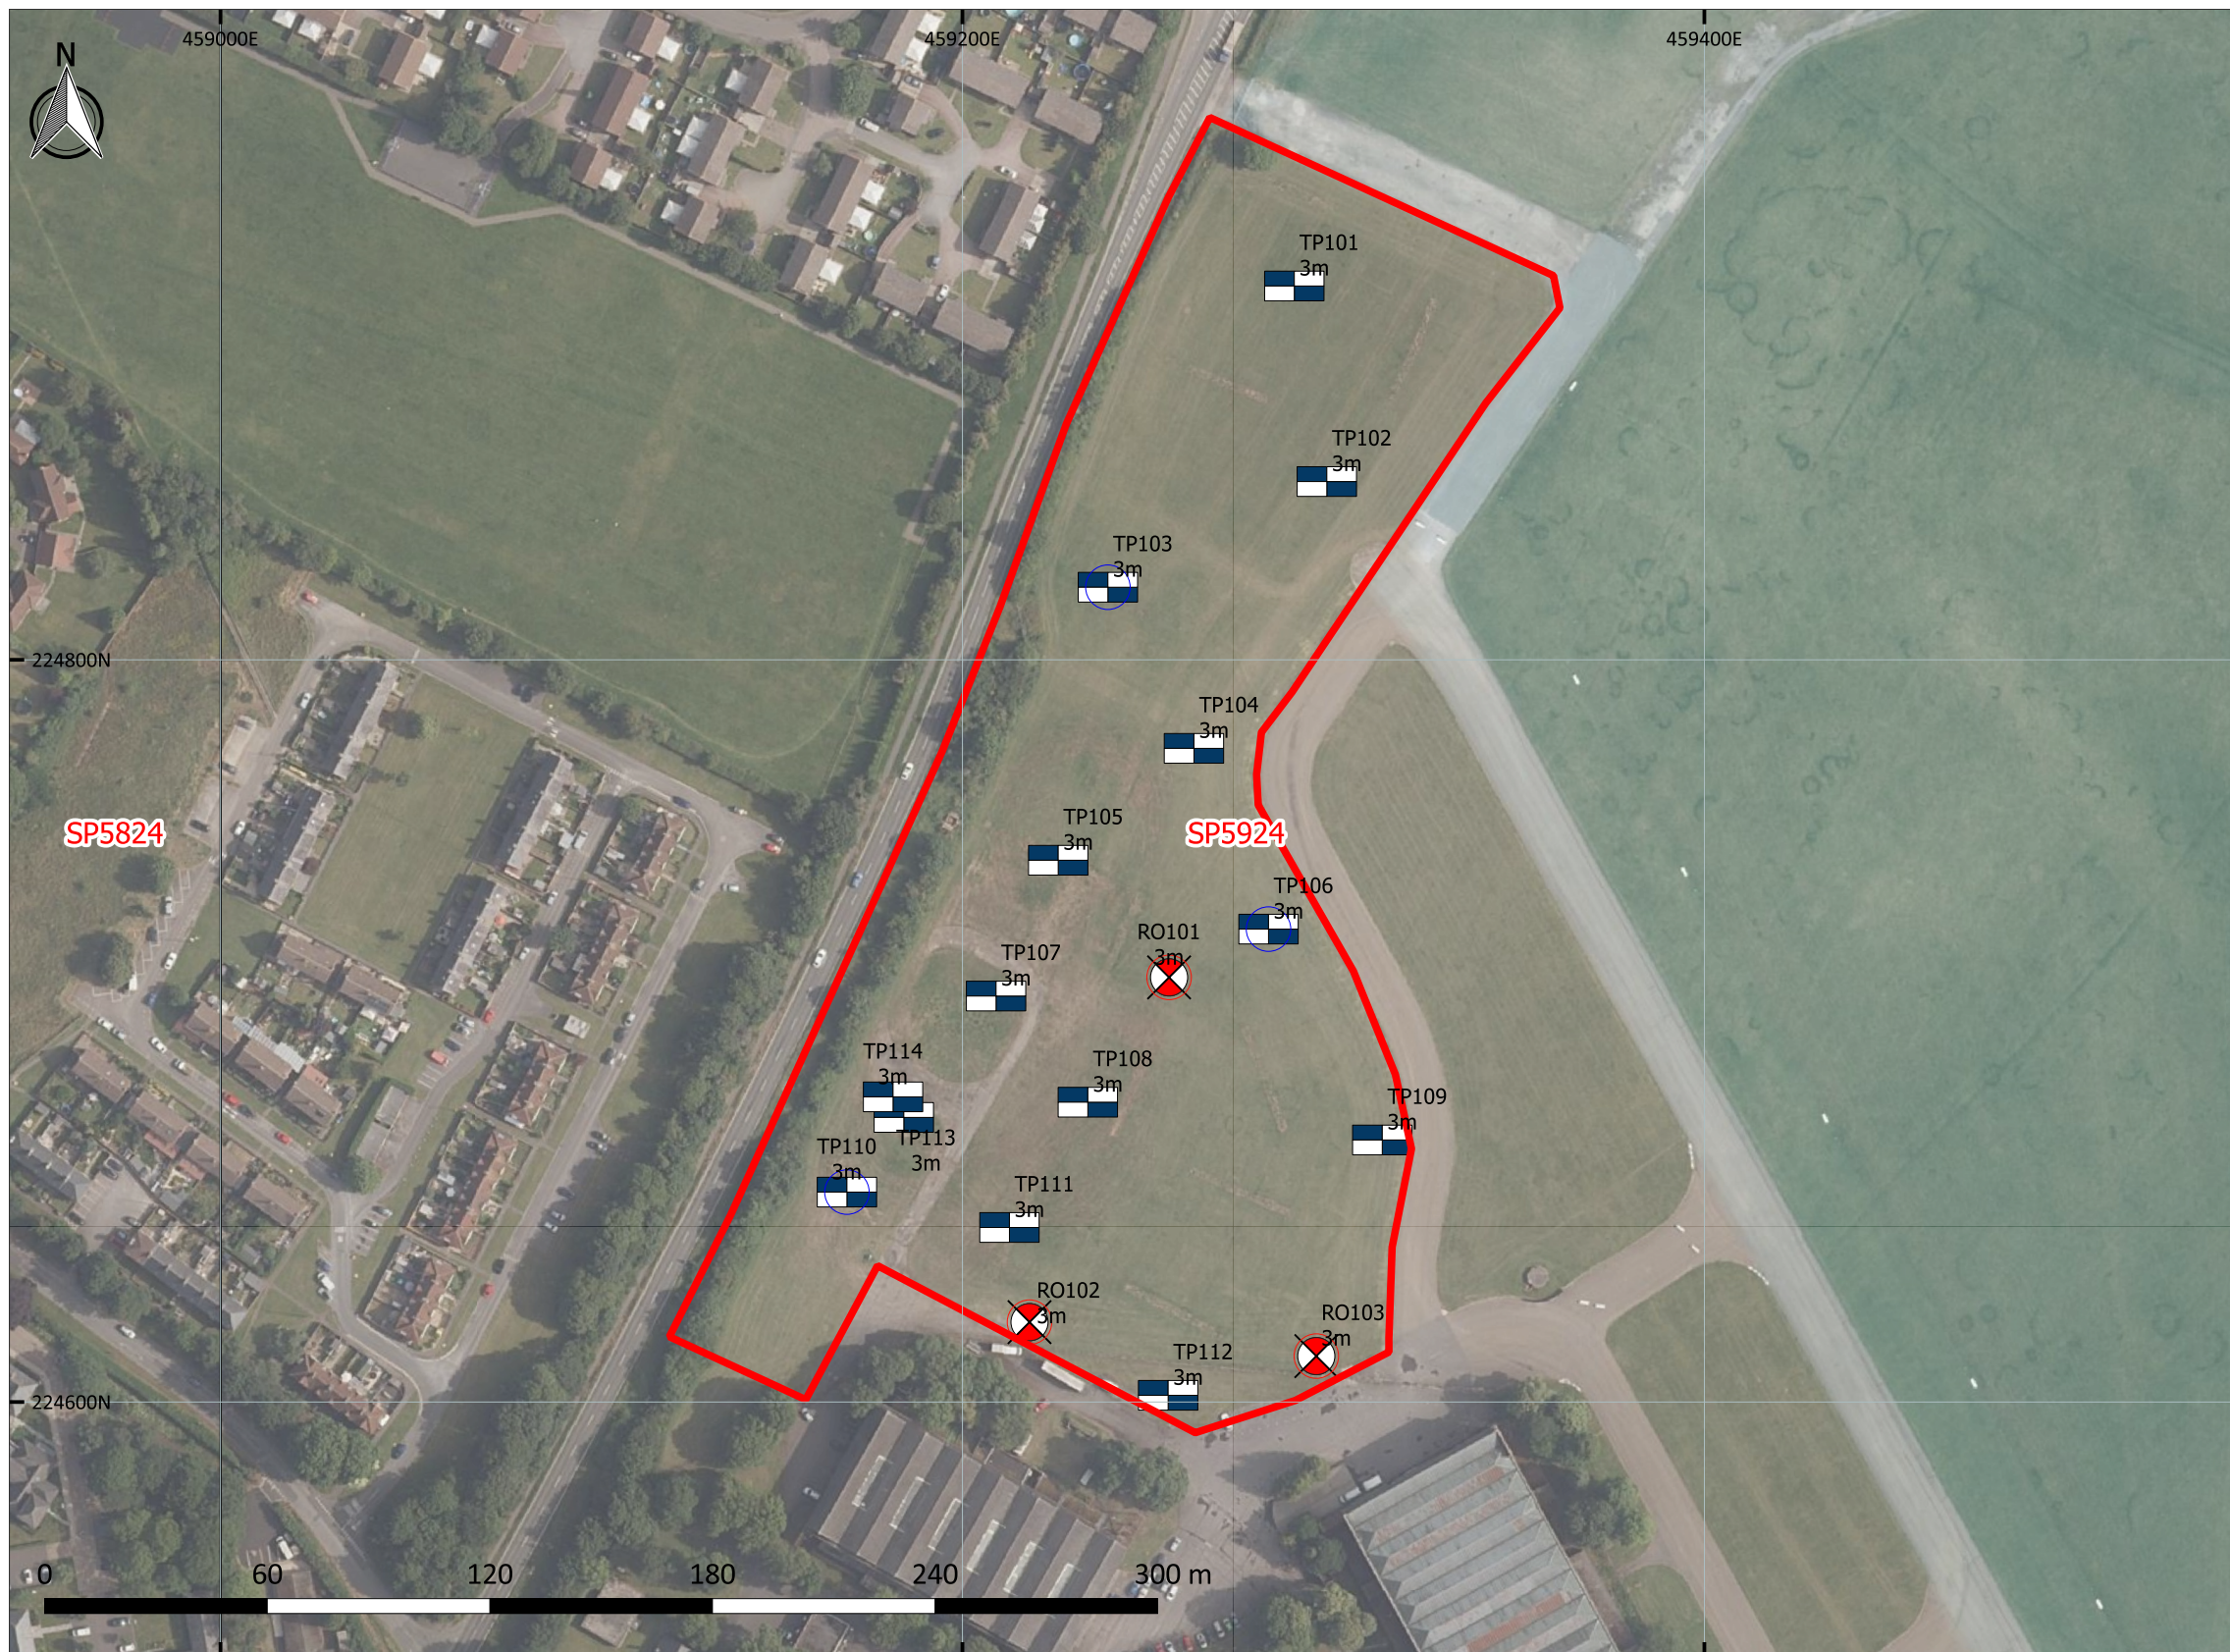
DRAWING NO.
22457-HYD-XX-XX-DR-GE-1001

ID	Type	X (Easting)	Y (Northing)	Proposed Depth (m)	Installation	Soakaway
TP113	TP	459184.17	224676.66	3	N	N
TP114	TP	459181.27	224682.2	3	N	N
TP101	TP	459289.44	224900.72	3		
TP102	TP	459298.2	224848.02	3		
TP103	TP	459239.19	224819.54	3		Y
TP104	TP	459262.38	224776.11	3		
TP105	TP	459225.79	224745.96	3		
TP106	TP	459282.48	224727.41	3		Y
TP107	TP	459209.03	224709.37	3		
TP108	TP	459233.78	224680.76	3		
TP109	TP	459313.15	224670.58	3		
TP110	TP	459168.83	224656.53	3		Y
TP111	TP	459212.64	224647	3		
TP112	TP	459255.42	224601.77	3		
RO101	RO	459255.68	224714.39	3	Y	
RO102	RO	459218.05	224621.48	3	Y	
RO103	RO	459295.37	224612.33	3	Y

- Site Boundary
- Proposed Locations [17]
 - Trial Pit [14]
 - Rotary Open [3]
 - Soakaway [3]
 - Installation [3]

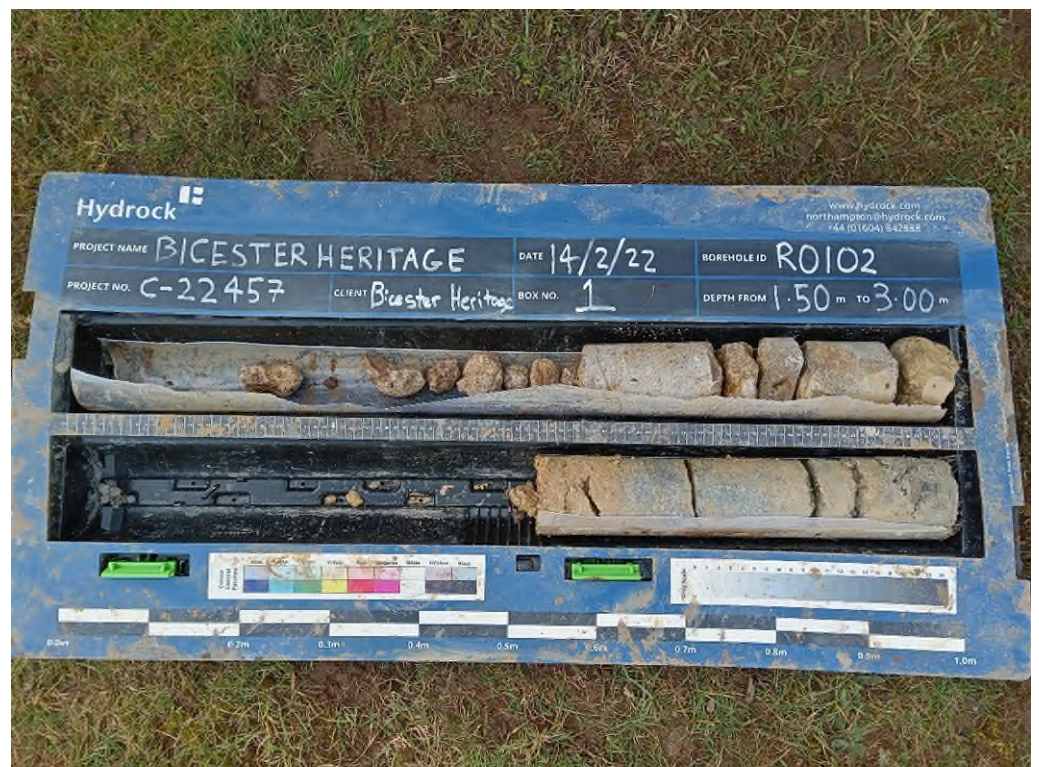
Site Investigation Photograph 2

Description: RC102 showing Cornbrash Formation.

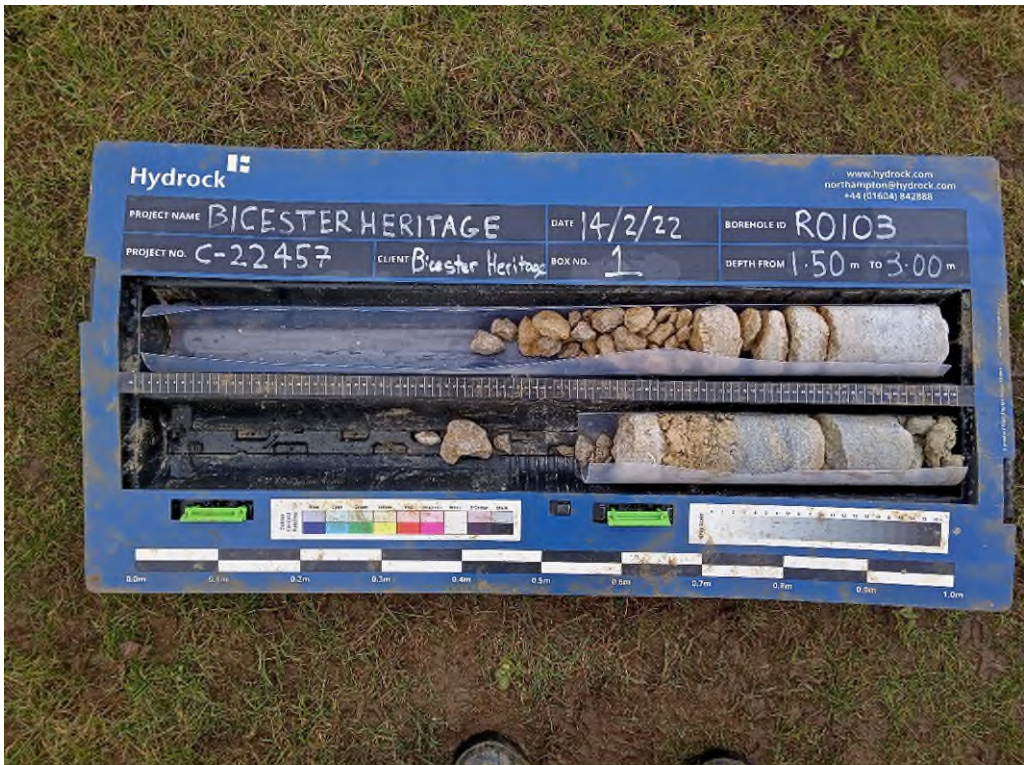
Site Investigation Photograph 3

Description: RC103 showing Cornbrash Formation.

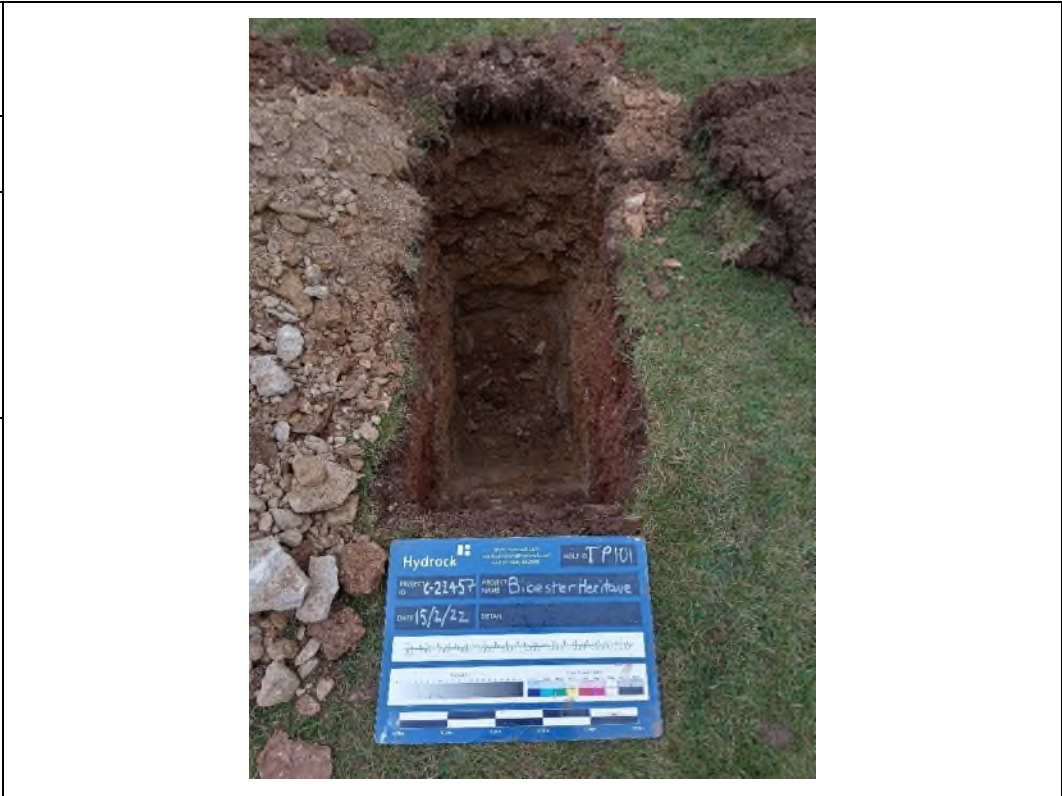
Site Investigation Photograph 4

Description: TP101 showing Made Ground onto Cornbrash Formation.

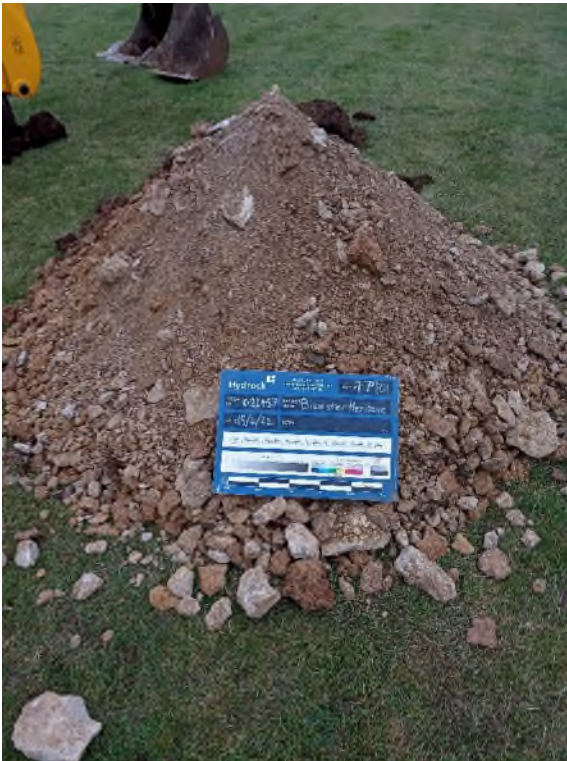
<p>Site Investigation Photograph 6</p>

<p>Date: 15/02/22</p>	
<p>Direction Photograph Taken: n/a.</p>	
<p>Description: Spoil from TP101 showing Cornbrash Formation.</p>

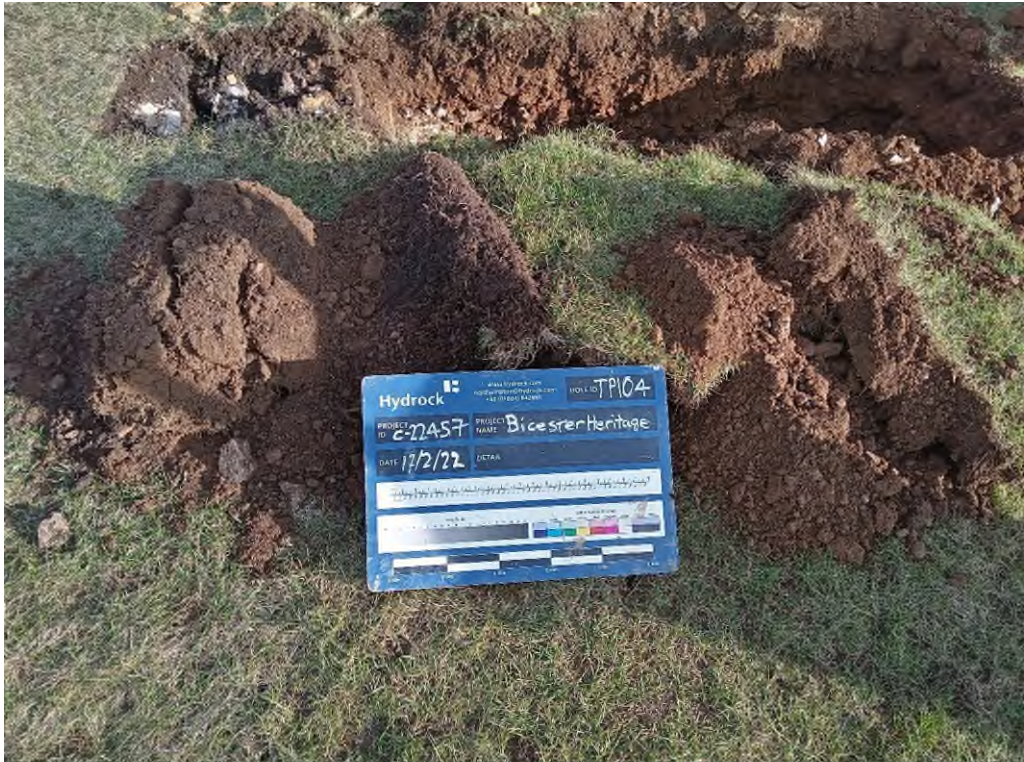
<p>Site Investigation Photograph 11</p>
<p>Date: 17/02/22</p>
<p>Direction Photograph Taken: n/a.</p>
<p>Description: Spoil from TP104 showing Made Ground.</p>

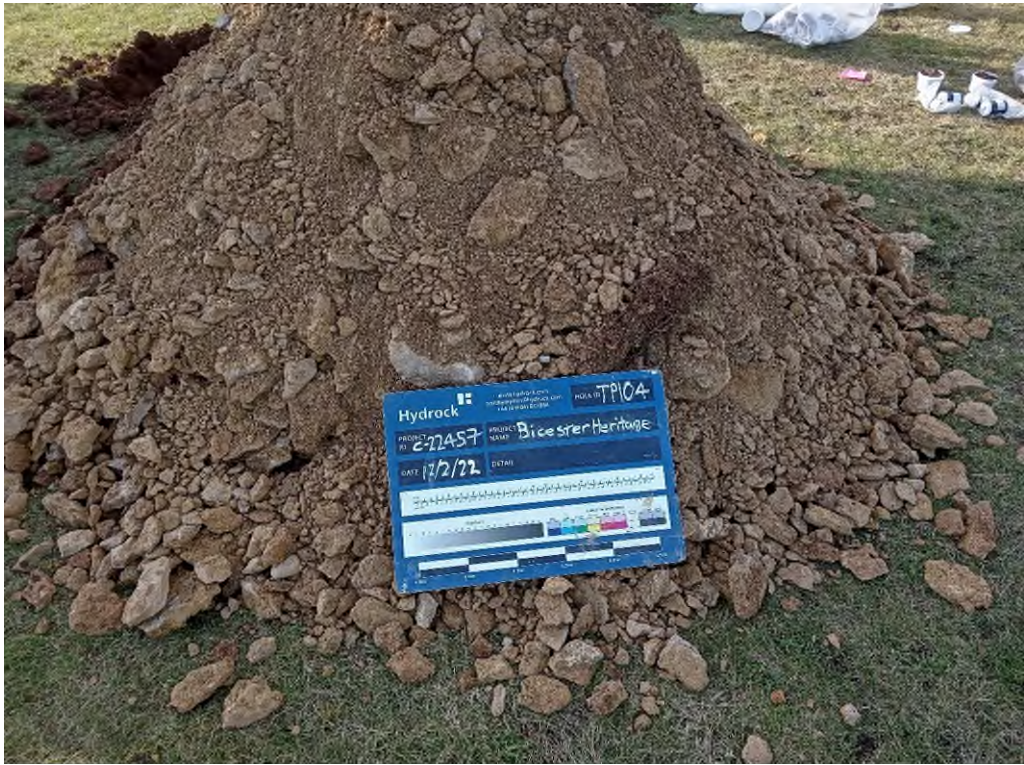
<p>Site Investigation Photograph 12</p>
<p>Date: 17/02/22</p>
<p>Direction Photograph Taken: n/a.</p>
<p>Description: Spoil from TP104 showing Cornbrash Formation.</p>

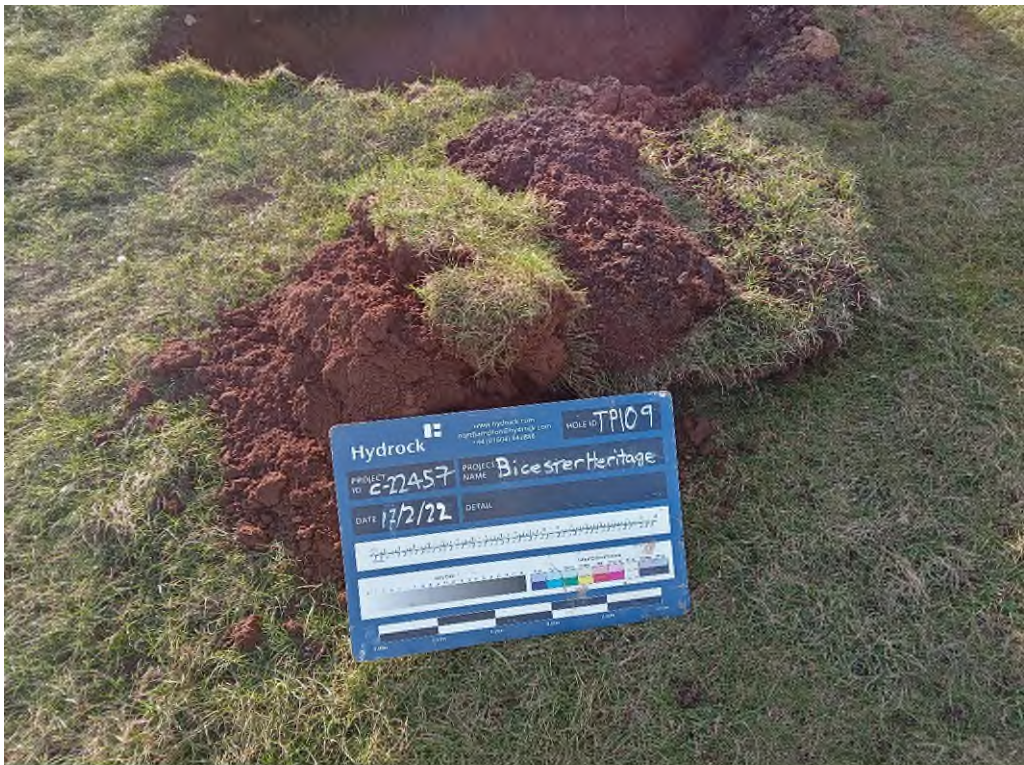
<p>Site Investigation Photograph 29</p>
<p>Date: 17/02/22</p>
<p>Direction Photograph Taken: n/a.</p>
<p>Description: Spoil from TP109 showing Made Ground.</p>

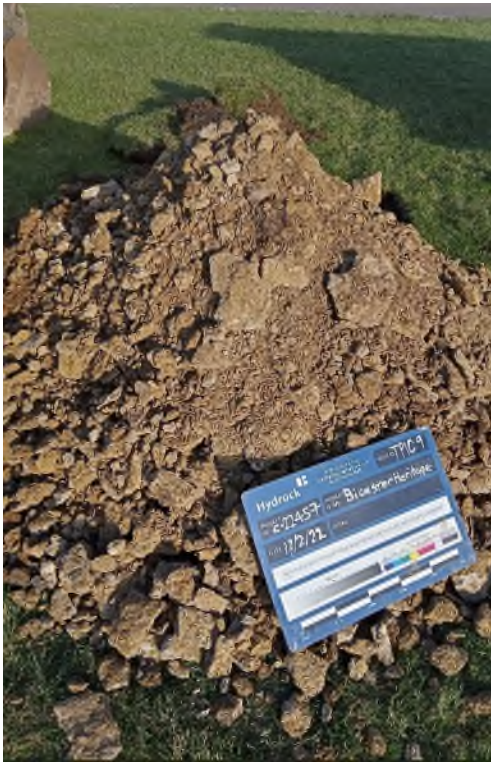
<p>Site Investigation Photograph 30</p>
<p>Date: 17/02/22</p>
<p>Direction Photograph Taken: n/a.</p>
<p>Description: Spoil from TP109 showing Cornbrash Formation.</p>

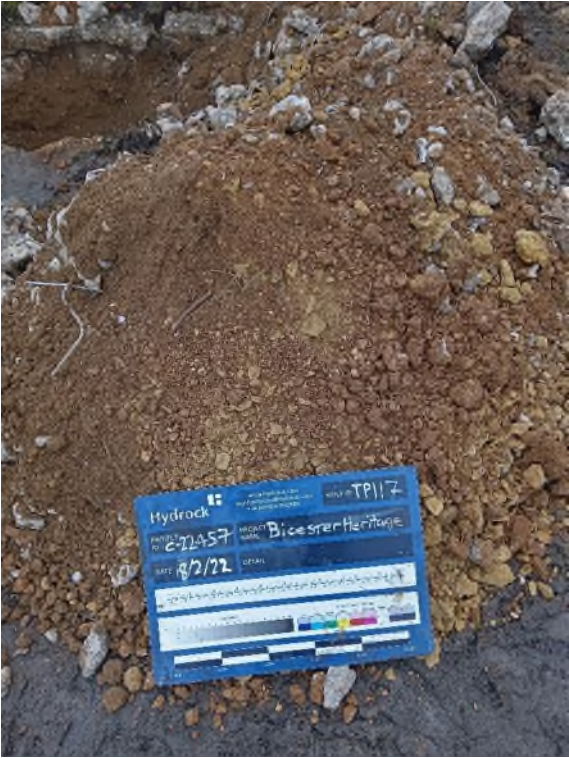
<p>Site Investigation Photograph 47</p>

<p>Date: 18/02/22</p>	
<p>Direction Photograph Taken: n/a.</p>	
<p>Description: Spoil from TP117 showing Made Ground and Cornbrash Formation.</p>
