Bicester Heritage Hotel

Desk Study Review and Ground Investigation Report

For IKS Consulting on behalf of Bicester Motion

Doc ref: 22457-HYD-XX-XX-RP-GE-1001-S2-P01

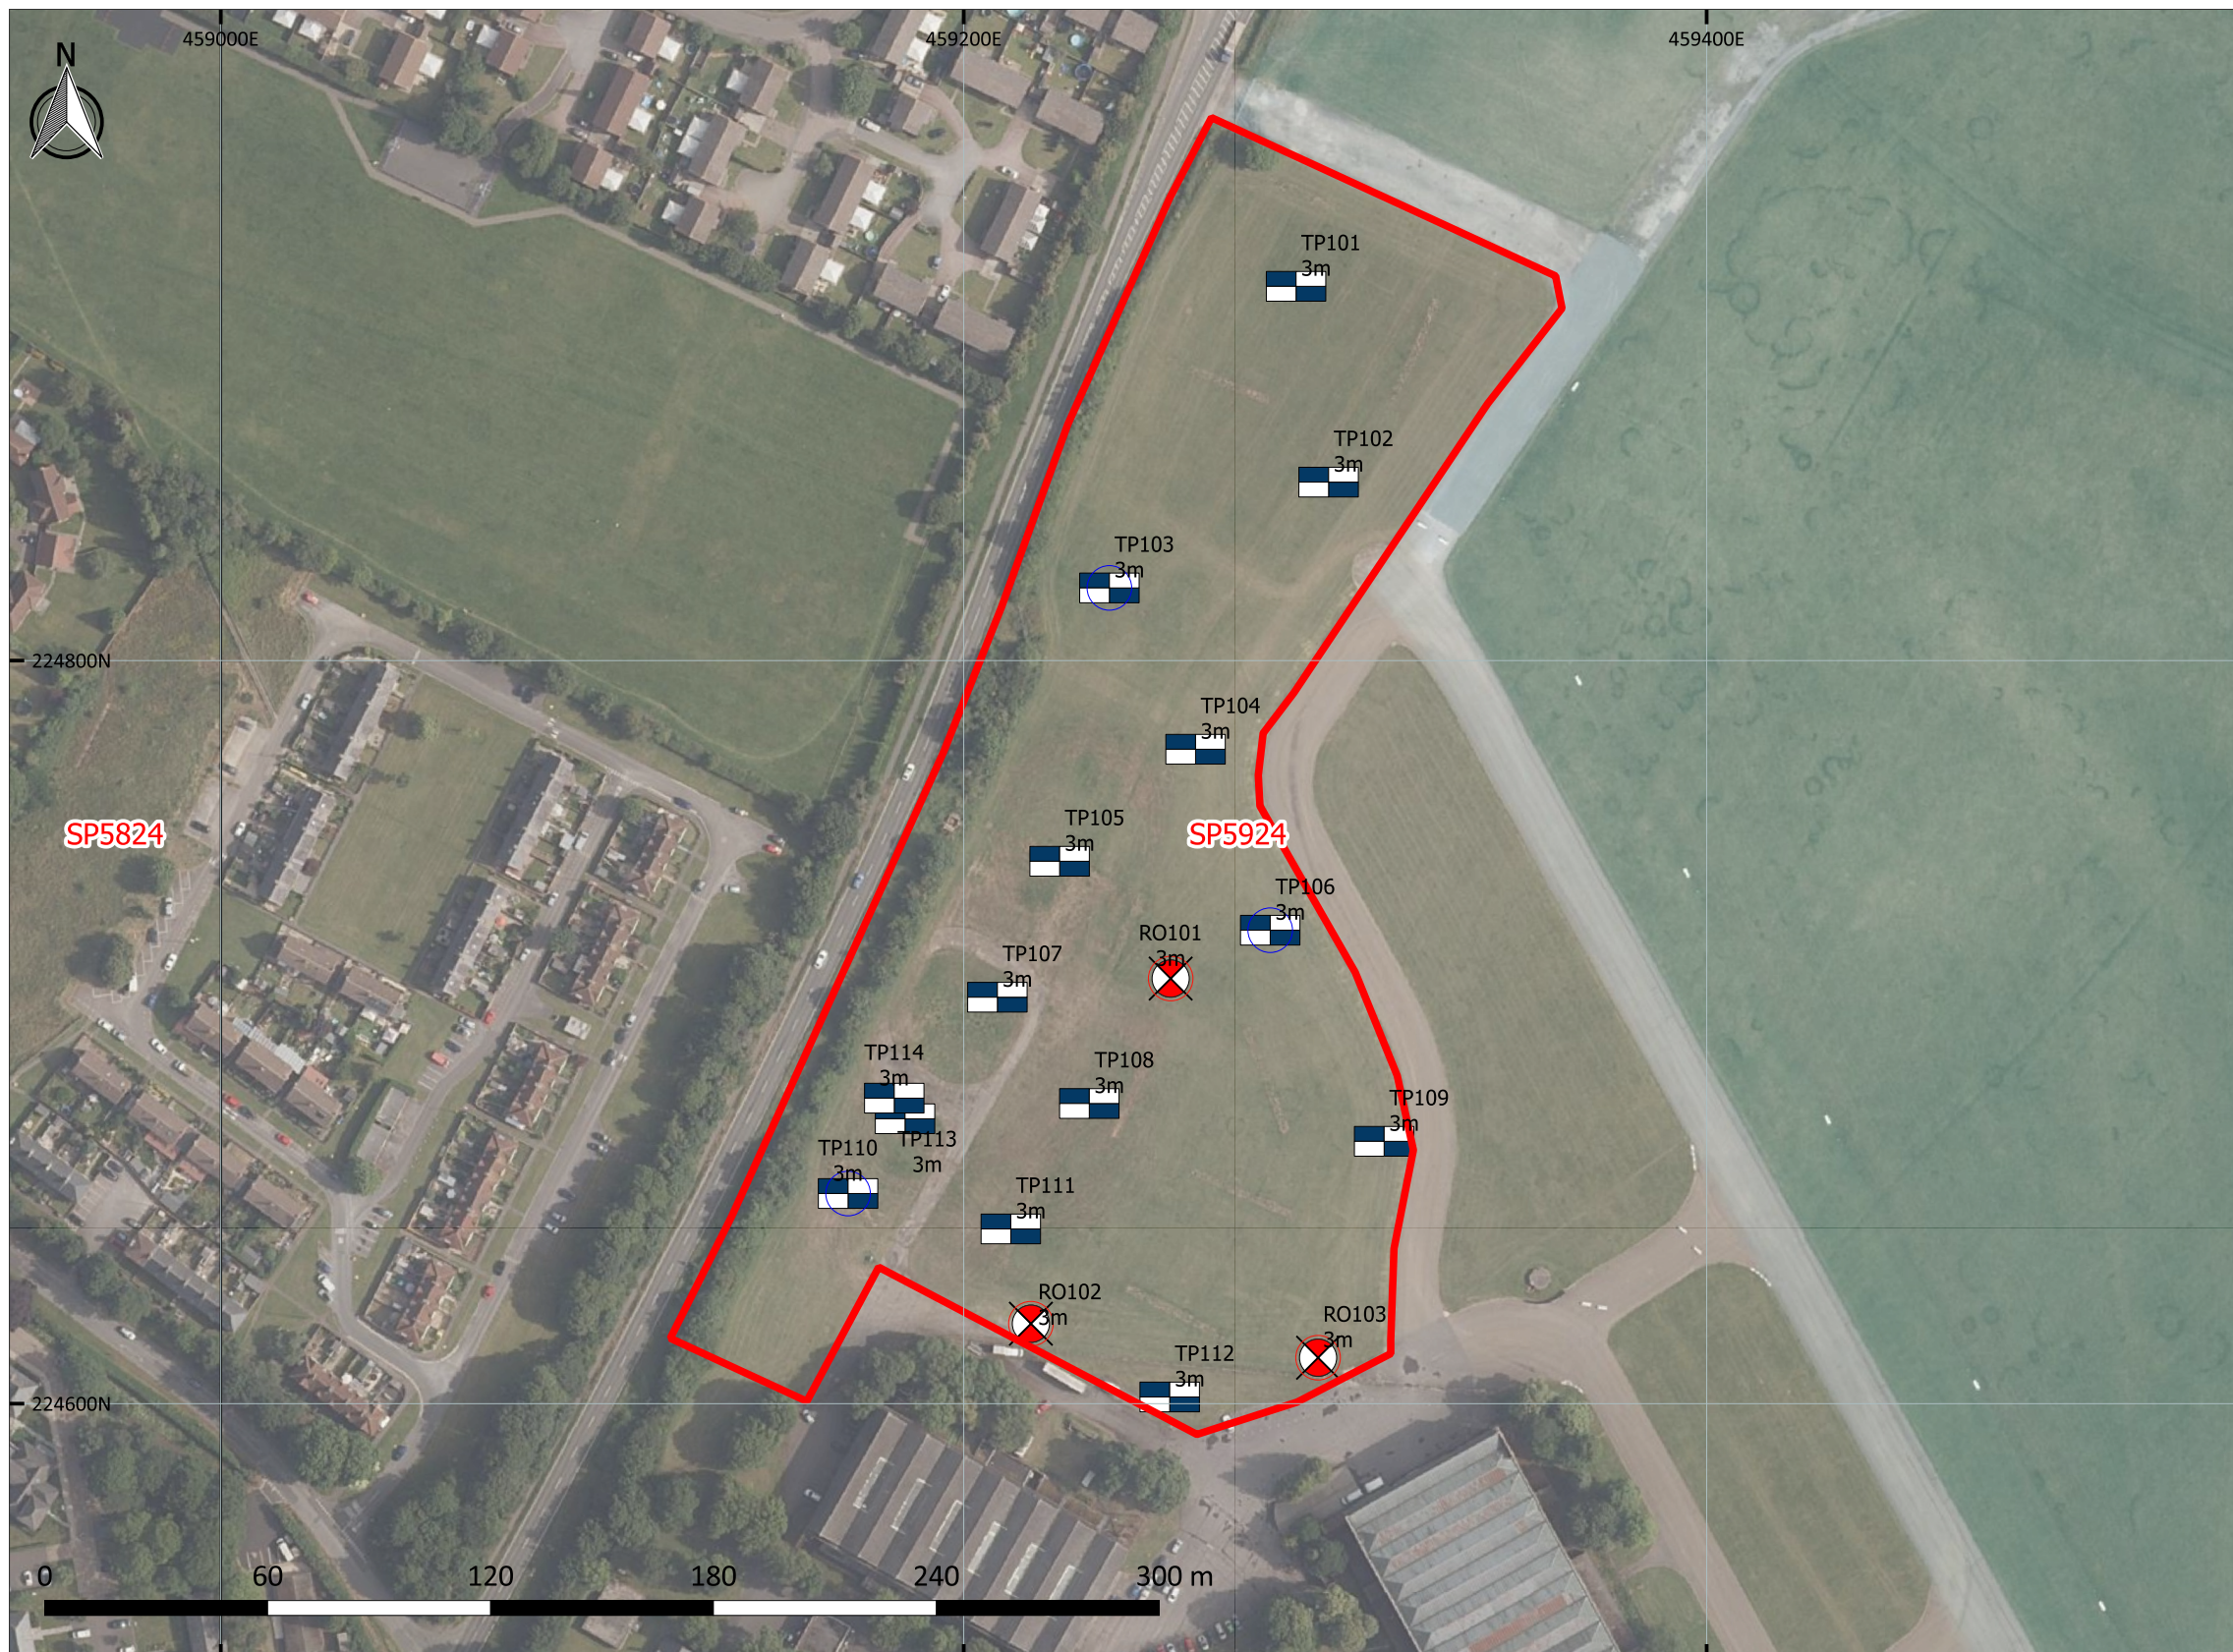
ID	Type	X (Easting)	Y (Northing)	Proposed Depth (m)	Installation	Soakaway
TP113	TP	459184.17	224676.66	3	N	N
TP114	TP	459181.27	224682.2	3	N	N
TP101	TP	459289.44	224900.72	3		
TP102	TP	459298.2	224848.02	3		
TP103	TP	459239.19	224819.54	3		Y
TP104	TP	459262.38	224776.11	3		
TP105	TP	459225.79	224745.96	3		
TP106	TP	459282.48	224727.41	3		Y
TP107	TP	459209.03	224709.37	3		
TP108	TP	459233.78	224680.76	3		
TP109	TP	459313.15	224670.58	3		
TP110	TP	459168.83	224656.53	3		Y
TP111	TP	459212.64	224647	3		
TP112	TP	459255.42	224601.77	3		
RO101	RO	459255.68	224714.39	3	Y	
RO102	RO	459218.05	224621.48	3	Y	
RO103	RO	459295.37	224612.33	3	Y

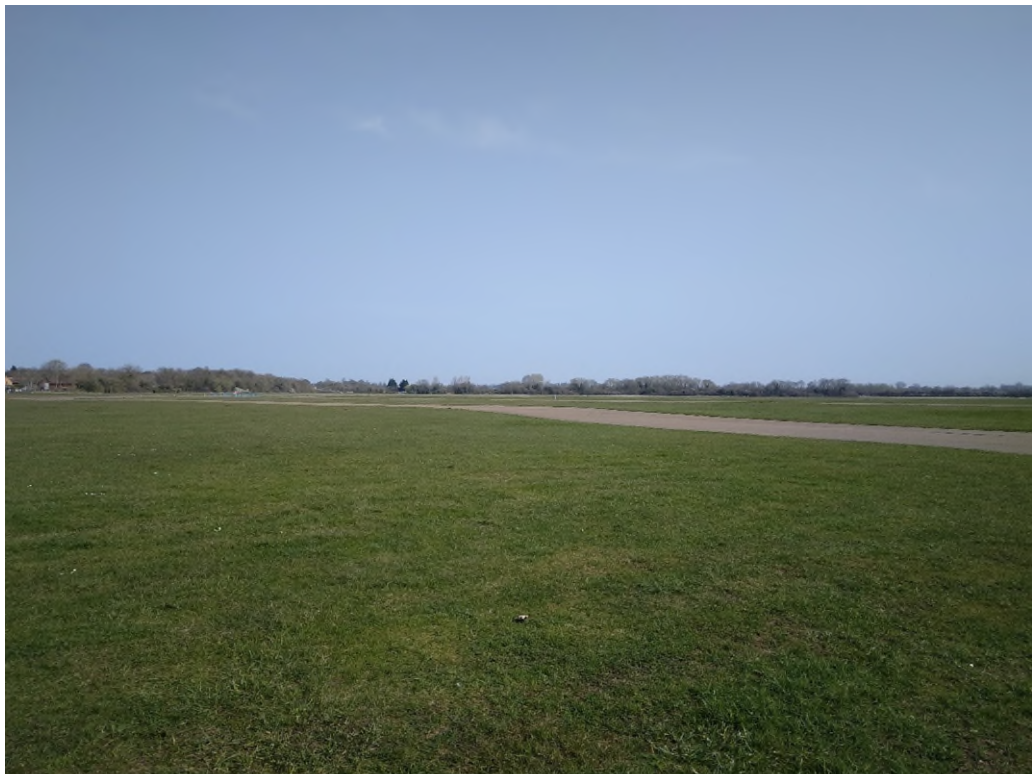
<p>Desk Study Photograph 5</p>

<p>Date: 14/02/2022</p>	
<p>Direction Photograph Taken:</p> <p>N/A.</p>	
<p>Description: Looking across area of grass with a section of track.</p>

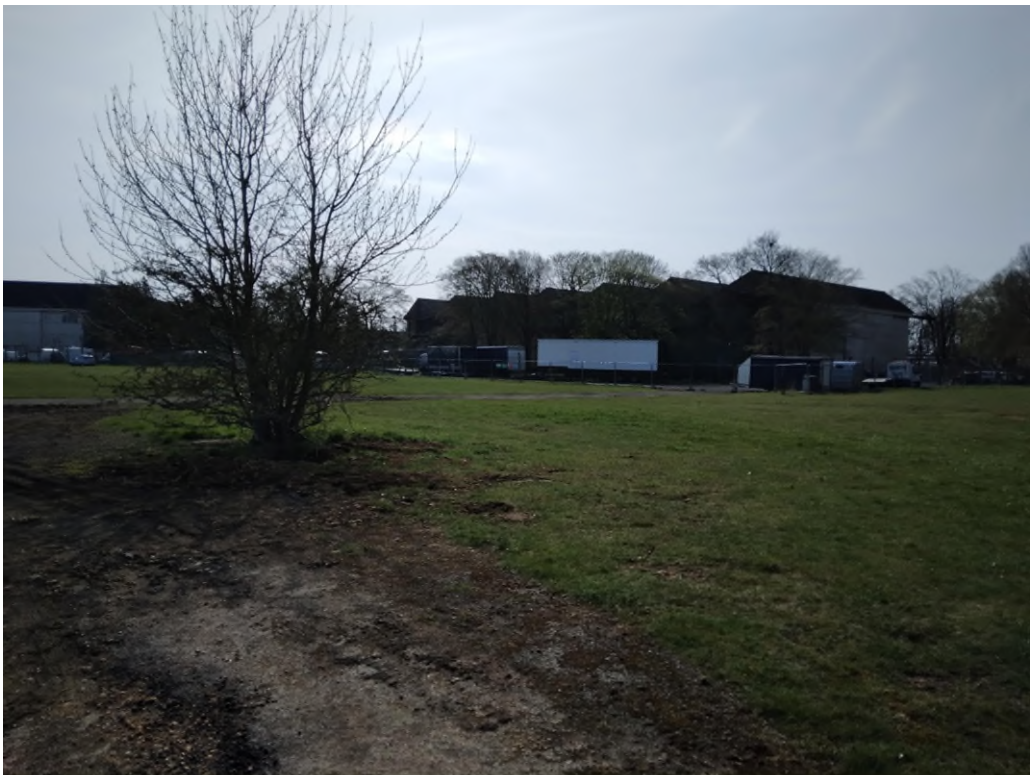
<p>Desk Study Photograph 26</p>
<p>Date: 14/02/2022</p>
<p>Direction Photograph Taken:</p> <p>East.</p>
<p>Description: Manhole cover leading to old fuel tank.</p>

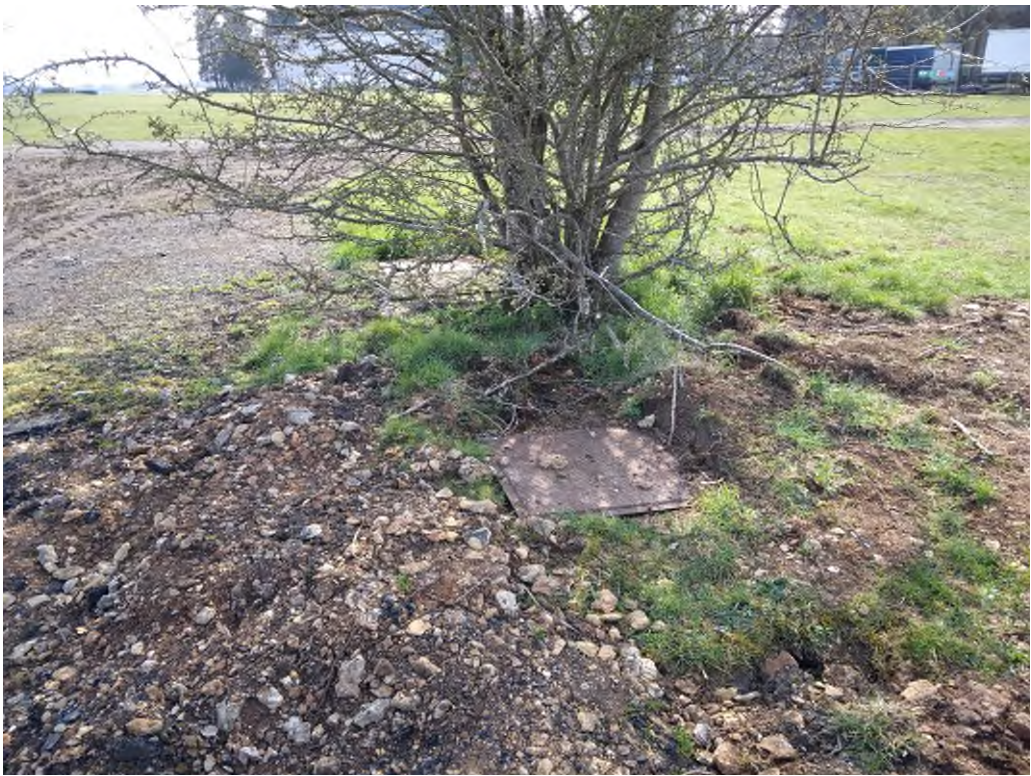
<p>Desk Study Photograph 27</p>	 
<p>Date: 14/02/2022</p>	
<p>Direction Photograph Taken:</p> <p>South East.</p>	
<p>Description:</p> <p>Another manhole cover leading to old fuel tank found by tree.</p>

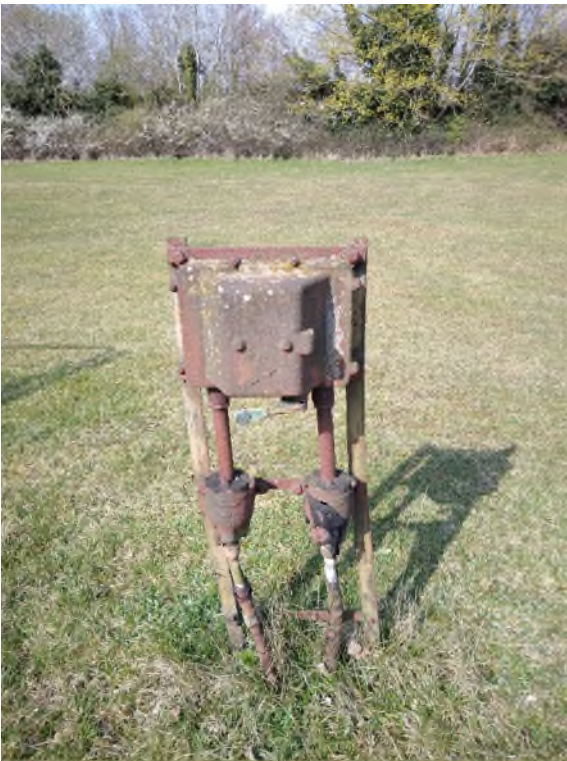
<p>Desk Study Photograph 32</p>

<p>Date: 14/02/2022</p>	
<p>Direction Photograph Taken:</p> <p>West.</p>	
<p>Description: Old control box.</p>

- an aviation fuel line with associated inspection chambers and inspection covers in the south west,
- a control box and small electricity sub-station in the south; and
- an RAF bunker in the west, interpreted to be the foundation of a former anti-aircraft gun as described in the Archaeological Report (Appendix D).
