**Phase 5C (5C derived from 5C, 5D and 5R as  
indicated on Drawing HPSLP/PH5C/001 08.01.20,  
Heyford Park, Upper Heyford, OX25 5HD)**

**Contamination Hotspot, Phase 4 of Urban Regen  
Remediation Works**

**Report Ref: R1742-R19-v2 Final**

**Report Title:** Phase 5C (5C derived from 5C, 5D and 5R as indicated on Drawing HPSLP/PH5C/001 08.01.20, Heyford Park, Upper Heyford, OX25 5HD  
Contamination Hotspot, Phase 4 of Urban Regen Remediation Works

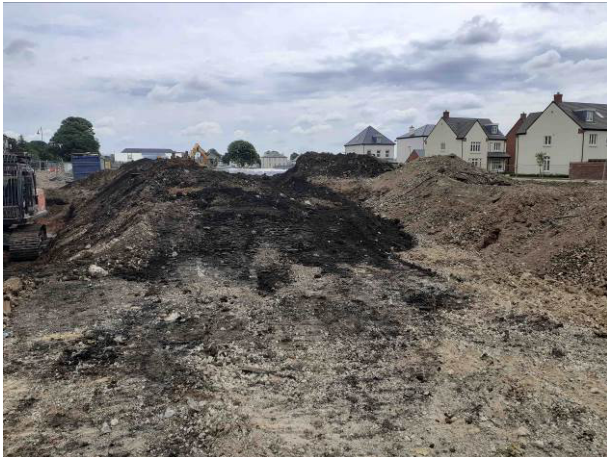
7.

04.06.20 – Soils not demonstrating significant contamination indicators stockpiled to south of excavation area (2/2).

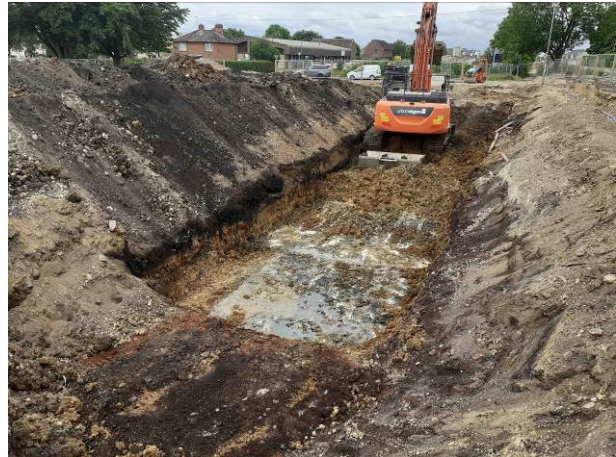
8.

04.06.20 – Excavation of hydrocarbon contaminated soils down to weathered bedrock.

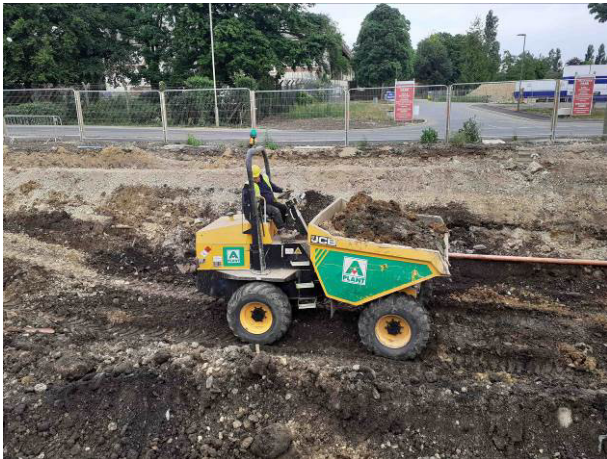
9.

04.06.20 – Removal of contaminated soils to quarantine area within wider development.

- 3.5.1. Following excavation of the contaminated soils, URL removed the materials to a quarantine area within the wider NSA where it will remain stockpiled until a decision is made to either treat the material or dispose of it to a suitable receiving facility.

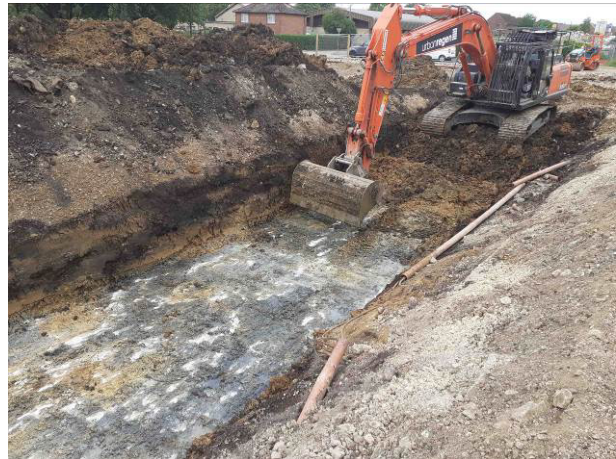
10.

04.06.20 – Continuation of excavation of hydrocarbon contaminated soils down to weathered bedrock.

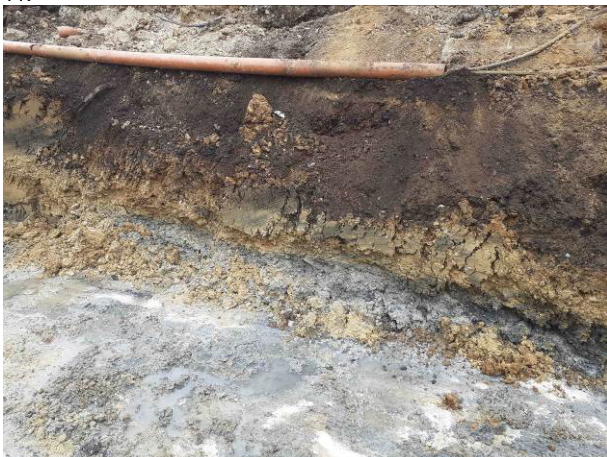
11.

04.06.20 – Soils demonstrating residual indicators of contamination present within northern sidewall of excavation; unable to progress excavation northwards.

- 3.4.4. Upon completion of these works indicators of contamination were still present within the northern excavation sidewall; however, as Camp Road is located directly to the north of the site and is to be incorporated within the wider development no further excavation works are

proposed. The hydrocarbon impacted northern sidewall was therefore sampled as part of the validation sampling regime, as discussed in Section 4.

4.3.6 Hydrocarbon concentrations were below the assessment criteria within the majority of the validation samples collected with the exceptions of 'SS4' and 'SS11' for the C12-16 aliphatic hydrocarbon range and the C10-12 aromatic hydrocarbon range, respectively. Sample 'SS4' was collected from the central area of the northern sidewall (where visually impacted material was observed but was unable to be excavated due to the presence Camp Road), and sample 'S11' was from the impacted bedrock for which there is no requirement for removal under the approved Strategy.

4.3.7 Both exceedances were minor with the C12-16 aliphatic hydrocarbon concentration of sample 'S4' reported at 1,215mg/kg (screening criteria 1,000mg/kg) and the C10-12 aromatic hydrocarbon of sample 'S11' at 24.1mg/kg (screening criteria 23mg/kg). This is therefore not

considered to be indicative of the presence of unacceptable levels of residual contamination with the potential to cause significant pollution.

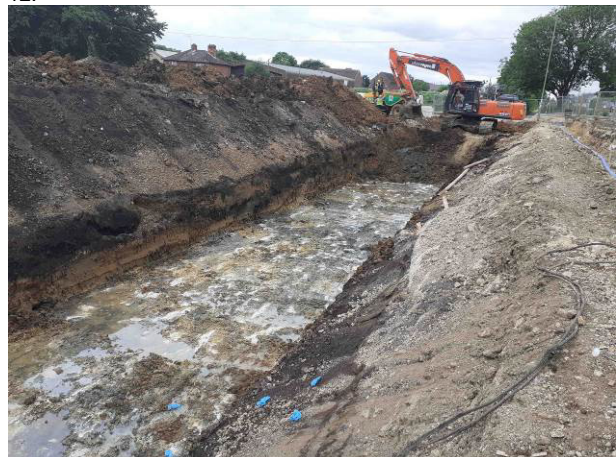
12.

04.06.20 – View west across excavation area.

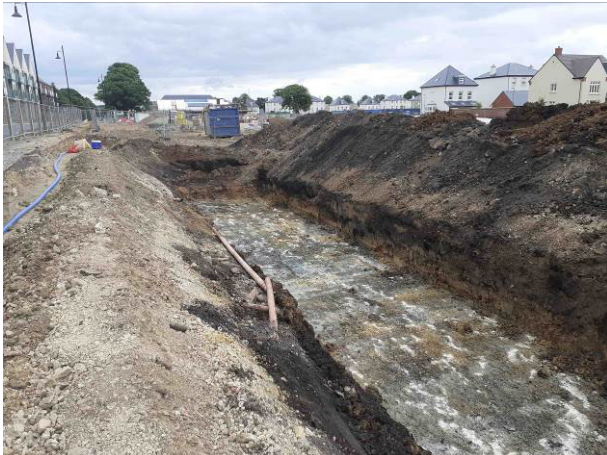
13.

04.06.20 – View east across excavation area.

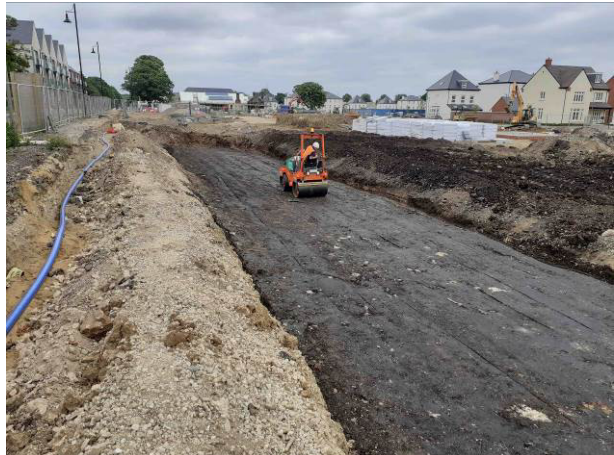
14.

08.06.20 – Retained soils replaced and compacted into Phase 4 excavation.

- 3.2.2 Upon receipt of laboratory results confirming that the soils stockpiled adjacent to the hotspot were suitable to be retained, these were replaced into the excavation area and compacted.

4.2.3 Hydrocarbon concentrations were below the assessment criteria within all three validation samples collected from the soils stockpiled for potential replacement. No criteria are derived within Table B3 for BTEX compounds and so screening thresholds were utilised from Table B1 of the Waterman Strategy (chemical criteria for material in the capping layer), none of which were exceeded. These soils were therefore deemed suitable for replacement within the excavation.

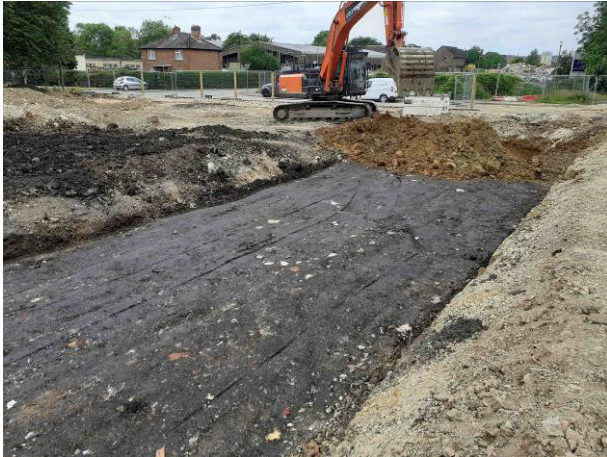
15.

08.06.20 – Continuation of excavation to west

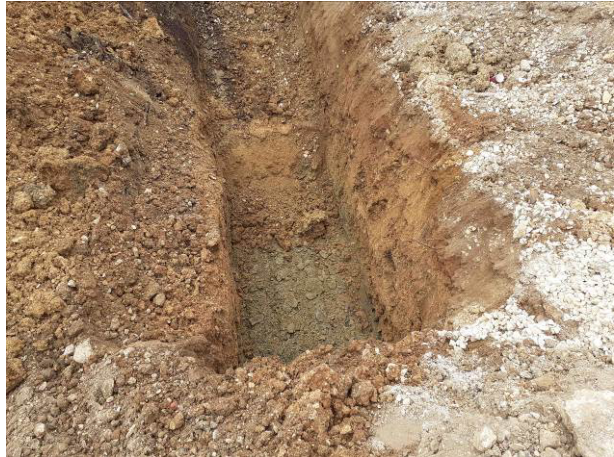
16.

08.06.20 – No significant indicators of contamination noted in west of Phase 4 excavation area.
