AGETUR UK LIMITED

Trenchard Circle, Upper Heyford Remedial Completion Report

Report Ref. 173042/RCR/001

**Trenchard Circle
Upper Heyford
Oxfordshire
OX25 5HD**

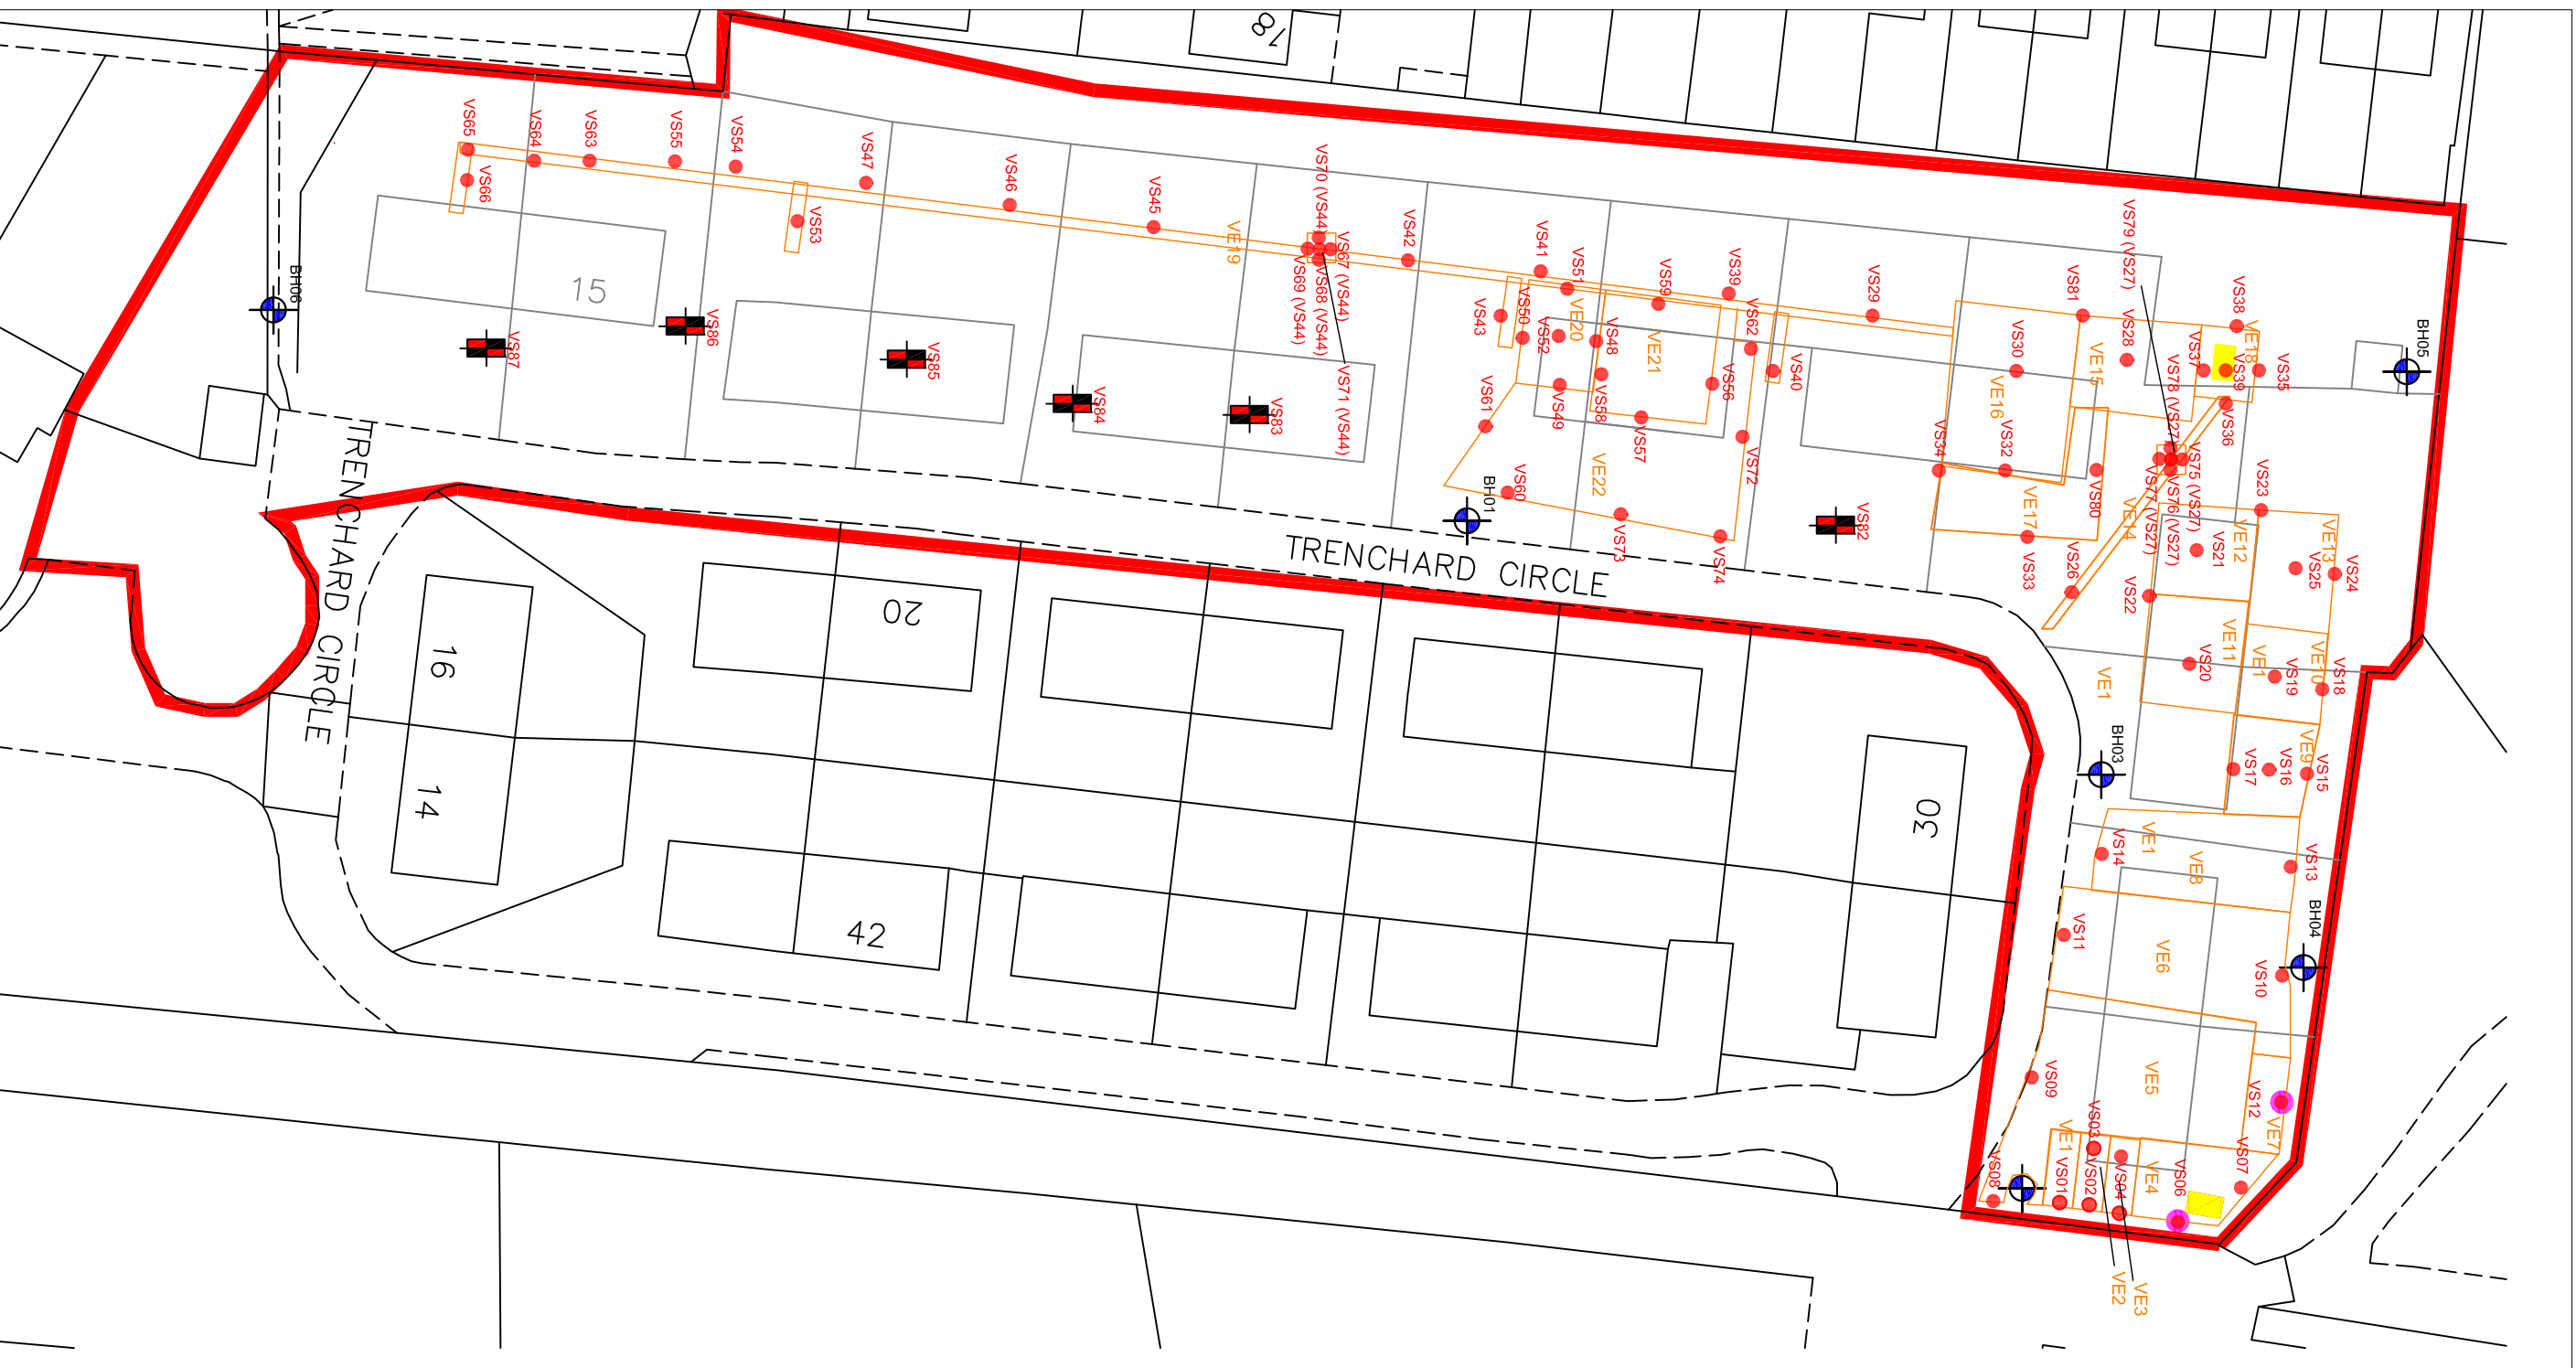
Figure 1 Validation Plan

- 2.1 Between 6th October and 3rd November 2017 AAe supervised the removal of petroleum hydrocarbon impacted soils and pipework at the site. Following removal of the grossly impacted soils and former pipework, validation soil samples were collected to demonstrate that all impacted soils had been fully removed. It should be noted that where excavations terminated on solid rock no validation samples could be obtained.

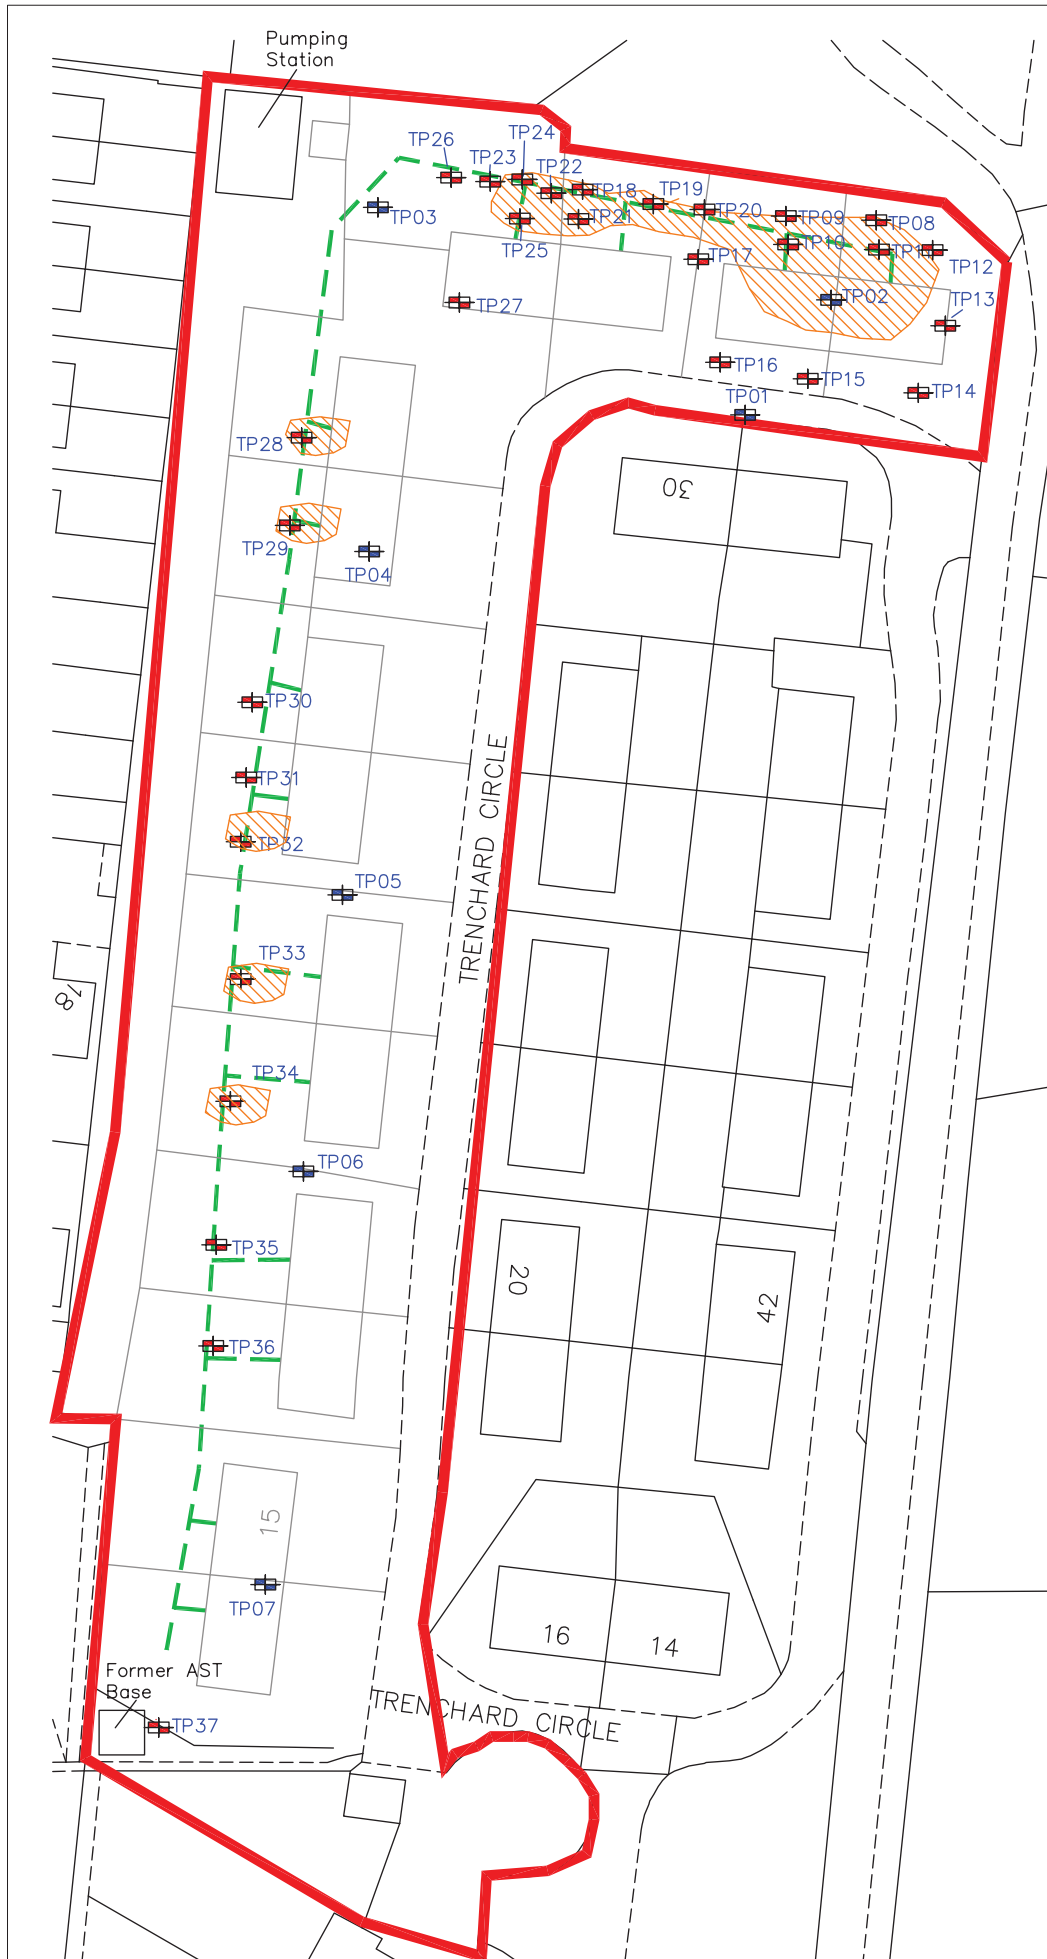
- 4.10 The investigation identified a buried fuel line (comprising 2 metal pipes) located to the rear of the former properties at approximately 0.50 to 1.30 m BGL. The fuel lines pass along the northern and western areas perimeter of the site, connecting to the former properties via feeder lines and the manholes. The approximate position of the fuel lines is shown on Figure 3. Hydrocarbon staining and odour was observed around the pipes and manholes.

- Site Boundary
- Trial Pits (TP01-07)
- Verification Pits (TP08-37)
- Indicative areas of recorded hydrocarbon contamination
- - - Indicative position of below-ground oil pipes

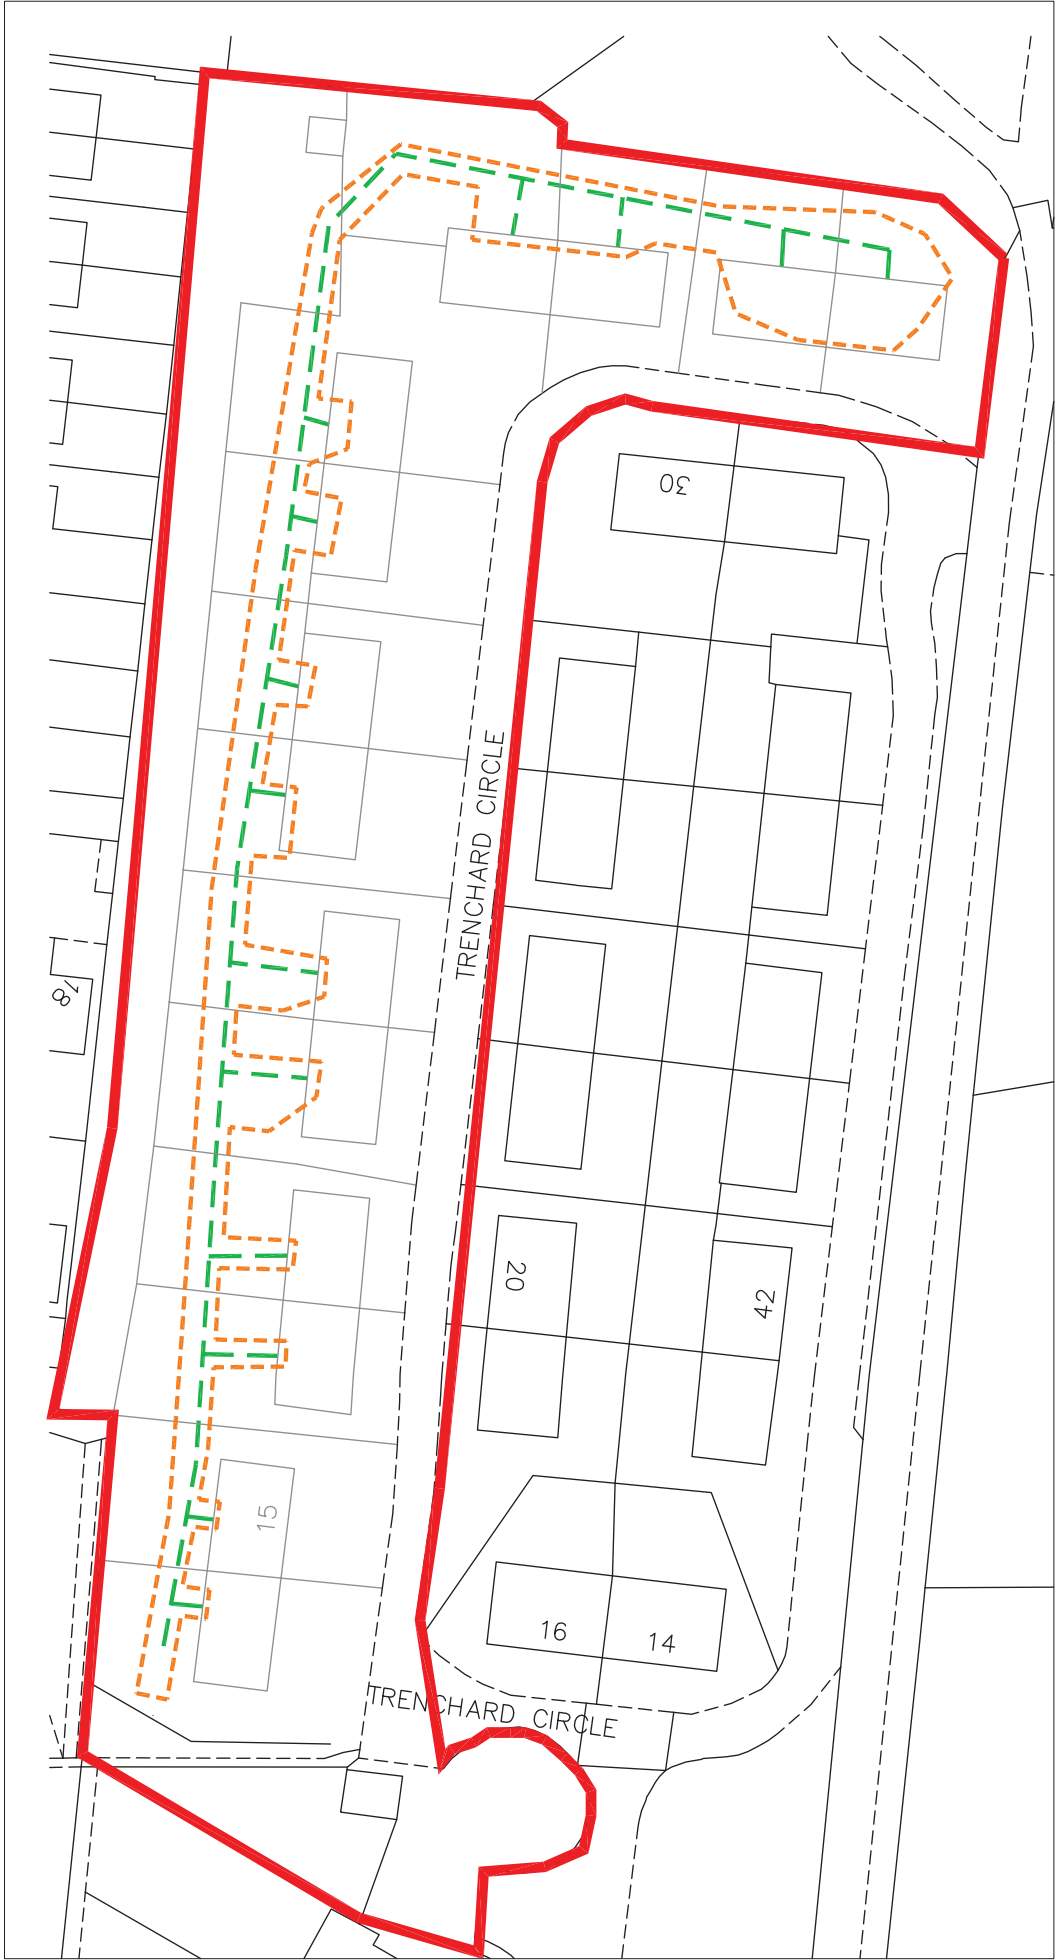
- Site Boundary
- - - Indicative position of below-ground oil pipes to be removed.
- - - Impacted soils around pipework to be segregated and treated/excavated. Validation testing of residual soils.

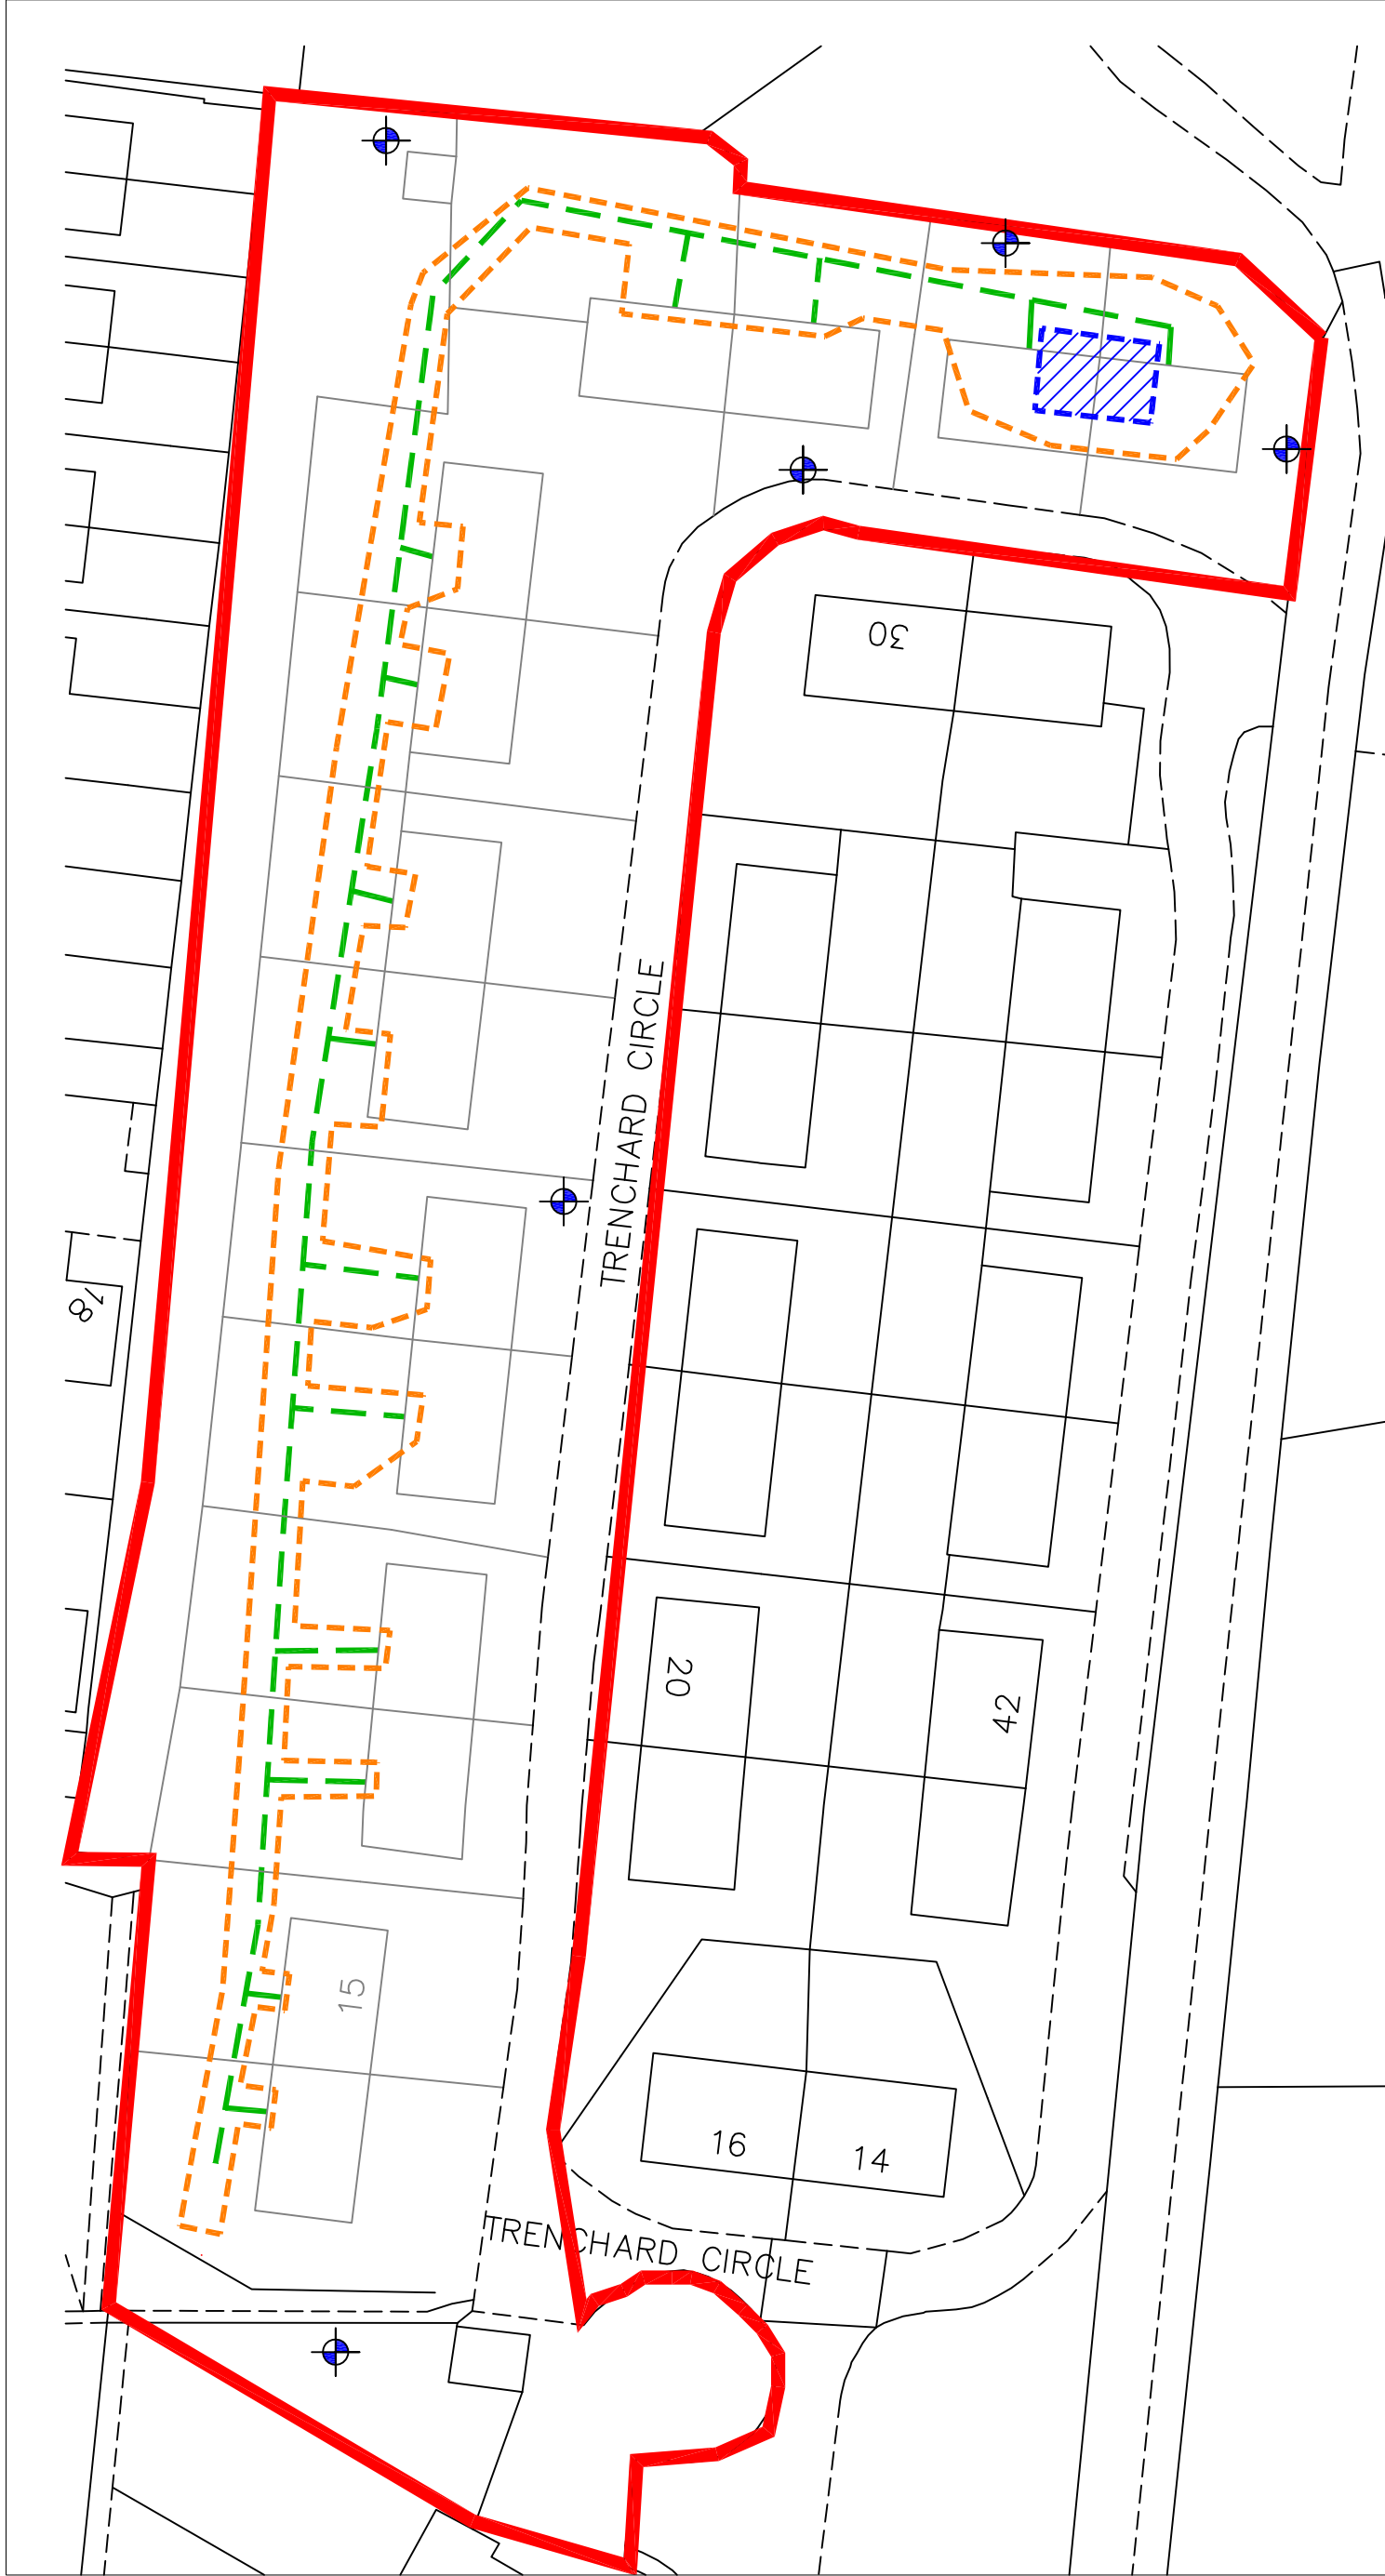
- Site Boundary
- Indicative position of below-ground oil pipes to be removed.
- Impacted soils around pipework to be segregated and treated/excavated. Validation testing of residual soils.
- ORC Application Area
- Proposed Boreholes - indicative locations to be agreed on site.
