Phase 2 Site Investigation

Ploughley Road, Ambrosden

B05927-CLK-XX-XX-RP-GT-002

Bellway Homes (North)

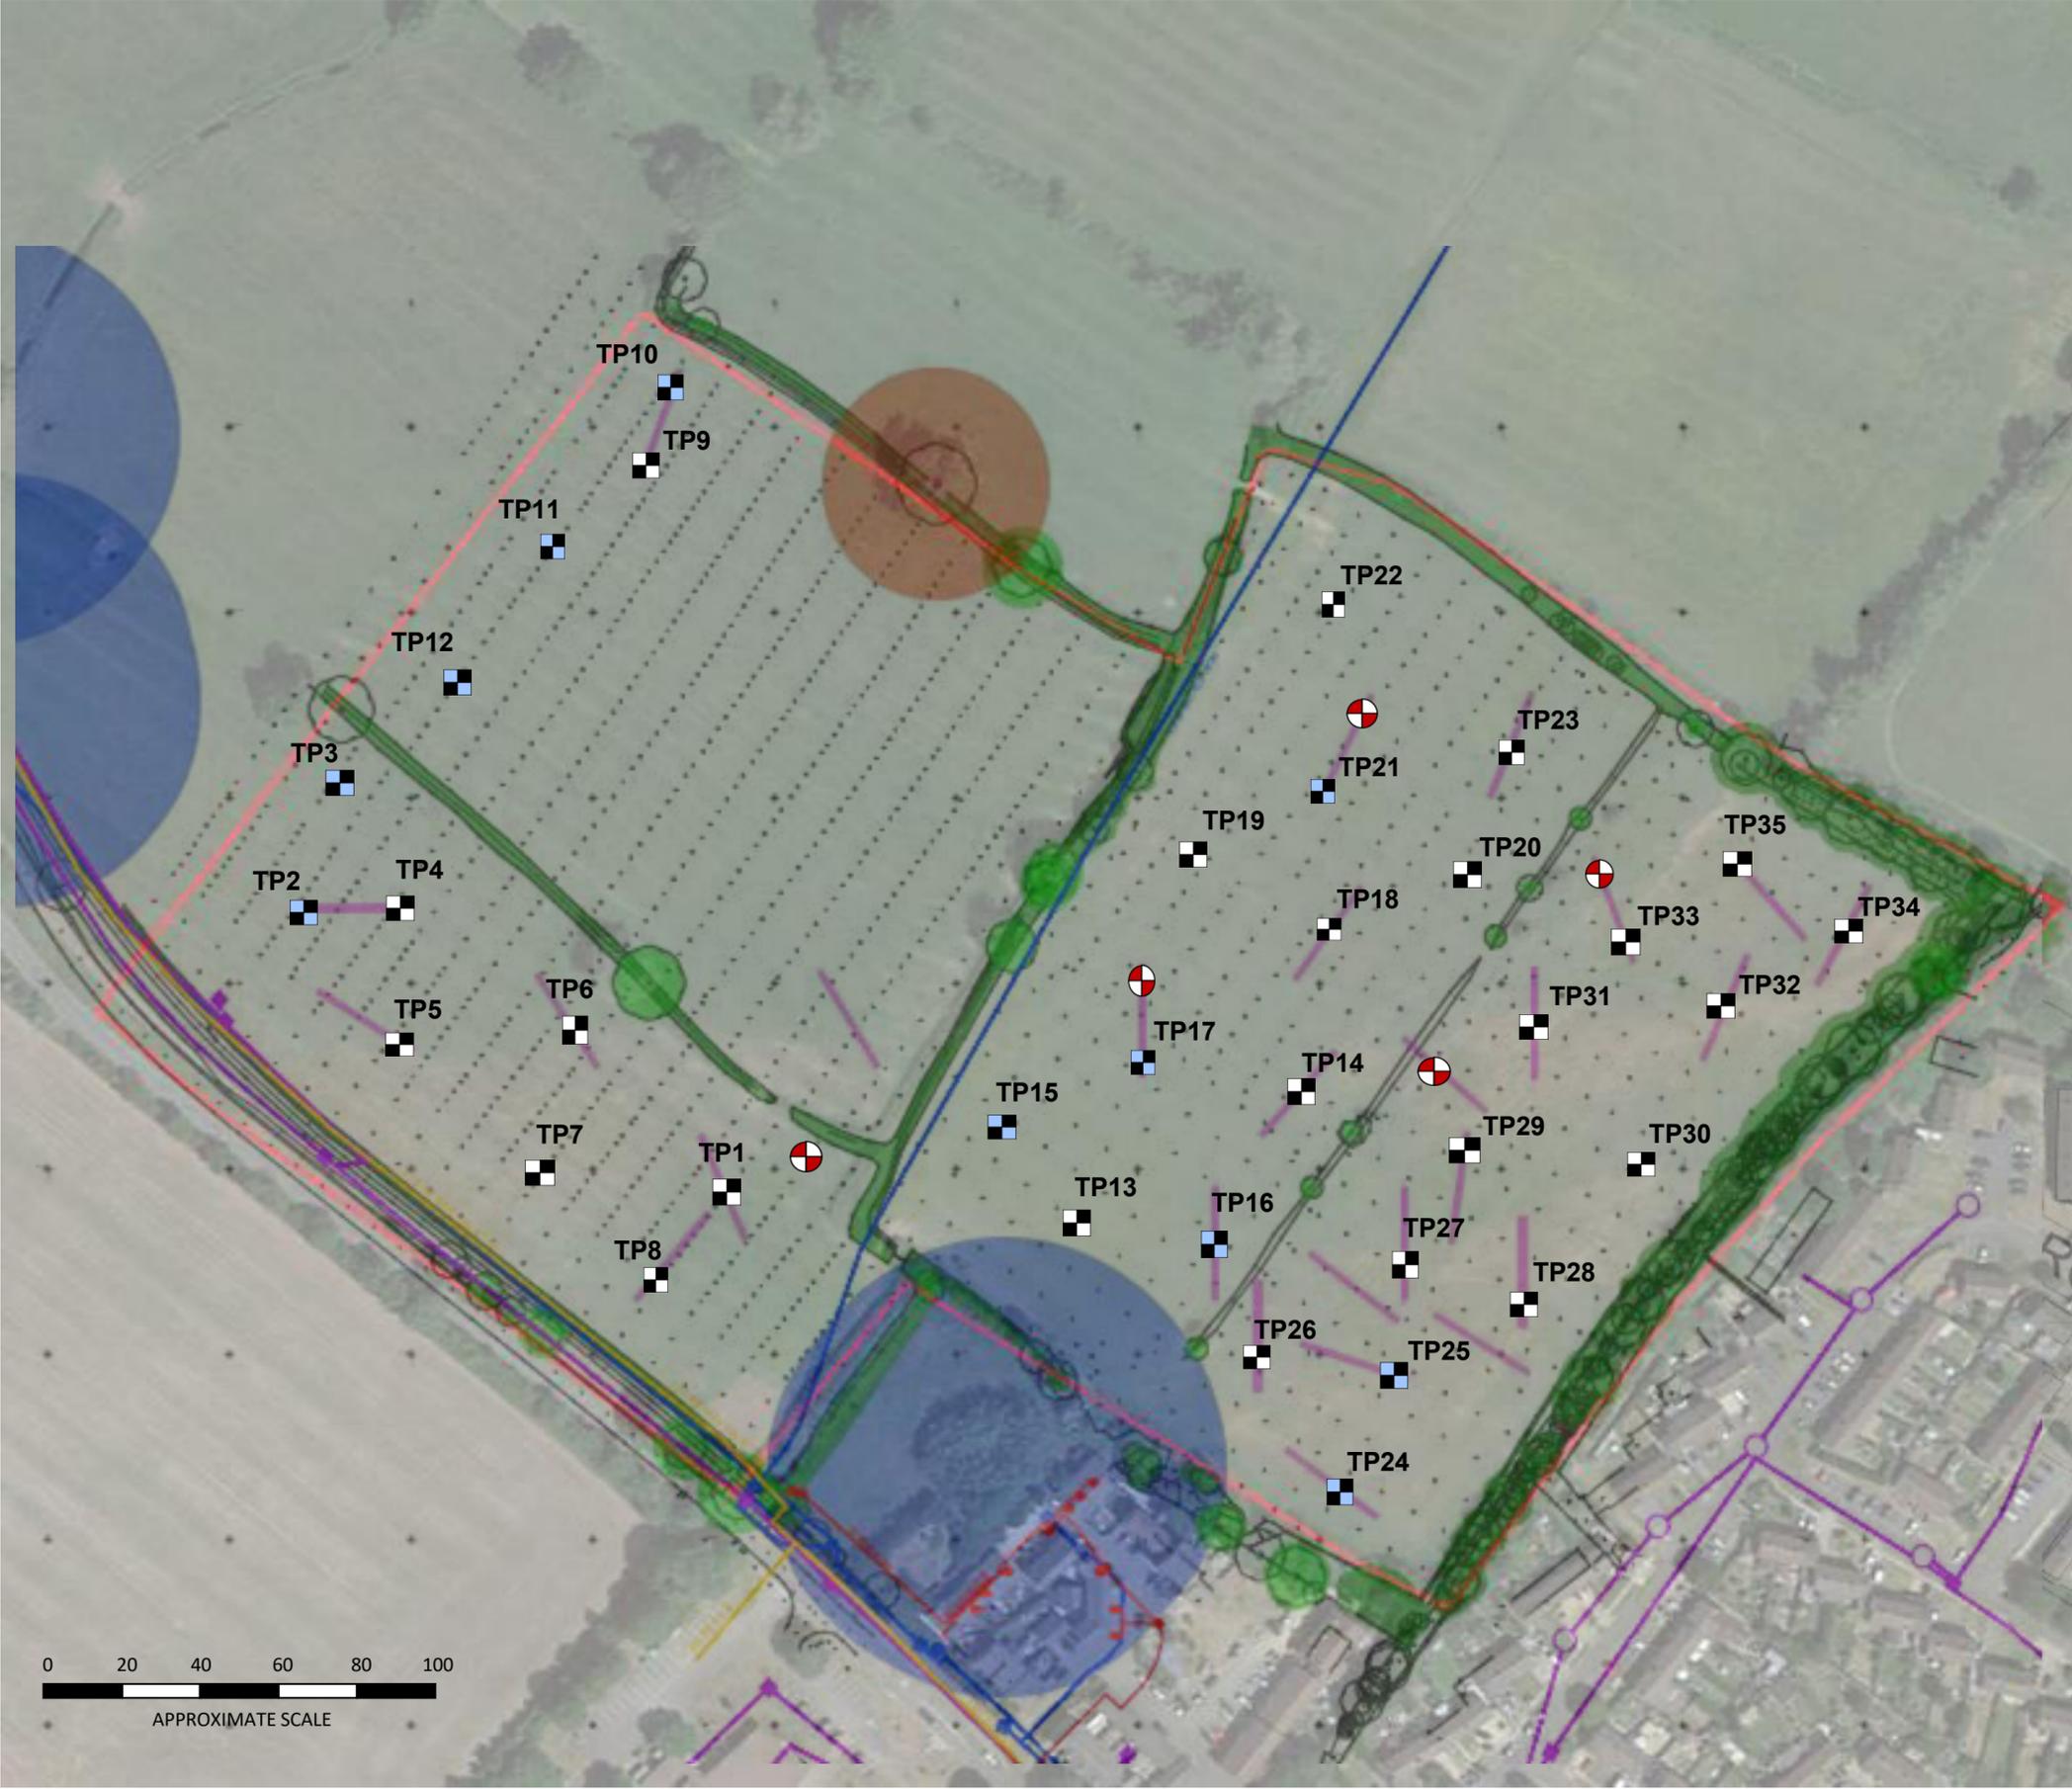
B Exploratory Hole Plans

Hole Locations Approximate. Sizes exaggerated for clarity.

The underlying near surface soils were of the Kellaways Clay Member were shrinkable (high volume change potential), while the weathered Cornbrash and Forest Marble may be considered low volume change. Therefore, a suspended floor slab is recommended with an appropriate underfloor void in these areas, see Appendix B.

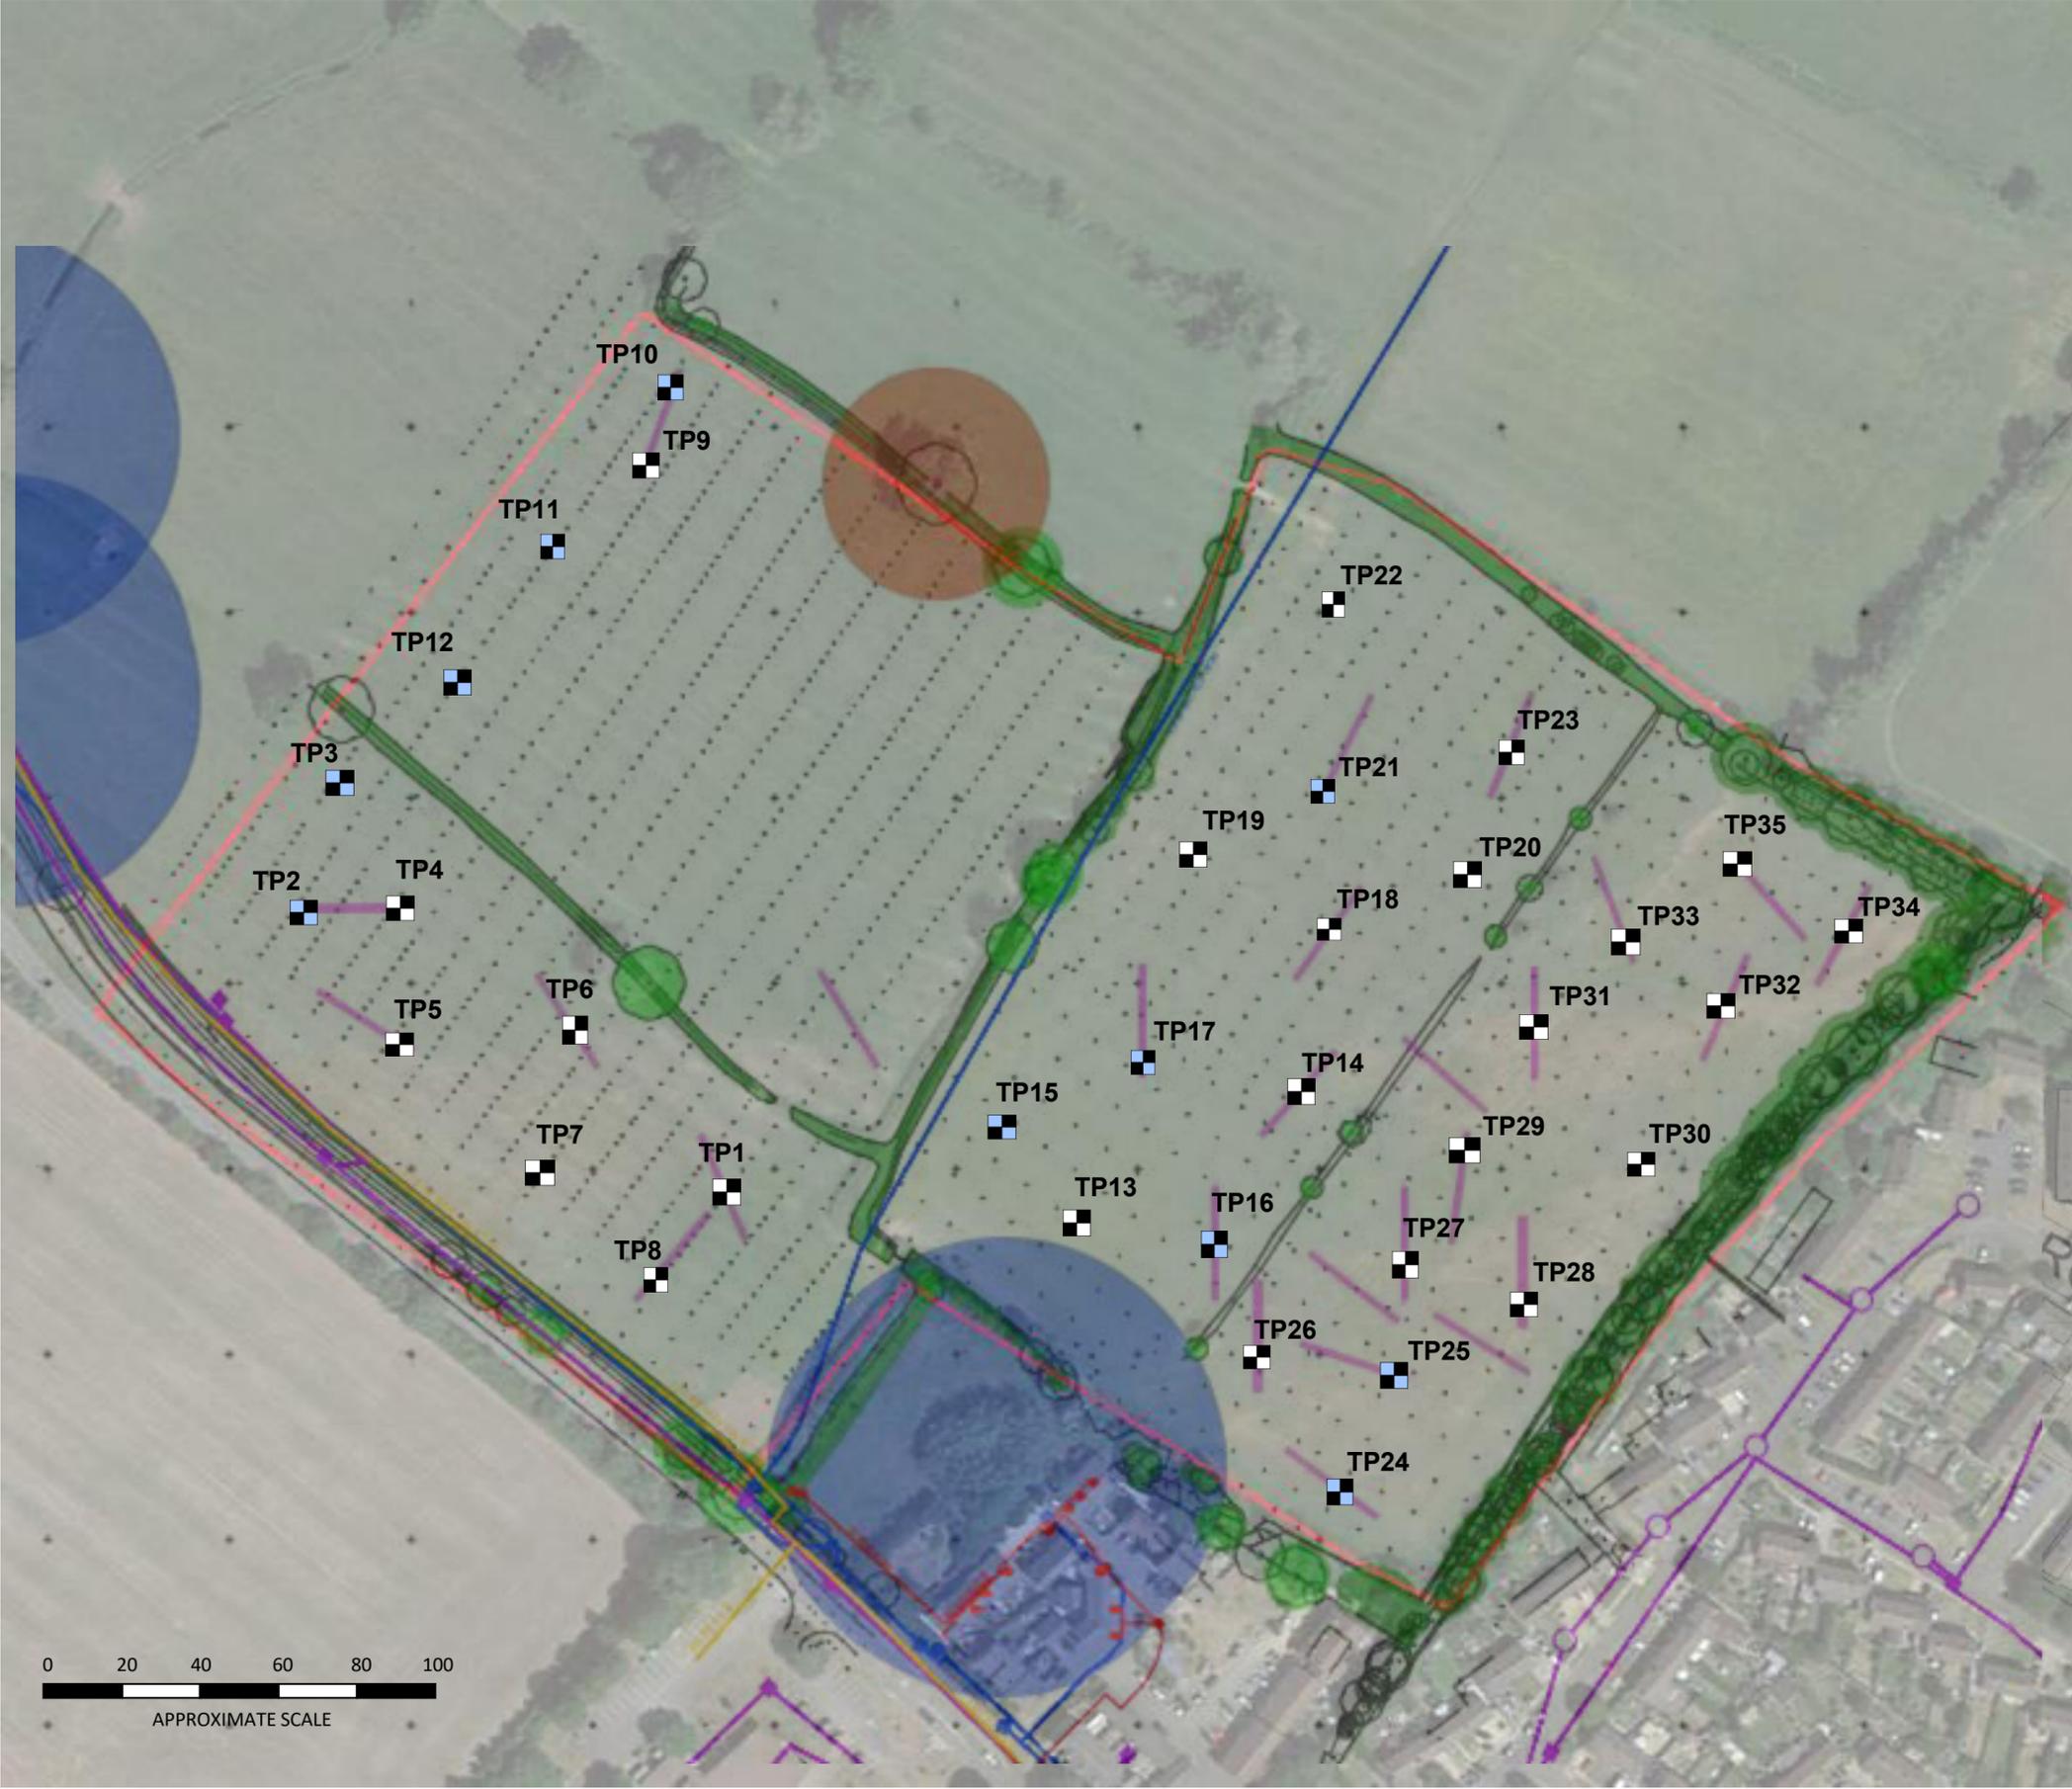
Hole Locations Approximate. Sizes exaggerated for clarity.

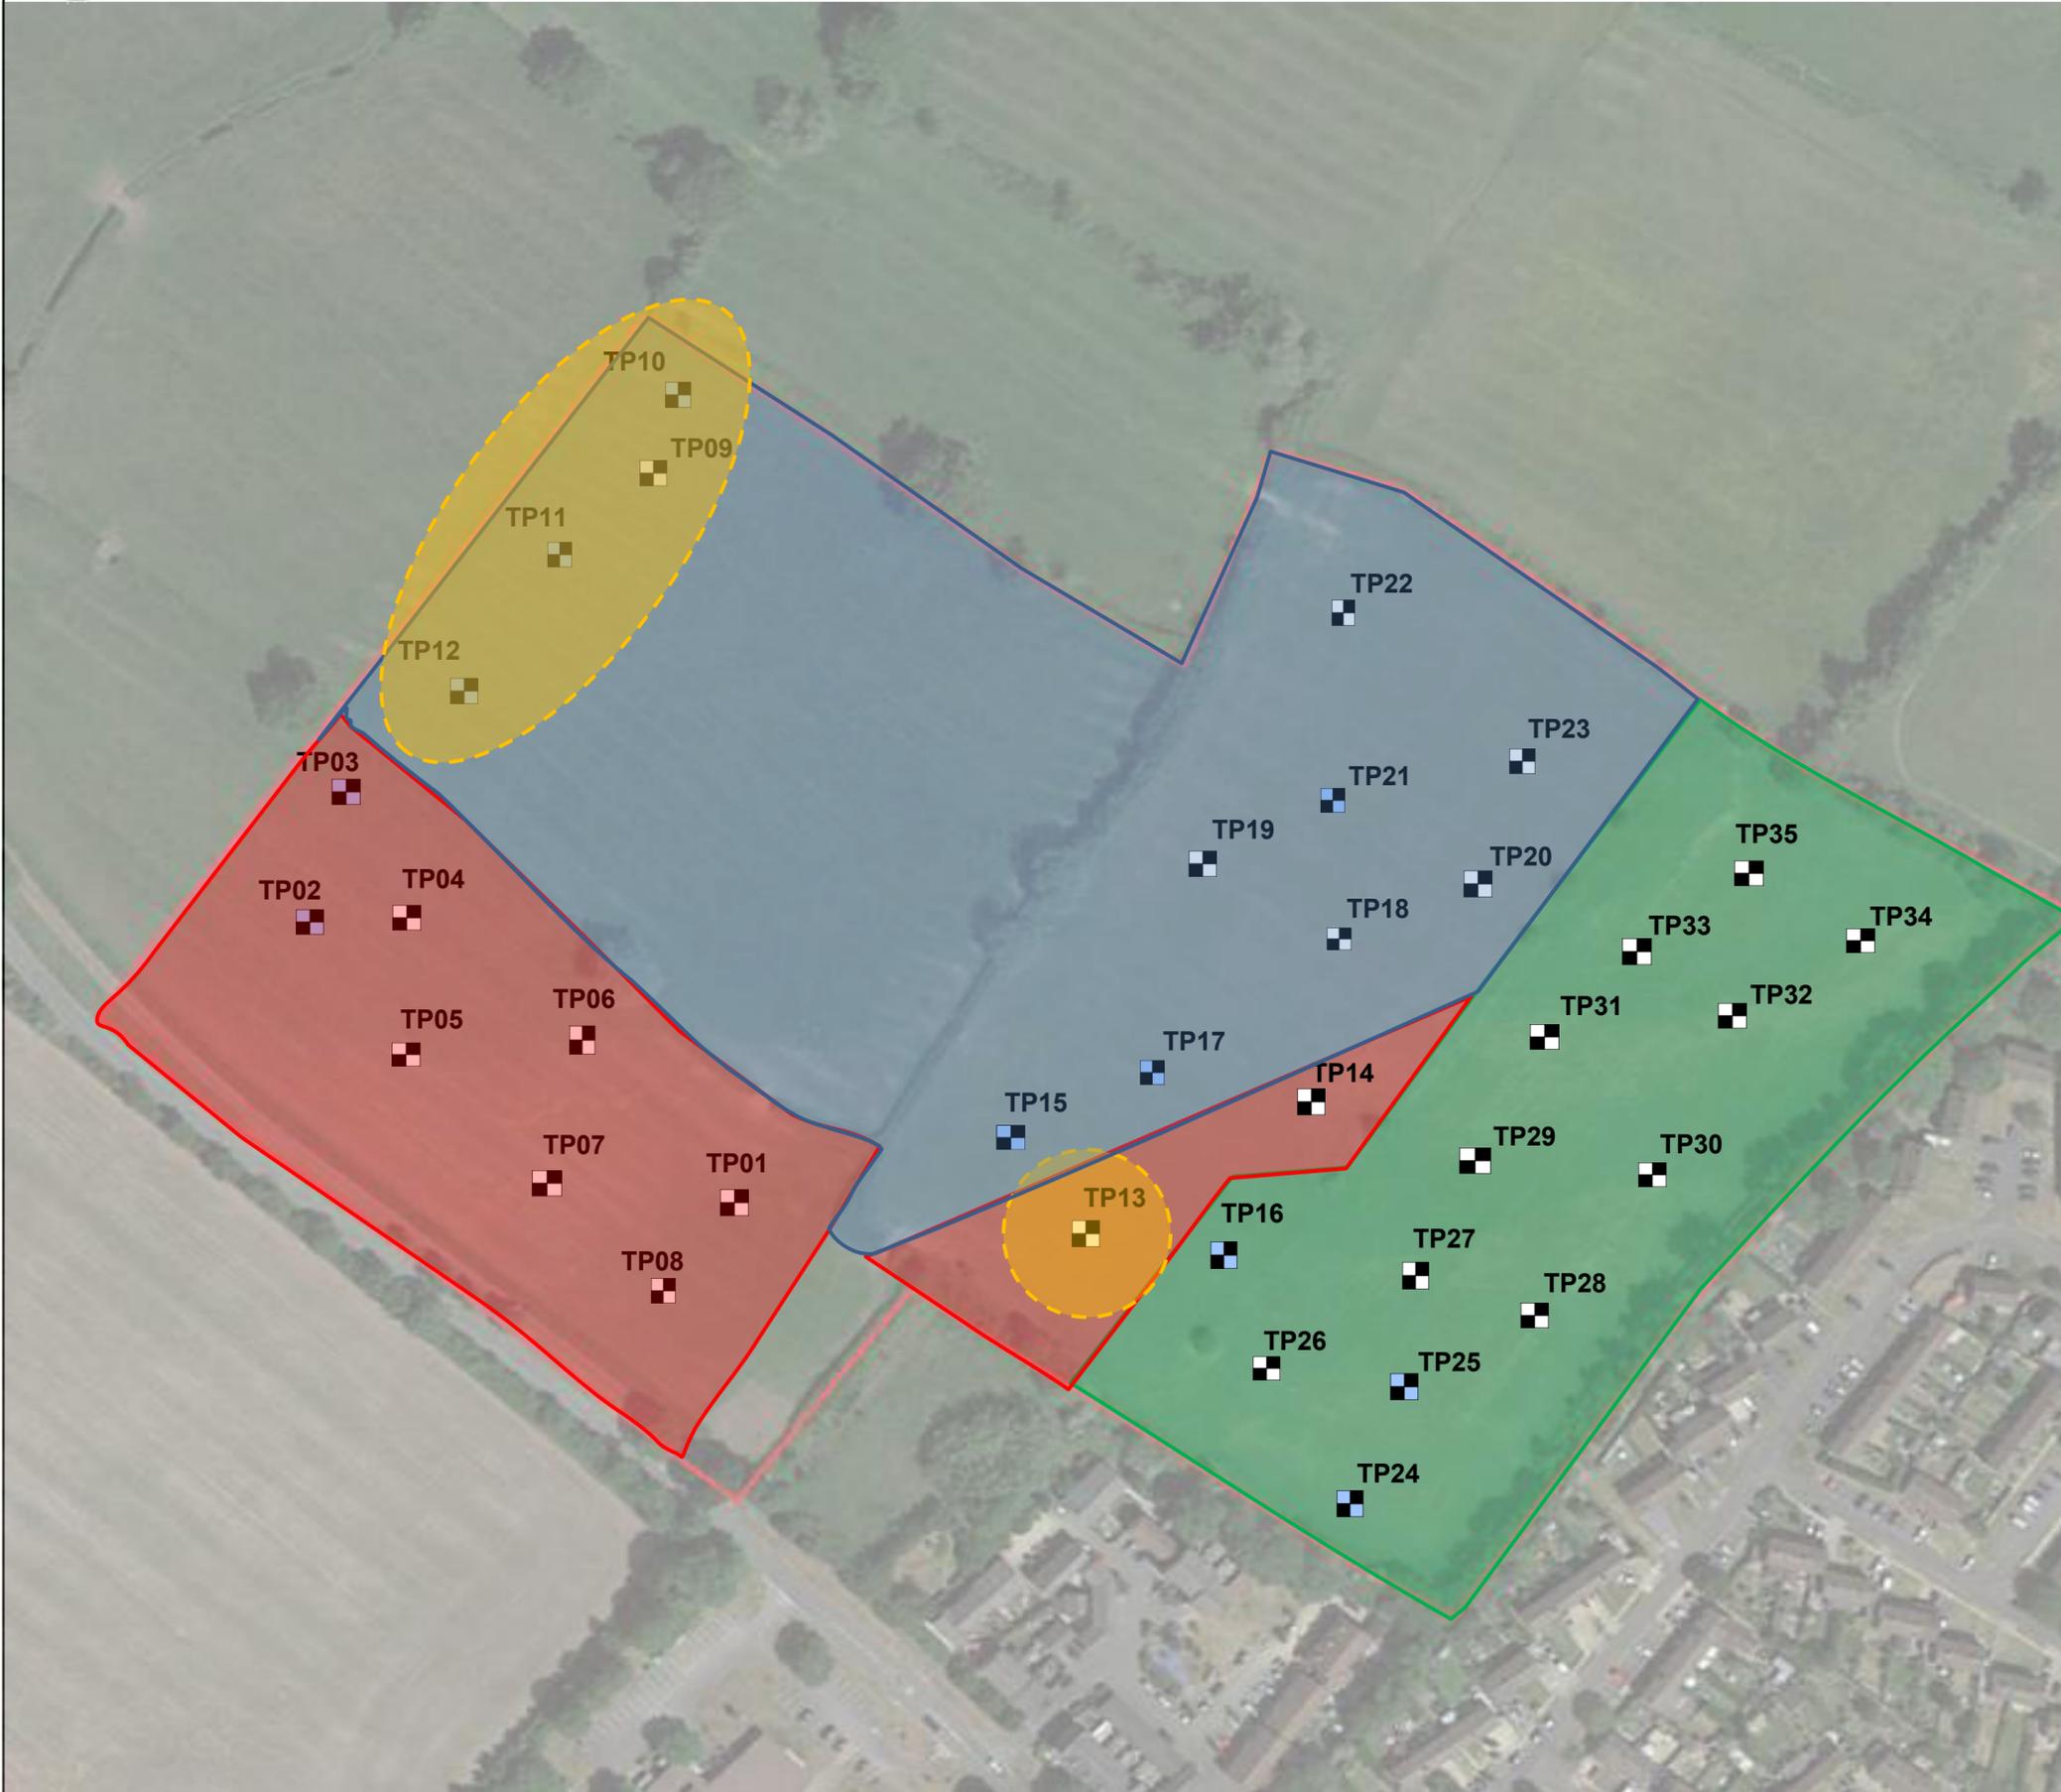
Hole Locations Approximate. Sizes exaggerated for clarity.
