GEO-ENVIRONMENTAL & GEOTECHNICAL ASSESSMENT (GROUND INVESTIGATION) REPORT

PHASE 10
HEYFORD PARK
CAMP ROAD
OX25 5BS

Report Title: Geo-environmental & Geotechnical Assessment Ground Investigation Report for Phase 10, Heyford Park, Camp Road, OX25 5BS

Job No: P4280J2513/SC

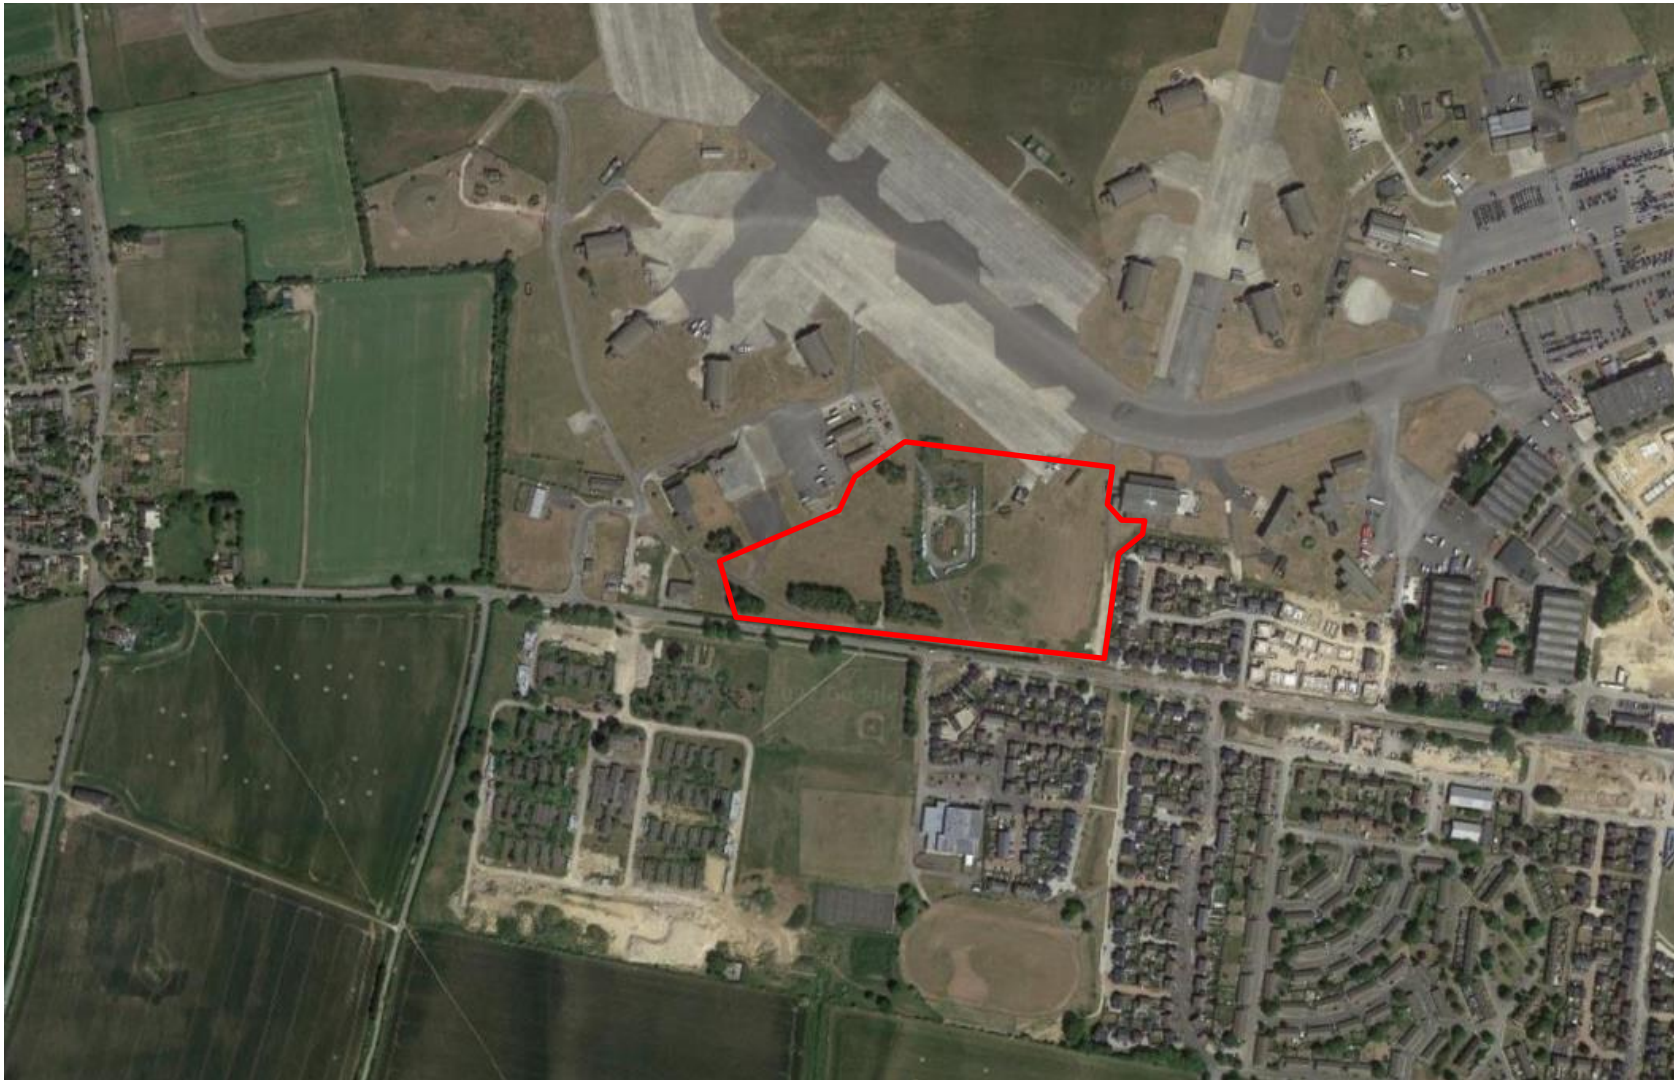
| TITLE | Phase 10 site shown with fuel distribution pipelines/tanks overlaid onto satellite image | PROJECT NO. | P4280J2513 |

- 2.2.21 It is understood that Hydrock were not provided with the Vertase report prior to their investigation, and so did not target potential sources that the report identified, principally the fuel pipelines buried throughout the site and the fuel spill noted in excavation 2-2.
