**2023 Updated Bat Survey Report for
North Arms House, Mills Lane, Wroxton,
Banbury, Oxfordshire, OX15 6PY**

North Arms House, Mills Lane, Wroxton, Banbury – 2023 Updated Bat Survey
Report

Report Number: 4574-CWS-01

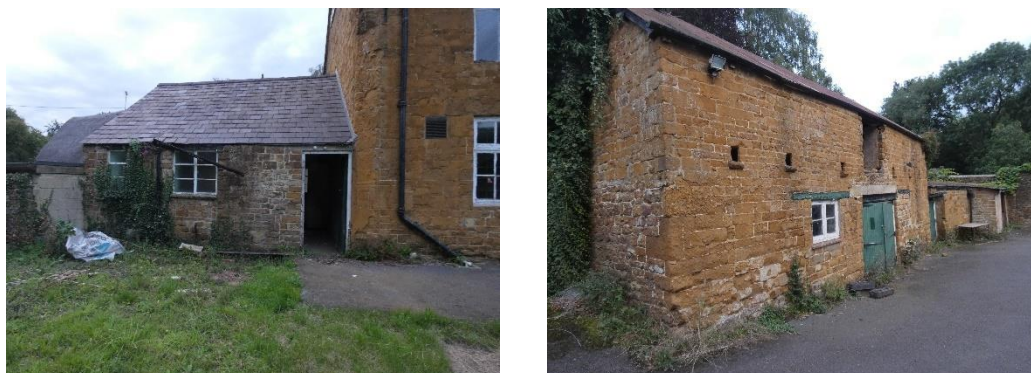
Figs. 1 & 2 Extension (L) and barns with adjoining sheds (R)

The survey site comprised a former public house with thatched roof and single storey extension (Fig. 1), a redundant barn with a pitched metal covered roof, and adjoining sheds (Fig. 2).

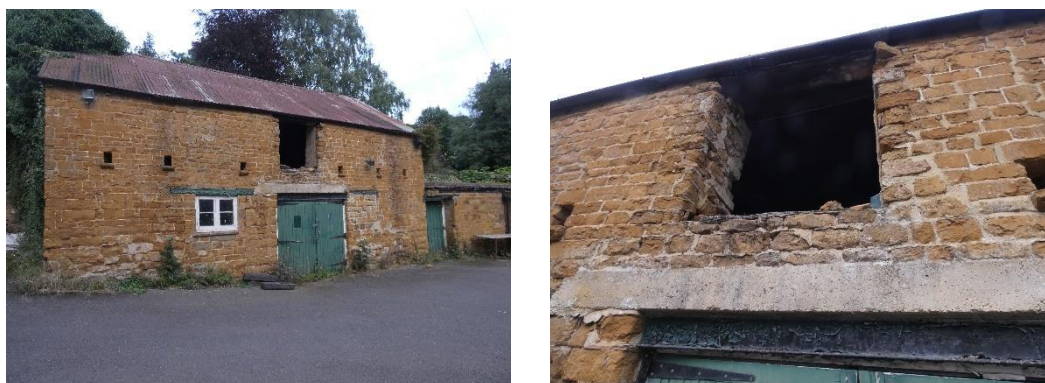
Figs. 4 & 5 Barn

The barn was built of stone and had a pitched corrugated metal roof, this intact with no panels missing.

There was an opening at the front of the building where a door had been removed, and there was a row of vent holes along the front elevation (Figs. 4 and 5).

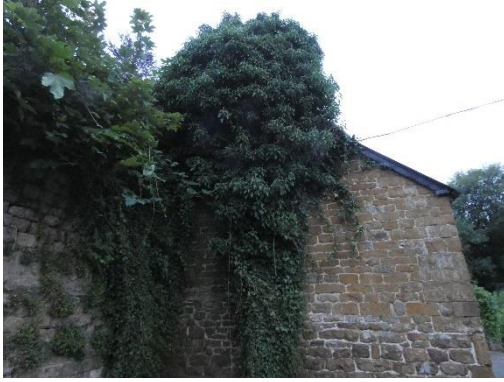
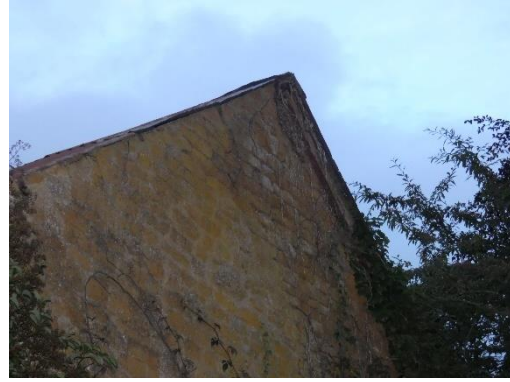
Figs. 6 & 7 Gable ends of barn

Although the gable ends were partially smothered with Ivy *Hedera helix*, the stonework was sound throughout, with no external gaps or crevices suitable for bat roosting (Figs. 6 and 7).

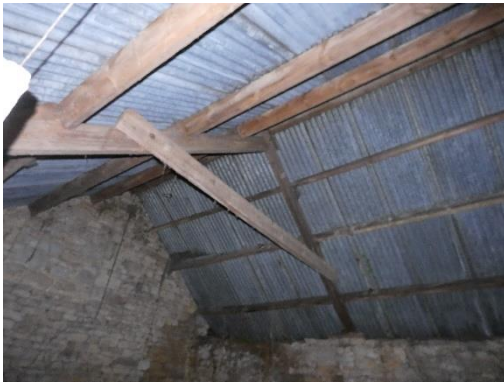
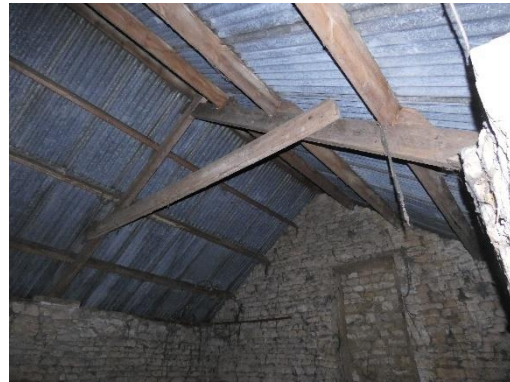
Figs. 8 & 9 Interior of middle barn

Internally the roof was unlined and supported by relatively modern timbers, these lightly cobwebbed (Figs. 8 and 9).

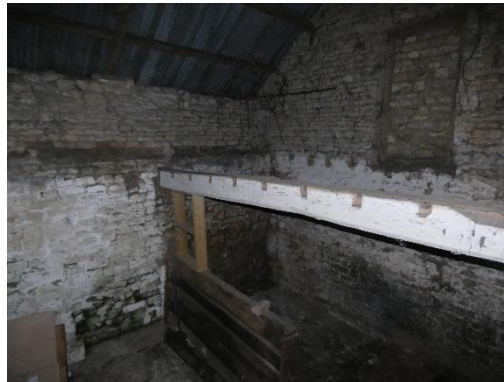
Fig. 10 Interior of barn

The first floor had been removed, and the building was now open to the roof (Fig. 10).

No sign of bat activity was found in the barn.

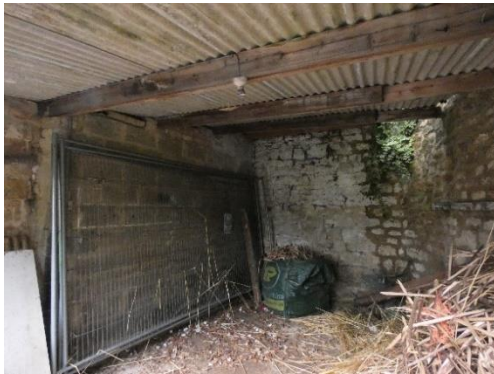
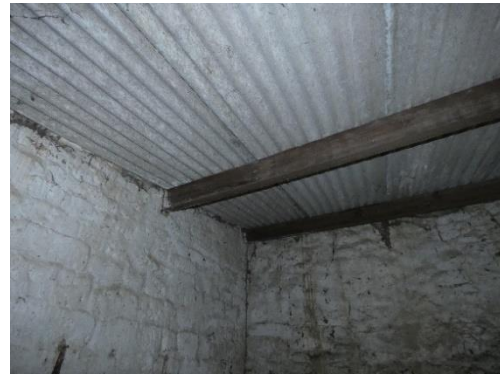
Figs. 11 & 12 Interior of sheds

The adjoining sheds were single storey, with gently sloping roofs covered by corrugated fibre cement panels. The panels were largely intact, but there was a hole in the panel in the southeastern corner.

One shed was enclosed and the other was open-fronted (Figs. 11 and 12). The latter had an open window in the rear and the aforementioned hole in the roof. The roof was heavily cobwebbed and the whole interior was brightly illuminated and drafty.

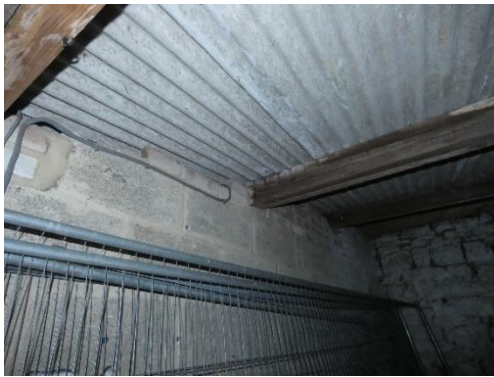
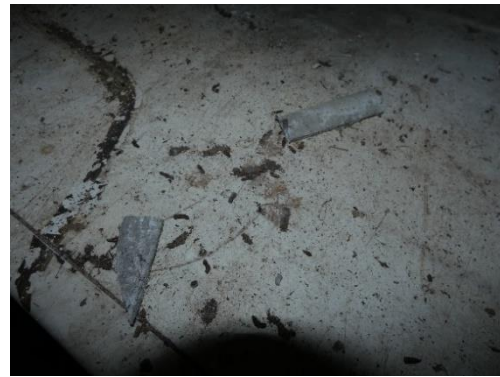
Figs. 13 & 14 Interior of shed and Brown Long-eared Bat droppings

The enclosed section was equally thickly cobwebbed, in particular the roof timbers and the rear wall stonework (Fig. 13).

No roosting Brown Long-eared Bat was observed in the corrugations, but the droppings noted in 2019 were still present, although now they were very old and crumbling to dust (Fig. 14). There were no recent droppings, and the building was not thought to have been used by the bat since 2019.

The few scattered Brown Long-eared Bat droppings found in the shed were very old, with no roosting bat present during the pre-survey inspections and nocturnals. Indeed, it was clear that no Brown Long-eared Bat had roosted in the shed since 2019, and the previous roost site was cobwebbed over.

Since the proposed works will cause the loss of the bat roost in the barn only, a licence from Natural England will be required.

Given the low status of the roost, the site is eligible for registration under Natural England's Bat Mitigation Class Licence (BMCL) scheme.

Mitigation measures will include a 'toolbox talk' by a Registered Consultant (RC) to contractors about bats and what to do if one is unexpectedly encountered, a pre-works inspection of the building by the RC, supervision of any destructive roof works by the RC, the latter undertaken by hand, and the provision of a Harlech Bat Box on the southern gable end of the barn in which to relocate a bat if one is discovered before or during works. The box will be retained in position for a minimum of five years.

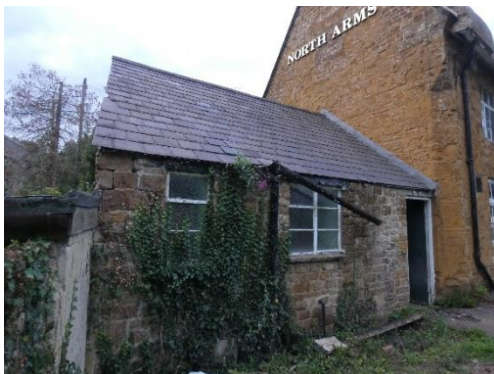
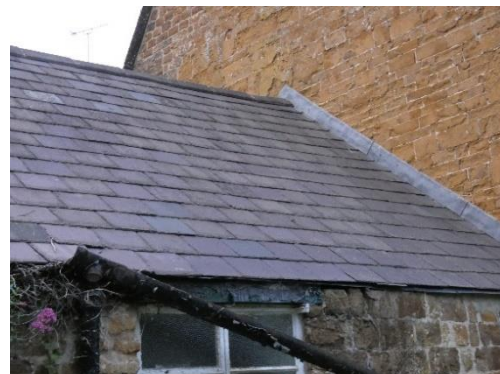
Figs. 15 & 16 Extension of house

The single storey extension had a pitched, slate tiled roof, this also in good condition, with just one dislodged slate (Figs. 15 and 16).

The external stonework was sound throughout, and the window casements and door frame were tightly fitting.

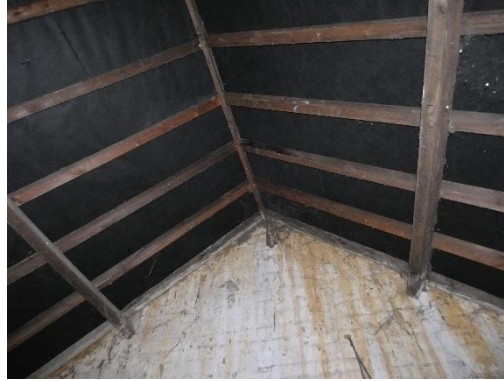
Fig. 17 Interior of extension

Internally the extension was open to the roof, this lined with 1F felt (Fig. 17). It was heavily cobwebbed and no signs of bat occupation were found.

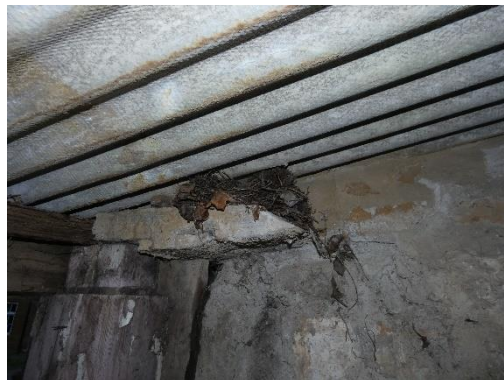
Fig. 18 Old Wrens' in Blackbirds' nest in shed

There was an old Blackbirds' *Turdus merula* nest in the sheds, this taken over by a Wren *Troglodytes troglodytes* (Fig. 18), but no sign of nesting birds in the barn or house.

Since all in-use bird's nests and their contents are protected from damage or destruction, any works which affect the building should ideally be undertaken outside the period March to August inclusive. If this time frame cannot be avoided, a close inspection of the building affected will be undertaken prior to works commencing. Work will not be carried out in close proximity to any in-use nest, and a minimum buffer of 5.0 metres will be established, although this could be more depending on the sensitivity of the species. Any in-use nest will be allowed to fledge before it is disturbed.

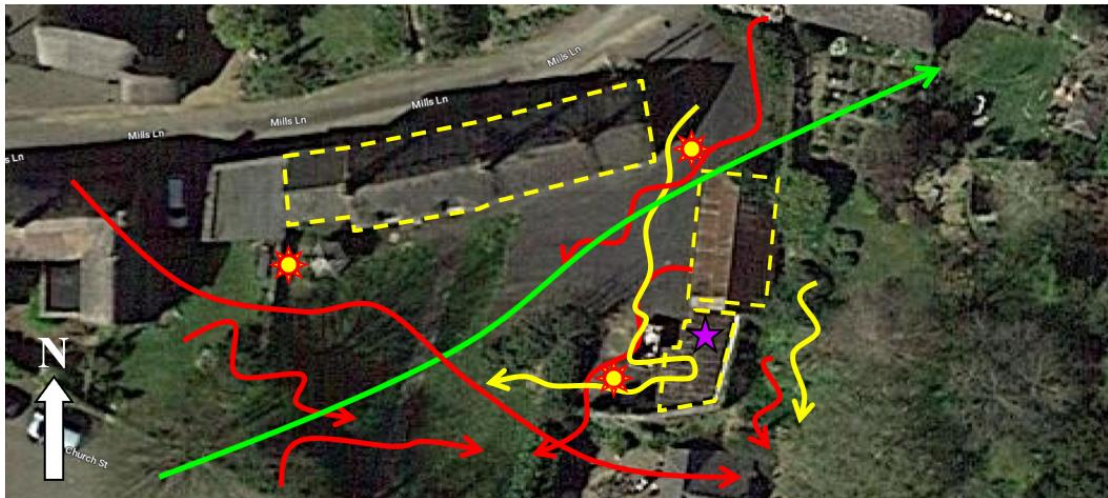
Plan 1 Bat flight paths at emergence on 17th August 2023

The nocturnal survey revealed one Common Pipistrelle emerging from the interior of the barn. Low levels of Common Pipistrelle and Soprano Pipistrelles were also observed, with a Noctule passing overhead.

The bat flight paths at emergence on 17th August 2023 are shown on Plan 1 below.

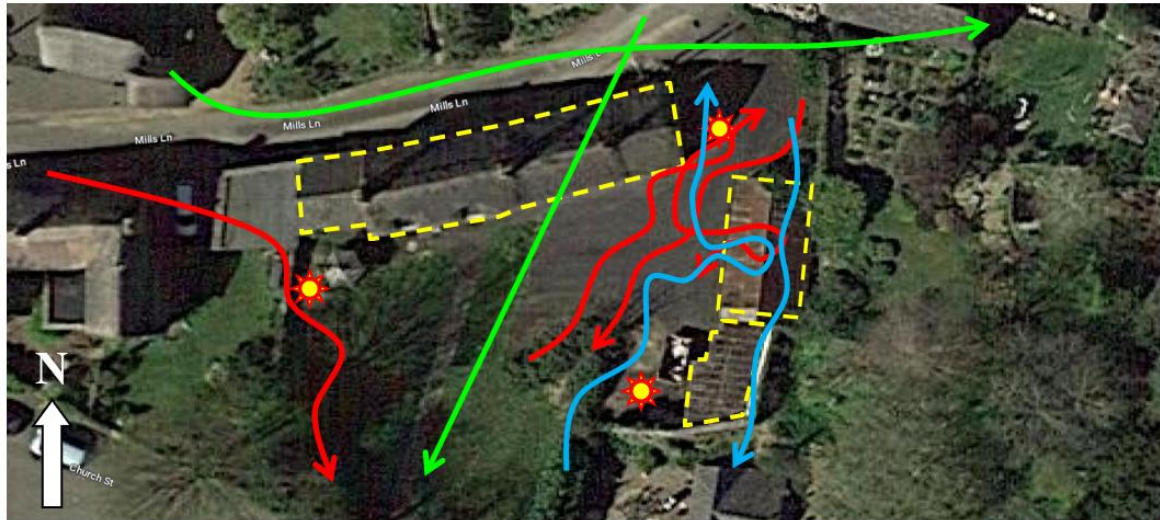
Plan 2 Bat flight paths at emergence on 5th September 2023

During the nocturnal survey, no bats emerged from any of the buildings. Common Pipistrelles were active around the site, with Noctules and Soprano Pipistrelles passing by infrequently. A Natterer's Bat flew through the site, briefly entering the barn and then flying off. It or another passed by.

The bat flight paths at emergence on 5th September 2023 are shown on Plan 2 overleaf.
