SITE INVESTIGATION REPORT

LAND OFF BERRY HILL ROAD, ADDERBURY, BANBURY. OX17 3HF

Report Reference: BC592 RE001

31st January 2022

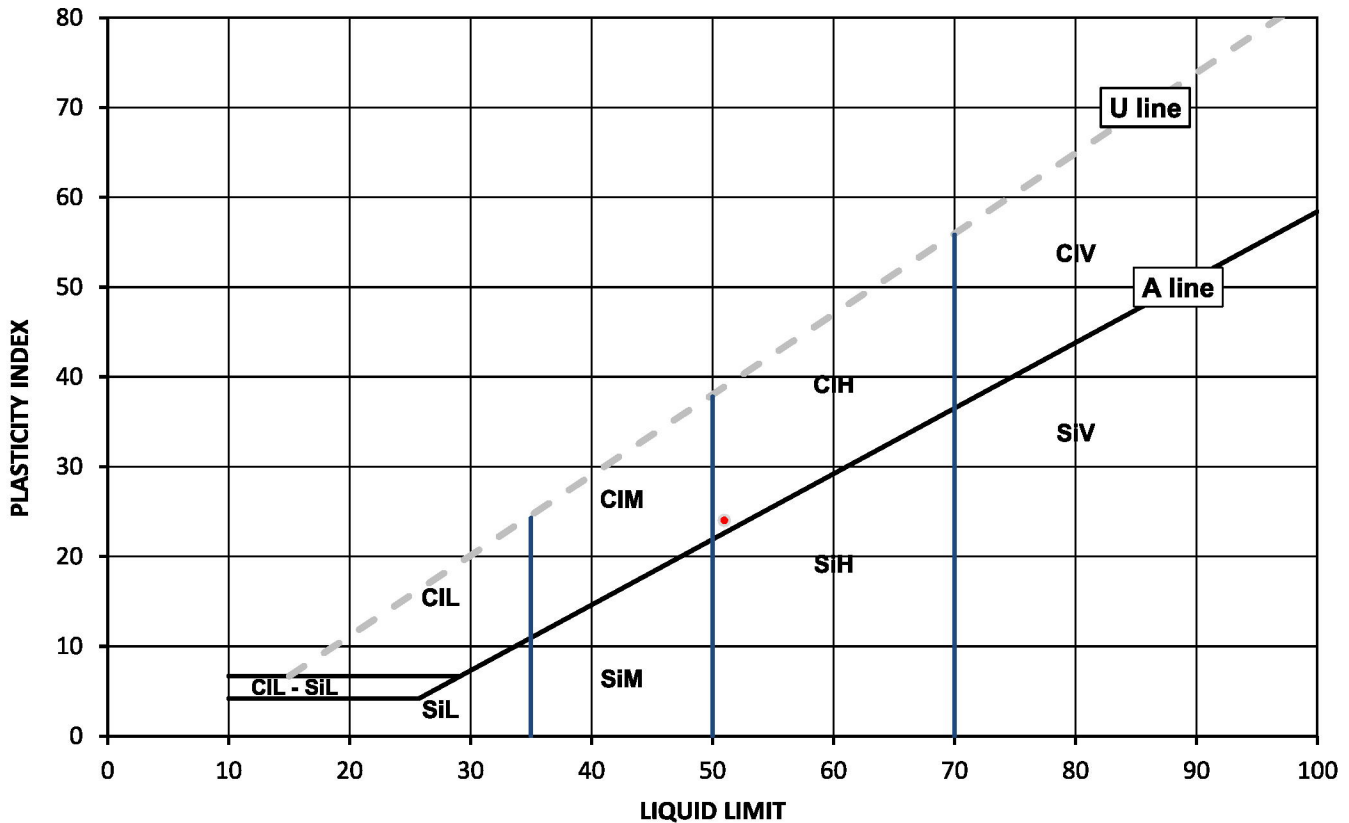
Sample Preparation: Tested in natural condition

As Received Water Content [W] %	Liquid Limit [WL] %	Plastic Limit [Wp] %	Plasticity Index [Ip] %	% Passing 425µm BS Test Sieve
24	51	27	24	100

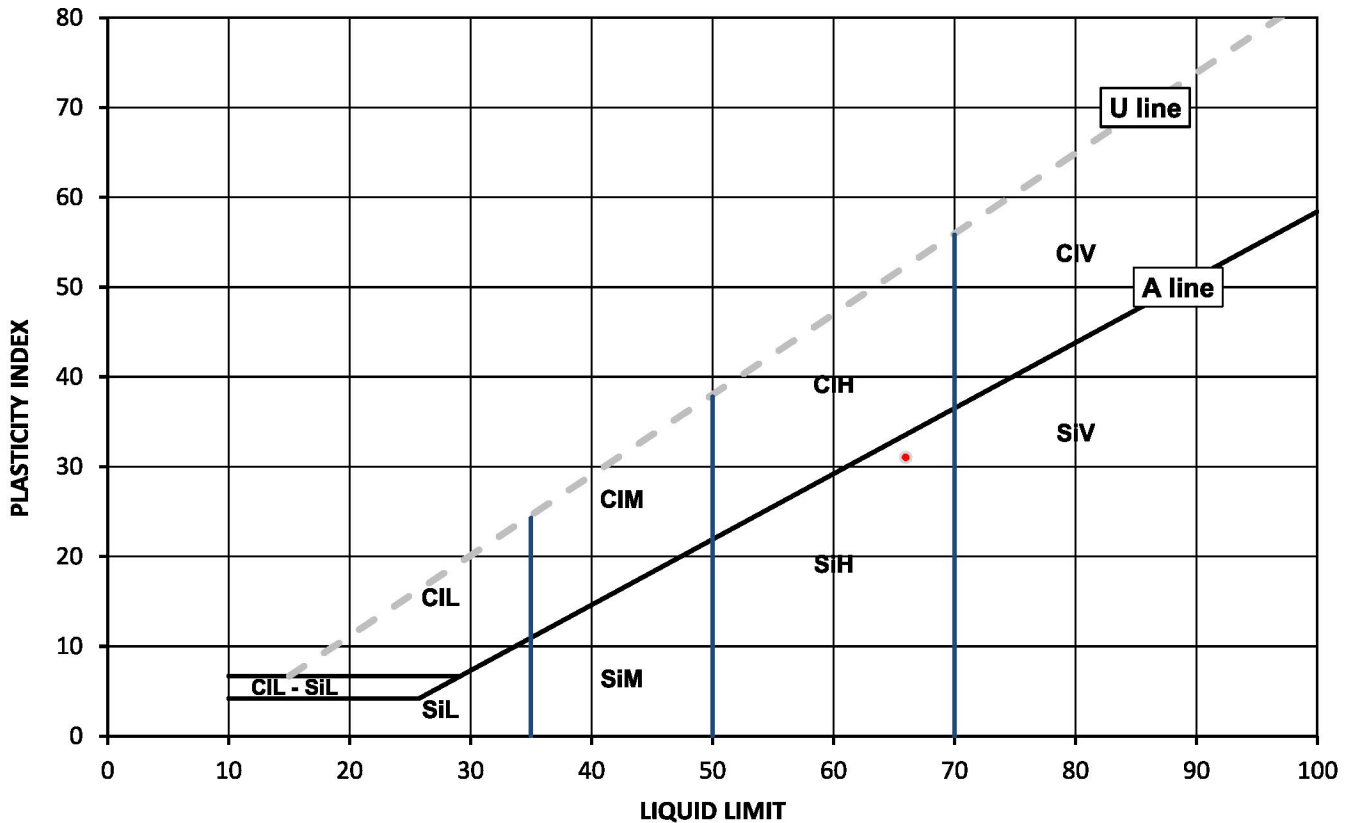
Sample Preparation: Tested after >425um removed by hand

As Received Water Content [W] %	Liquid Limit [WL] %	Plastic Limit [Wp] %	Plasticity Index [Ip] %	% Passing 425µm BS Test Sieve
39	66	35	31	82

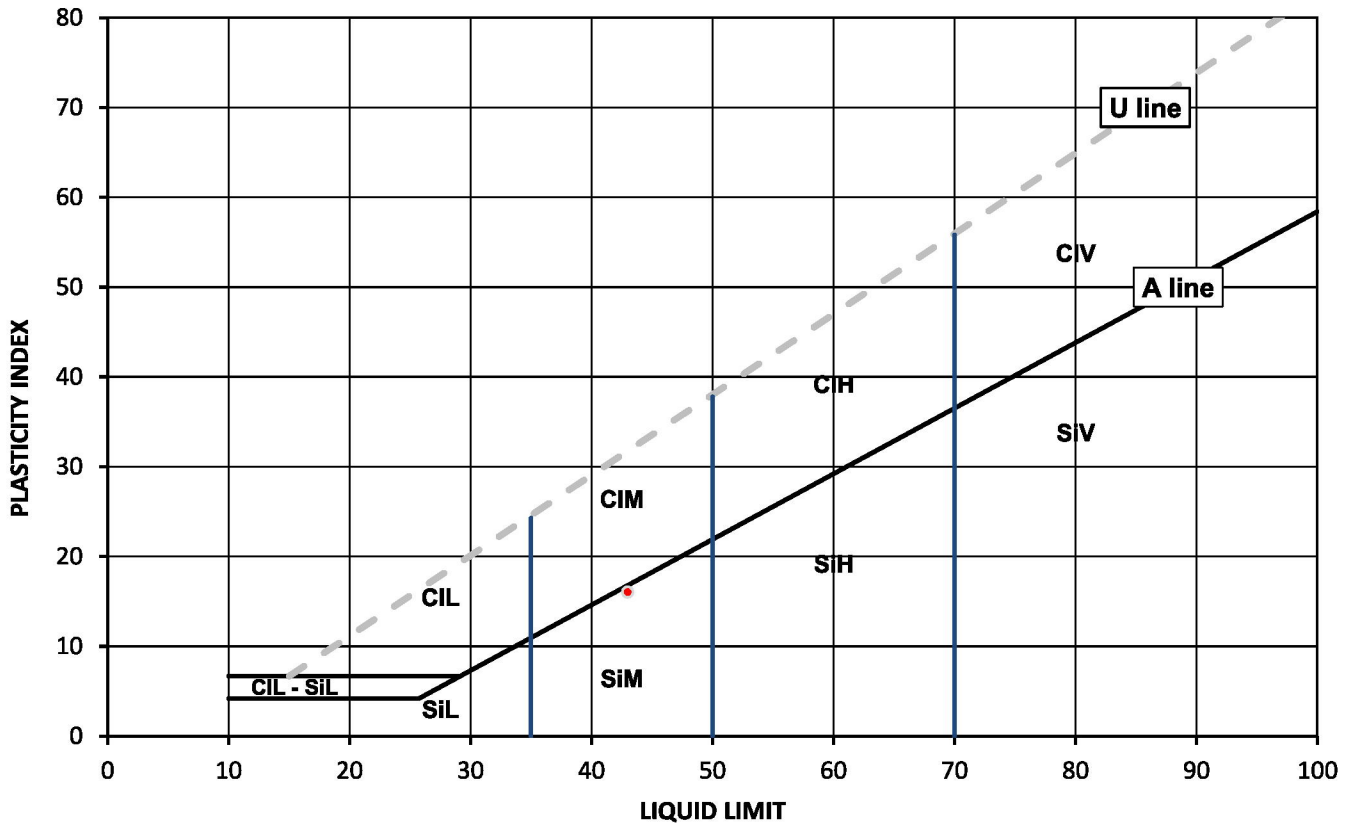
Sample Preparation: Tested in natural condition

As Received Water Content [W] %	Liquid Limit [WL] %	Plastic Limit [Wp] %	Plasticity Index [Ip] %	% Passing 425µm BS Test Sieve
22	43	27	16	100

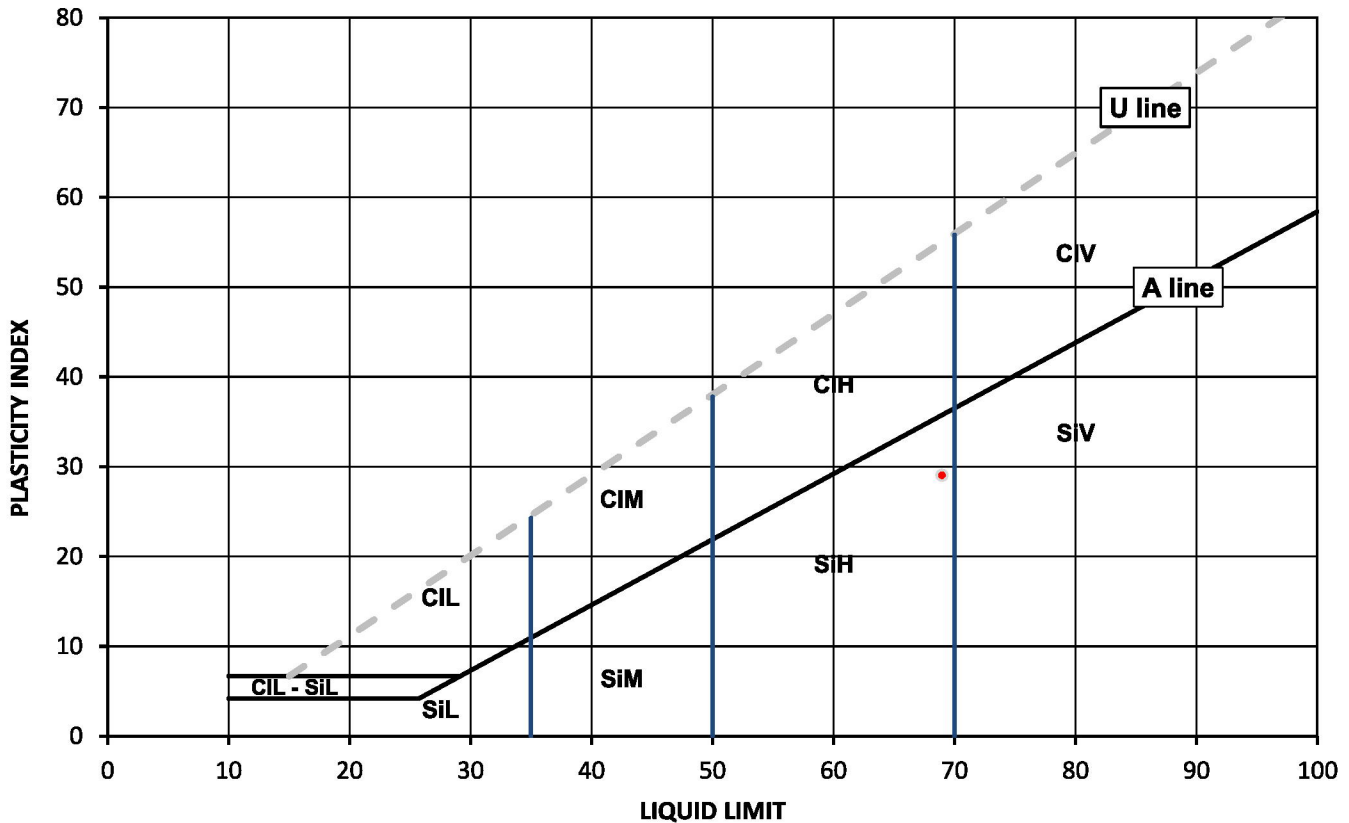
Sample Preparation: Tested after washing to remove >425um

As Received Water Content [W] %	Liquid Limit [WL] %	Plastic Limit [Wp] %	Plasticity Index [Ip] %	% Passing 425µm BS Test Sieve
38	69	40	29	79

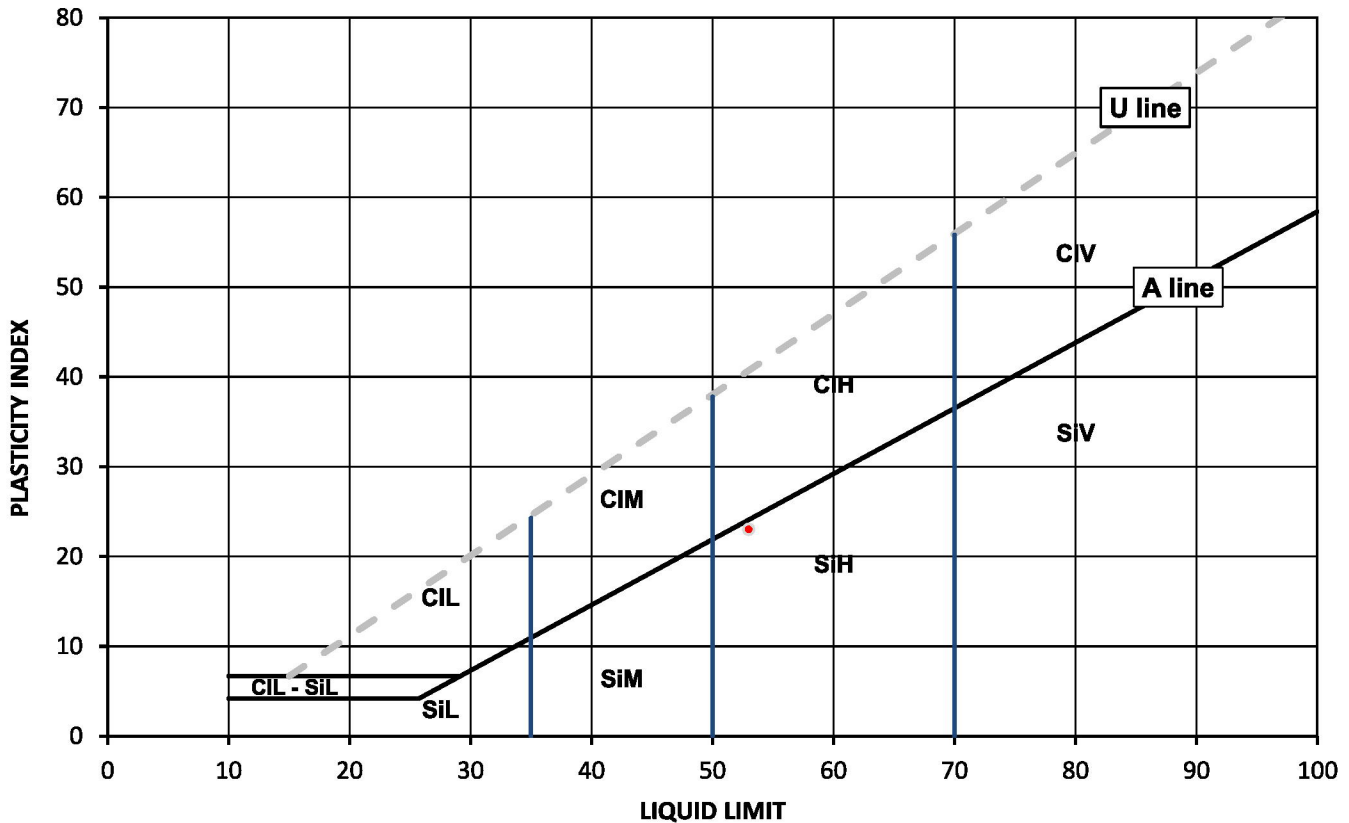
Sample Preparation: Tested after washing to remove >425um

As Received Water Content [W] %	Liquid Limit [WL] %	Plastic Limit [Wp] %	Plasticity Index [Ip] %	% Passing 425µm BS Test Sieve
37	53	30	23	52

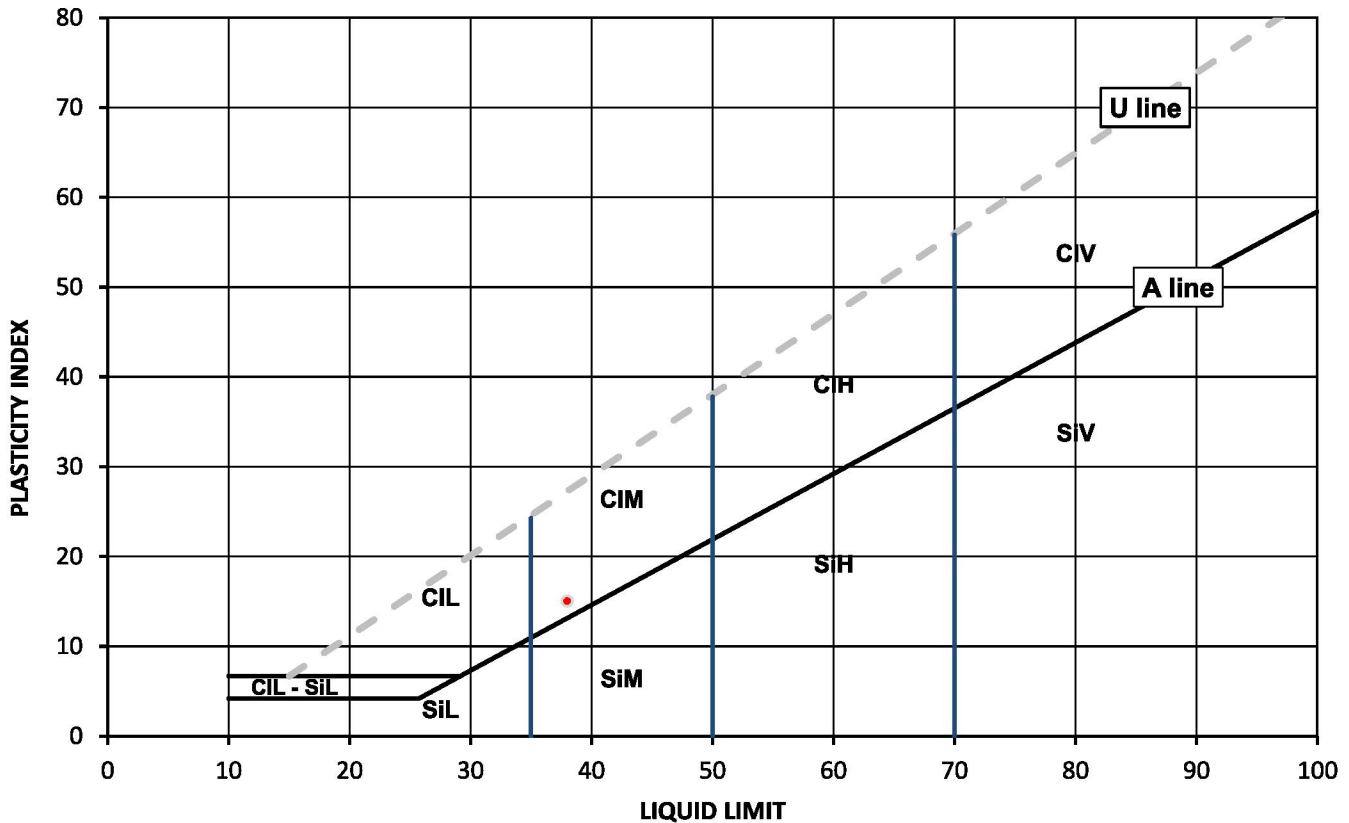
Sample Preparation: Tested after washing to remove >425um

As Received Water Content [W] %	Liquid Limit [WL] %	Plastic Limit [Wp] %	Plasticity Index [Ip] %	% Passing 425µm BS Test Sieve
24	38	23	15	72

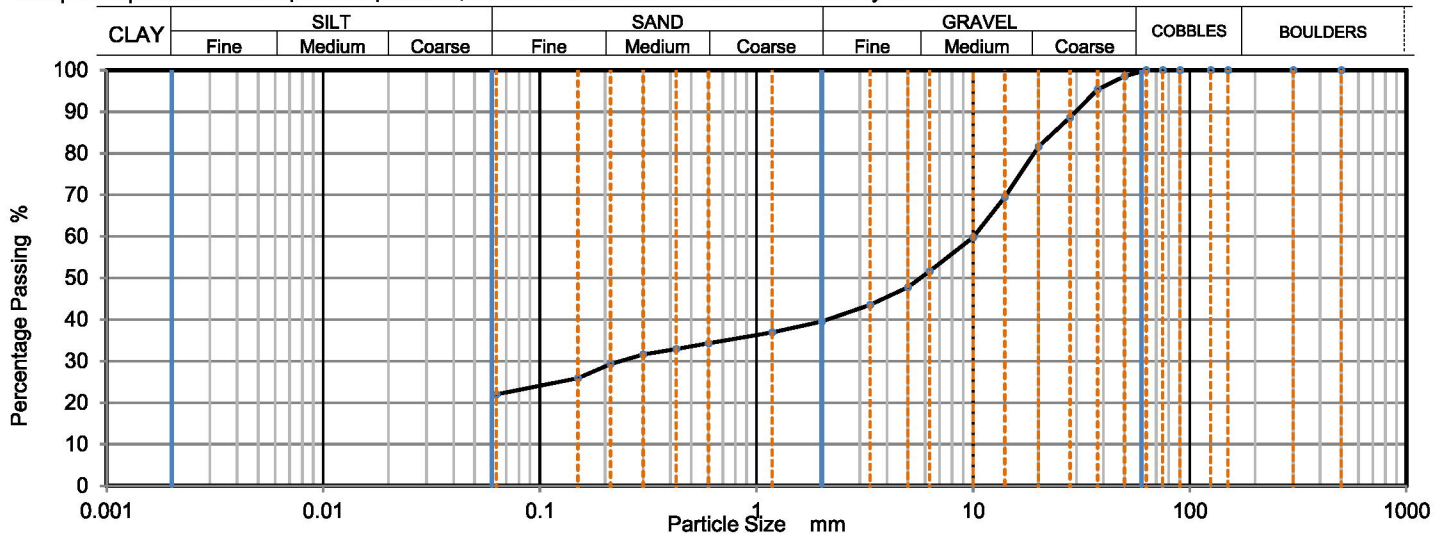
Sieving		Sedimentation	
Particle Size mm	% Passing	Particle Size mm	% Passing
500	100		
300	100		
150	100		
125	100		
90	100		
75	100		
63	100		
50	99		
37.5	95		
28	89		
20	82		
14	70		
10	60		
6.3	52		
5	48		
3.35	44		
2	40		
1.18	37		
0.6	34		
0.425	33		
0.3	32		
0.212	29		
0.15	26		
0.063	23

Sample Proportions	% dry mass
Very coarse	0
Gravel	60
Sand	17
Fines <0.063mm	23

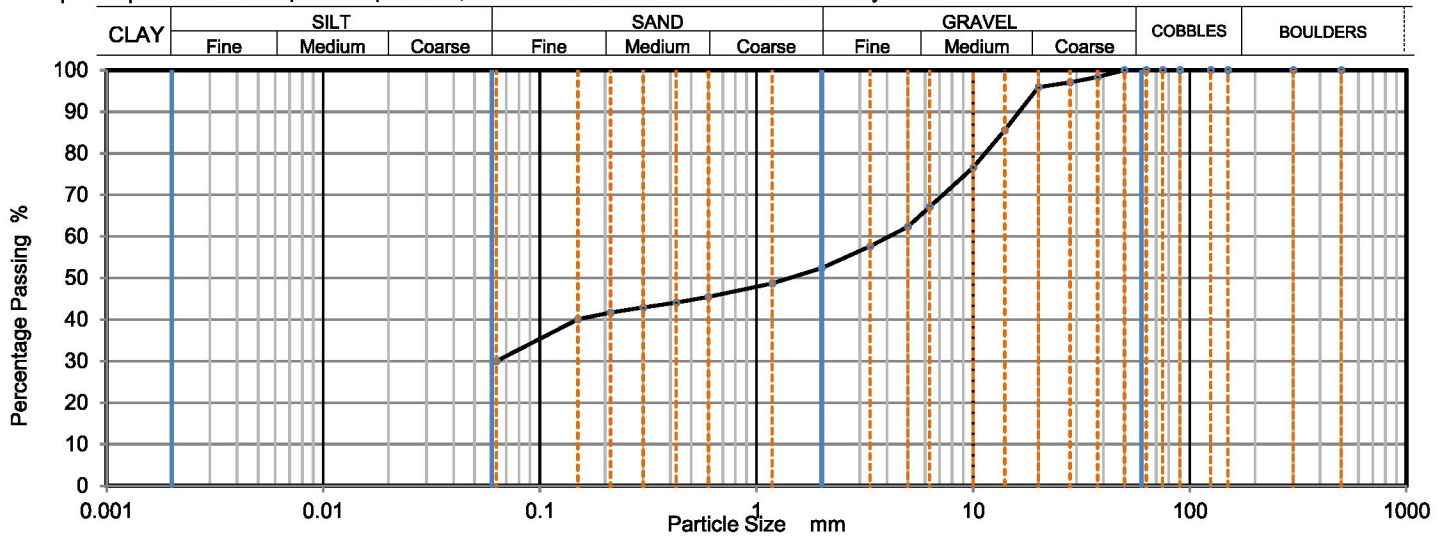
Sieving		Sedimentation	
Particle Size mm	% Passing	Particle Size mm	% Passing
500	100		
300	100		
150	100		
125	100		
90	100		
75	100		
63	100		
50	100		
37.5	98		
28	97		
20	96		
14	86		
10	77		
6.3	67		
5	62		
3.35	58		
2	52		
1.18	49		
0.6	46		
0.425	44		
0.3	43		
0.212	42		
0.15	40		
0.063	30

Sample Proportions	% dry mass
Very coarse	0
Gravel	48
Sand	22
Fines <0.063mm	30

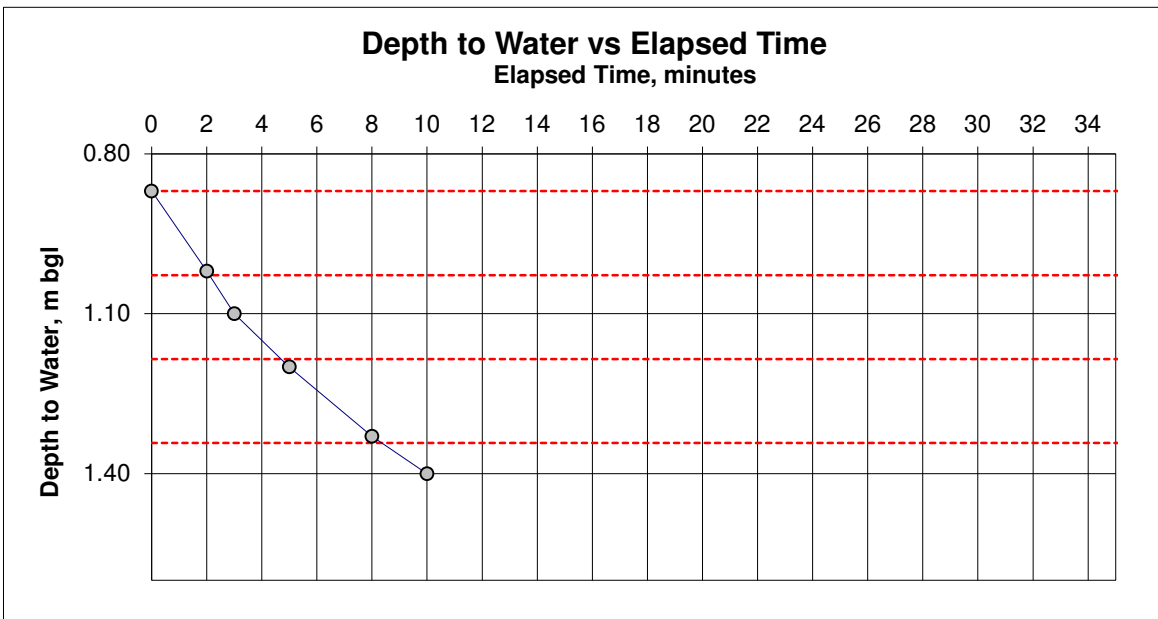
Calculated Soil Infiltration Rate =

2.8E-04 m/sec

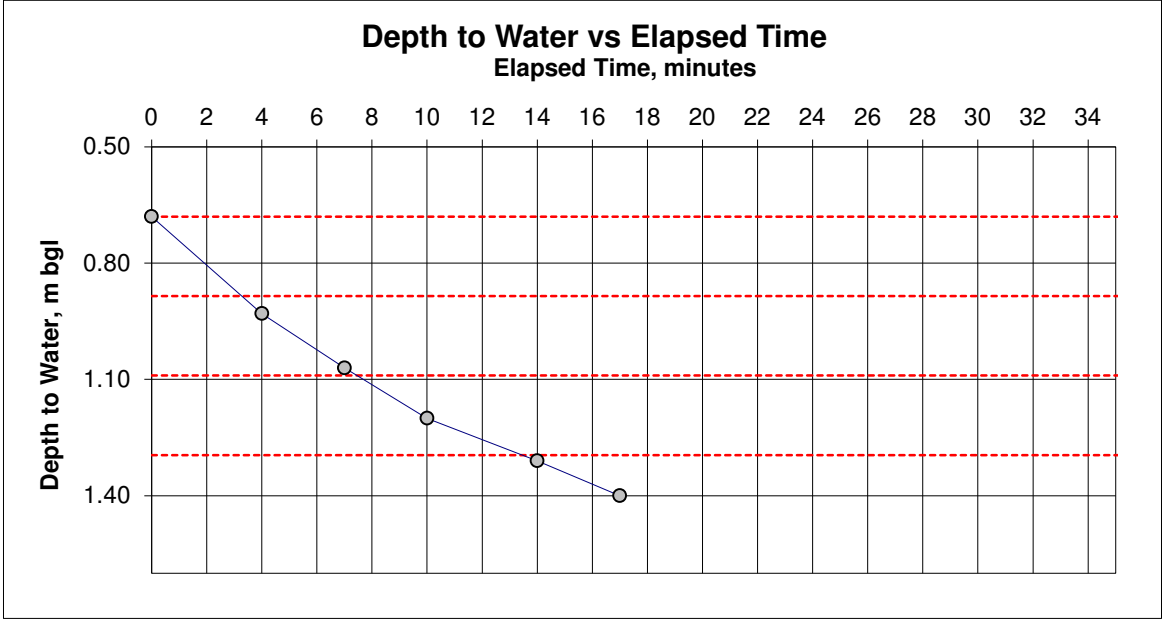
time at 75% effective depth (mins)	3.5
time at 25% effective depth (mins)	14
(from graph)

Calculated Soil Infiltration Rate = 1.8E-04 m/sec

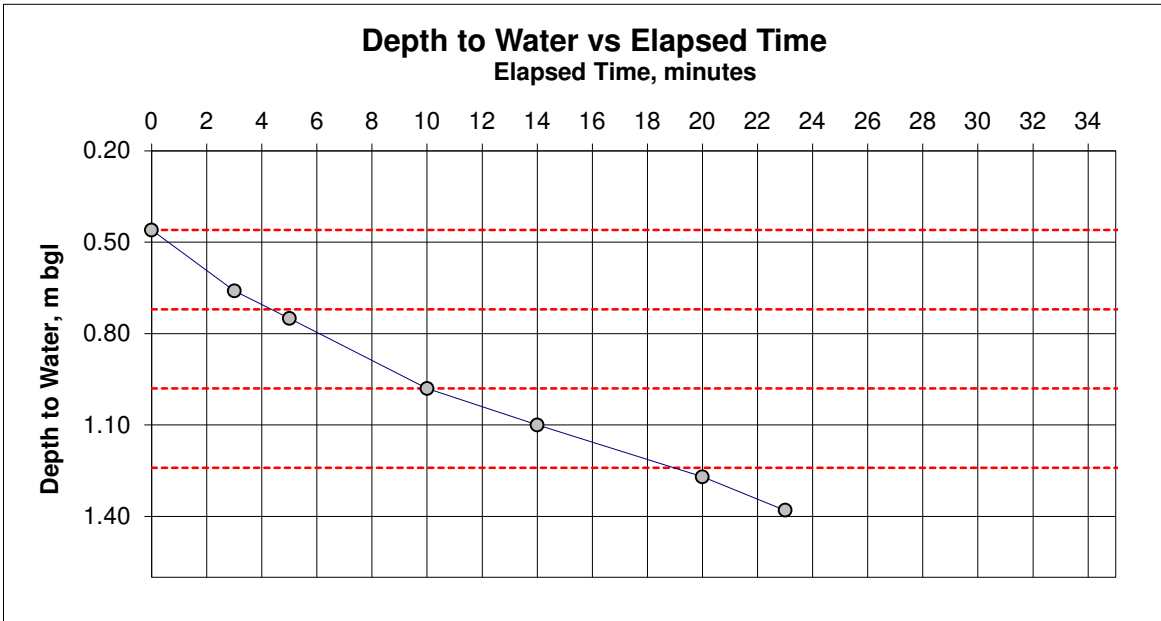
Test Location: SA1

time at 75% effective depth (mins) 4.5
time at 25% effective depth (mins) 19
(from graph)

Calculated Soil Infiltration Rate = 1.4E-04 m/sec

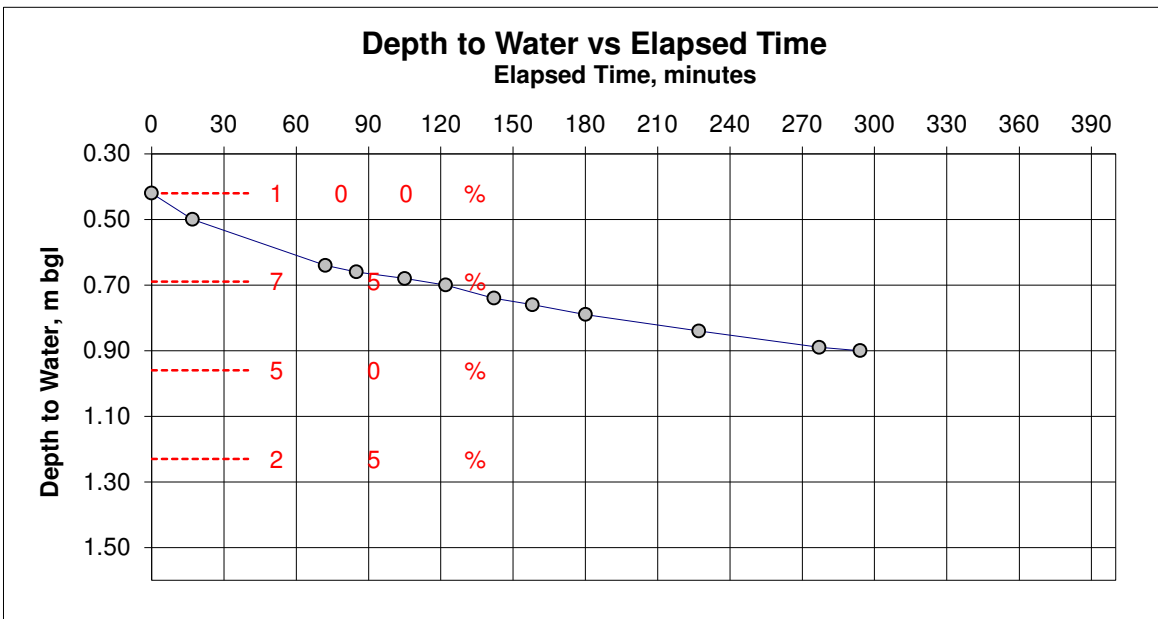
Test Location: SA2

Calculated Soil Infiltration Rate =

- m/sec

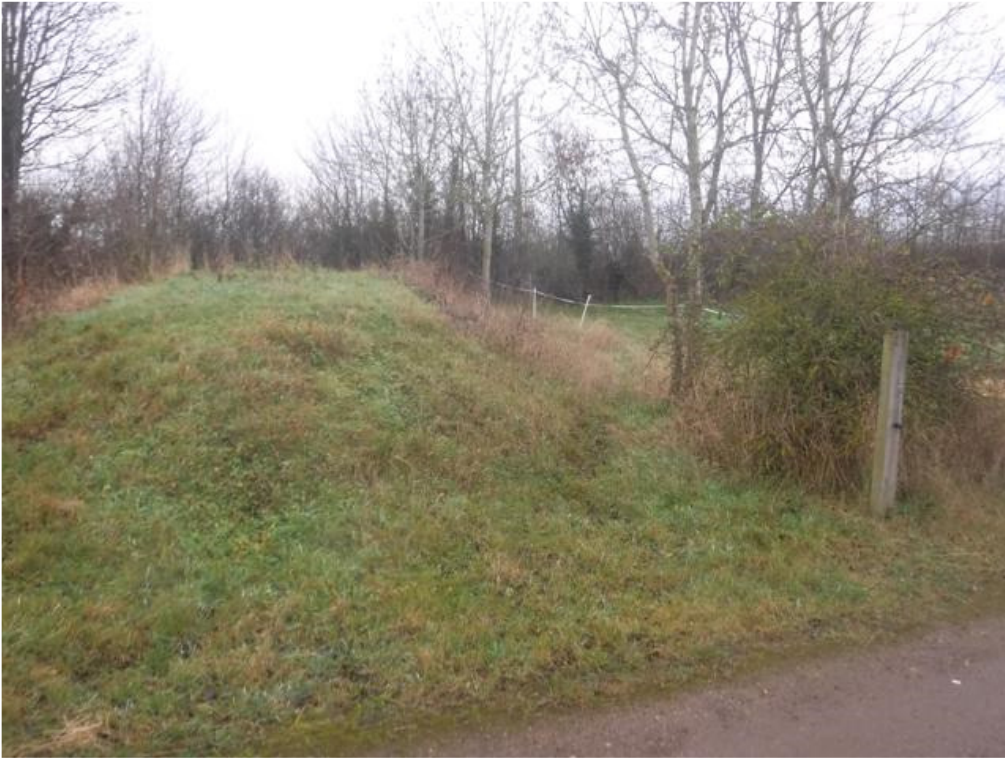
Bund immediately south of the arena.

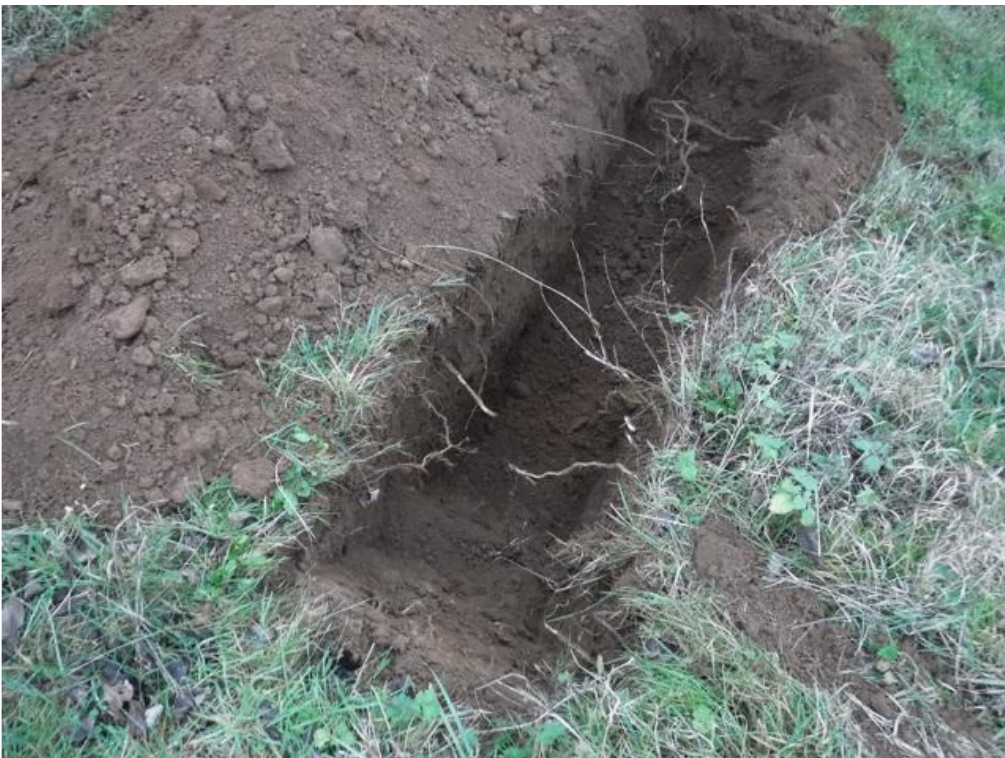
Machine excavation into the bund.

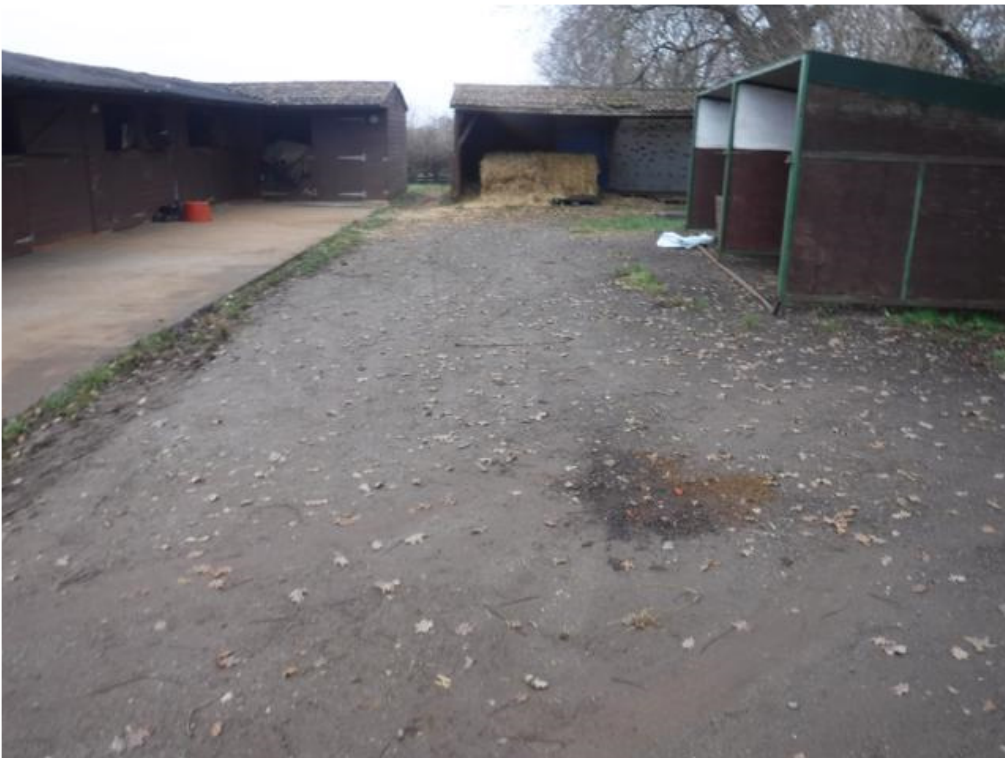
Stable Block looking Northerly. Backfilled HP3 in the foreground.

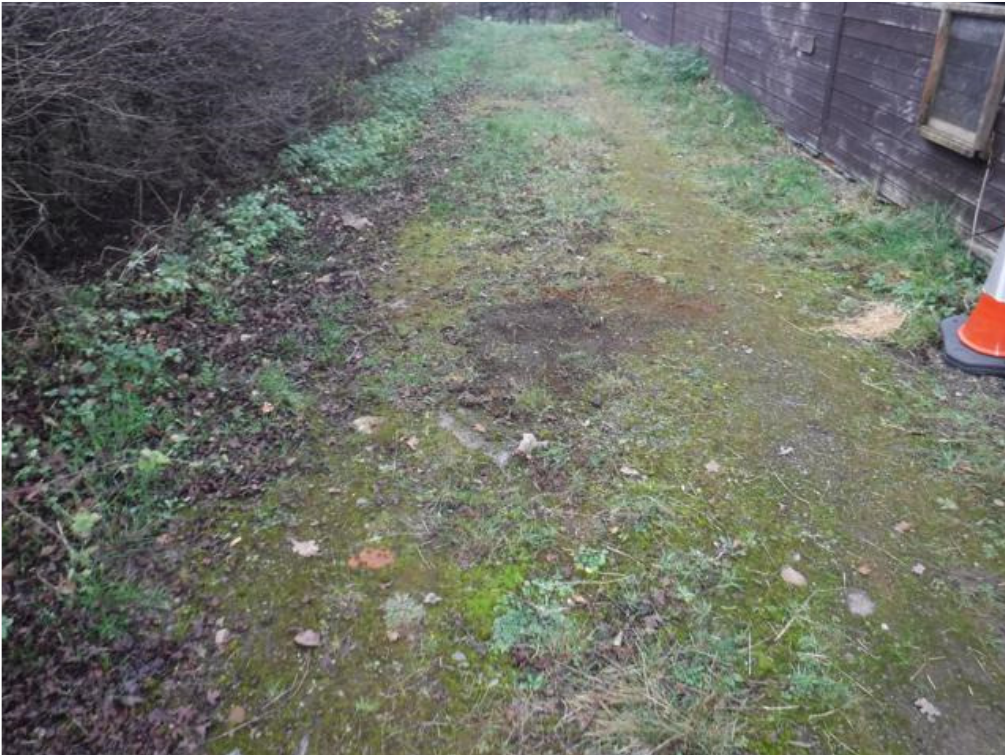
HP1 Location immediately west of the main Stable building.

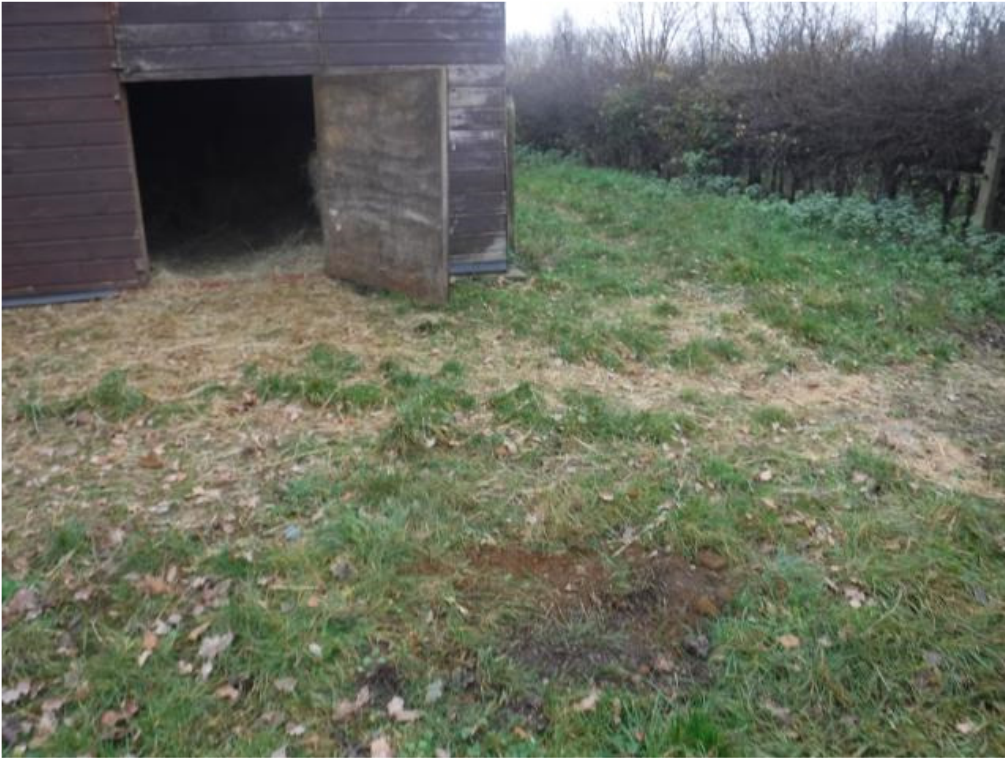
HP2 location, North of the Stable Block.

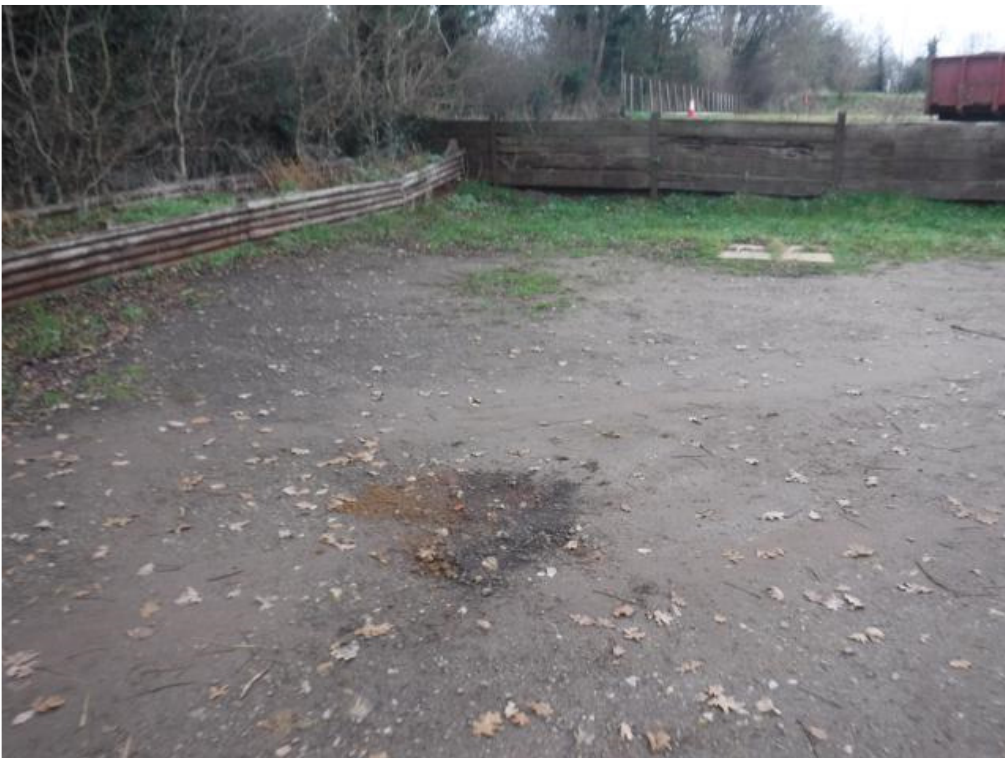
HP3 location, looking southerly.
