Proposed Care Home Development Land at Longford Park Road and Canal Lane Bodicote

Phase I Desk Study Report

Report Reference R-DS-24934-01-00

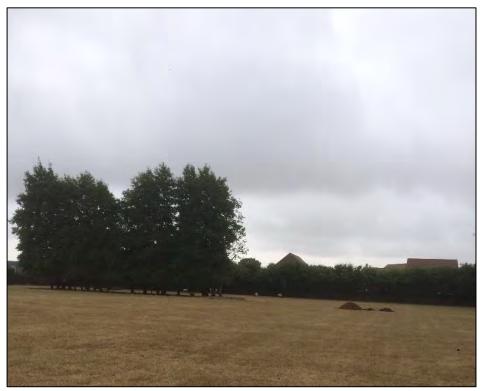
Photograph 5.1 view from the north of the site looking south showing the row of mature trees in the south of the site.

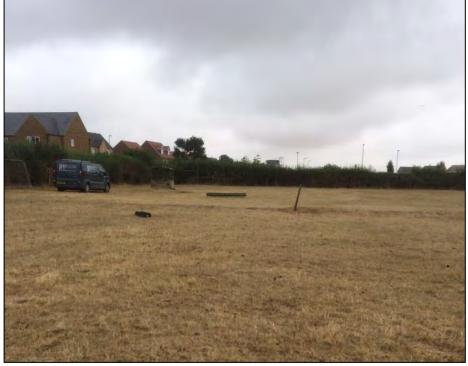
Photograph 5.2 view from the north of the site looking north east showing the grassed site with residential houses off to the north of the site.

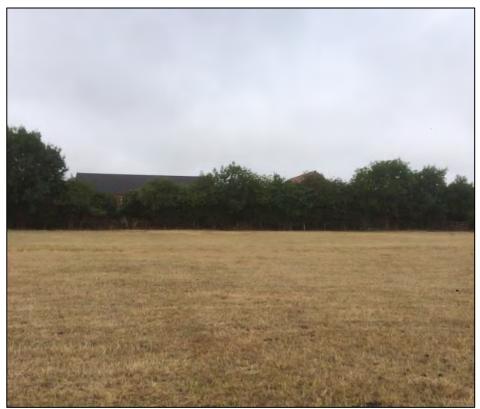
Photograph 5.3 View from the centre of the site looking south showing the grassed site with hedgerow and mature trees along the southern site boundary.

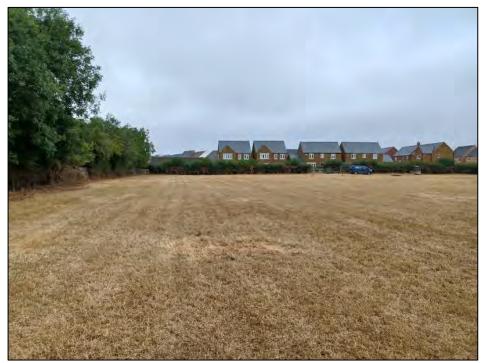
Photograph 5.4 View along the southern site boundary looking north showing the grassed site with residential houses beyond off site.
