**REPORT ON
GROUND INVESTIGATION
AT
CATALYST BICESTER,
WENDLEBURY ROAD**

Client:	Albion Land Ltd
Report Title:	Report on Ground Investigation at Catalyst Bicester, Wendlebury Road
Report Number:	AG2875A-20-AK72
Report Status:	Validated Issue 1
Date:	September 2020

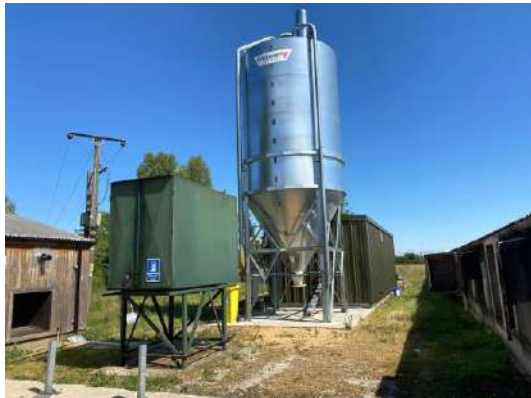
Above ground diesel tank in the west of the former chicken farm, view facing north.

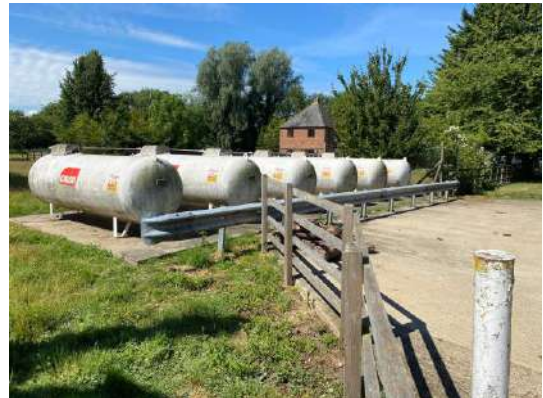
Propane gas cylinders in the west of the former chicken farm, view facing southwest.

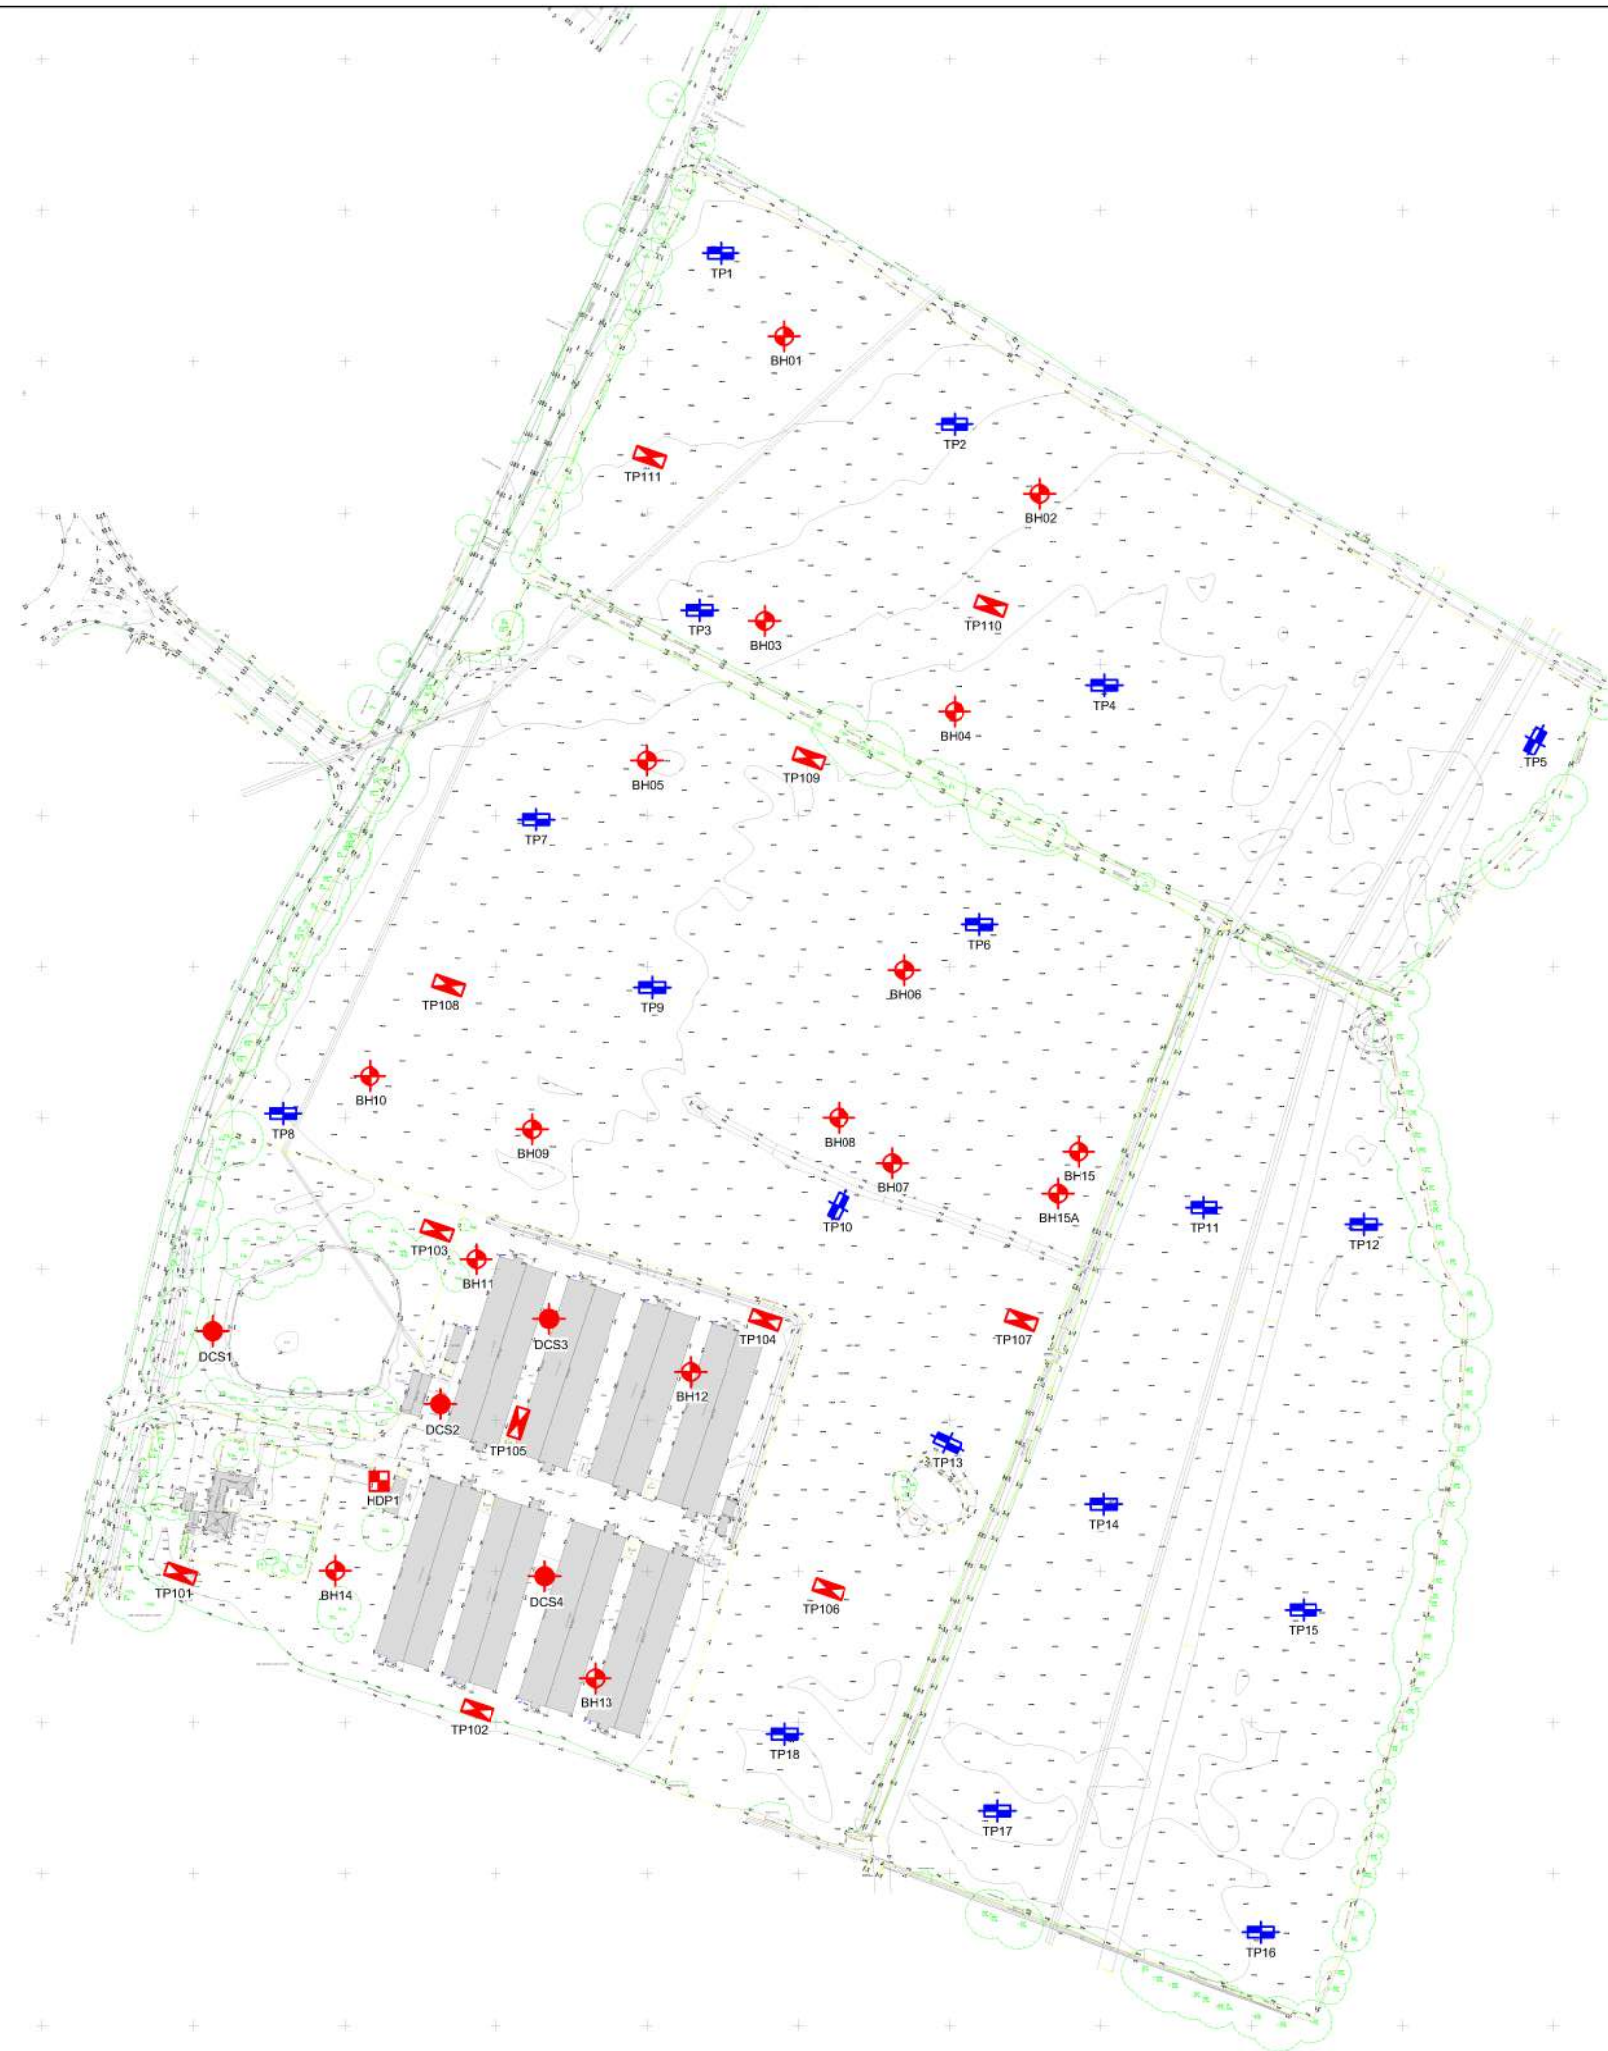
Drawing No: AG2875A-20-02	Revision: 1
---------------------------	-------------

-   Trial Pit (undertaken in 2018)
TP1
-   Trial Pit
TP101
-   Cable Percussion Borehole
BH01
-   Driven Continuous Sampling Borehole
DCS1
