TE1585-TE-00-XX-RP-GE-005-V01

Prepared for: Prepared by: J Mullen

Tritax Symmetry Ltd Tier Environmental Ltd

Stage 3 - LCRM Remediation Strategy

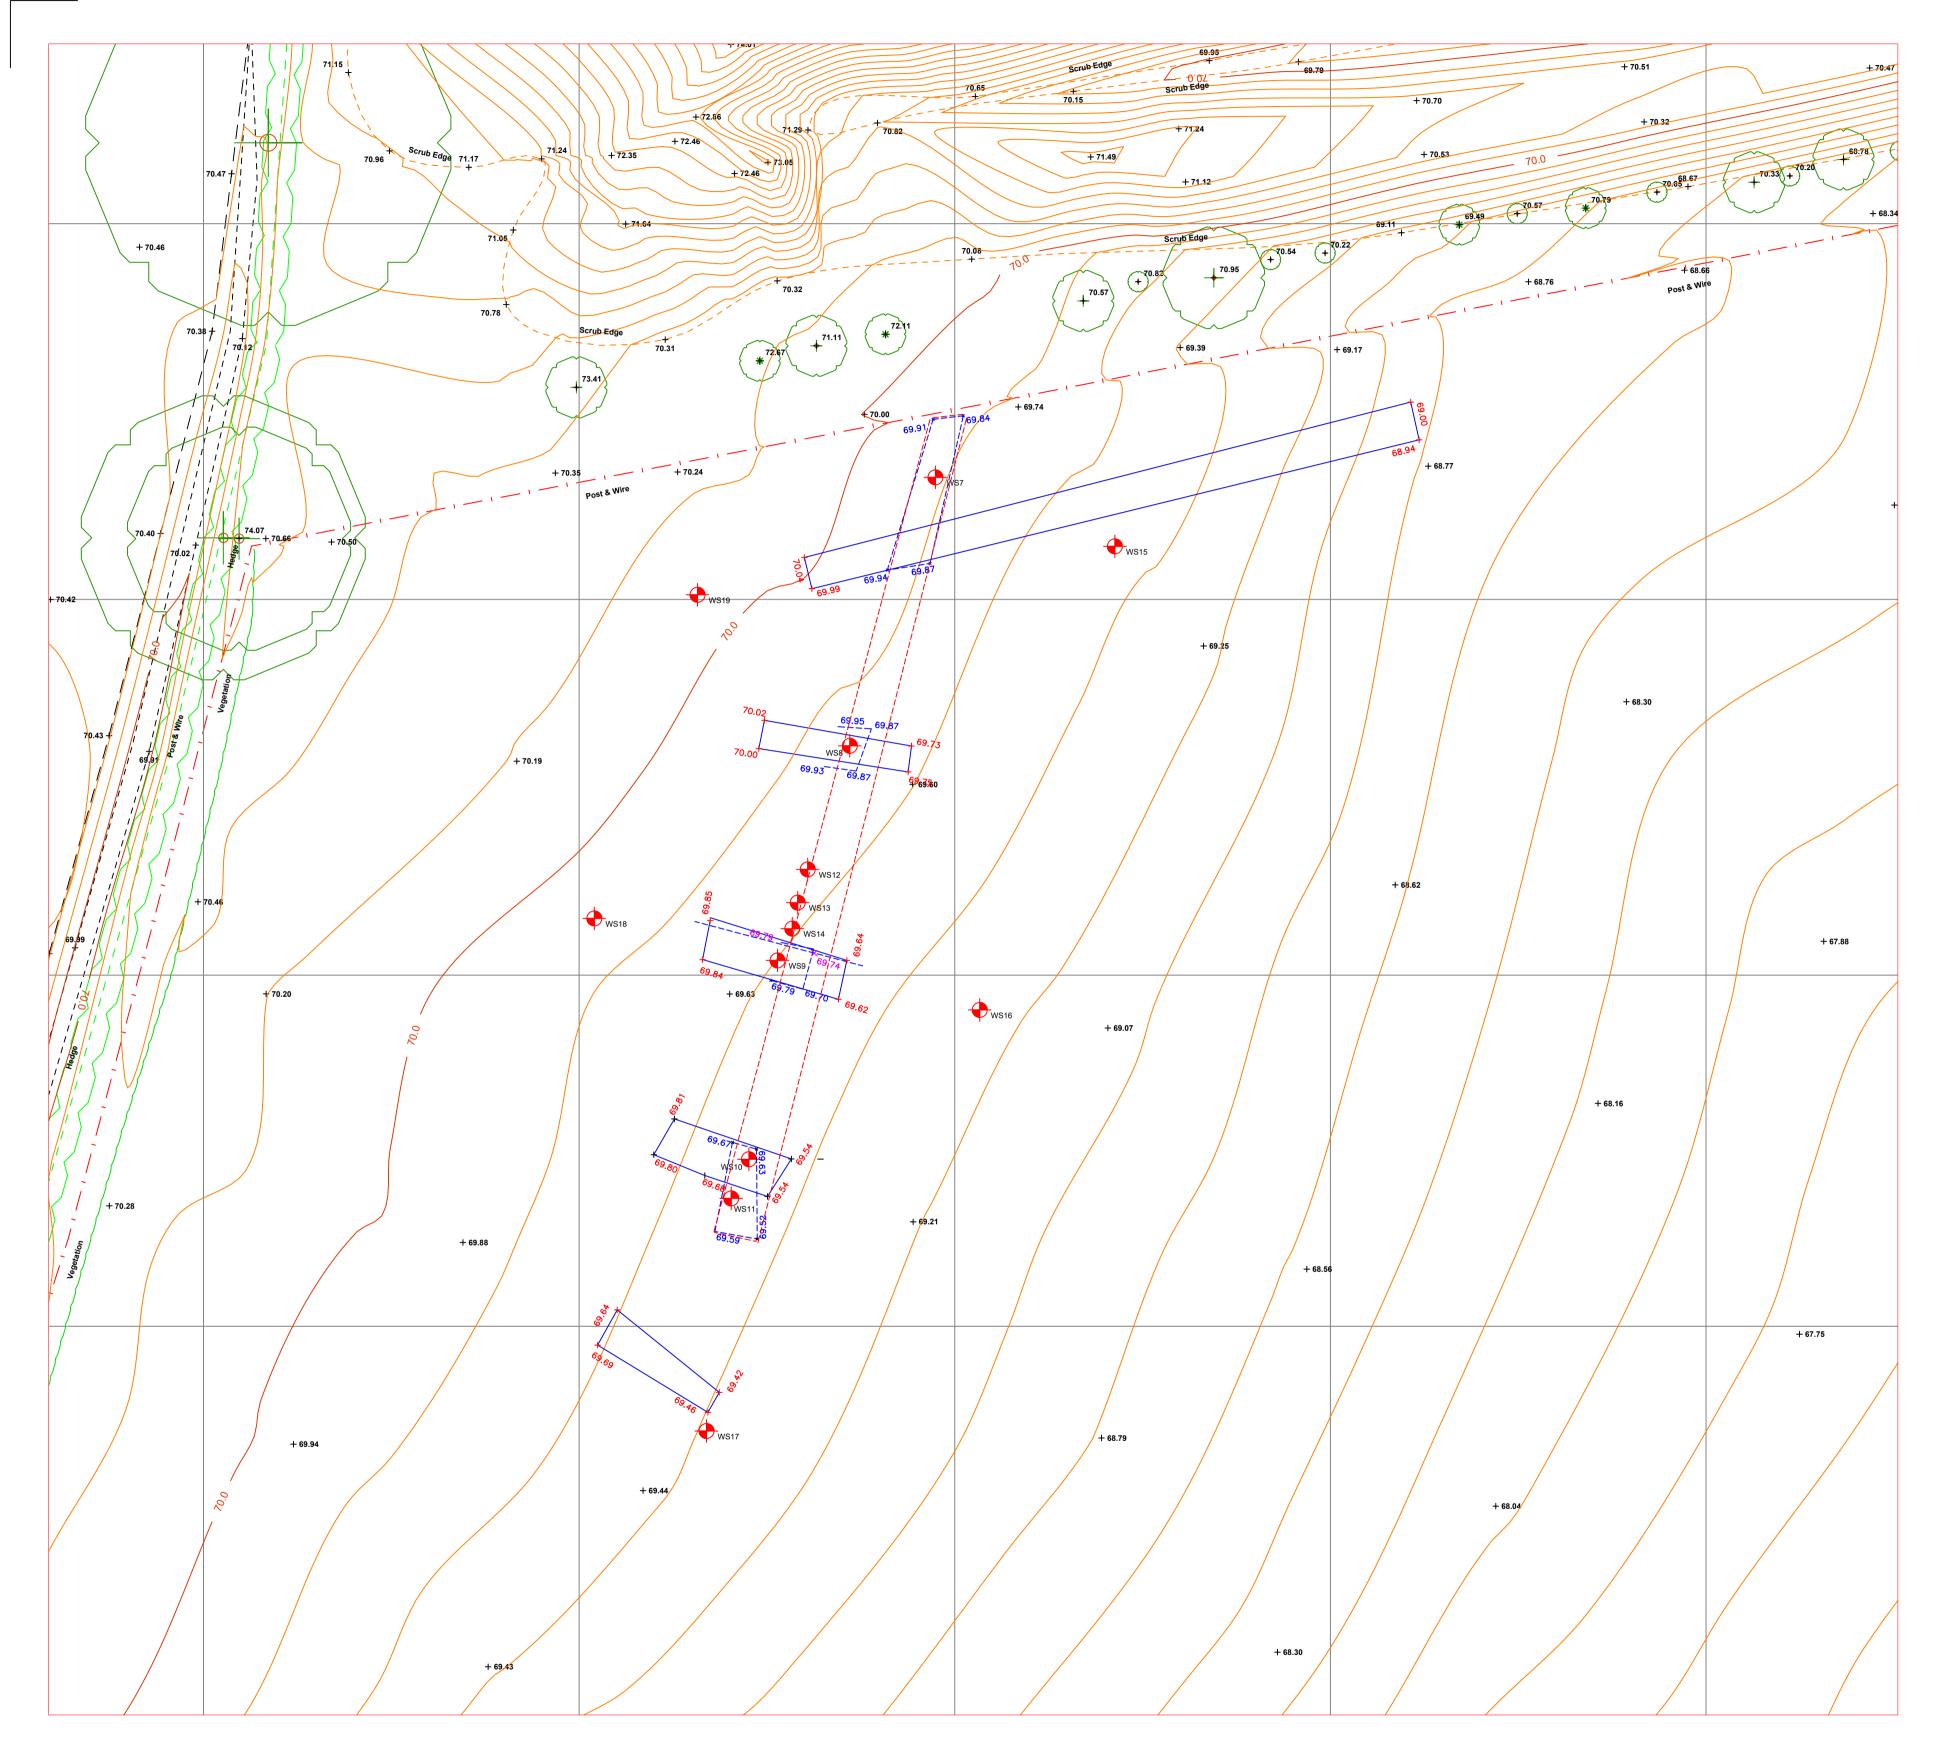
A second phase of investigation was undertaken by Tier Environmental in February 2022 in the vicinity of an historic Foot and Mouth pyre. The results of the investigation are presented in the technical note referenced in Section 1.3. Residual clinker from the pyre was recorded below topsoil and Made Ground at depths between 0.6m bgl and 1.3m bgl. The pyre material was found to cover an area of approximately 88m². The location of the Foot & Mouth pyre material is shown in Drawing TE1585-TE-00-XX-DR-GE-001 (Appendix A).
