Preliminary Ecological Appraisal

Pasteur, F & A

Cedar Lodge, Steeple Aston

Ref: 22-0480

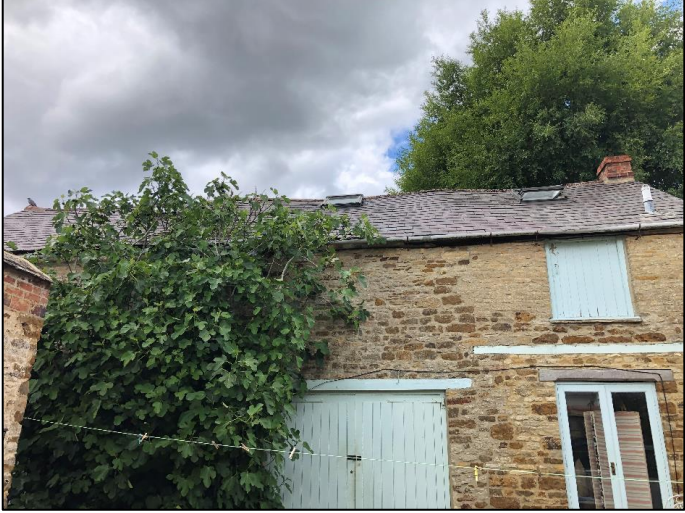
Building No.	Description	Suitability for Roosting Bats
B1	<p>External: Two storey residential annex (currently vacant) with storage room on ground floor and living quarters on first floor.</p> <p>B1’s walls were of stonework which was in good condition. A double garage door constructed from timber was present at the west of B1 and was well sealed throughout.</p> <p>The roof comprised slate tiles, stone ridge tiles and two Velux windows. Numerous gaps were present between slate tiles and ridge tiles.</p> <p>A timber soffit was present at B1’s east facing elevation. Several gaps were recorded between the soffit and adjoining stonework.</p> <p>A Fig tree <i>Ficus carica</i> 5m in height was present growing against the east facing elevation of B1.</p> <p>Potential access features for roosting bats included the following:</p> <ul style="list-style-type: none"> • Gaps between lifted slate tiles. • Gaps between warped ridge tiles. • Gaps between slate tiles and stone ridge tiles. 	High

<p data-bbox="564 875 928 898">Figure 4: East facing elevation of B1</p> <p data-bbox="373 920 472 943">Internal:</p> <p data-bbox="373 954 1118 1111">The ground floor of B1 comprised rendered stone walls which were in good condition throughout. The ceiling of the ground floor featured timber ceiling joists and a single timber hanging beam supporting exposed floorboards. The hanging beam formed a crevice within the stone wall at the north of B1.</p> <p data-bbox="373 1149 1118 1305">The 1st floor of B1 has been converted to living quarters which were well lit by Velux windows and a window within the south facing wall. No crevices were present within the stone walls and the ceiling was comprised of smooth MDF boards. Two timber purlins were adjoined to the ceiling of B1 as well as three pairs of timber rafters.</p>

- 8.8 Four buildings on Site (B1, B2, B3 and B5) were suitable for roosting bats. The features of B1 were assessed as being of High suitability for roosting bats. Brown long-eared bat droppings were found in B1’s 1st storey, therefore this species is known to use B1 as a roost.

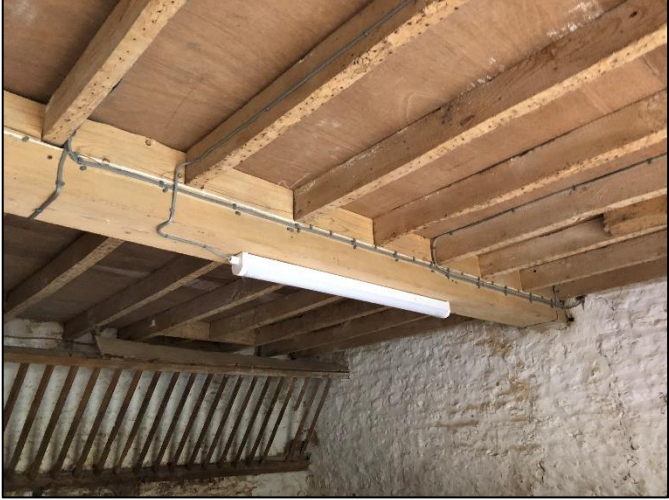
<p data-bbox="560 1852 933 1874">Figure 5: Ceiling and north wall of B1</p>

Building No.	Description	Suitability for Roosting Bats
	  <p data-bbox="555 786 938 813">Figure 6: 1st floor of B1, looking south</p> <p data-bbox="371 864 564 891">Evidence of bats:</p> <p data-bbox="371 898 1121 1055">Numerous droppings were found on the first floor of the building which were indicative of either brown long-eared bat; this was later confirmed by DNA analysis of the droppings. Two pairs of butterfly and moth wings (likely feeding remains) were found within B1's ground floor and three pairs were found within the 1st floor.</p>   <p data-bbox="539 1615 954 1641">Figure 7: Brown long-eared bat dropping</p> <p data-bbox="371 1659 572 1686">Evidence of birds:</p> <p data-bbox="371 1693 440 1720">None.</p>	
B2	<p data-bbox="371 1727 478 1753">External:</p> <p data-bbox="371 1760 1121 1854">Single-storey former stable now used for domestic storage. B2's walls comprised stonework with two timber stable doors and a single timber vent.</p> <p data-bbox="371 1888 1121 1915">The pitched roof of B2 was comprised of clay tiles in good condition.</p> <p data-bbox="371 1951 1086 1977">Potential access features for roosting bats included the following:</p>	Moderate

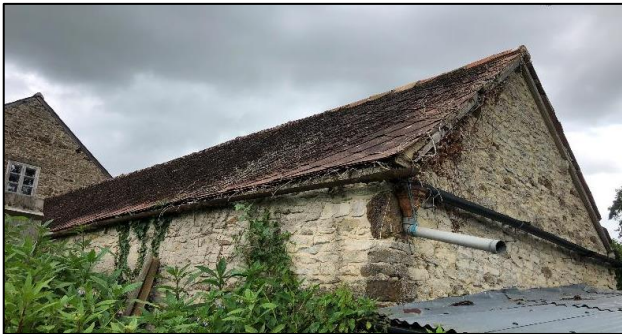
Building No.	Description	Suitability for Roosting Bats
	<ul style="list-style-type: none"> • Gaps between stable doors. • Cracks at top of external stonewall. • Gaps within timber vent. • Gaps within timber eaves. • Gaps between roof tiles and stonewall.   <p>Figure 8: Gap between stable doors at east facing elevation</p>

<p>Figure 9: Southwest elevation of B2</p> <p>Internal:</p> <p>The ground level of B2 featured two rooms used for domestic storage. The internal wall separating the two rooms was comprised of timber boards whilst the remaining walls were comprised of rendered stonework. The internal stonework was in good condition, however a substantial gap at the top of the wall was present within the southern room.</p> <p>A shallow loft space with a floor to ridge height of approximately 1.5m in height was accessed via a hatch at the north of B2. The structure of the void was formed by two vertical timber beams, a timber ridge beam, two timber purlins and numerous timber rafters.</p> <p>The roof of B2 was unlined and several gaps between clay tiles were made visible by daylight entering the void. Numerous gaps were also recorded at the north apex of the void where B2 adjoined B1's stone wall. Despite gaps between tiles and at the north apex of the void, B2's void was dark and no draughts were felt.</p>

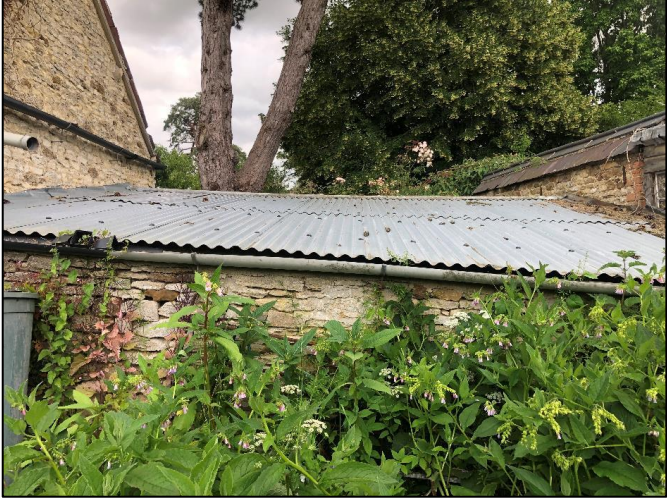
<p data-bbox="555 779 940 808">Figure 12: West facing elevation of B3</p> <p data-bbox="373 824 564 853">Evidence of bats: None.</p> <p data-bbox="373 891 572 920">Evidence of birds: None.</p>	
<p data-bbox="204 958 240 987">B4</p>	<p data-bbox="373 958 475 987">External: Single storey former bathhouse. B4’s north, east and west walls were of stone construction. The stone walls were in good condition and no gaps suitable for roosting bats were recorded. The south wall of B4 was comprised of glass panels between timber frames.</p> <p data-bbox="373 1151 1118 1211">The roof of B4 was also comprised of glass panels between timber frames and featured no gaps.</p> <p data-bbox="373 1249 472 1279">Internal: The stone walls inside B4 were in good condition and no gaps were recorded. The glass roof allowed for substantial light spill within all areas of B4.</p>

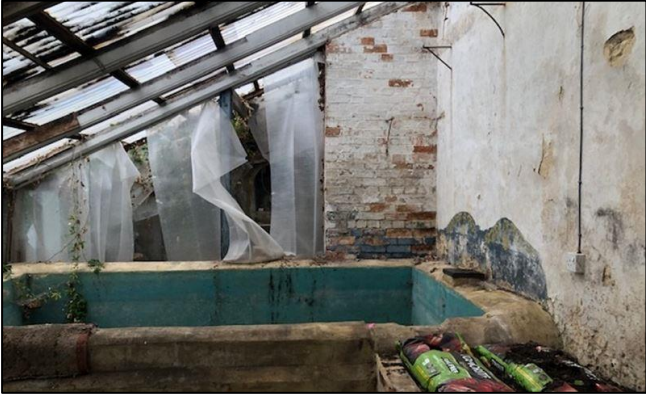
<p data-bbox="603 1805 892 1834">Figure 13: East section of B4</p> <p data-bbox="373 1883 564 1912">Evidence of bats: None.</p> <p data-bbox="373 1951 572 1980">Evidence of birds: None.</p>	<p data-bbox="1145 958 1259 987">Negligible</p>

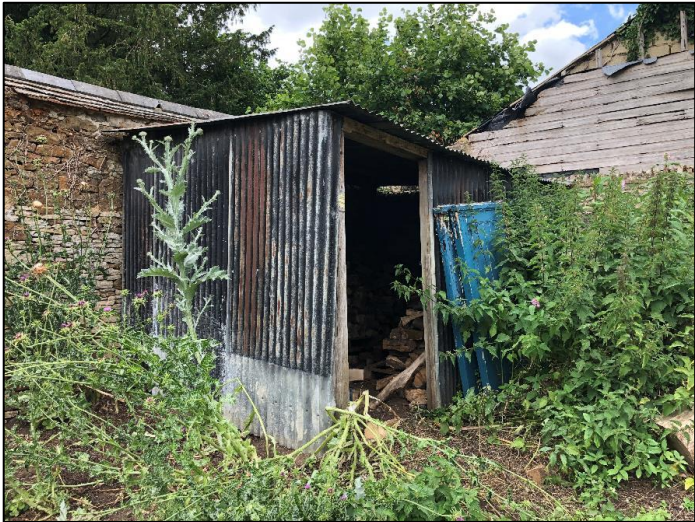
Building No.	Description	Suitability for Roosting Bats
	<p>Timber storage lean-to approximately 2m in height. Comprised of corrugated metal walls at the east and south, adjoined to stone walls which formed B5's west and north elevations. The roof of B5 was flat and of corrugated metal construction. No external features suitable for roosting bats were identified.</p>

<p>Figure 14: Southeast elevation of B5</p> <p>Internal: B5 was used for timber storage and was subject to substantial light spill via gaps between corrugated metal sheeting. Five gaps approximately 5cm wide between stonework at the west wall of B5 were present. The gaps were approximately 10cm in depth and were suitable for hibernating bats.</p>

- 10.19 B5's stone wall is of Moderate suitability to roosting bats. However, works to B5 will not directly impact any potential roosting features. Although no further survey work at B5 is recommended, works should take place outside of the bat hibernation period (October-March) as a precaution.

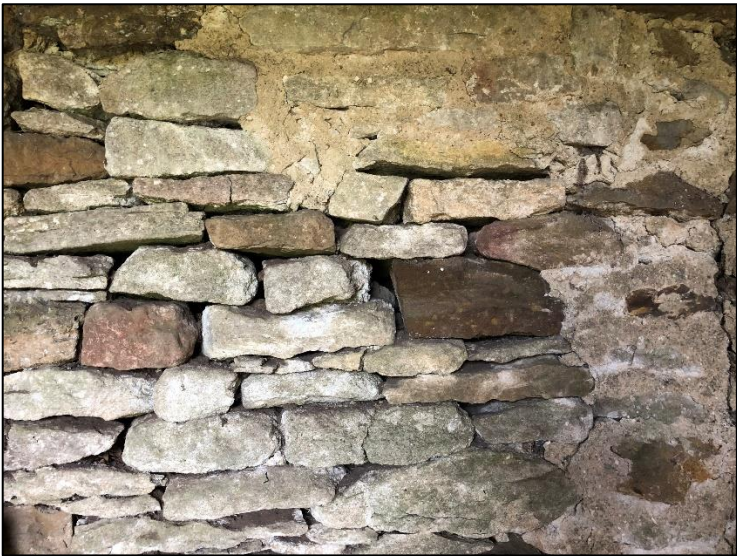
<p>Figure 15: Gaps between B5's stone wall</p> <p>Evidence of bats: None.</p> <p>Evidence of birds: None.</p>

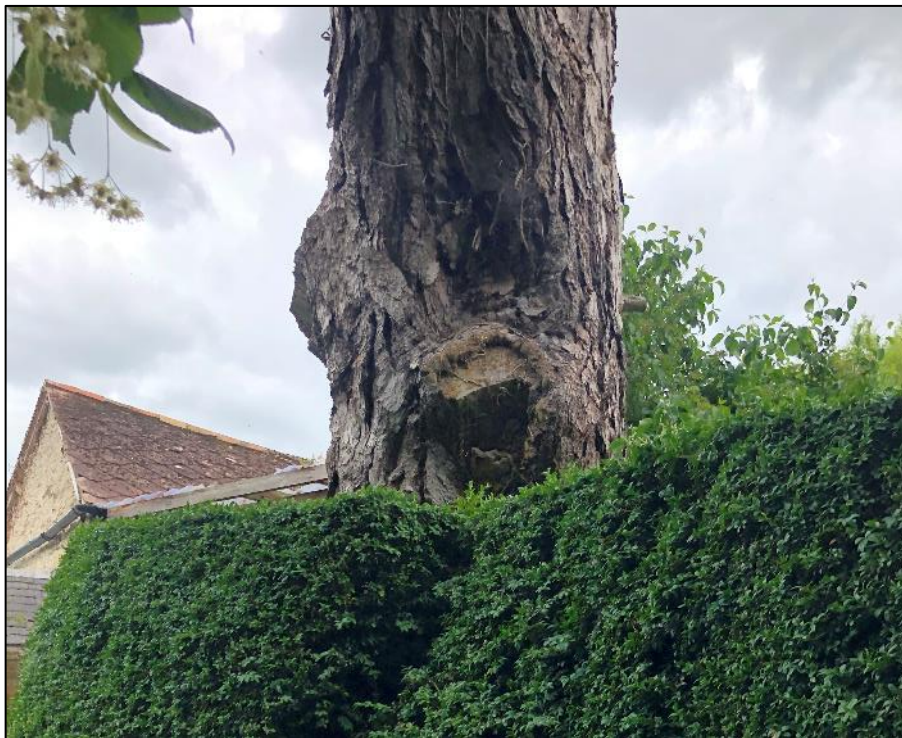
- 6.22 Numerous scattered trees were present throughout the Site.
- 6.23 Species present included horse chestnut *Aesculus hippocastanum*, hazel *Corylus avellana*, hawthorn *Crataegus monogyna*, common lime *Tilia x europaea*, maple *Acer* sp., apple *Malus domestica*, beech *Fagus sylvatica*, crack willow *Salix x fragilis*, ash *Fraxinus excelsior*, atlas cedar *Cedrus atlantica* and holly *Ilex aquifolium*.
- 6.24 A single pine *Pinus* tree (T1) was identified as being of Low suitability for roosting bats. A rot hole was present at the south facing elevation of T1 approximately 2.5m above ground level.
- 6.25 This habitat was of 'Low 'ecological value.

Figure 19: Rot hole at T1's south facing elevation

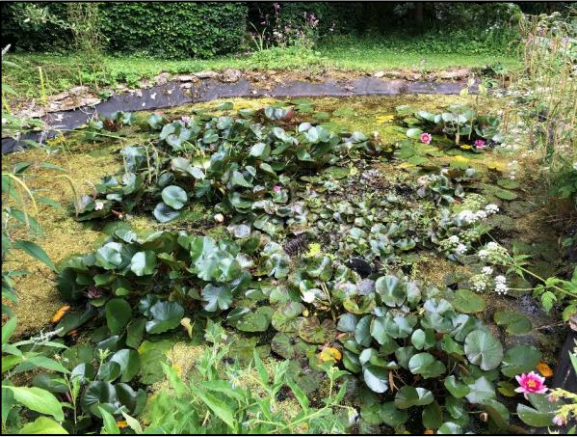
Table 6: Descriptions of waterbodies surveyed within the Site Pond No.	Description	HSI Score
P1	<p>Small circular pond lined with butyl containing ornamental aquatic species such as water lily <i>Nymphaeacea</i>. P1's water was approximately 30cm in depth at its deepest point.</p>

<p>Figure 20: P1, looking east</p>	0.66 Average
P2	<p>Narrow, rectangular pond dominated by duckweed <i>Lemnoideae sp.</i> The south bank of P2 was dominated by pendulous sedge <i>Carex pendula</i>. P2 was connected to a small spring fed stream.</p>

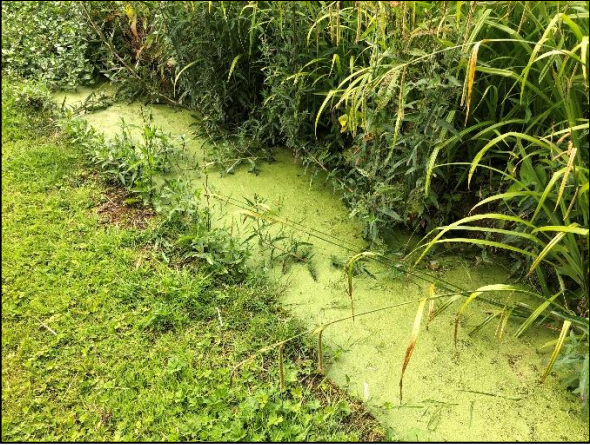
<p>Figure 21: P2, looking southeast</p>	0.66 Average

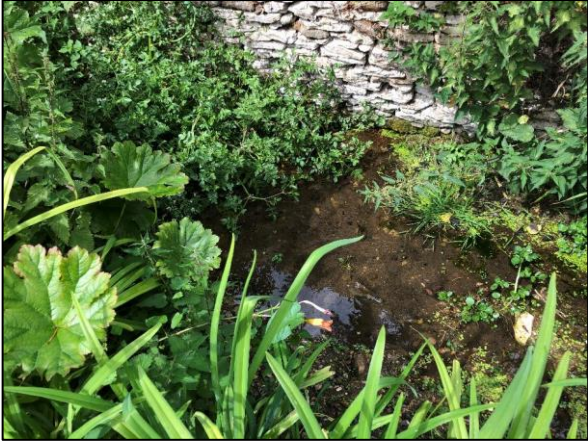
Table 6: Descriptions of waterbodies surveyed within the Site Pond No.	Description	HSI Score
P3	<p>Ornamental linear pond which was unlined and mostly dry at the time of assessment with a depth of approximately 10cm at its east extent. Most of the pond was choked with encroaching introduced shrub species.</p>

<p>Figure 22: East extent of P3, looking north</p>	<p>0.53 Below Average</p>
P4	<p>Medium sized rectangular pond bound by a lined of mature scattered trees to the south and west and marginal aquatic species to the north. Himalayan balsam <i>Impatiens glandulifera</i> was abundant at the north bank of the pond. Himalayan Balsam is an invasive species in the UK and it is illegal to facilitate its spread into adjacent land under the Wildlife and Countryside Act 1981. P4' water was approximately 50cm in depth at its deepest point.</p>

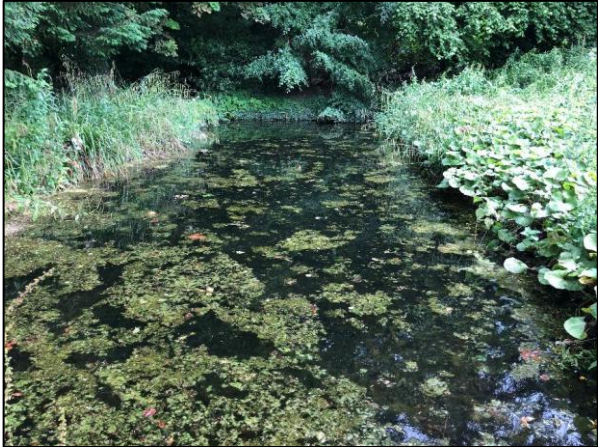
<p>Figure 23: P4, looking west</p>	<p>0.75 Good</p>

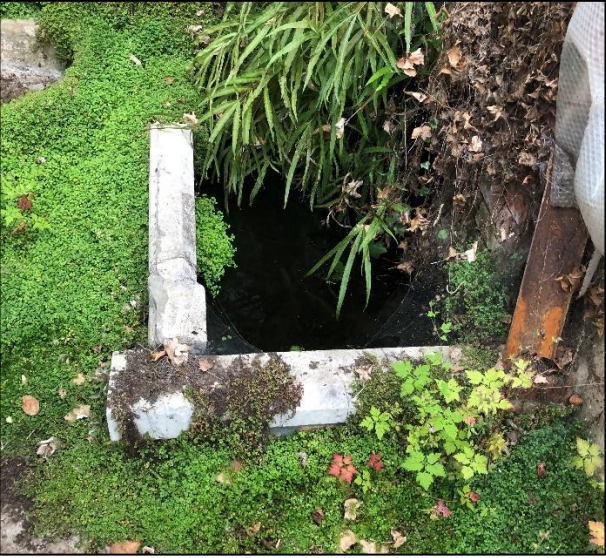
<p>Figure 25: P6</p>	<p>0.31 Poor</p>
