Arboricultural Impacts and Method Statement 01

New Barn Farm, Sibford Gower, OX15 5RY

Prepared by: Philip Bridger, TechArborA, PTI

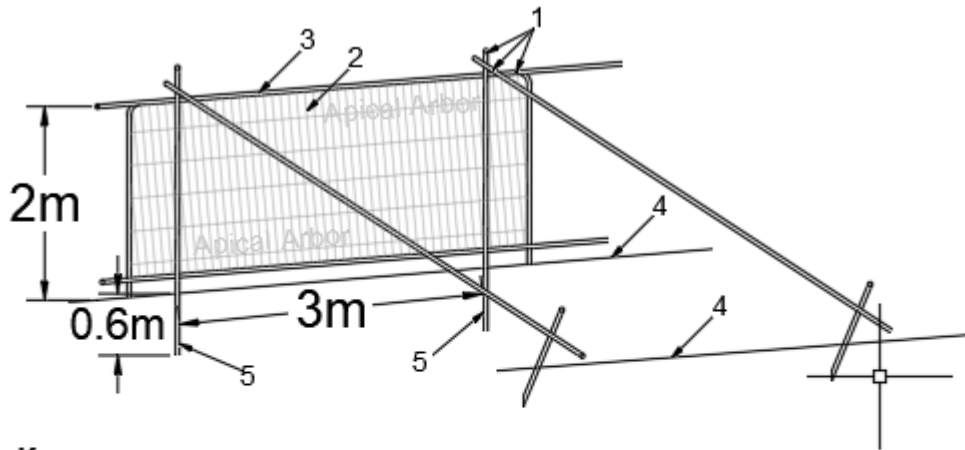
Key

- 1 Standard Scaffold poles
- 2 Heavy Gauge 2m tall, galvanized tube and welded mesh infill panels
- 3 Panels secured to uprights and cross members with wire ties
- 4 Ground level
- 5 Uprights driven into the ground until secure (min. 0.6m)
- 6 Standard Scaffold clamps

9.1 Tree protection fencing should be installed prior to development, along the bold blue line, indicated on the associated Tree Protection Plan (AA TPP 03).

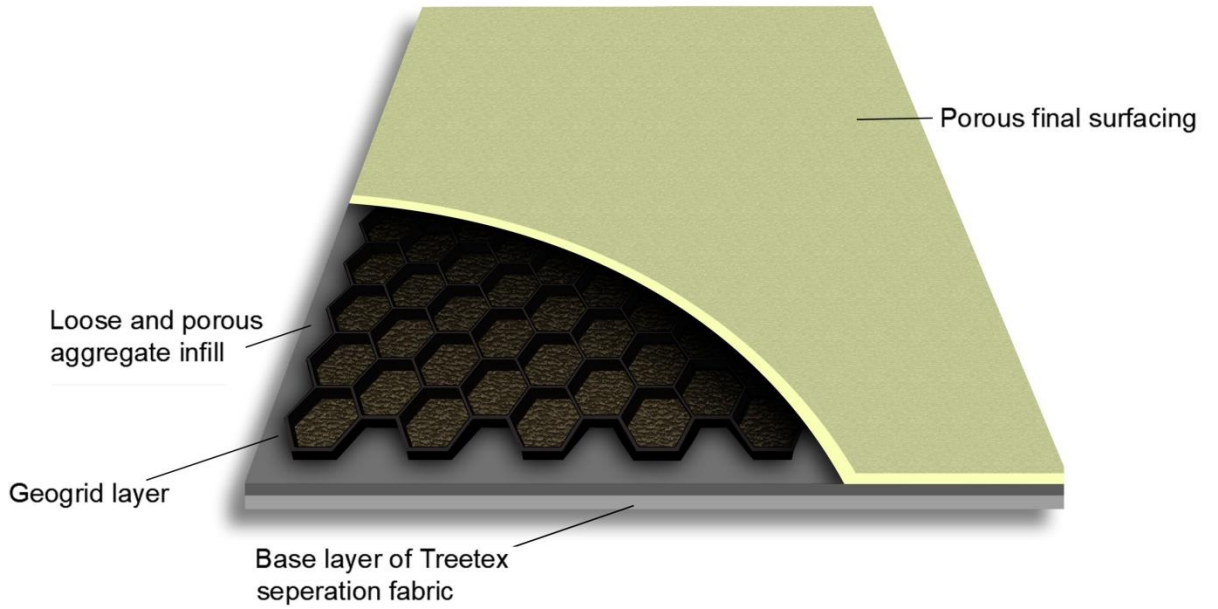
11.1 Above soil surface should be installed where the pink honeycomb hatch is shown on the associated Tree Protection Plans.

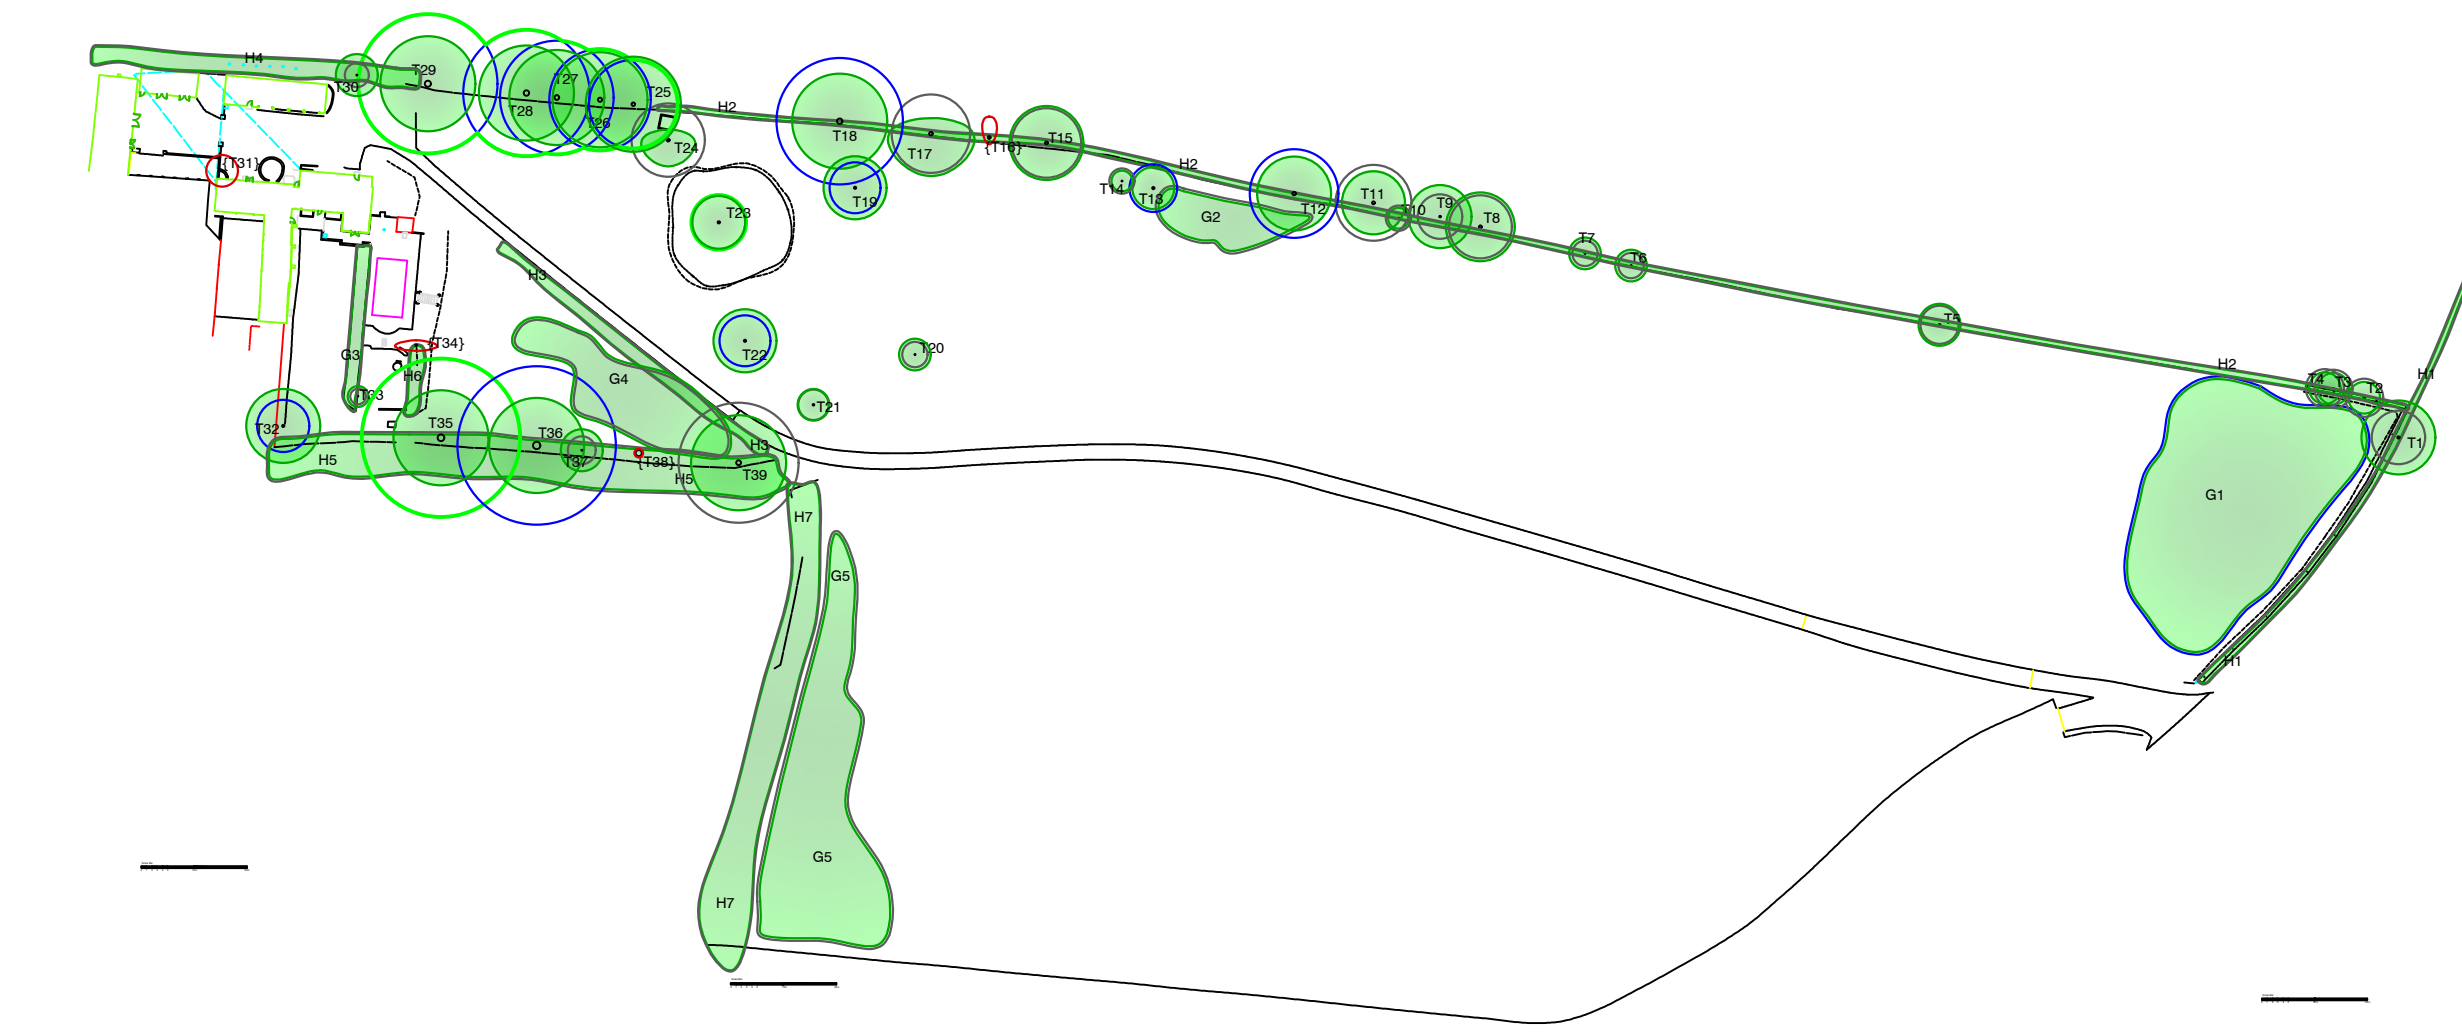
Based On: 003 - Proposed Site Plan
Title: Arboricultural Impacts Assessment
Drawing No: AA AIA 01
Date: 21.12.22 | Drawn: PPDB | Checked: PPDB

H3 will impact the views from the new property, since partial removal will be required, consider removing all the hedge to open views and create space for adjacent orchard trees.

Proposed vegetable patch should be created on top of the existing soil surface, allowing moisture and geaous exchange within the roots of Cat. 'A' Tree.

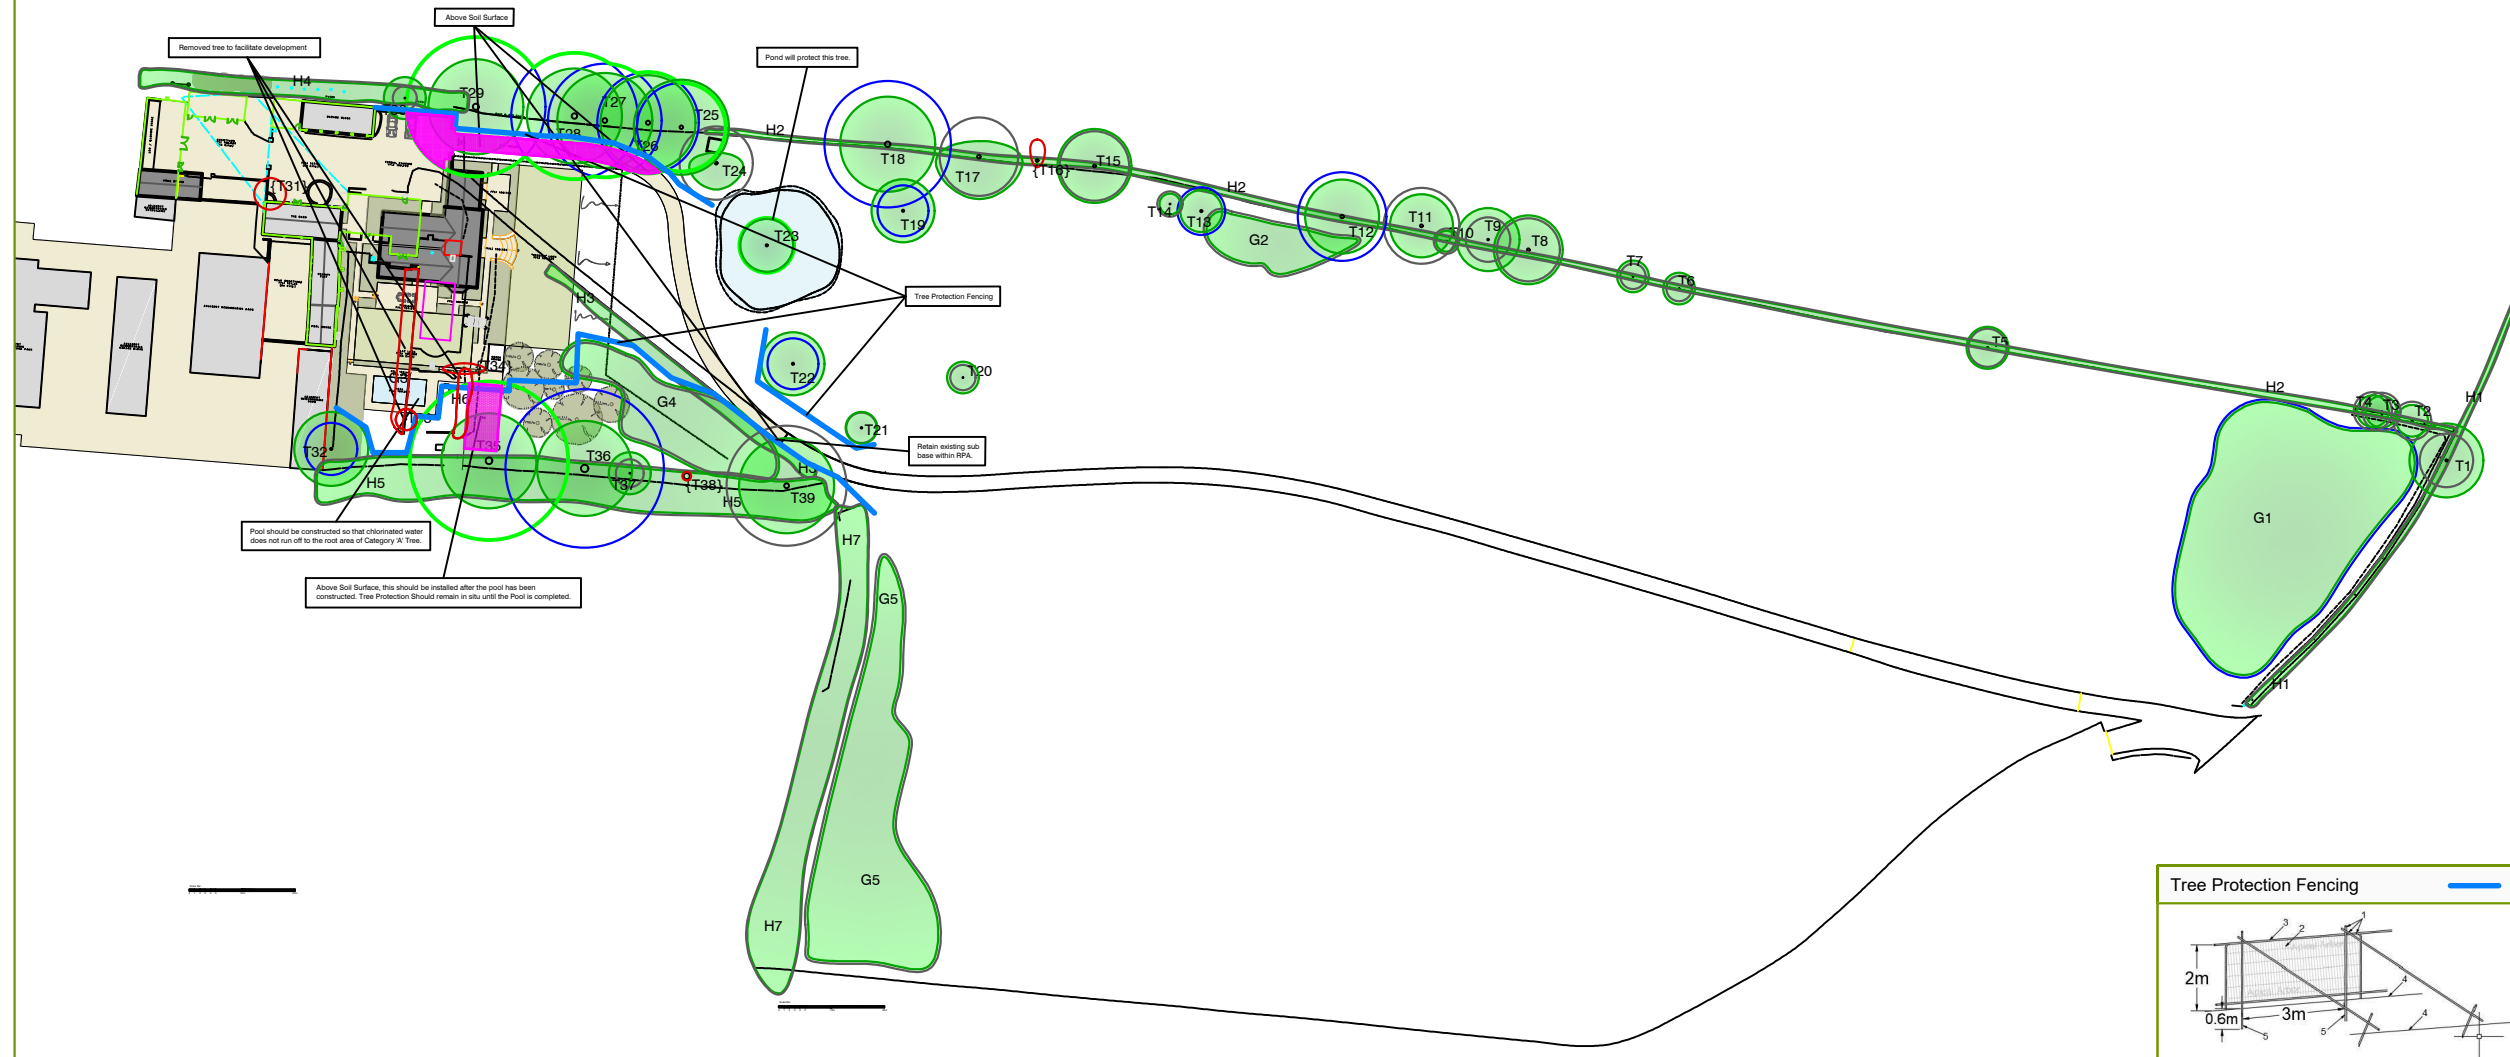
Tree Protection Fencing

A scaffold framework in accordance with Figure 2 above comprising of a vertical and horizontal framework, well braced to resist impacts, with vertical tubes driven into the ground spaced at maximum intervals of 3m. Onto this, welded mesh panels should be securely fixed with wire, scaffold clamps or cable ties. If required, fence bases or feet will be secured into the ground with upright scaffold tubes. Panels supported on unsecured rubber or concrete feet are not resistant to impact and should not be used.
