**Heyford Park
Dorchester Living: Phase 9
Remediation Earthworks Completion Report
For Urban Regen Ltd. & Dorchester Living
May 2023**

Report Ref: R1742-R23-v4

Report Title: Heyford Park, Dorchester Phase 9
Remediation Earthworks Completion Report

Client: Urban Regen Ltd & Dorchester Living

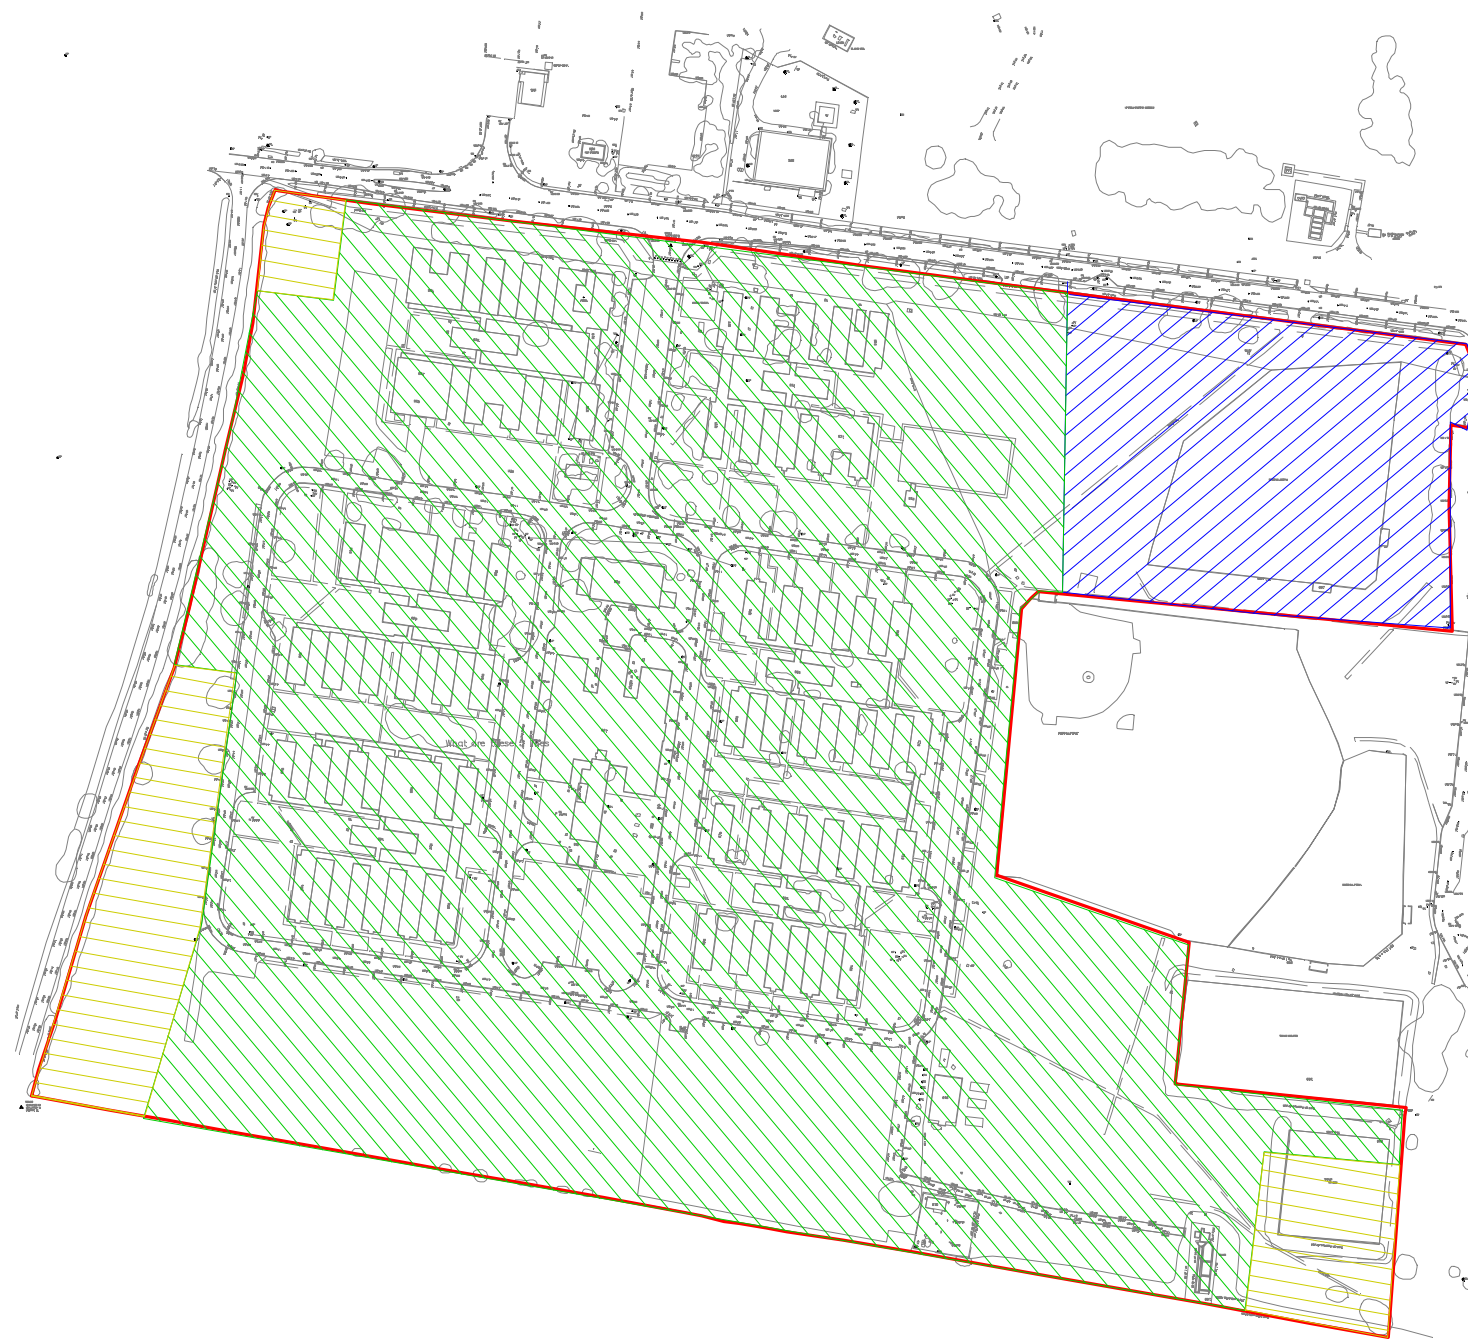
Drawing:
 Phase 9 Boundary Plan

- Phase 9 Boundary
- Extent of URL PH9 Remedial Works Reported within R1742-R23-v3
- PH9 Baseball Pitch Completed - Reported in R1742b-R22
- Remedial Works Outstanding - To be completed at a later date

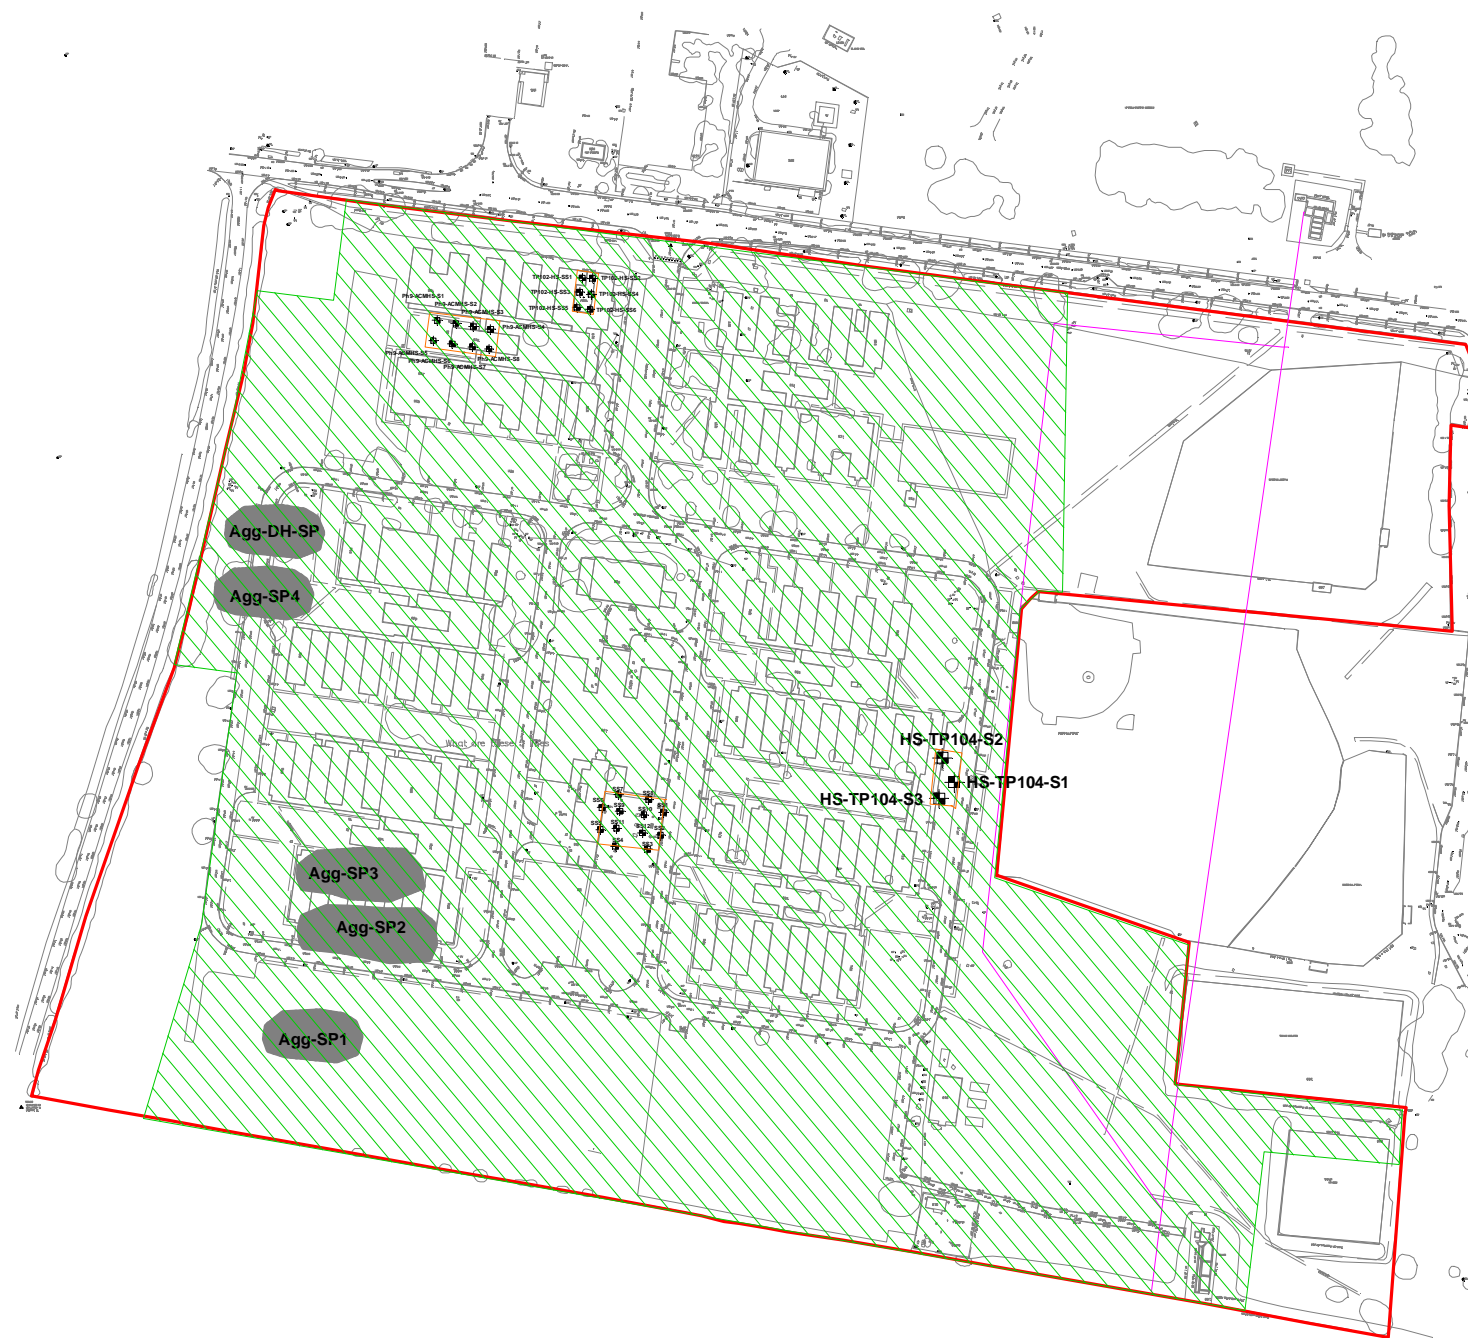
Job No: R1742b	Drg No: R23-D02-v2
-------------------	-----------------------

- Phase 9 Boundary
- ▨ Extent of URL P49 Remedial Works Reported within R1742-R23-v3
- Approx Line of POL pipeline
- Validation Sample Location

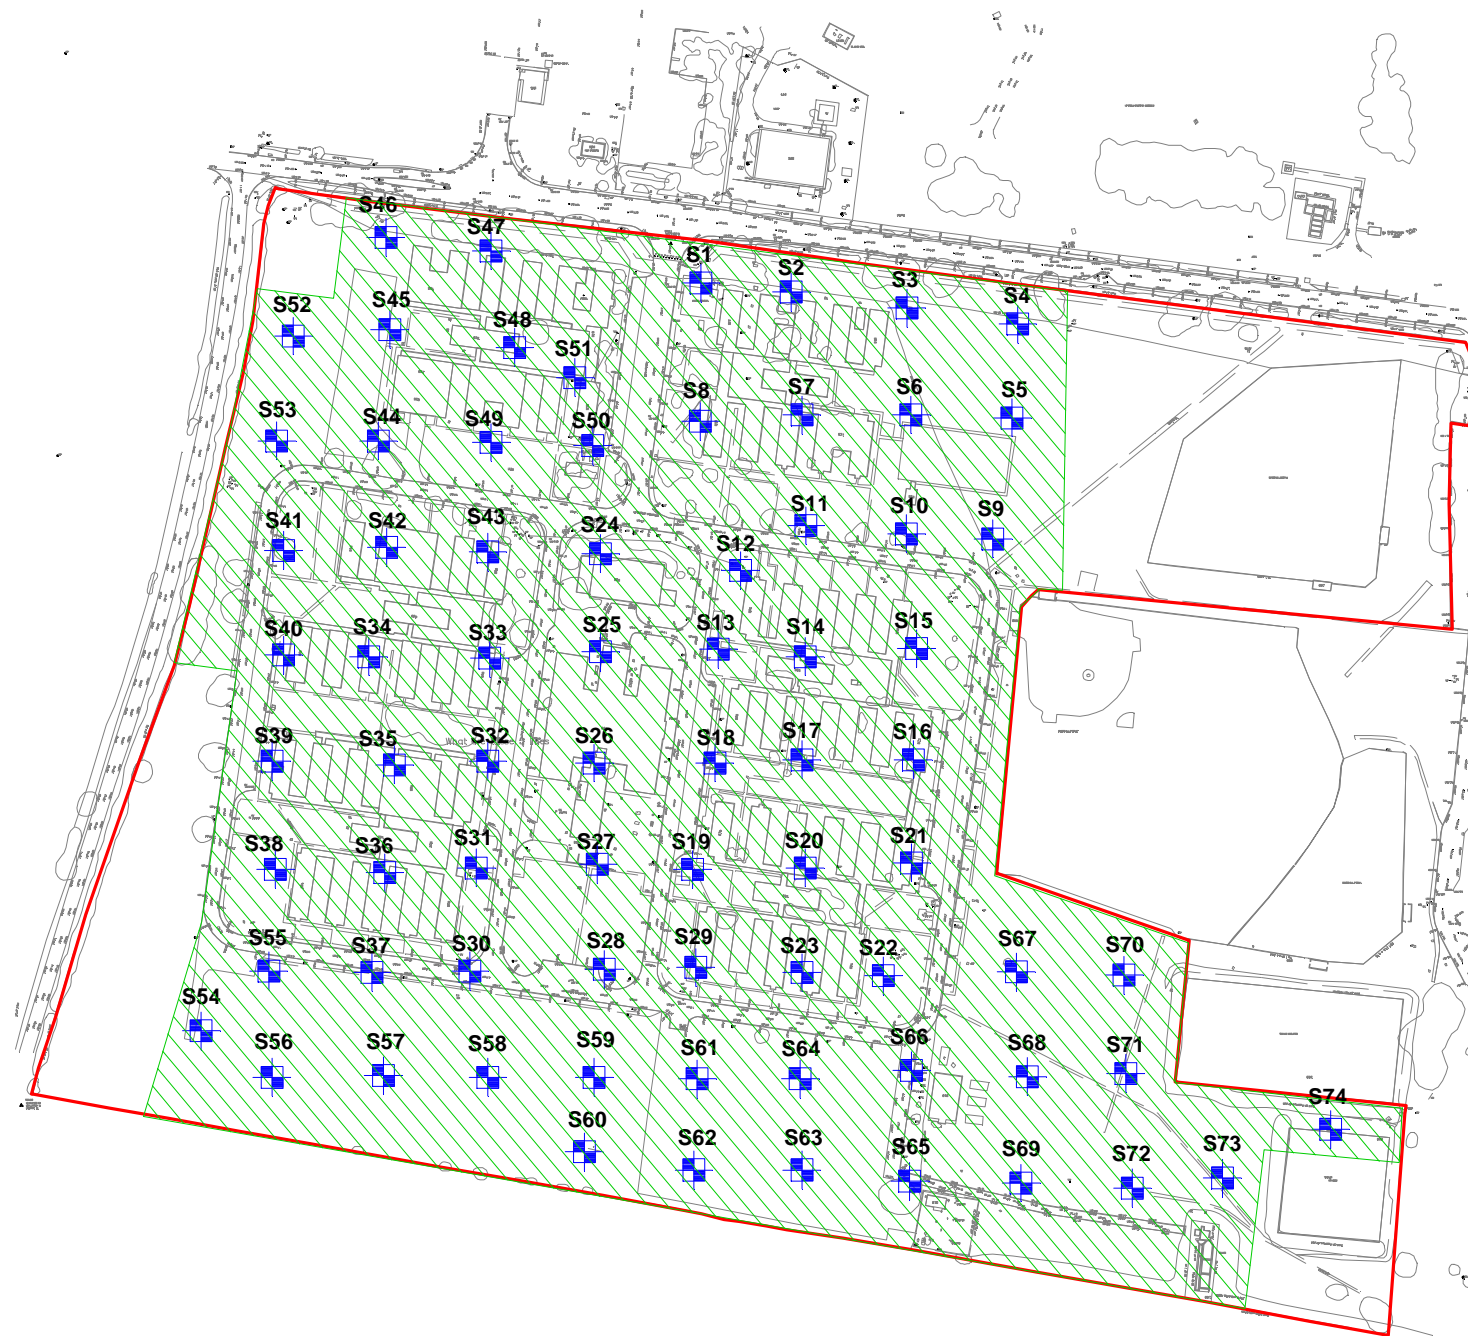
Drawing:
Formation Sampling Locations

— Phase 9 Boundary
▨ Extent of URL P10 Remedial Works Reported within R1742-R23-v1
⊕ Formation Sample Location

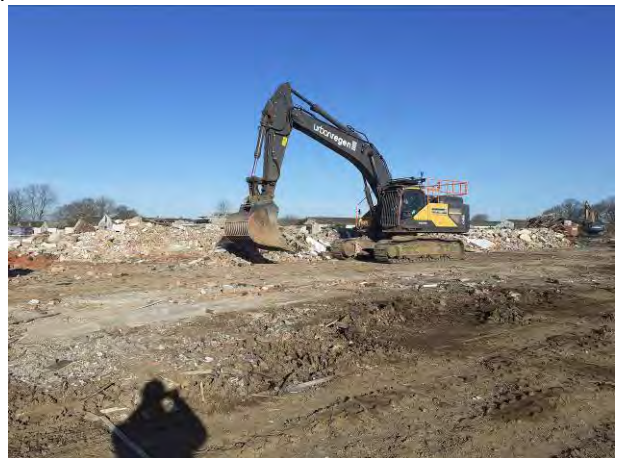
30.

09.03.21 – Breaking out of hardstanding (slab) below demolished building footprint

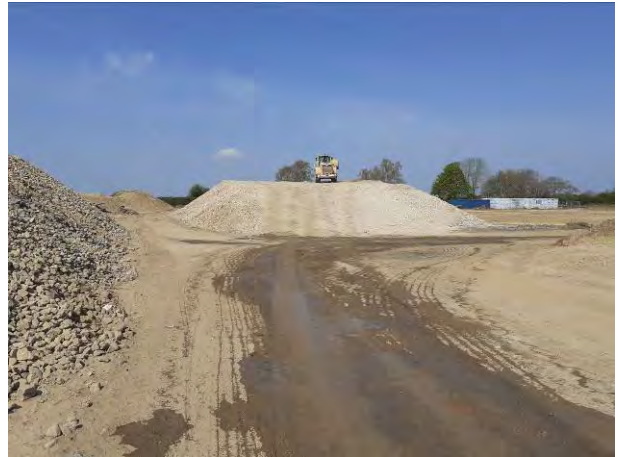
46.

20.04.21 – Dust suppression taking place during dry conditions

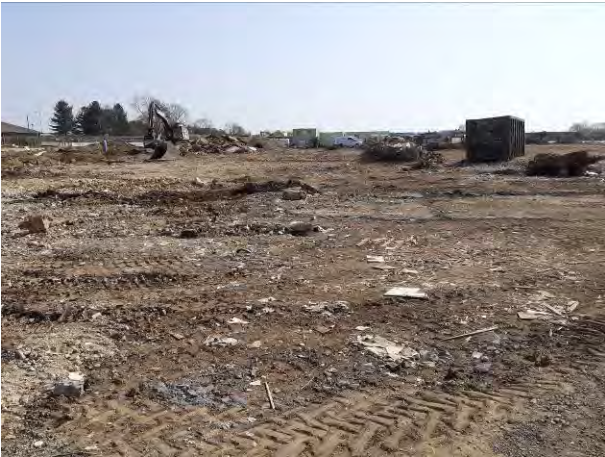
47.

20.04.21 – Eastern view across the north of the site following building demolition and hardstanding removal but prior to regrade

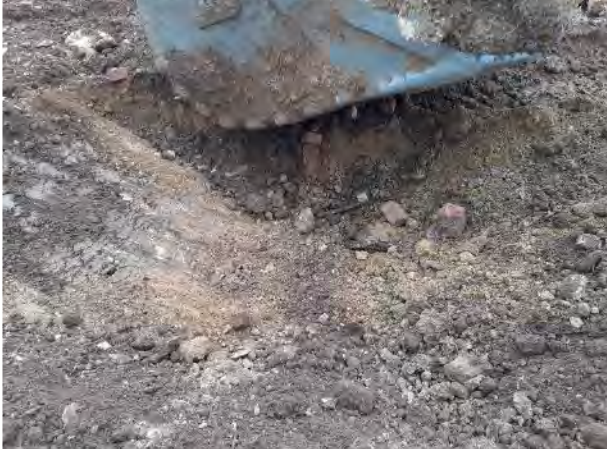
- 4.4.3 During sampling the soils were inspected for any potential ACM, no such materials were observed with the soils consisting of re-worked sandy clay with coarse limestone gravel and inclusions of brick. A photographic record is presented in Appendix B and a copy of the laboratory test results (lab ref. 21-14505) in Appendix D.

<p data-bbox="114 767 763 842">28.04.21 – Excavation to 0.6m bgl and collection of sample (S1) following completion of hand-picking. No visible ACM observed</p>

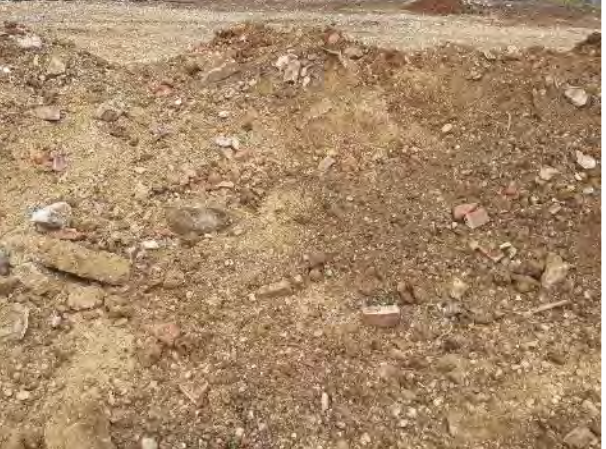
<p data-bbox="797 767 1447 842">28.04.21 - Excavation to 0.6m bgl and collection of sample (S2) following completion of hand-picking. No visible ACM observed</p>	  <p data-bbox="1469 767 2119 842">28.04.21 - Excavation to 0.6m bgl and collection of sample (S3) following completion of hand-picking. No visible ACM observed</p>

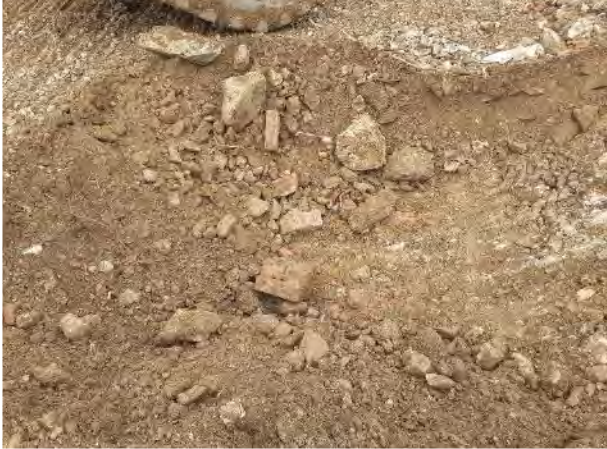
<p data-bbox="114 1310 763 1385">28.04.21 - Excavation to 0.6m bgl and collection of sample (S4) following completion of hand-picking. No visible ACM observed</p>

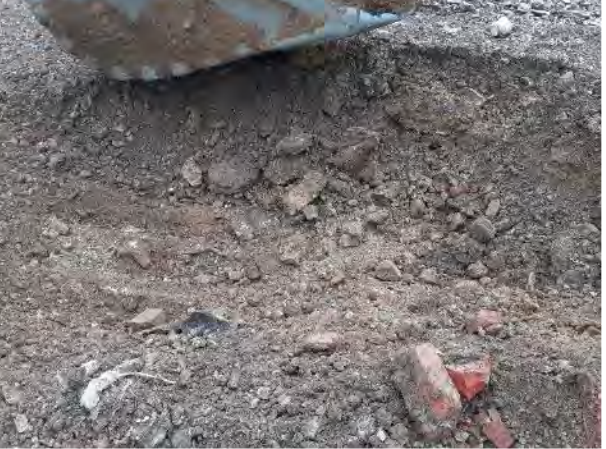
<p data-bbox="797 1310 1447 1385">28.04.21 - Excavation to 0.6m bgl and collection of sample (S5) following completion of hand-picking. No visible ACM observed</p>

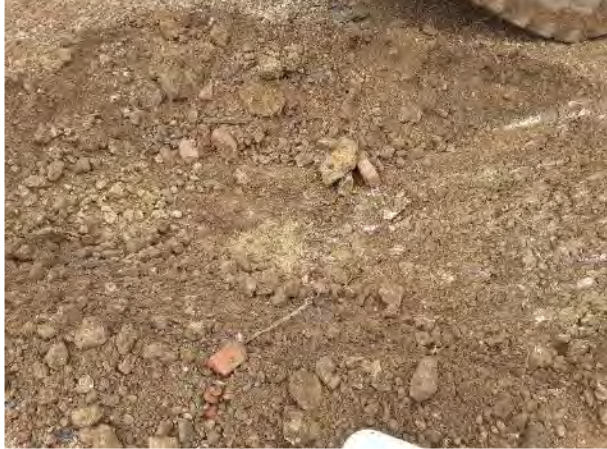
<p data-bbox="1469 1310 2119 1385">28.04.21 - Excavation to 0.6m bgl and collection of sample (S6) following completion of hand-picking. No visible ACM observed</p>

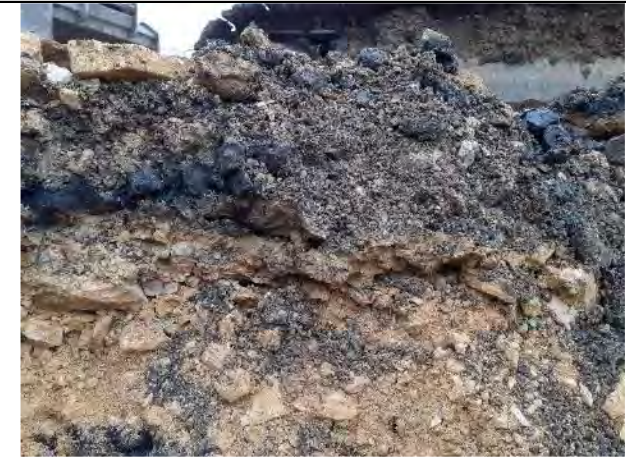
28.04.21 – Black gravel within approximate area of former aerial mast, possible former base

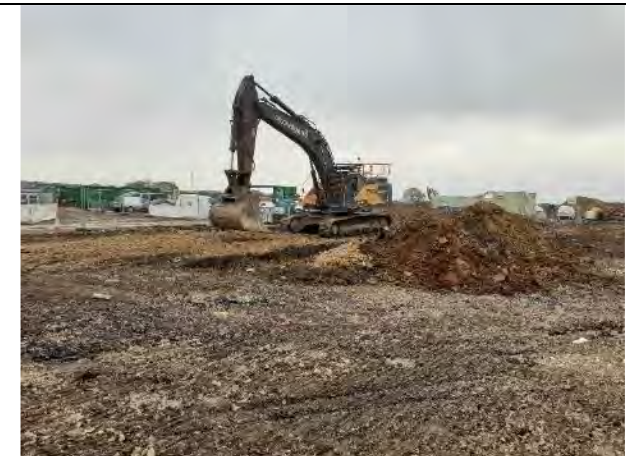
28.04.21 – URL removal of black stained gravel

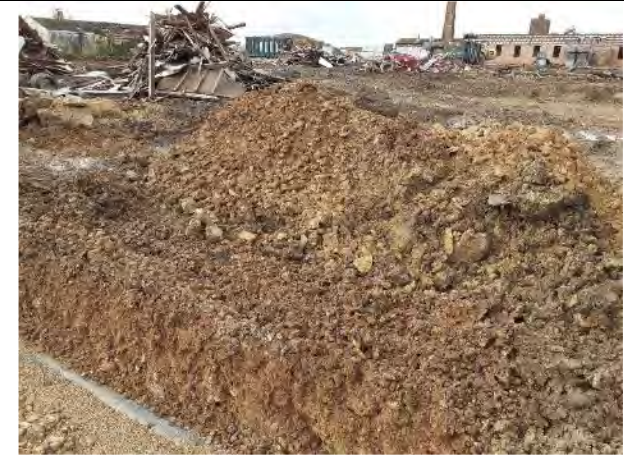
17.02.21 – Arisings side cast and consisted of coarse limestone gravel in brown clay (weathered bedrock). No visual or olfactory evidence of contamination, PID <0.1ppm.

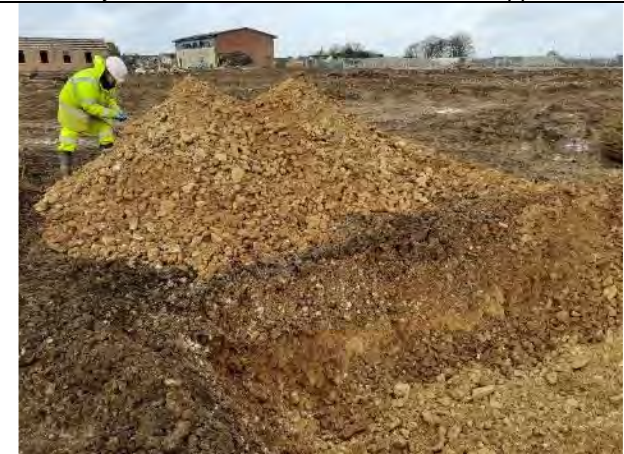
17.02.21 – Inspection of arisings and collection of validation samples. No visual or olfactory evidence of contamination, PID <0.1ppm.

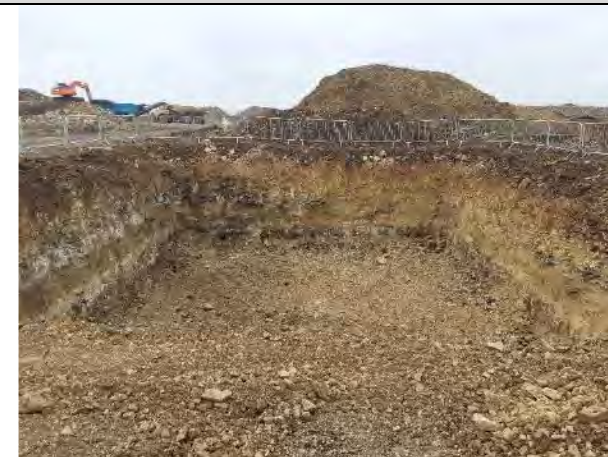
- 4.5.5 Visual inspection of the base and sidewalls was undertaken with no staining or areas of free product observed. No odours were recorded from the excavation and screening of soils from the base and sidewall with a PID failed to exceed detection limits (<0.1ppm). A photographic record is provided in Appendix B.

28.04.21 – Excavation void following removal of tanks. Natural soils present on all sides. No evidence of staining on sidewalls or base

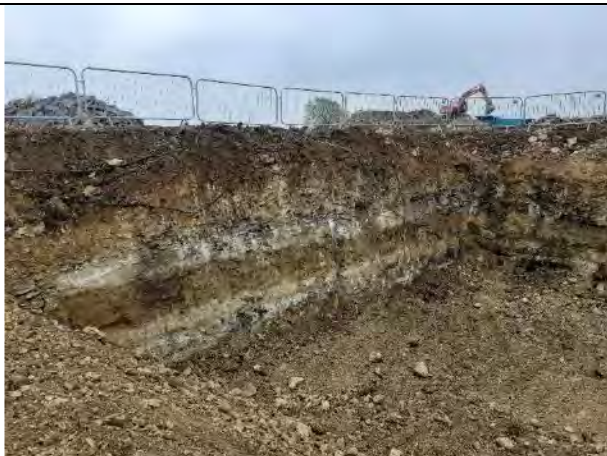
- 4.5.4 Observed ground conditions consisted of a sandy clay soil with coarse limestone gravel to approximately 2.3m bgl where weathered bedrock was encountered. The depth of the excavation extended to a depth of approximately 2.8m.

28.04.21 – Base of excavation at approximately 2.8m bgl. Limestone gravel present to 2.3m bgl with limestone bedrock to base

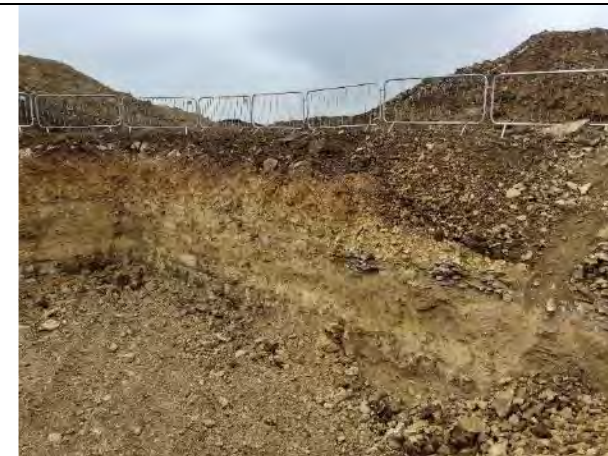
28.04.21 – Sidewalls and base absent from staining or indicators of fuel contamination
