Water Eaton

PR6a : Land East of Oxford Road

Phase 1 Geo-Environmental Appraisal

PHASE 1 GEO-ENVIRONMENTAL APPRAISAL
Water Eaton, Oxford
PR6a: Land East of Oxford Road

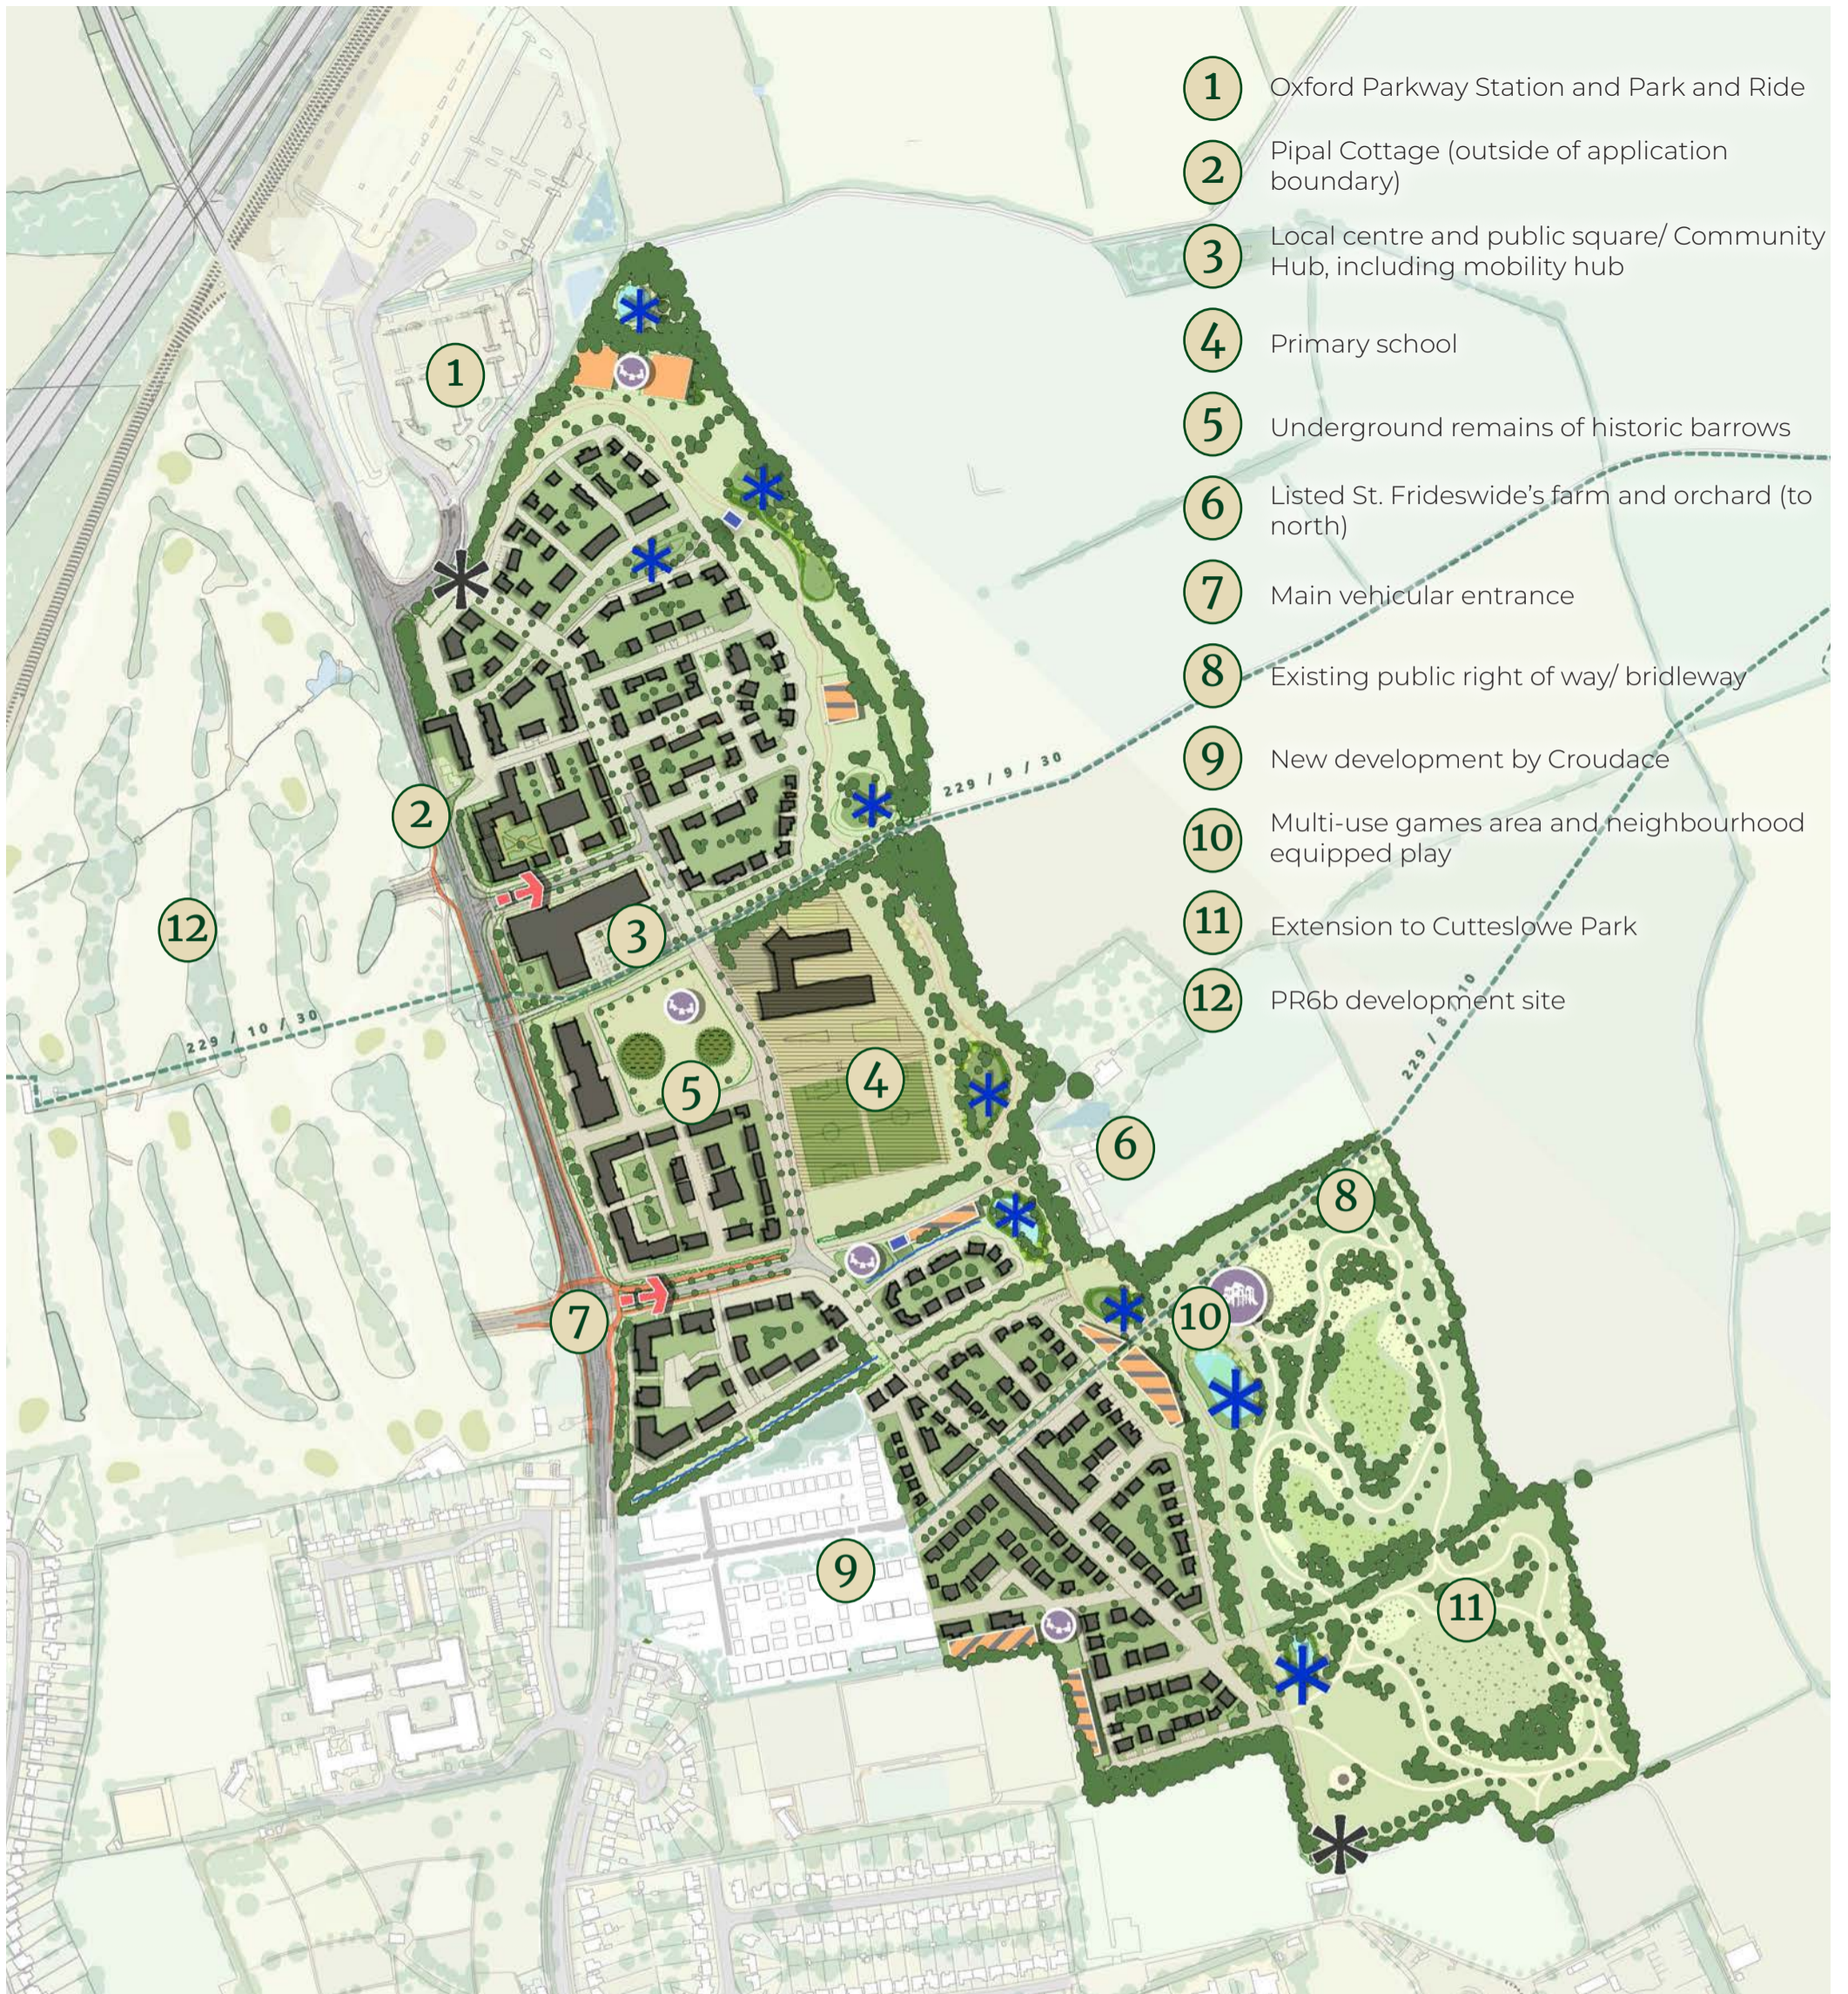
Appendix D
Illustrative Masterplan

- 1 Oxford Parkway Station and Park and Ride
- 2 Pipal Cottage (outside of application boundary)
- 3 Local centre and public square/ Community Hub, including mobility hub
- 4 Primary school
- 5 Underground remains of historic barrows
- 6 Listed St. Frideswide's farm and orchard (to north)
- 7 Main vehicular entrance
- 8 Existing public right of way/ bridleway
- 9 New development by Croudace
- 10 Multi-use games area and neighbourhood equipped play
- 11 Extension to Cutteslowe Park
- 12 PR6b development site

2.1 A copy of the illustrative masterplan is included in Appendix D. The proposed development consists of:
