# Water Eaton

PR6a : Land East of Oxford Road

Archaeology and Heritage Assessment

February 2024  
Report Reference  
**edp5650\_r006g**

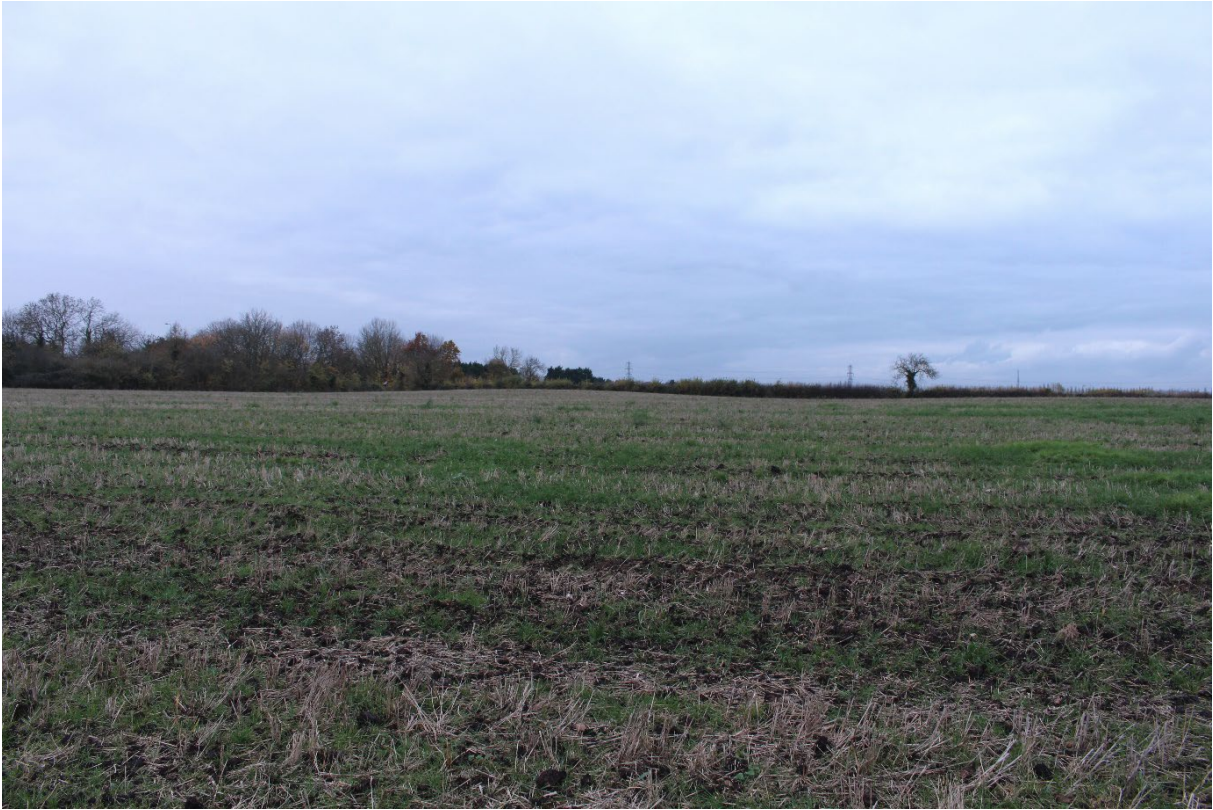
**Image EDP 1:** View north towards the two round barrows in the east of the site. Note their very reduced and diffuse nature due to continued ploughing.

- S7 The heavily eroded, diffuse earthwork remains of the two round barrows were observed within the site during the site walkover and were later recorded as buried remains during archaeological investigations, as well as showing positively on LiDAR imagery as subtle earthwork features.

4.120 The heavily eroded, diffuse remains of two of the round barrows were observed within the east of the site during the site walkovers (**Image EDP 1**).

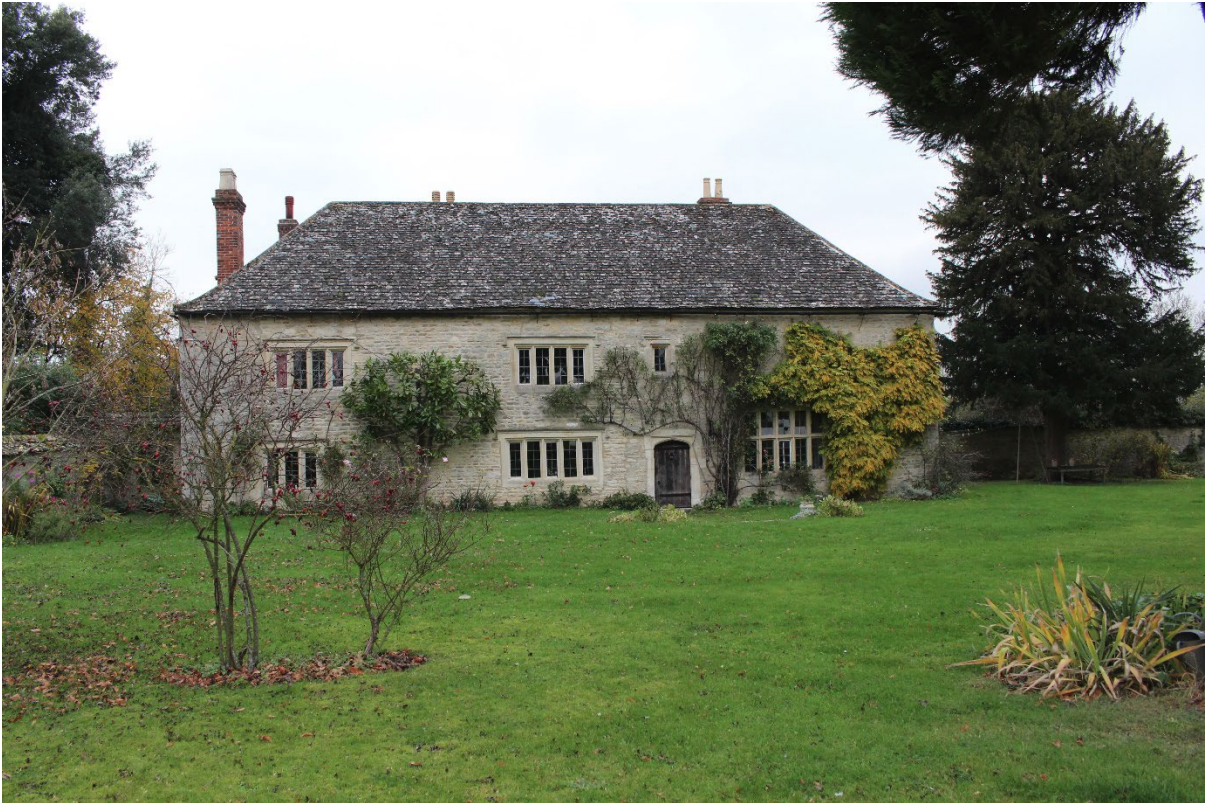
**Image EDP 2:** View of the principal southern façade of St Frideswide's Farm House, Grade II\* listed building. The associated Grade II listed garden wall lies to the right of frame and this image illustrates the immediate and enclosed garden setting of the farmhouse.

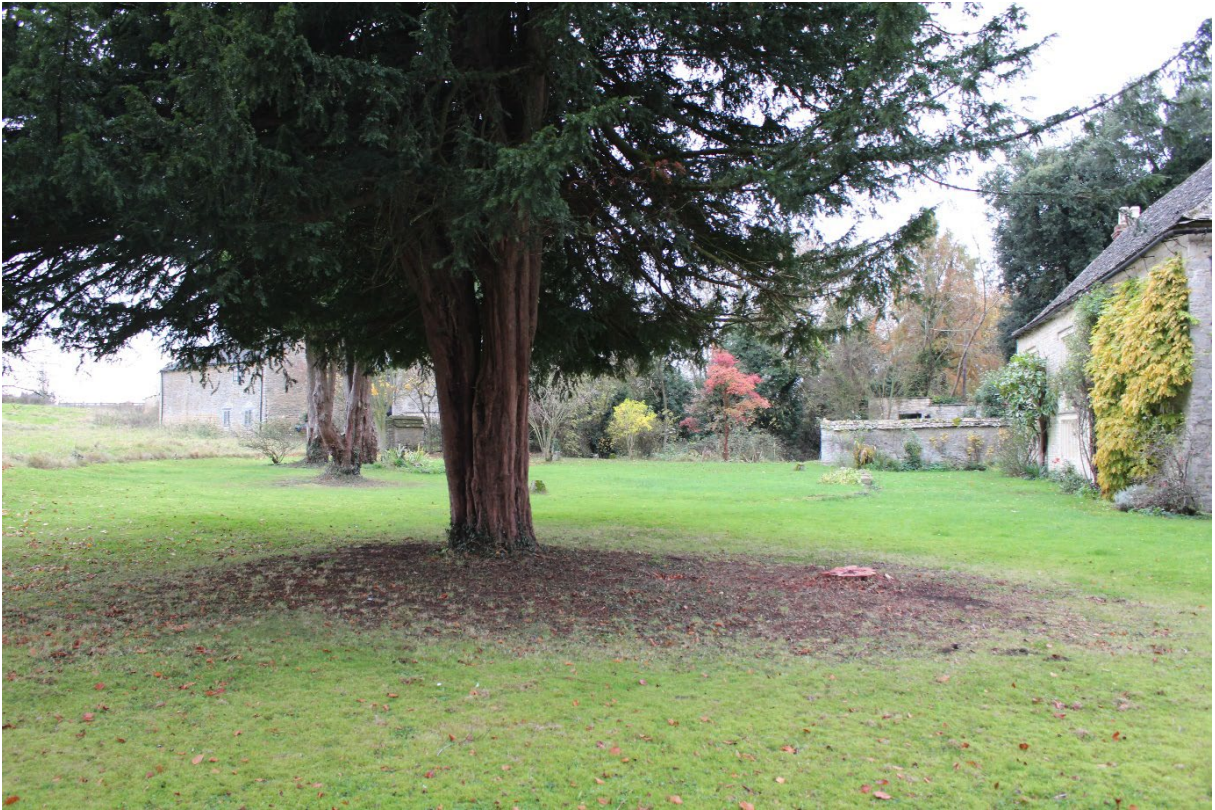
**Image EDP 3:** General view west from within the front (southern) garden of St Frideswide's Farm House. This image further demonstrates the enclosed and well-vegetated nature of the garden, particularly to the west (i.e. in the direction of the greater part of the site).

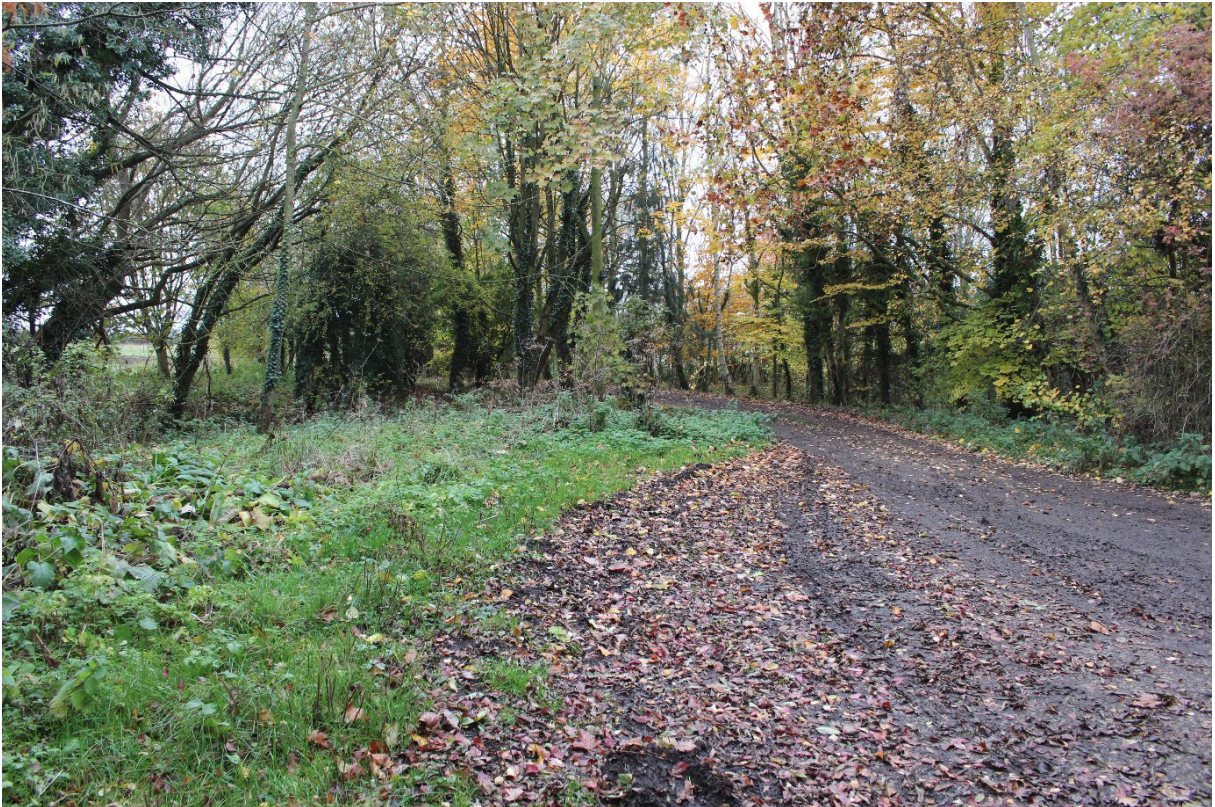
**Image EDP 4:** General view of the dense woodland planting at the main western approach to St Frideswide's Farm House, looking west. This image demonstrates the lack of intervisibility with the site in this direction.

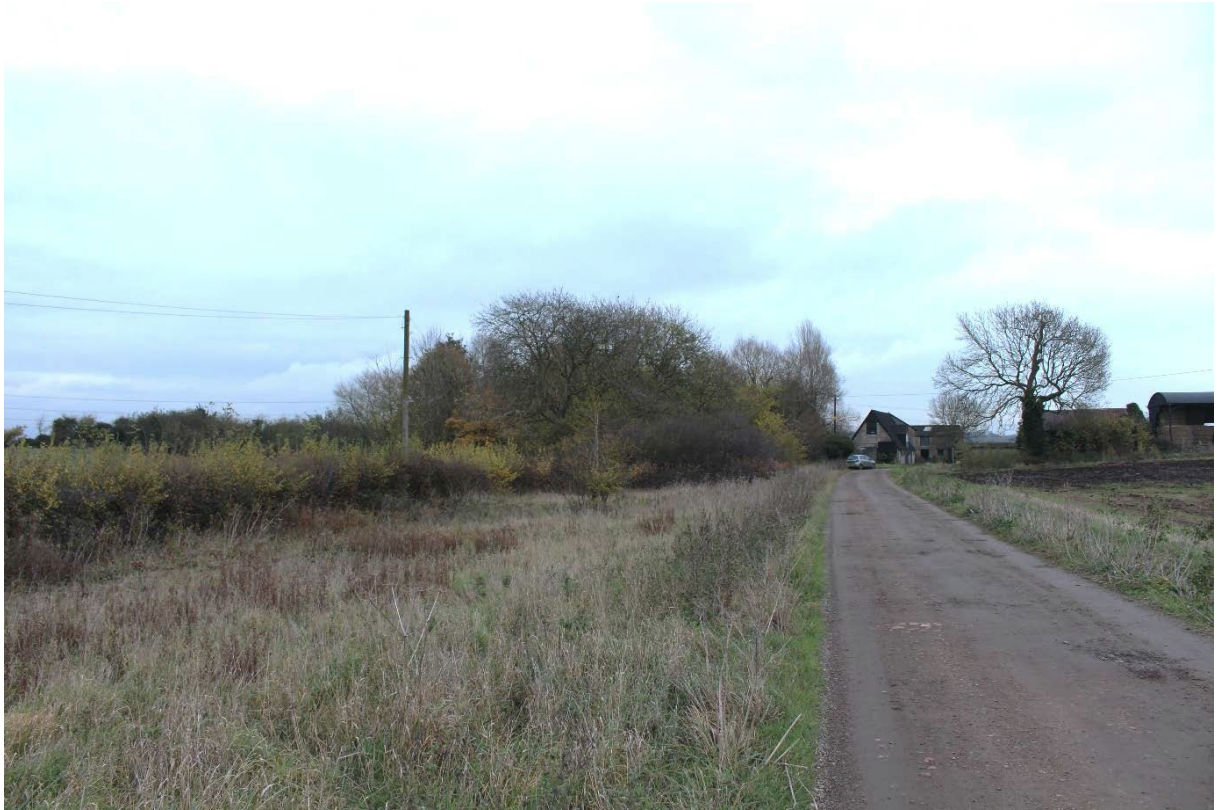
**Image EDP 5:** General view east toward St Frideswide's Farm from within the site, looking along the main access track. Note the listed farm house and walls are entirely screened by dense woodland (even in winter), with only the wider farmstead buildings visible, of which these are in varying states of disrepair and age.

- 5.16 The enclosed nature of the listed buildings was confirmed during the site visit, with mature trees and dense vegetation present to the west (**Image EDP 5**), north and east of the property. The northern boundary of the farmstead is defined by an orchard, which is an historic feature (as noted in the Second Edition OS 1899 map (**Plan EDP 3**)), which spans the full width of the farm complex and which the northern frontage of the farmhouse addresses. The orchard may once have been larger, perhaps extending to Water Eaton Copse to the north (now replaced as arable fields (**Plan EDP 3**)), and perhaps further to the west into the land within the site. The southern aspect of the farmhouse's garden is more open, and a shallow, curving ditch affords outward views southwards across a pasture field (**Image EDP 6**), comprising the purported moat and DMV site.

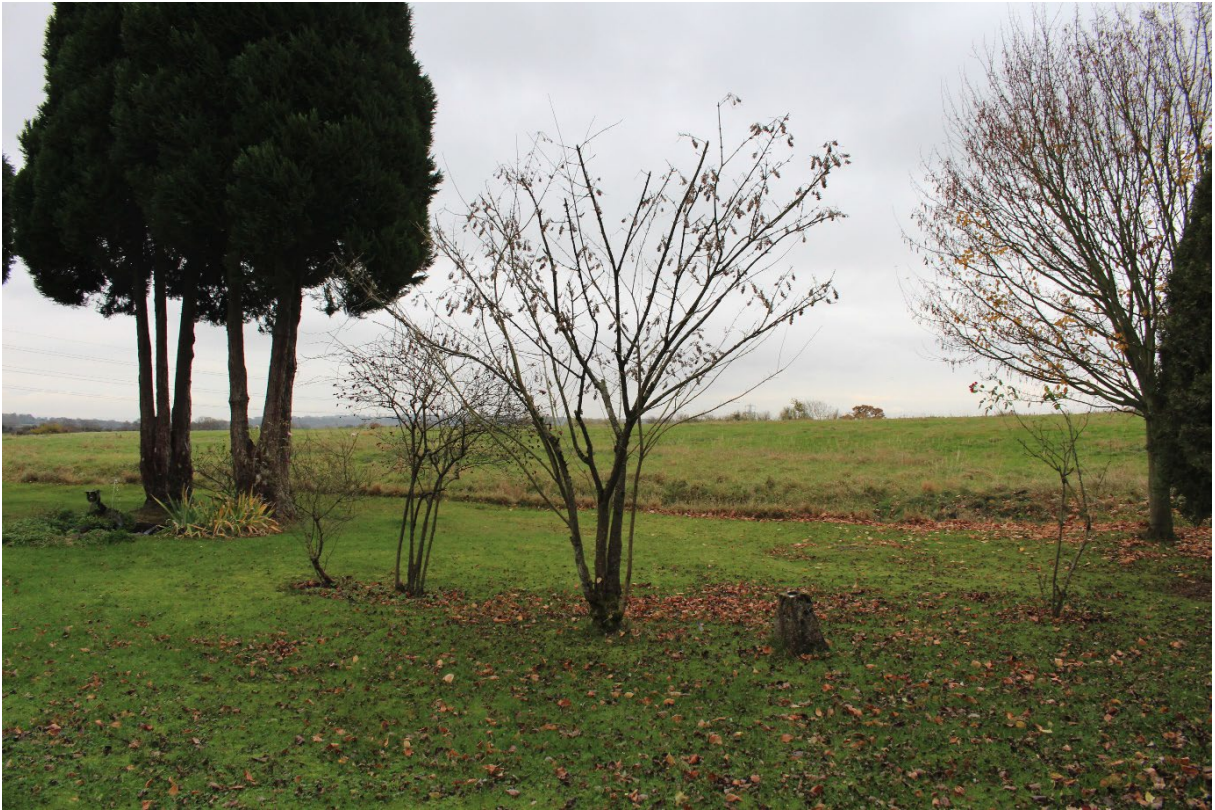
**Image EDP 6:** General view south from within St Frideswide's garden. Note outward views in this direction are curtailed by the rising ground, such that there is minimal experience of the wider landscape (including the site).

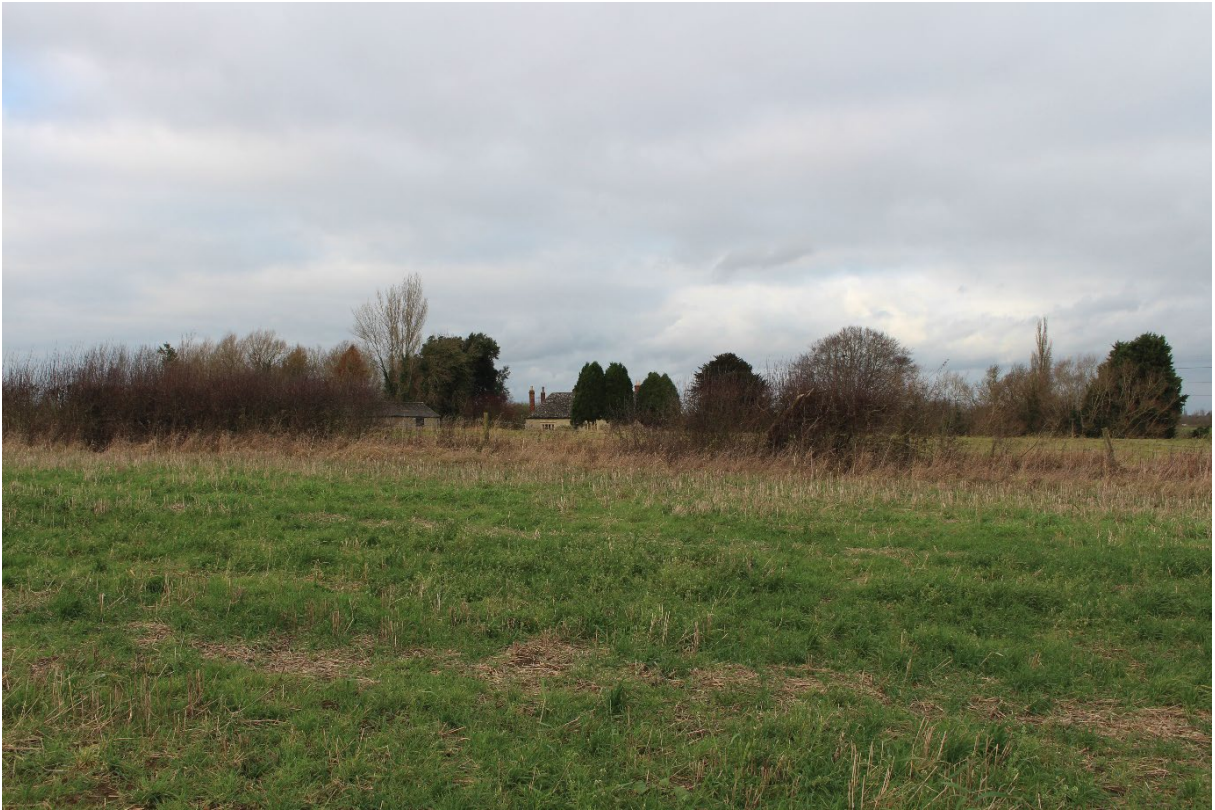
**Image EDP 7:** View north towards St Frideswide's Farm House from within the southern part of the site. Note only the roofline and upper storey is visible, however, the architectural interest of the building cannot be appreciated at such distance.

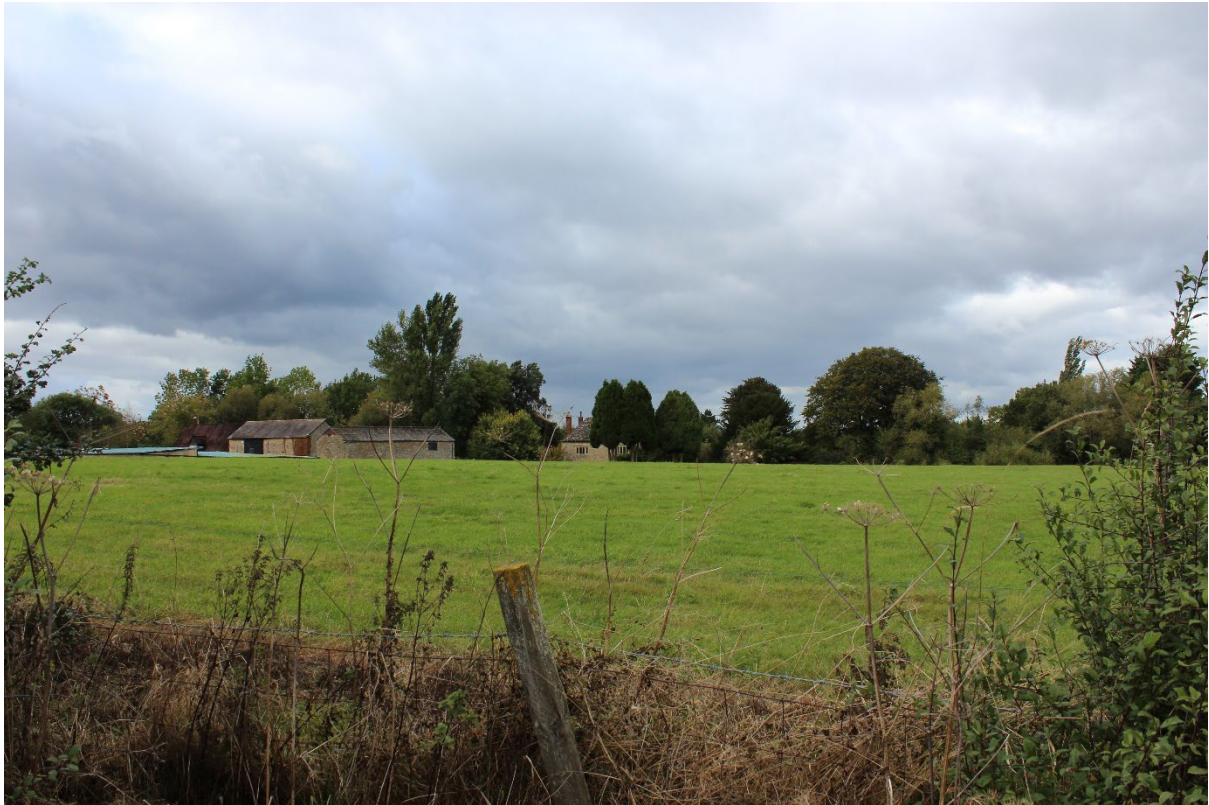
**Image EDP 8:** View north-east towards St Frideswide's Farm House from within the south-eastern part of the site. Although the later outbuildings are clearly visible, just the roofline and a small part of the St Frideswide's Farm House are visible. However the architectural interest of the building cannot be appreciated at such distance.

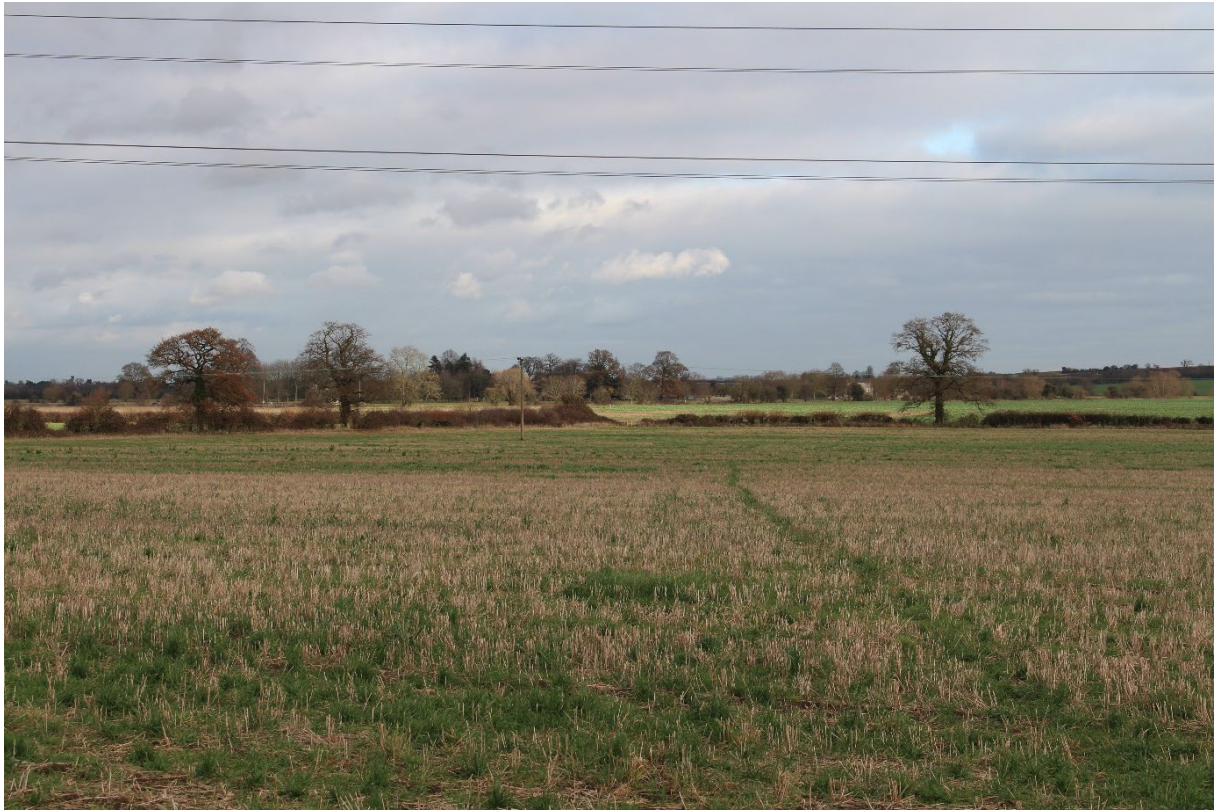
**Image EDP 9:** Zoomed view east across agricultural fields towards Water Eaton Manor. This view was taken from the site's eastern boundary, looking along the course of the footpath to the south of St Frideswide's Farm. Note the individual buildings at Water Eaton are not discernible, even in winter.

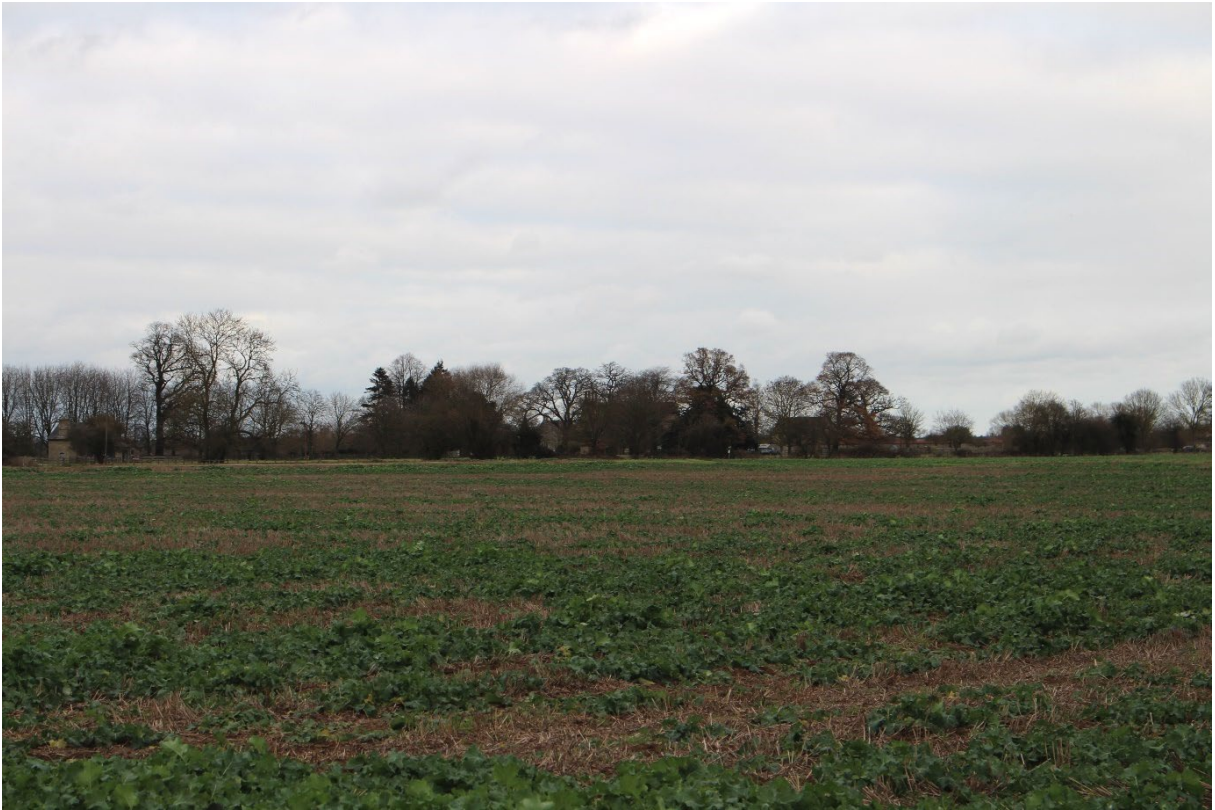
**Image EDP 10:** The listed buildings at Water Eaton Manor are not discernible, even when in close proximity to the complex. View from outside the site's boundary along the public Bridleway.

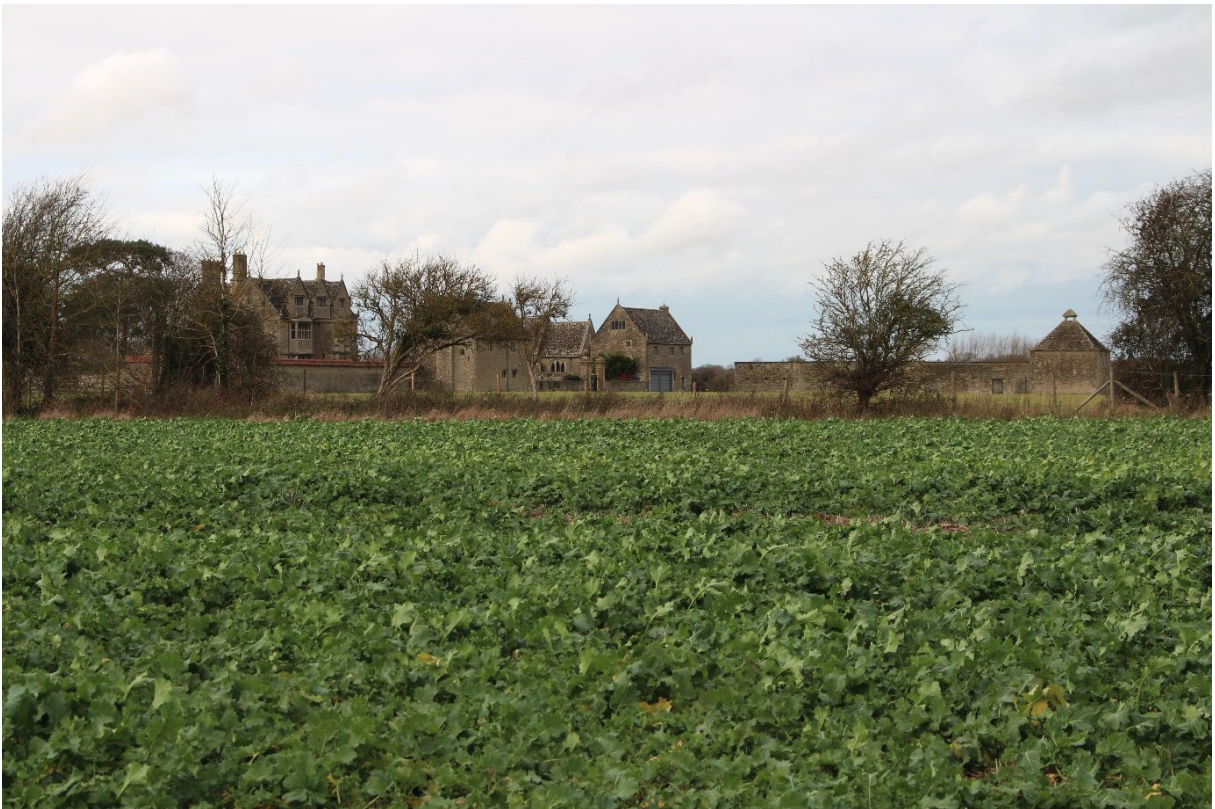
**Image EDP 11:** View of Water Eaton Manor from the immediate south, from where the site forms no part of the experience of the listed buildings.

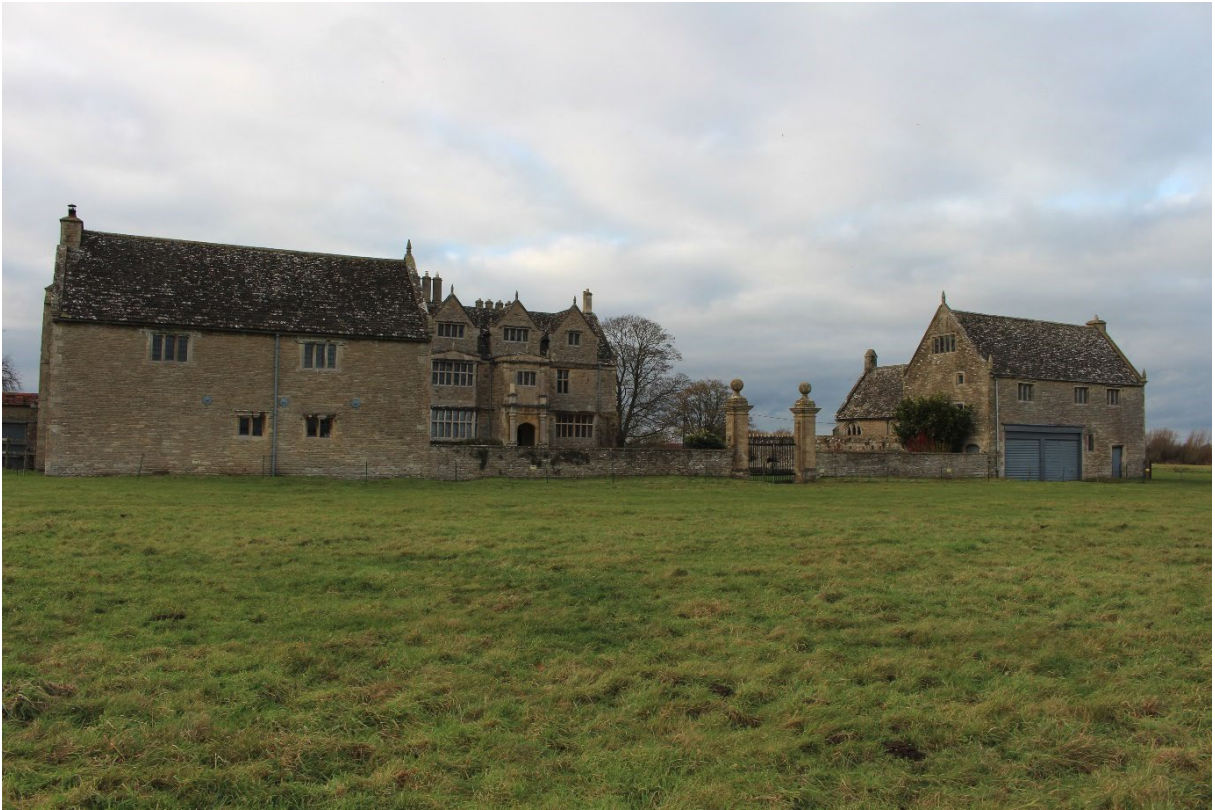
**Image EDP 12:** View of Water Eaton Manor from the immediate east, from where the site forms no part of the experience of the listed buildings.

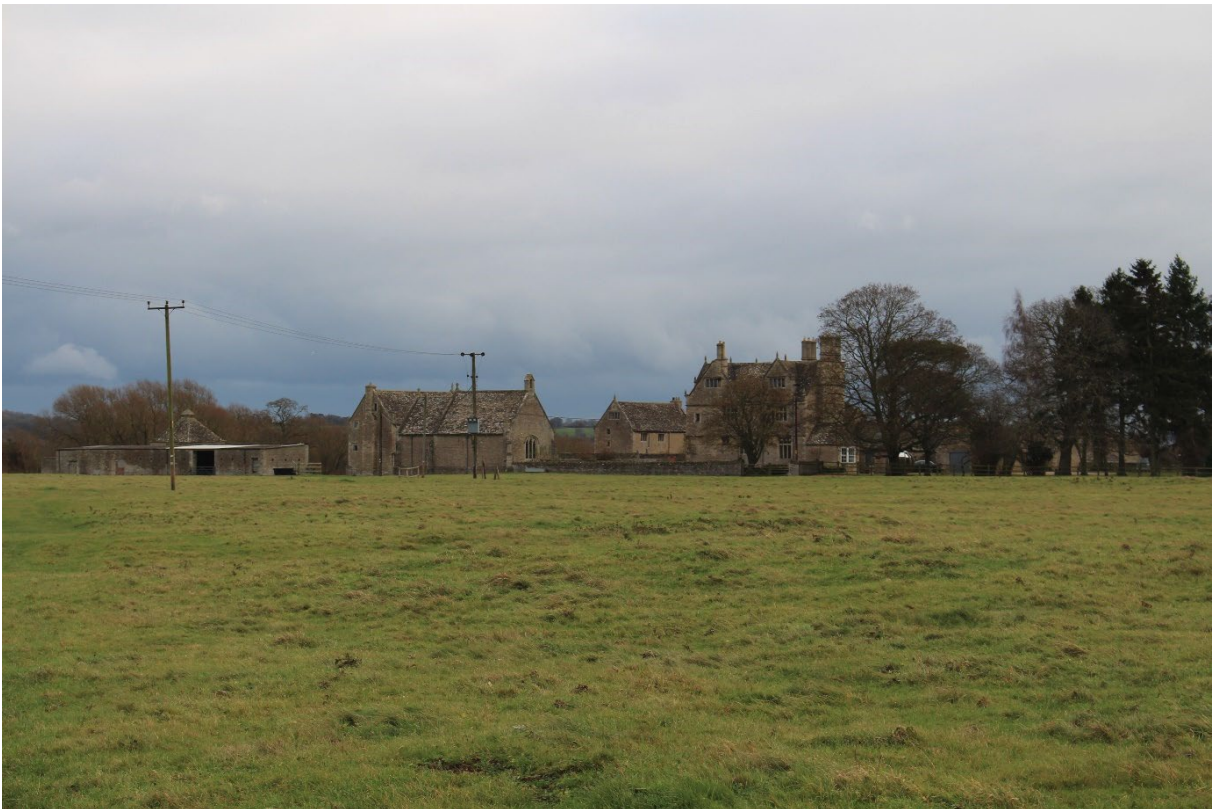
**Image EDP 13:** View of Water Eaton Manor from the immediate north, from where the site forms no part of the experience of the listed buildings.

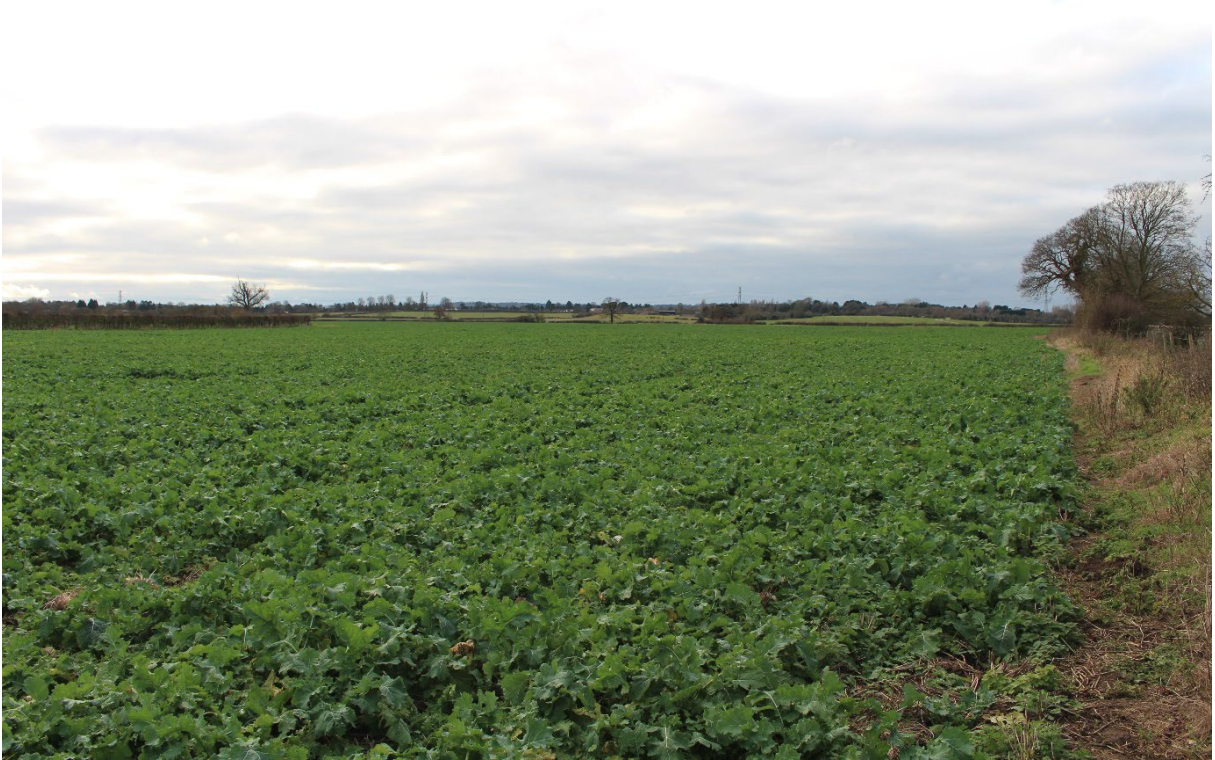
**Image EDP 14:** Long-distance view west towards the site, taken from the southern edge of the Water Eaton Manor complex (see **Image EDP 11**). A residential development in the site would likely be visible along the ridgeline in the far distance, however, any 'in-combination' views with the assets here would be experienced in the context of an existing urban fringe, already comprising built form, sports pitch lighting, pylons and a park and ride complex.

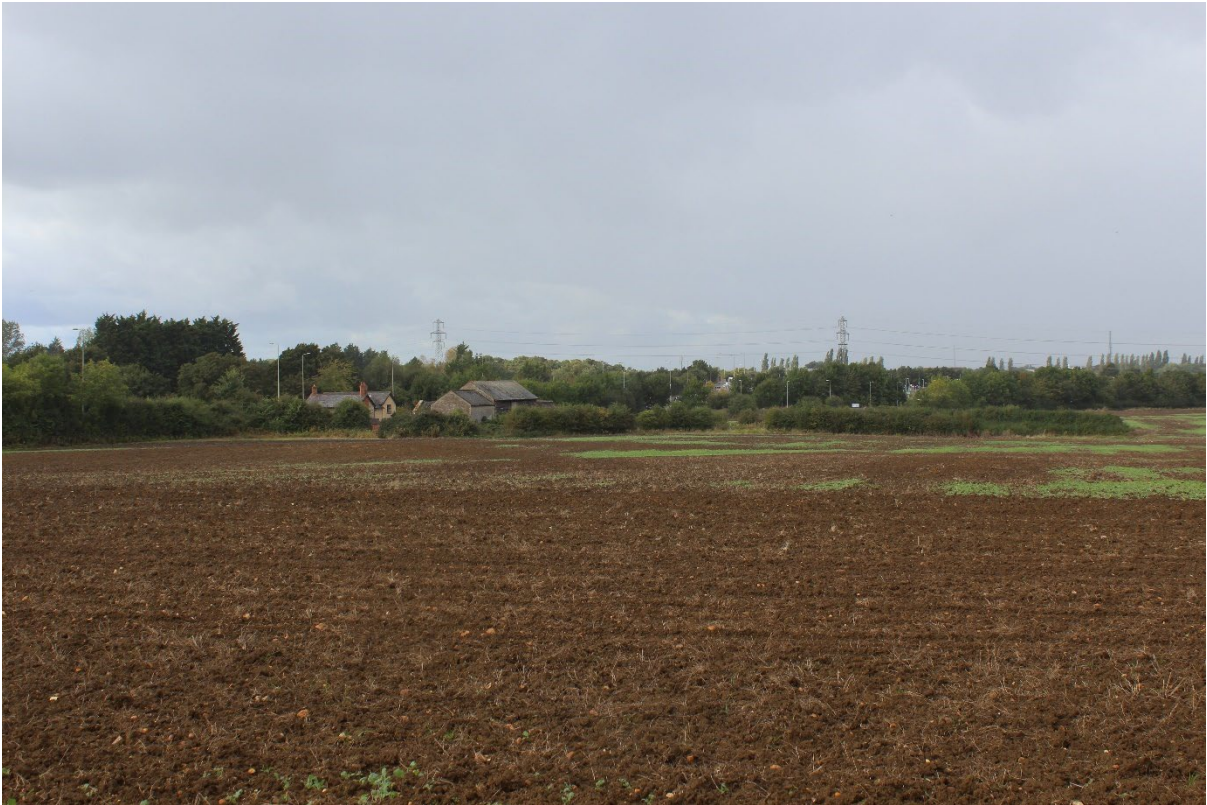
**Image EDP 15:** Long-distance view of the site to the north-east taken from the bridleway towards Pipal Cottage and farmyard. The buildings are largely obscured by high hedgerows and trees which obscures most of the main windows from the site

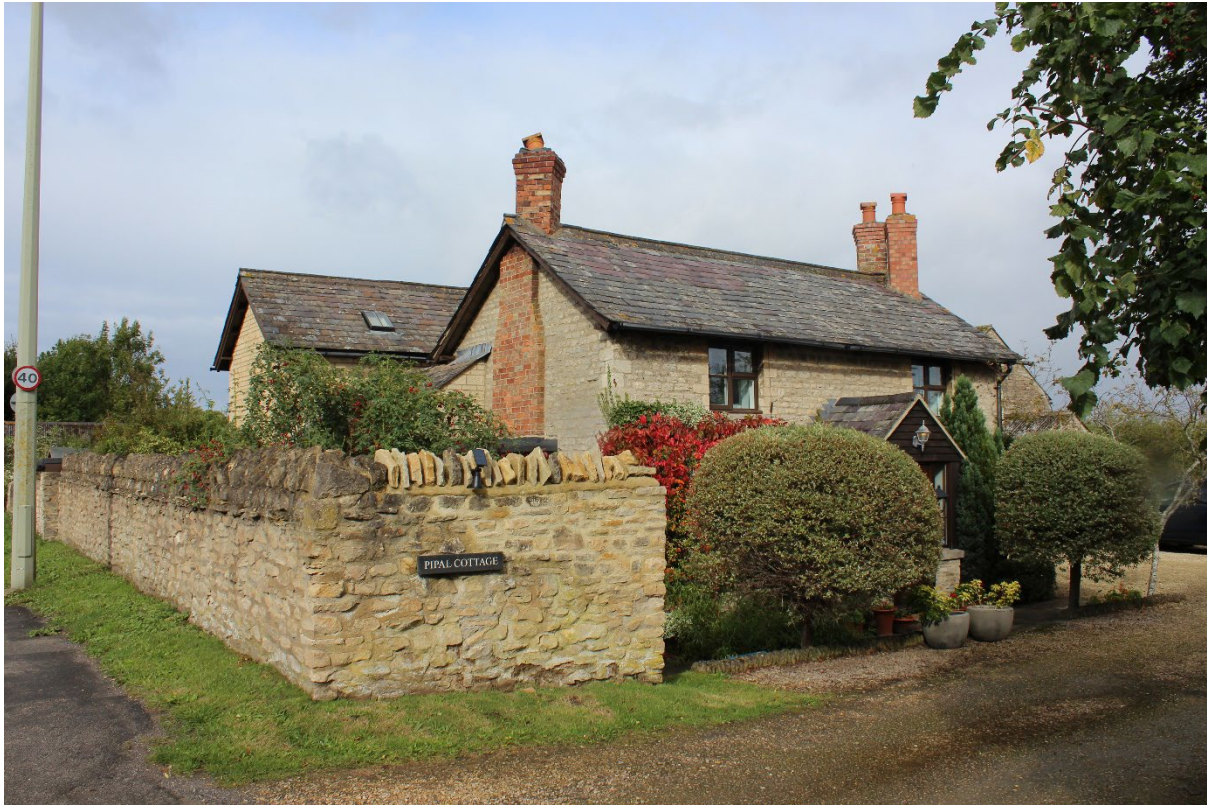
**Image EDP 16:** The south-facing historic façade and frontage of Pipal Cottage showing the brick angled chimneys and large rear northern 1980–1990s extension

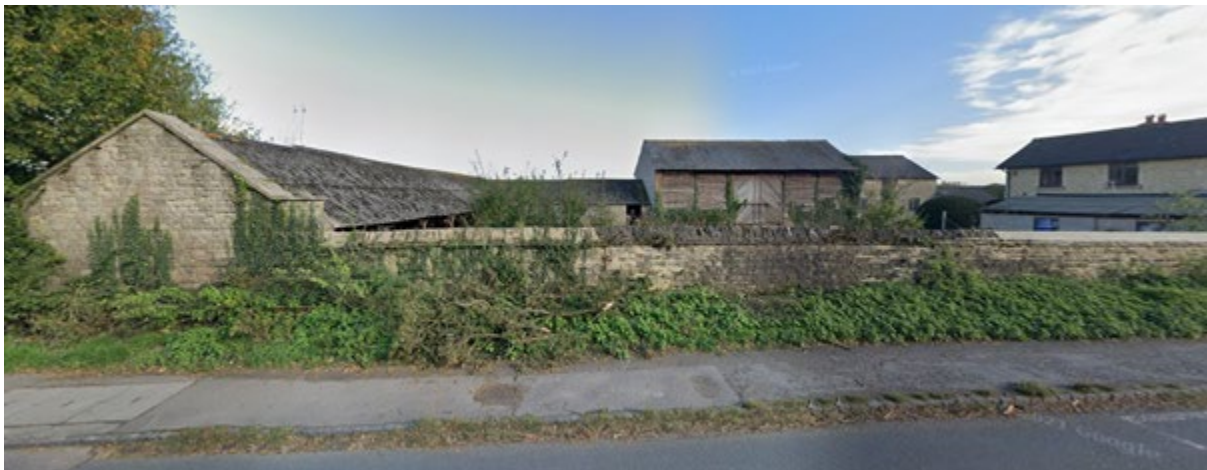
**Image EDP 17:** The west-facing elevations of Pipal Barns and outbuildings and the rear elevation of Pipal Cottage from Oxford Road.
