Phase 1 Desk Study

Phase 2a Preliminary Ground Investigation

Land off Woodbury Road, Sibford Ferris, Oxfordshire

Report: GCE01141/R1v2

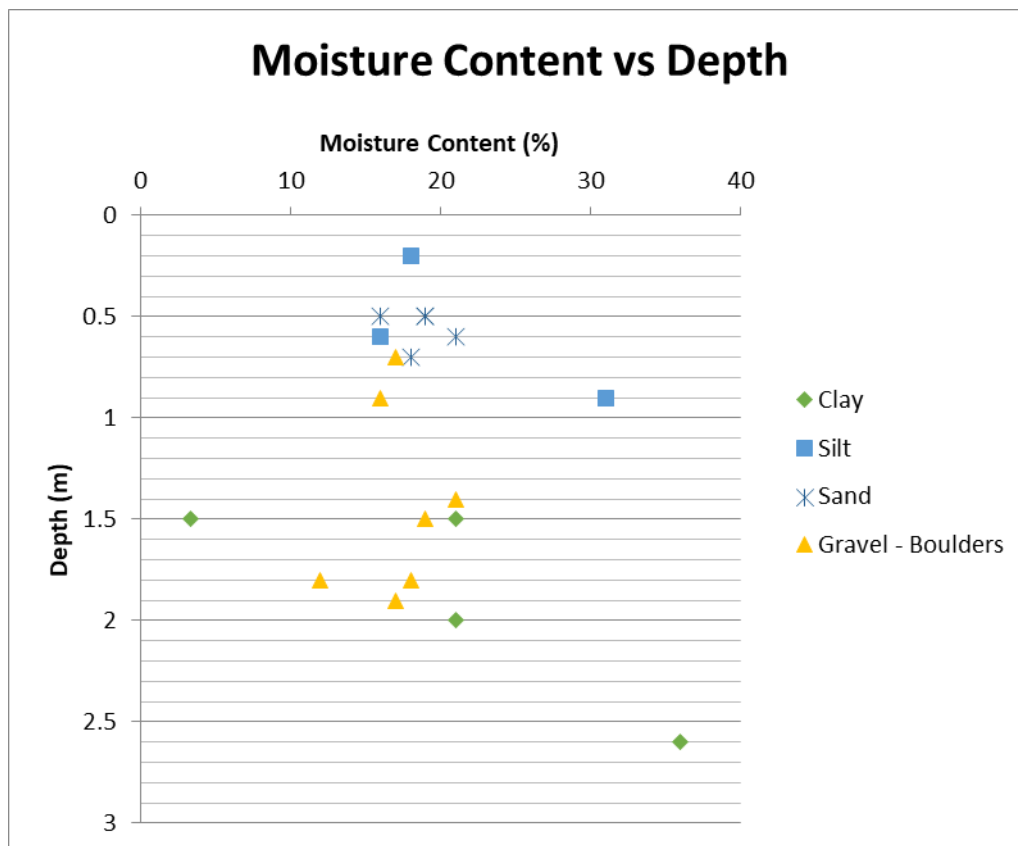
Moisture Content

Nineteen soil samples were tested to determine their moisture content (W_n). The moisture content results are shown in the plot below which shows depth versus moisture content by stratum:

The above plot shows moisture content percentages ranged from 3.3% to 36%.
