# MIDDLETON STONEY ROAD, BICESTER.

## PROPOSED PHASE 1B WORKS

### Stage 1 Road Safety Audit

**SG-AA-2024-4431-RSA1**

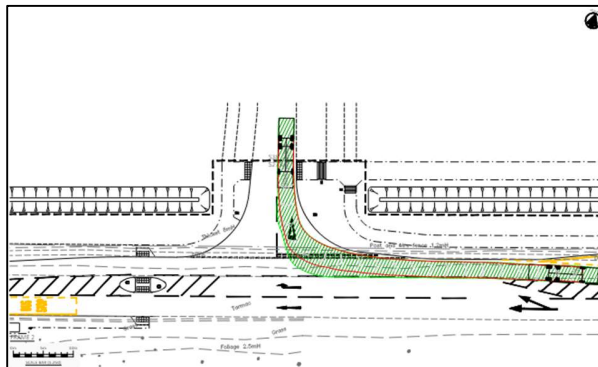
LOCATION: Middleton Stoney Road – Vehicular Access Eastern end

SUMMARY: Insufficient carriageway geometry

From the vehicle swept path analysis provided as part of the scheme submission, it is evident that larger service/refuse vehicle cannot turn left from the site without encroaching onto the right turn lane. Insufficient carriageway widths to accommodate long wheel based vehicular turning movements may increase the risk of vehicle on vehicle side impact/sideswipe type collisions.

The Audit Team recommends providing adequate carriageway geometry to ensure that all likely vehicle types to use this junction can carry out turning safely and without obstruction.
