# Begbroke Innovation District

## Desk Study Review and Ground Investigation

*For Oxford University Development Limited*

*Doc ref: 19114-HYD-XX-XX-RP-GE-01002-S2-P08*

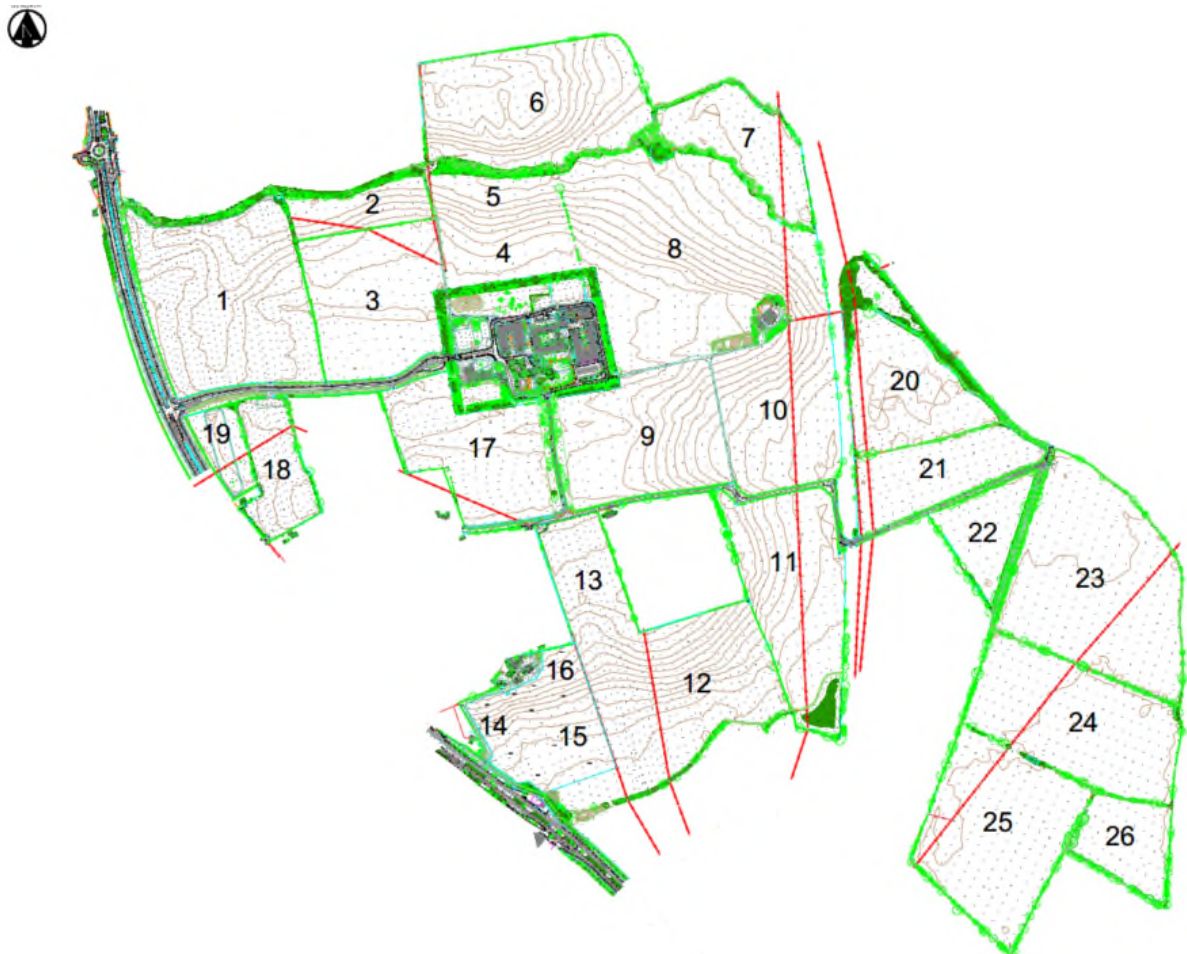
Figure 2.2: Field Numbering Plan

Jubb Consulting (2018) subdivided the site into 19 individual areas west of the railway line (east of the railway line was beyond the scope of their report) (see Appendix B) which are summarised below, along with Hydrock’s observations during later walkover surveys and investigation works. Field numbering is as indicated in Figure 2.2, which corresponds with Jubb (2018) and, in order to retain consistency, Hydrock have continued the numbering sequence to cover the remaining fields (Fields 20 to 26). Individual field descriptions are presented in Table 2.1 and Table 2.2.
