Appendix B Desk Study Research Information

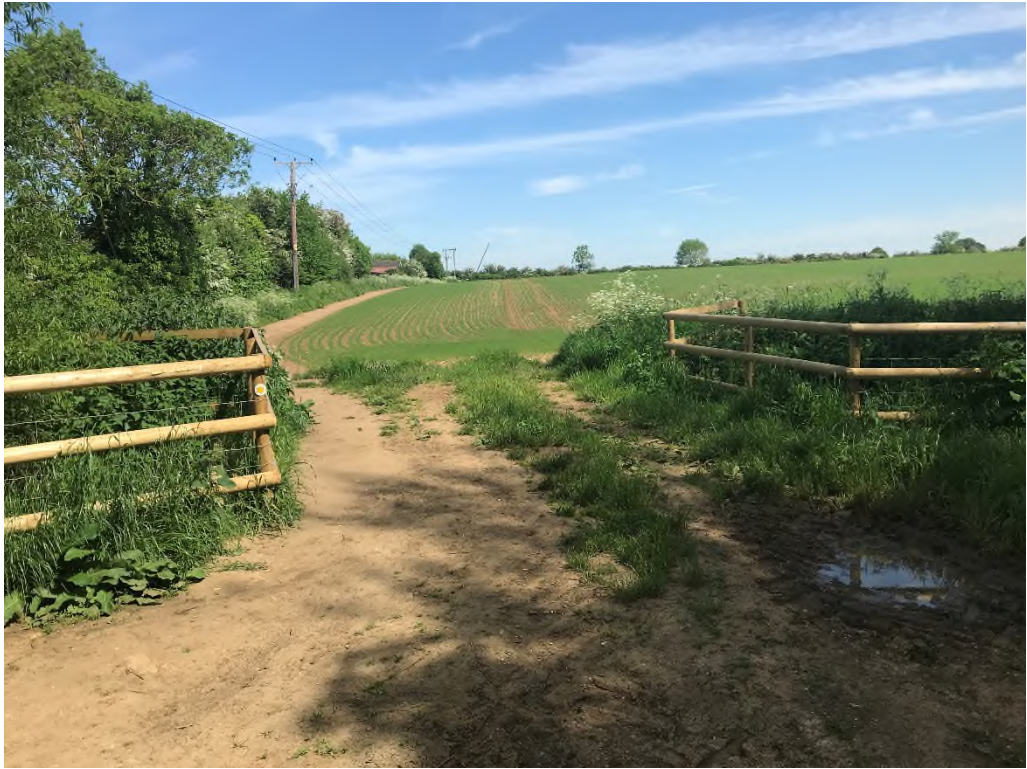
<p>Desk Study Photograph 12</p>
<p>Date: 02/06/2021</p>
<p>Direction Photograph Taken: East</p>
<p>Description: Overview of Field 6</p>

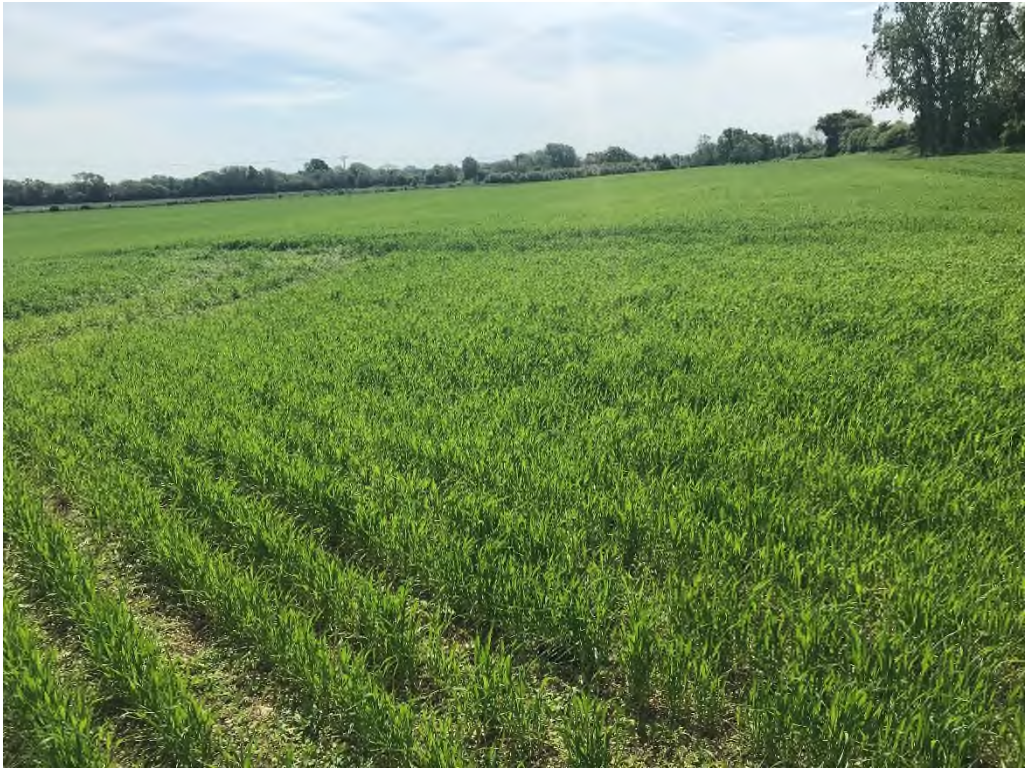
<p>Desk Study Photograph 26</p>
<p>Date: 02/06/21</p>
<p>Direction Photograph Taken: South</p>
<p>Description: Overview of field 12 / 13</p>

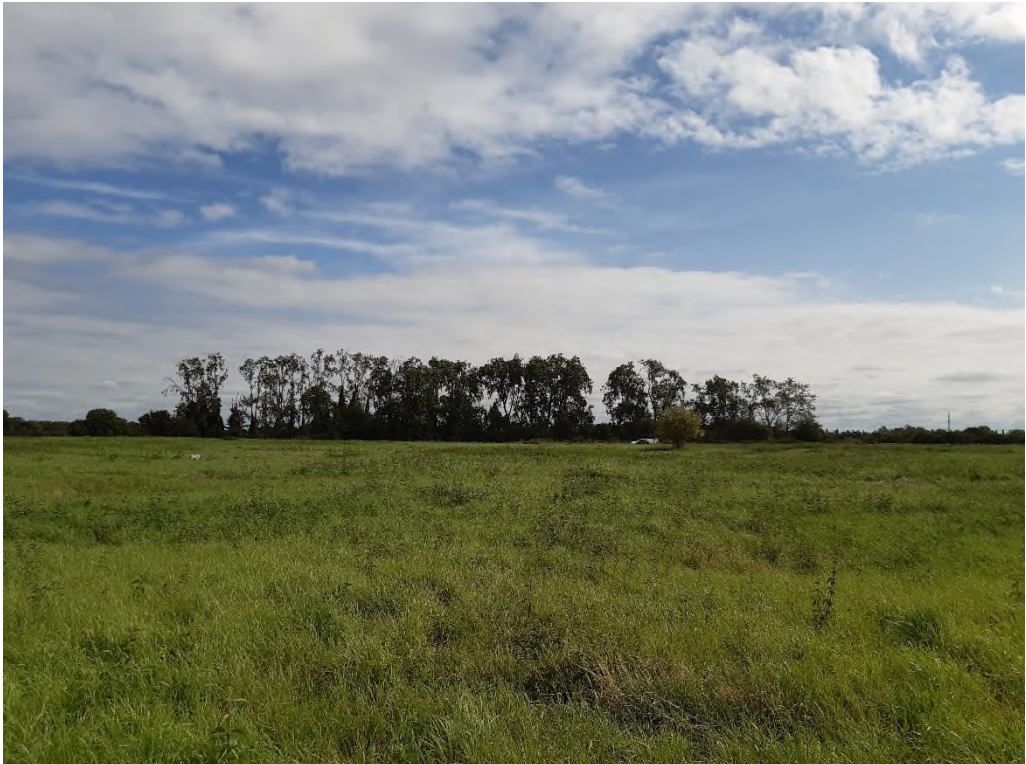
<p>Desk Study Photograph 29</p>

<p>Date: 19/08/21</p>	
<p>Direction Photograph Taken: Looking east from western site boundary.</p>	
<p>Description: Site from the western site boundary. Trees on eastern boundary. (Landfill)</p>

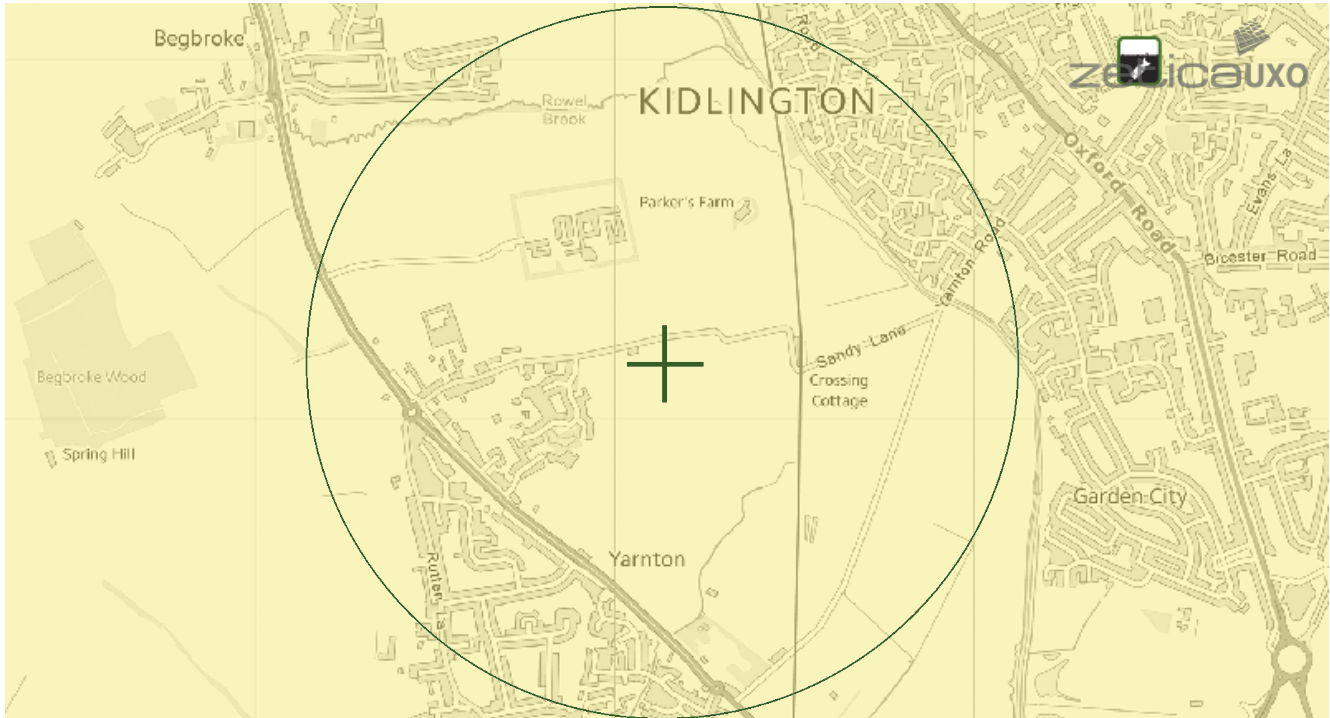
UNEXPLODED BOMB RISK MAP

- High:** Areas indicated as having a bombing density of 50 bombs per 1000acre or higher.
- Moderate:** Areas indicated as having a bombing density of 15 to 49 bombs per 1000acre.
- Low:** Areas indicated as having 15 bombs per 1000acre or less.

The map indicates the potential for Unexploded Bombs (UXB) to be present as a result of World War Two (WWII) bombing.

Generally, we recommend that a detailed UXO desk study and risk assessment is undertaken for sites in a moderate or high UXB risk area.

Similarly, if your site is near to a designated Luftwaffe target or bombing decoy then additional detailed research is recommended.

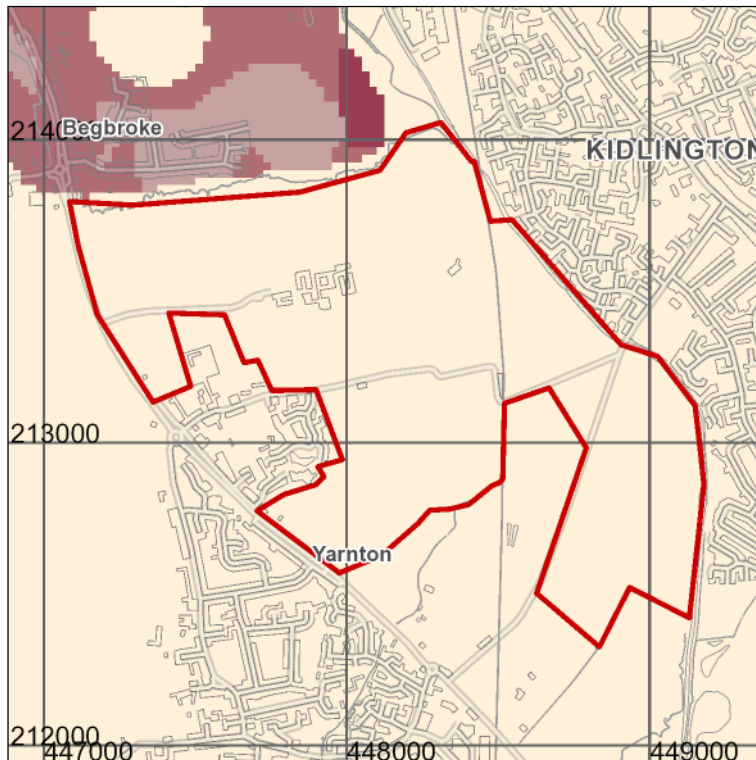
Radon Affected Area

% Homes estimated to be at or above the action level
0-1%
1-3%
3-5%
5-10%
10-30%
30-100%

Contains OS data © Crown Copyright and database right 2023
 Scale: 1:25 000 (1cm = 250 m)
 Search area indicated in red

The UKHSA recommends a radon 'Action Level' of 200 Becquerels per cubic metre of air (Bq m^{-3}) for the annual average of the radon gas concentration in a home. Where 1% or more of homes are estimated to be at or above the Action Level the area should be regarded as a radon Affected Area.
