Method: Dynamic Sampled & Rotary Cored	Date(s): 07/02/2023	Logged By: ZC	Drilled By: Marshall Drilling
Client: Oxford University Development	Co-ords: 447465.29, 213576.01	Checked By: NT	Flush:
Hydrock Project No: C-19114-C	Ground Level: 68.30m OD		Scale: 1:50

Project: Begbroke

Borehole No
RO308
Page No. 2 of 2

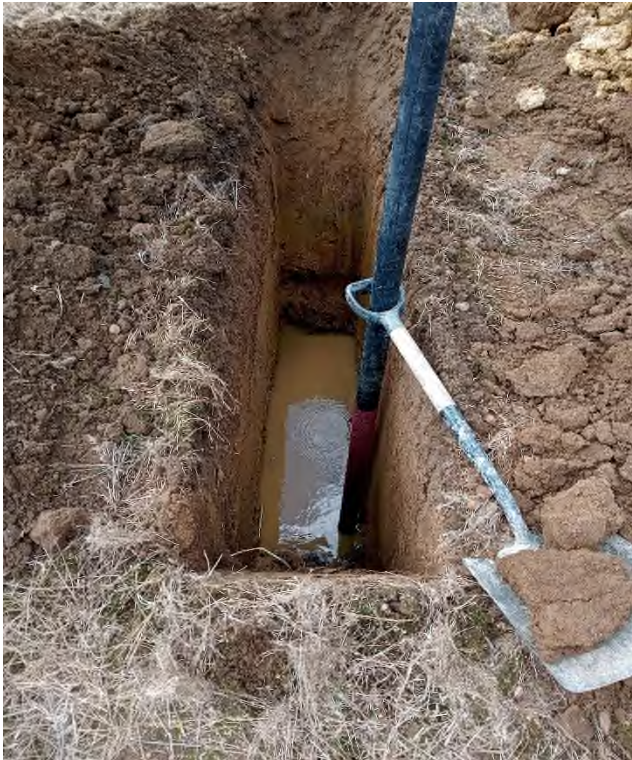
<p>Site Investigation Photograph 4</p>

<p>Date: 27/09/21</p>	
<p>Direction Photograph Taken: n/a.</p>	
<p>Description: SA04 water ingress at base of the pit, with soakaway monitoring pipes being installed.</p>

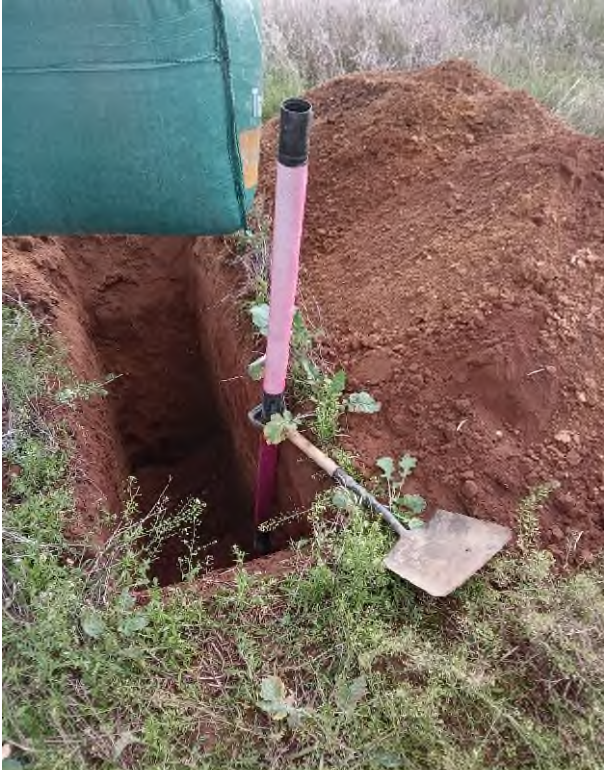
<p>Site Investigation Photograph 9</p>

<p>Date: 28/09/21</p>	
<p>Direction Photograph Taken: n/a</p>	
<p>Description: SA06 with gravel about to be placed in the pit and arisings comprising agriculturally disturbed topsoil over river terrace deposits.</p>

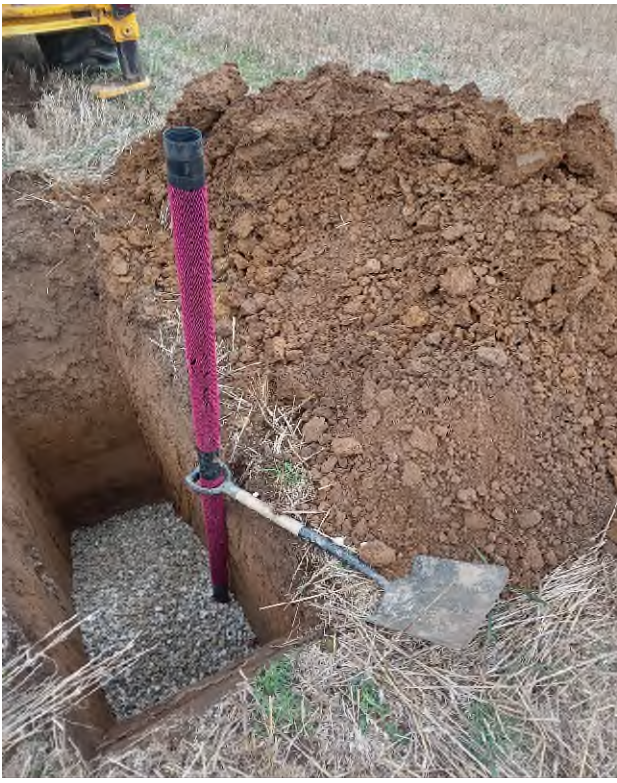
<p>Site Investigation Photograph 12</p>

<p>Date: 28/09/21</p>	
<p>Direction Photograph Taken: n/a</p>	
<p>Description: SA08 with gravel and soakaway monitoring pipes placed in the pit. Arisings comprising of agriculturally disturbed topsoil over river terrace deposits over oxford clay.</p>

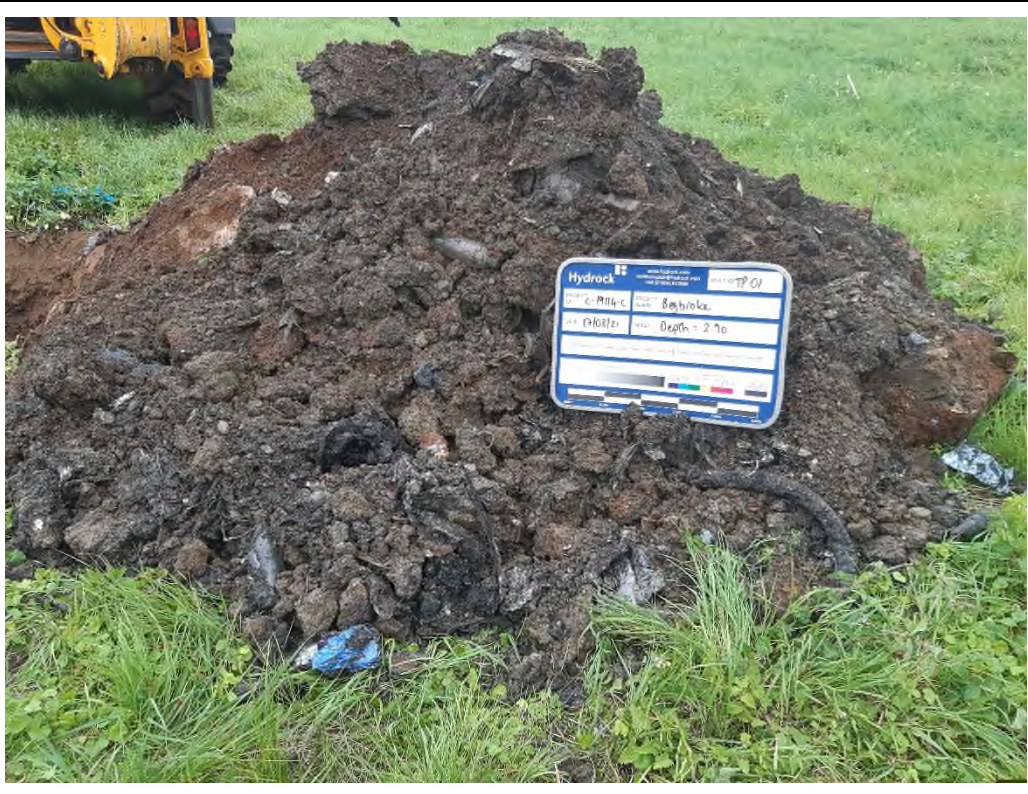
Site Investigation Photograph 15
Date: 17/08/21
Direction Photograph Taken: n/a.
Description: Spoil from TP01.

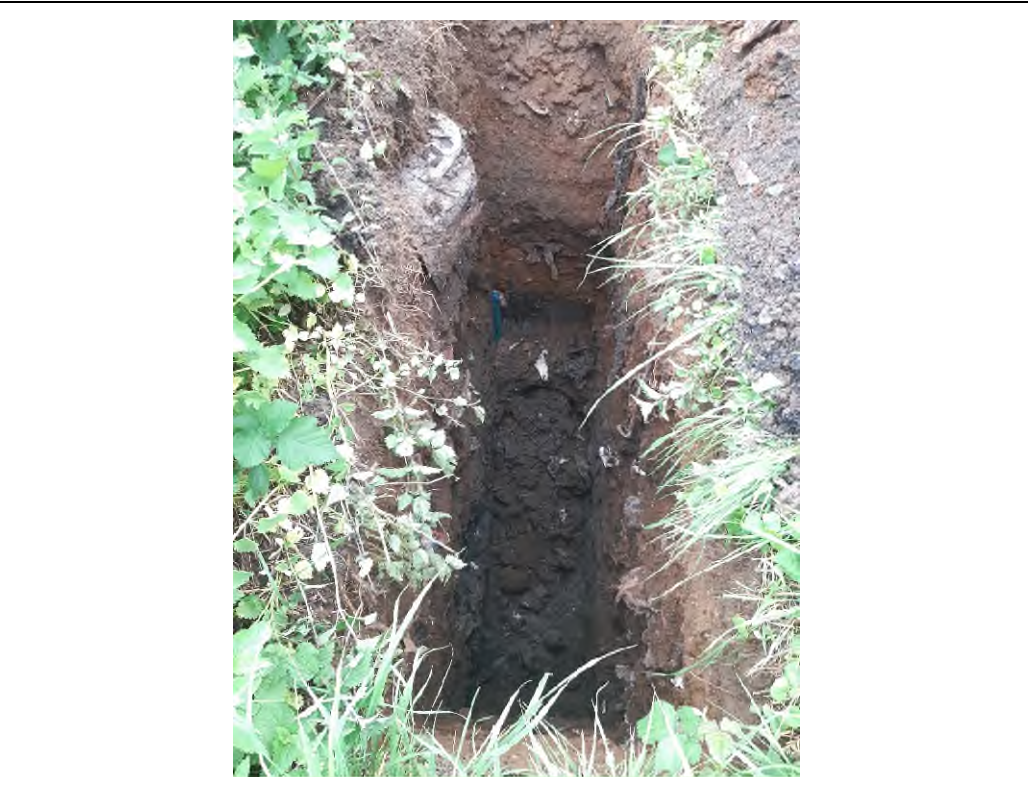
Site Investigation Photograph 16
Date: 17/08/21
Direction Photograph Taken: n/a.
Description: TP01 down pit.

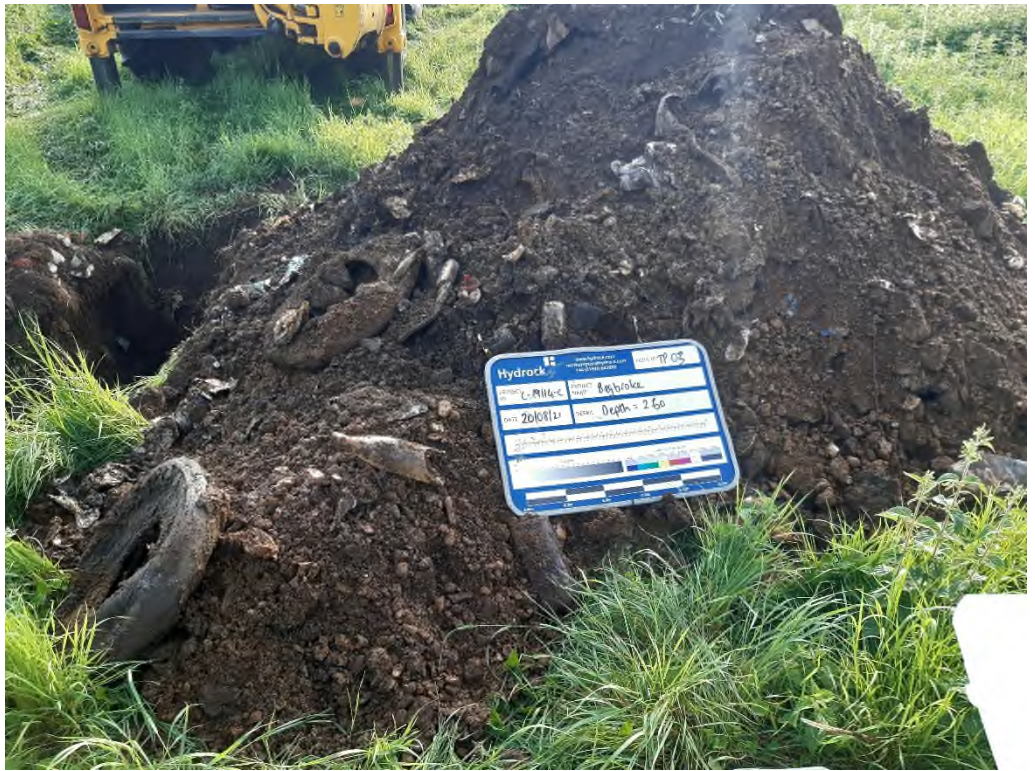
Site Investigation Photograph 19
Date: 20/08/21
Direction Photograph Taken: n/a.
Description: Spoil from TP03.

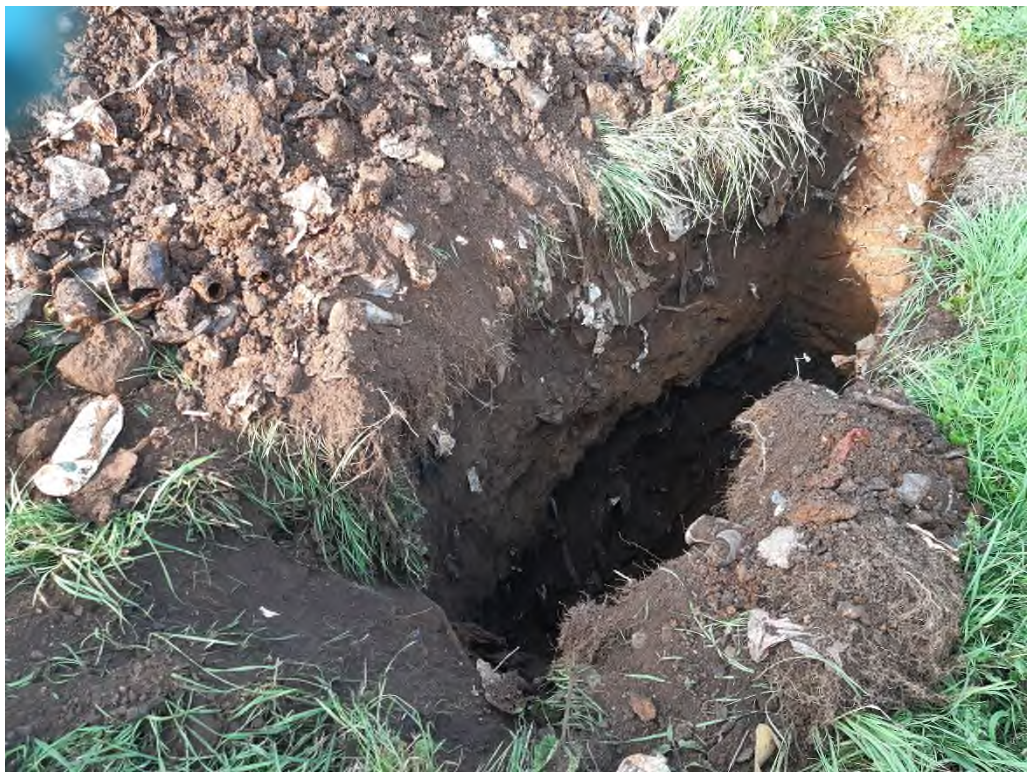
Site Investigation Photograph 20
Date: 20/08/21
Direction Photograph Taken: n/a.
Description: TP03 down pit.

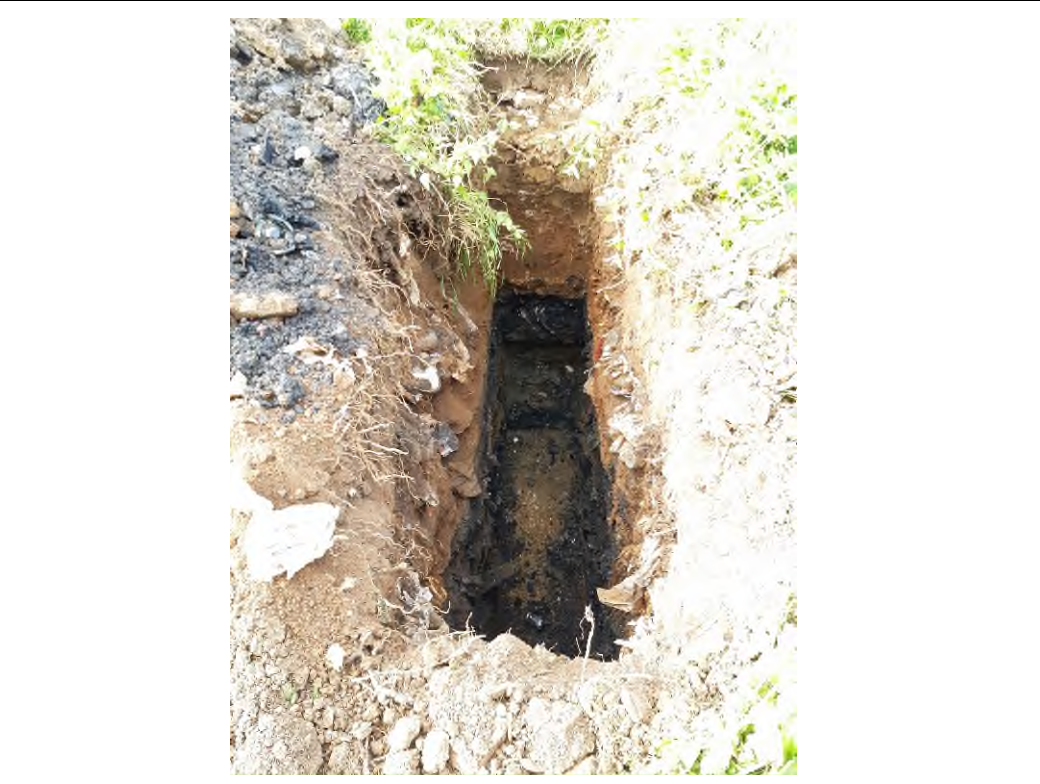
<p>Site Investigation Photograph 24</p>

<p>Date: 20/08/21</p>	
<p>Direction Photograph Taken: n/a.</p>	
<p>Description: TP05 down pit.</p>

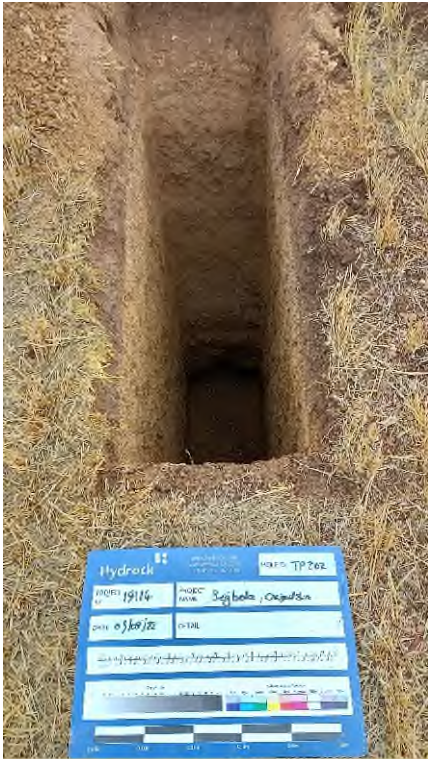
<p>Site Investigation Photograph 31</p>
<p>Date: 09/09/22</p>
<p>Direction Photograph Taken: n/a.</p>
<p>Description: TP202 down pit showing River Terrace Deposits.</p>

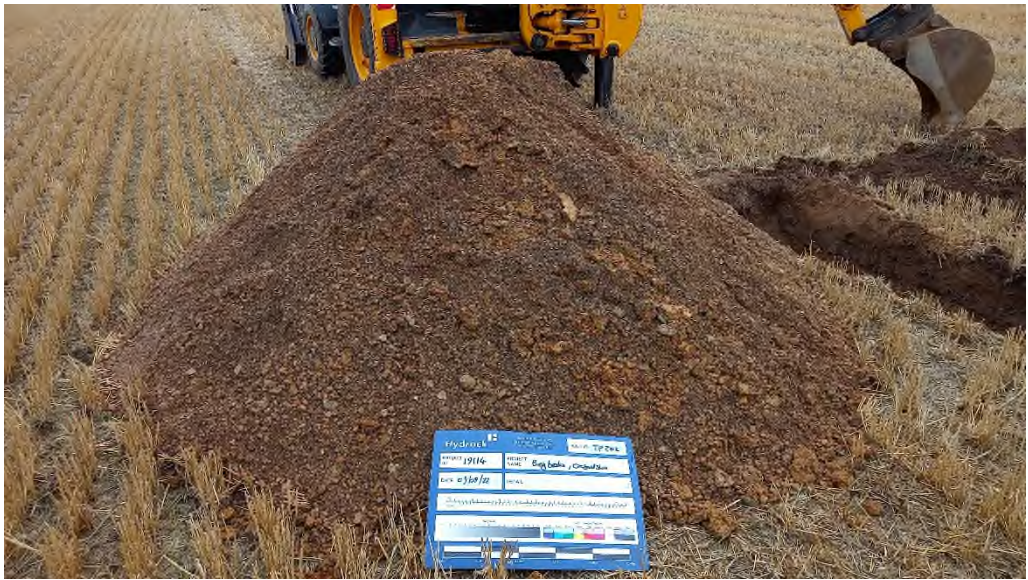
<p>Site Investigation Photograph 32</p>
<p>Date: 09/09/22</p>
<p>Direction Photograph Taken: n/a.</p>
<p>Description: TP202 spoil pile showing arisings of River Terrace Deposits.</p>

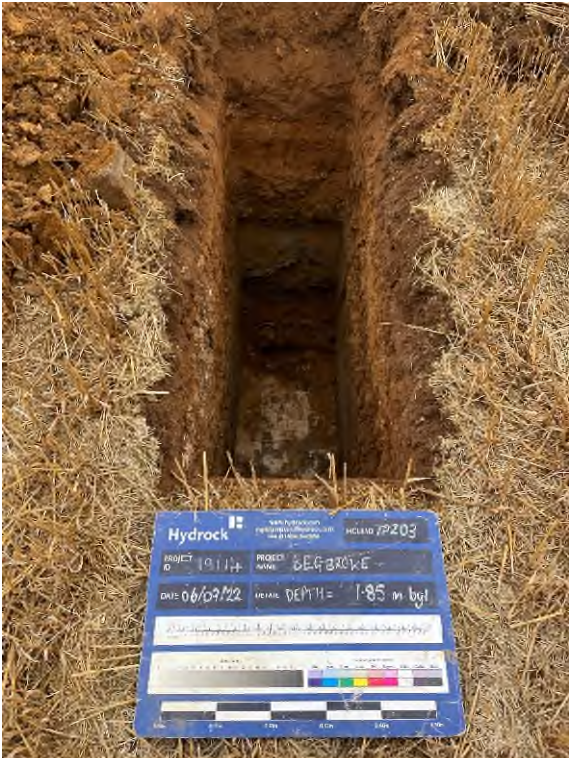
<p>Site Investigation Photograph 33</p>
<p>Date: 06/09/22</p>
<p>Direction Photograph Taken: n/a.</p>
<p>Description: TP203 down pit showing Cornbrash Limestone at base.</p>

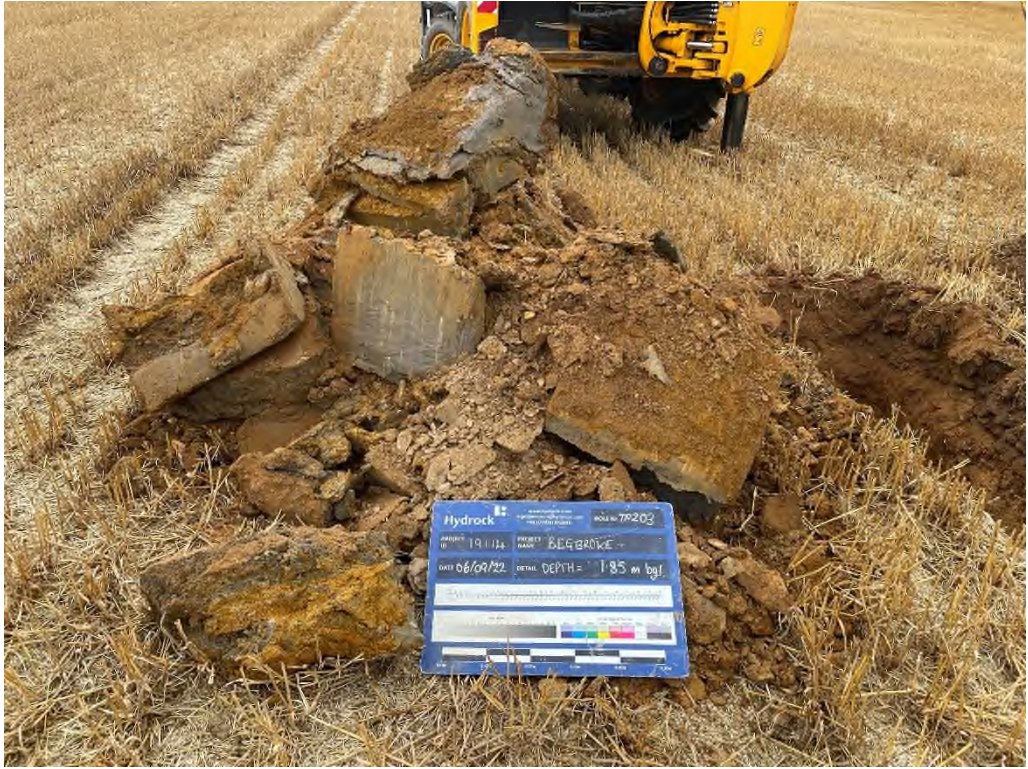
<p>Site Investigation Photograph 34</p>
<p>Date: 06/09/22</p>
<p>Direction Photograph Taken: n/a.</p>
<p>Description: TP203 spoil pile showing River Terrace Deposits and Kellaways Clay Member.</p>

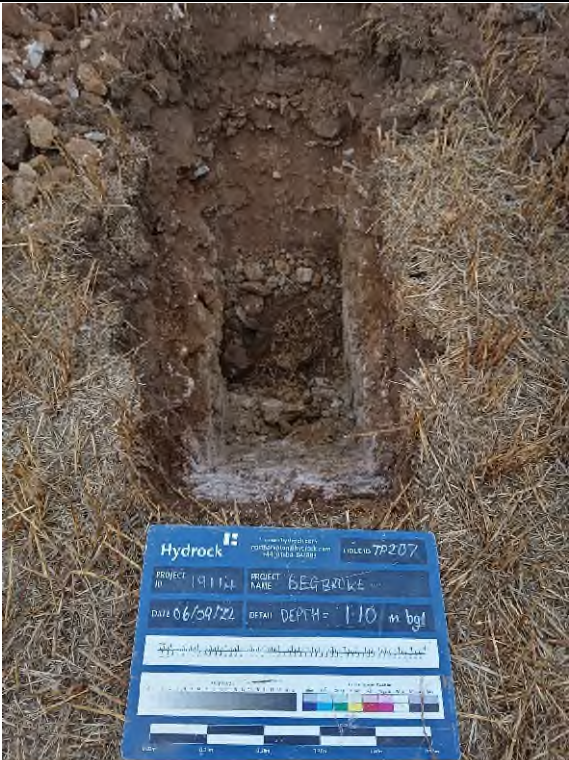
<p>Site Investigation Photograph 41</p>
<p>Date: 06/09/22</p>
<p>Direction Photograph Taken: n/a.</p>
<p>Description: TP207 down pit showing Cornbrash Limestone Formation.</p>

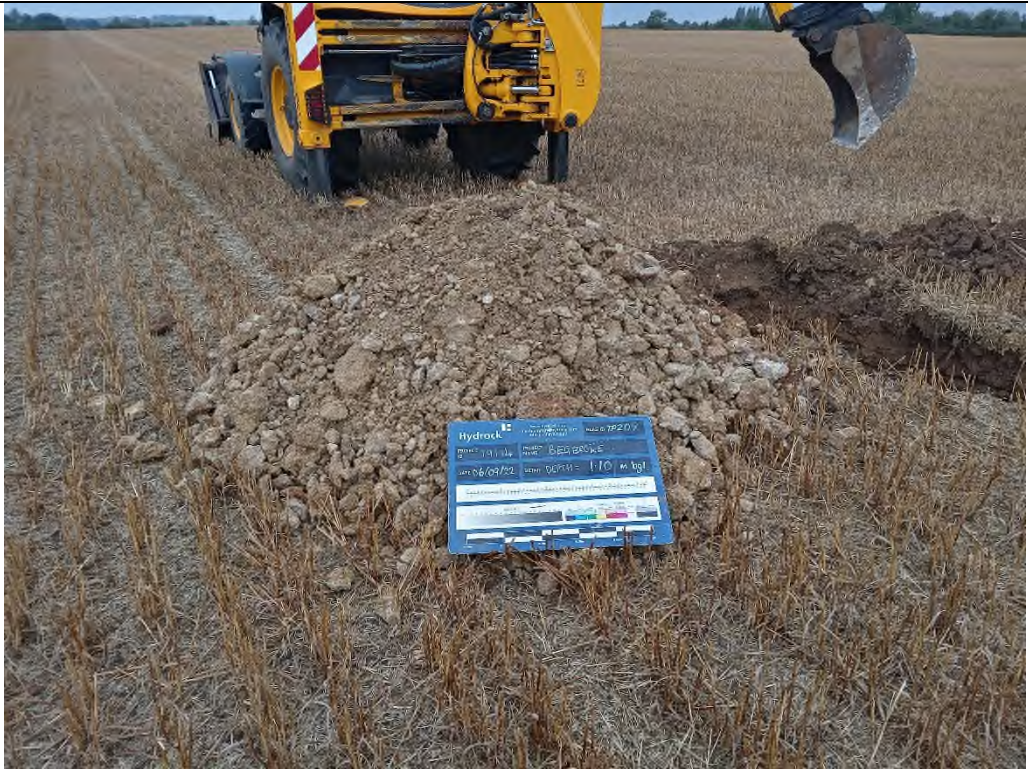
<p>Site Investigation Photograph 42</p>
<p>Date: 06/09/22</p>
<p>Direction Photograph Taken: n/a.</p>
<p>Description: TP207 spoil pile showing arisings of Cornbrash Limestone Formation.</p>

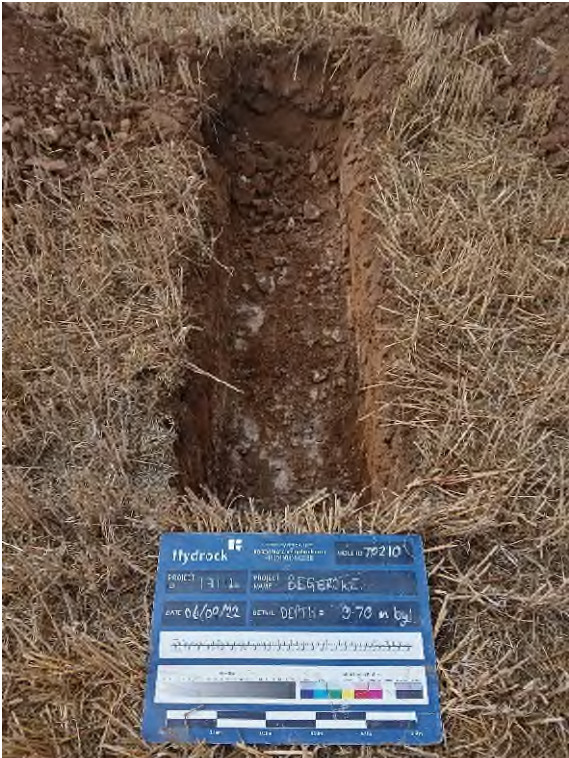
Site Investigation Photograph 47
Date: 06/09/22
Direction Photograph Taken: n/a.
Description: TP209 showing Head Deposits over Cornbrash Limestone Formation.

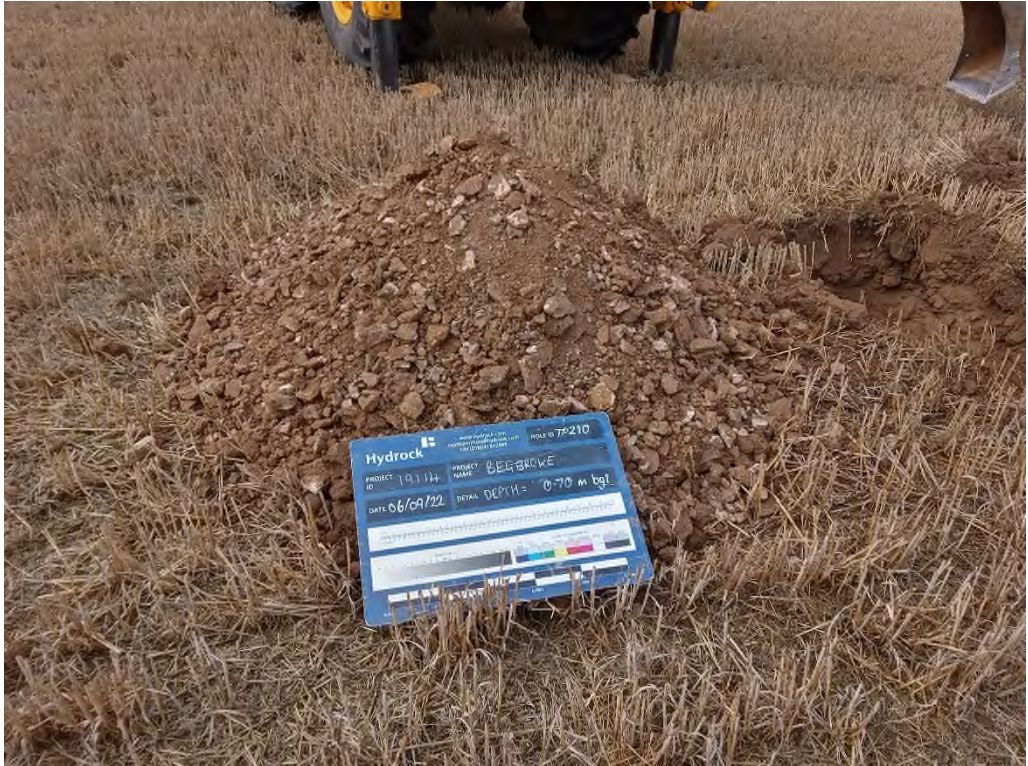
Site Investigation Photograph 48
Date: 06/09/22
Direction Photograph Taken: n/a.
Description: TP210 spoil pile showing arisings of Cornbrash Limestone Formation.

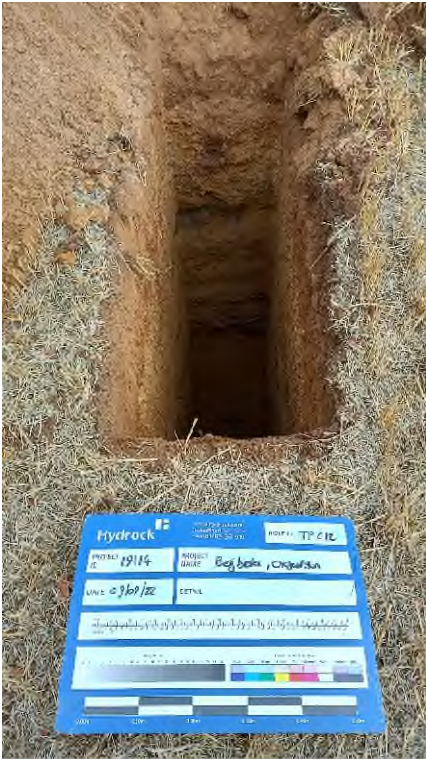
<p>Site Investigation Photograph 51</p>

<p>Date: 09/09/22</p>	
<p>Direction Photograph Taken: n/a.</p>	
<p>Description: TP212 showing River Terrace Deposits.</p>

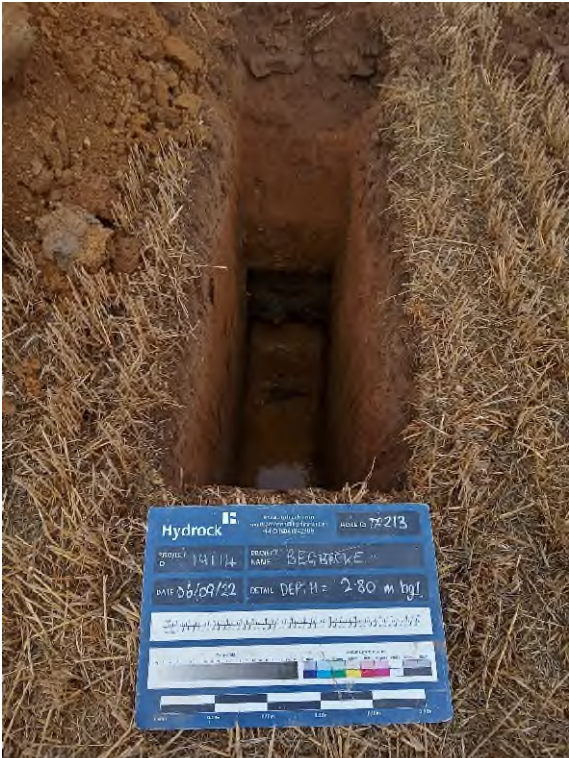
<p>Site Investigation Photograph 53</p>

<p>Date: 06/09/22</p>	
<p>Direction Photograph Taken: n/a.</p>	
<p>Description: TP213 down pit showing River Terrace over Kellaways Clay Member and groundwater.</p>

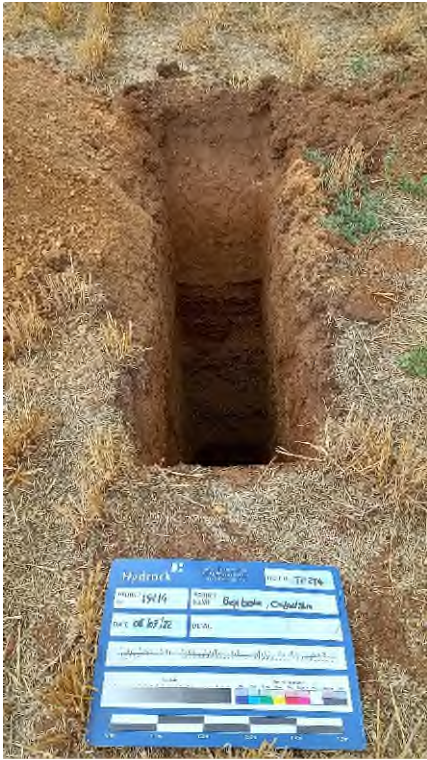
<p>Site Investigation Photograph 55</p>

<p>Date: 08/09/22</p>	
<p>Direction Photograph Taken: n/a.</p>	
<p>Description: TP214 down pit showing River Terrace Deposits.</p>

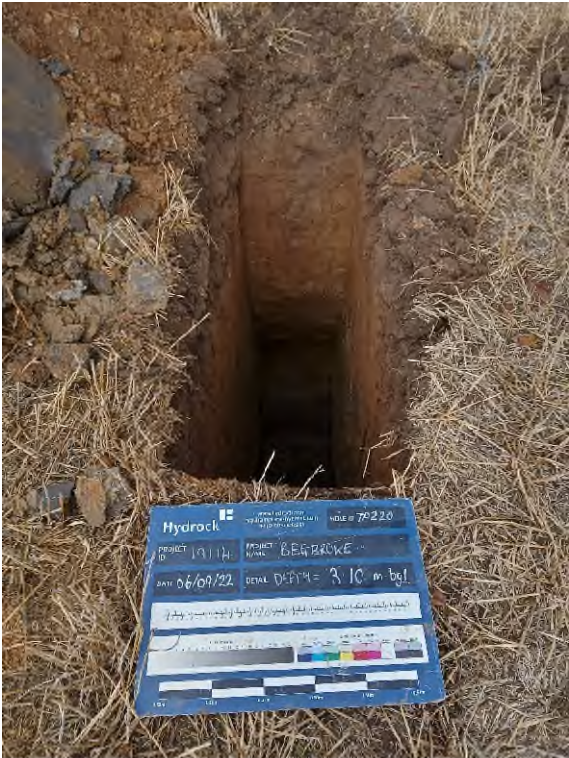
Site Investigation Photograph 65
Date: 06/09/22
Direction Photograph Taken: n/a.
Description: TP220 down pit showing River Terrace Deposits over Kellways Clay and Sand Members.

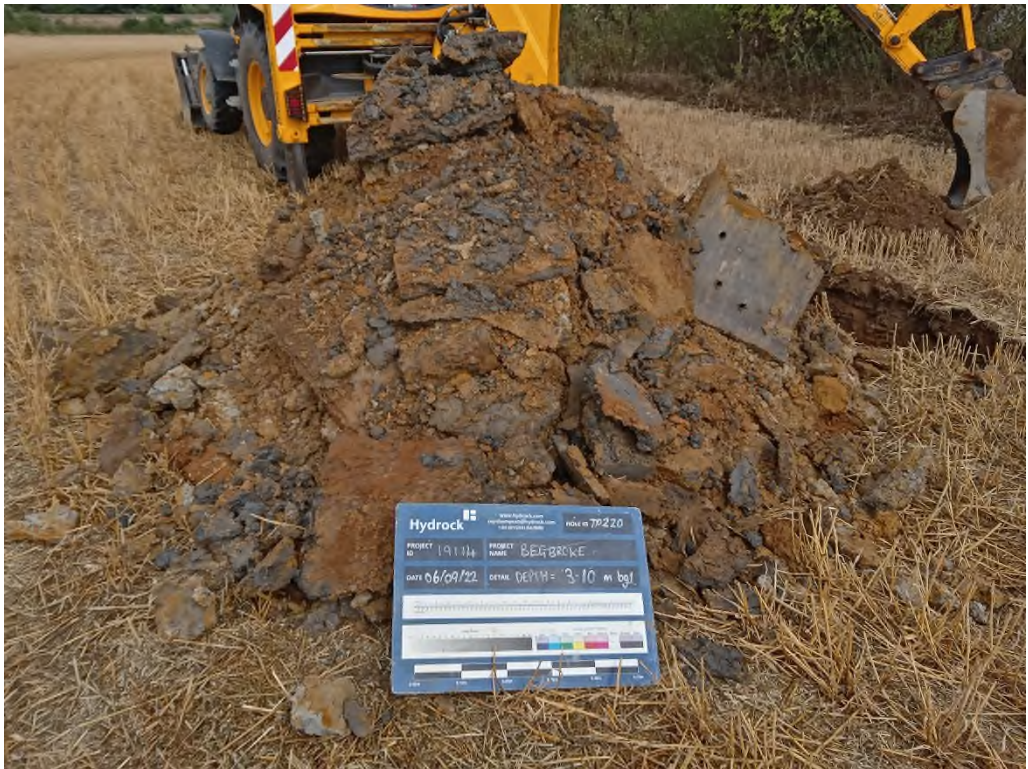
Site Investigation Photograph 66
Date: 06/09/22
Direction Photograph Taken: n/a.
Description: TP220 spoil pile showing arisings of Kellways Clay and Sand Members.

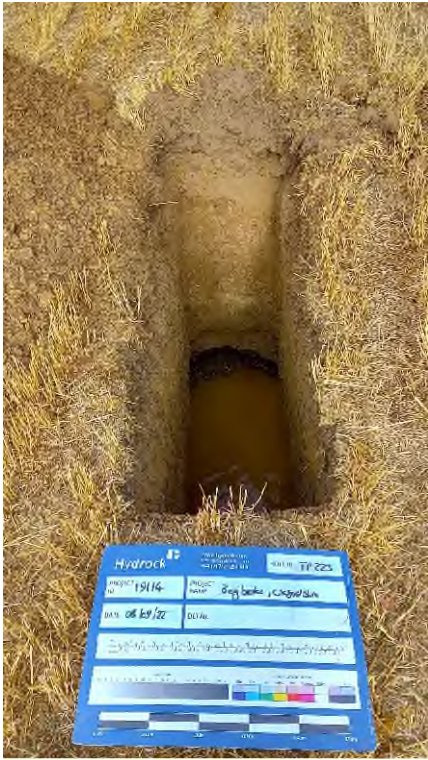
<p>Site Investigation Photograph 69</p>
<p>Date: 08/09/22</p>
<p>Direction Photograph Taken: n/a.</p>
<p>Description: TP223 down pit showing Alluvium over River Terrace Deposits and a groundwater strike.</p>

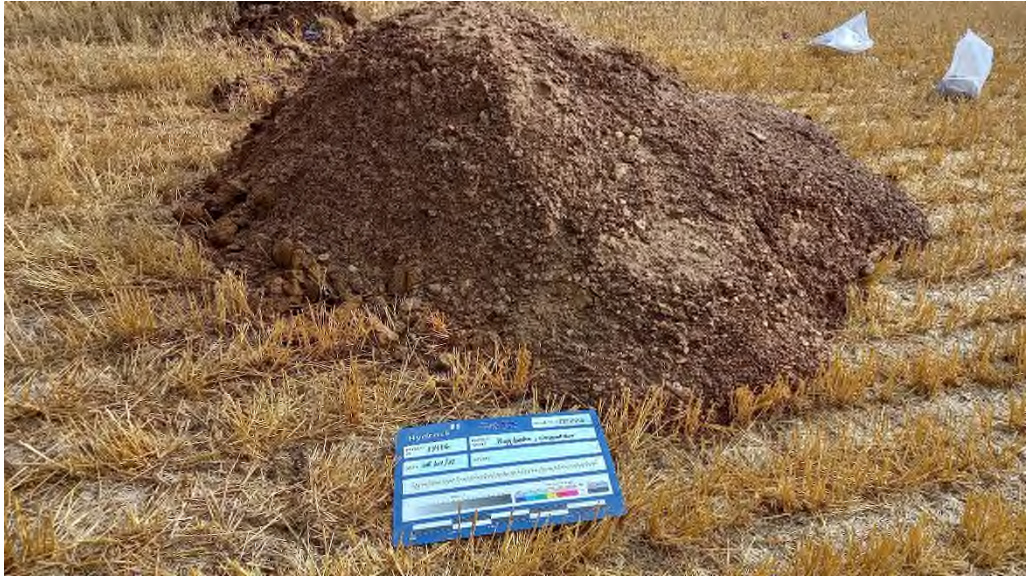
<p>Site Investigation Photograph 70</p>
<p>Date: 08/09/22</p>
<p>Direction Photograph Taken: n/a.</p>
<p>Description: TP223 spoil pile showing arisings of River Terrace Deposits.</p>

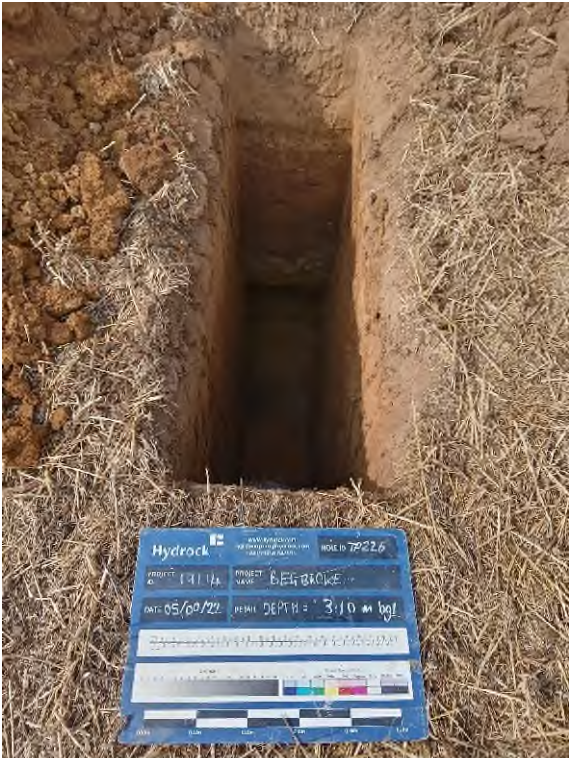
Site Investigation Photograph 73
Date: 05/09/22
Direction Photograph Taken: n/a.
Description: TP226 down pit showing alluvium over River Terrace Deposits.

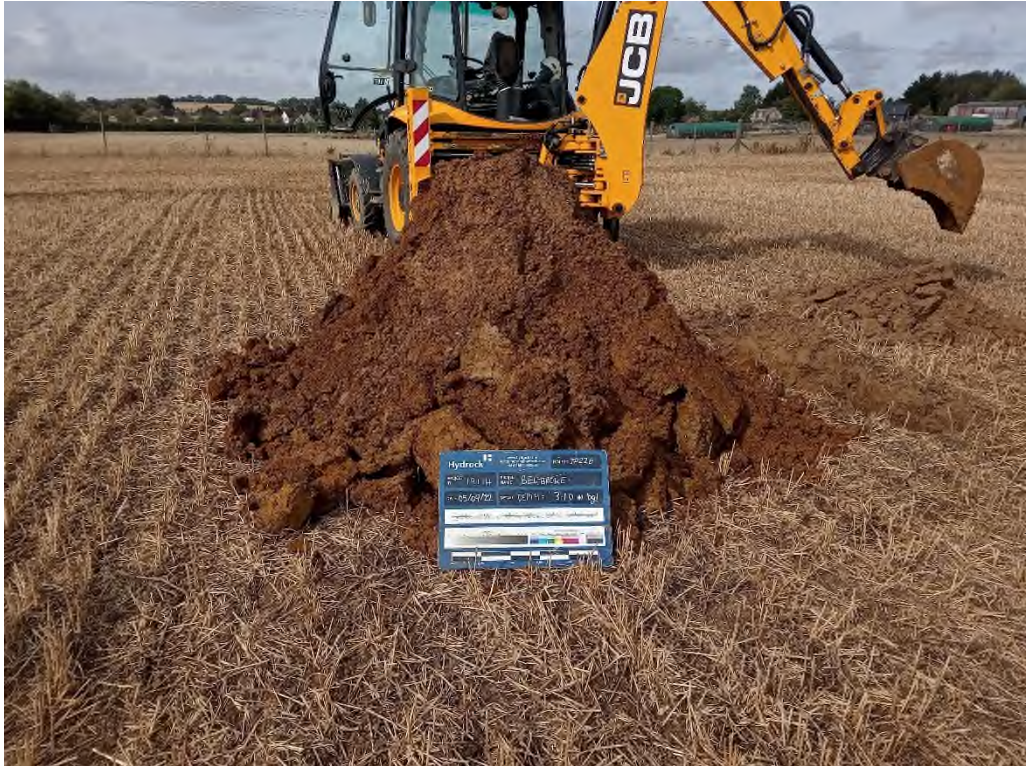
Site Investigation Photograph 74
Date: 05/09/22
Direction Photograph Taken: n/a.
Description: TP226 spoil pile showing arisings of Alluvium and River Terrace Deposits.

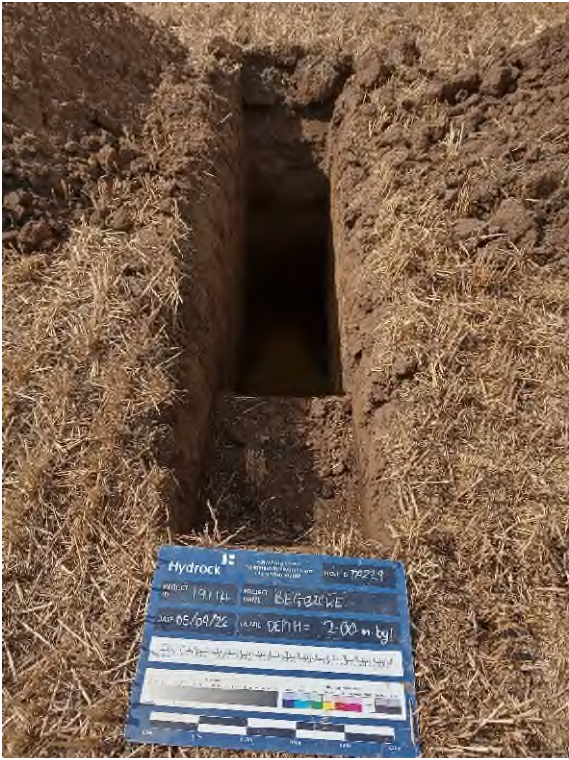
<p>Site Investigation Photograph 75</p>
<p>Date: 05/09/22</p>
<p>Direction Photograph Taken: n/a.</p>
<p>Description: TP229 down pit showing alluvium over River Terrace Deposits.</p>

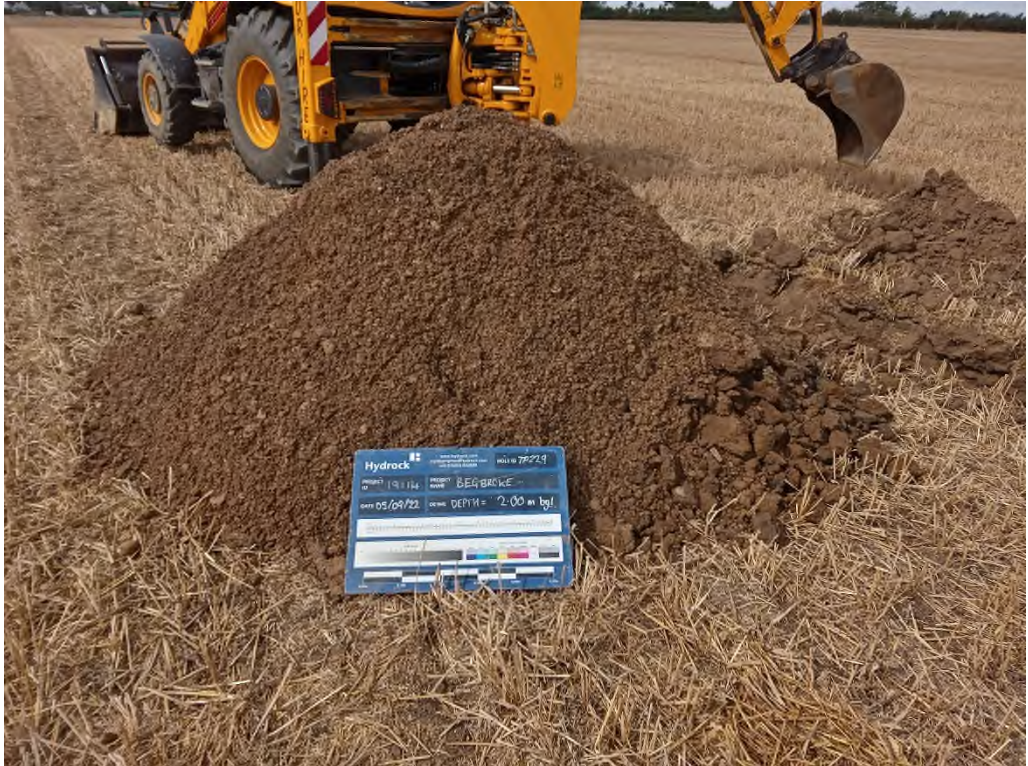
<p>Site Investigation Photograph 76</p>
<p>Date: 05/09/22</p>
<p>Direction Photograph Taken: n/a.</p>
<p>Description: TP229 spoil pile showing arisings of River Terrace Deposits.</p>

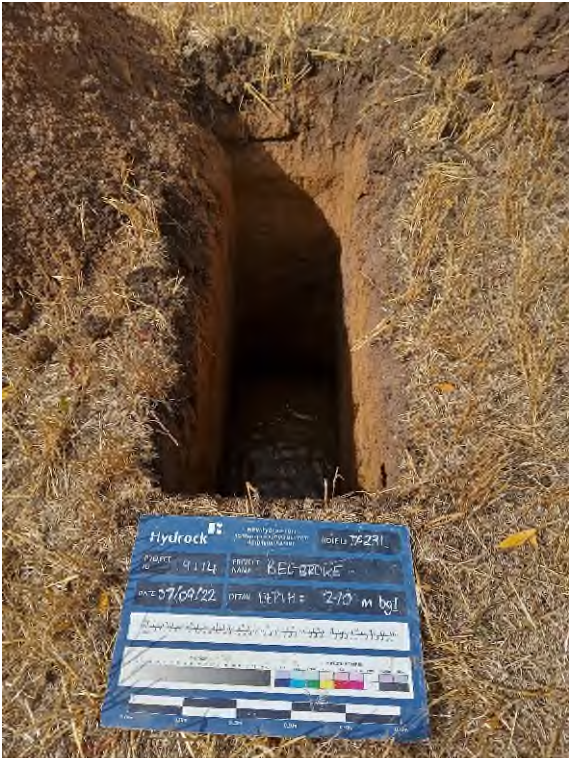
<p>Site Investigation Photograph 79</p>
<p>Date: 07/09/22</p>
<p>Direction Photograph Taken: n/a.</p>
<p>Description: TP231 down hole showing Alluvium over River Terrace Deposits and a groundwater strike.</p>

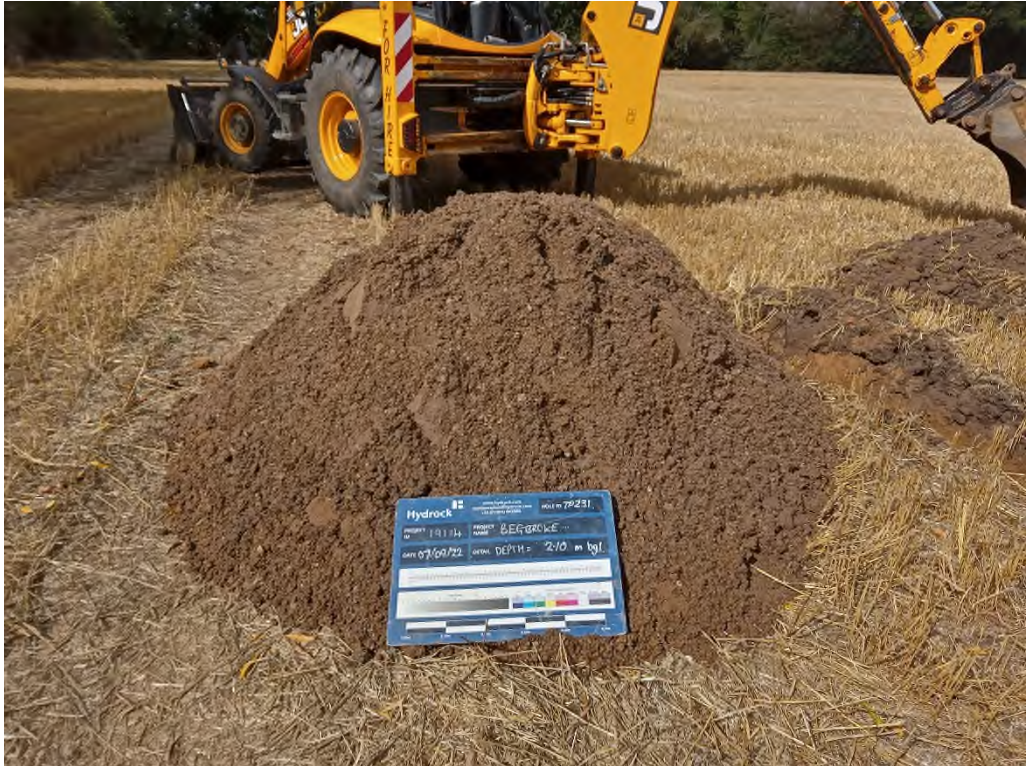
<p>Site Investigation Photograph 80</p>
<p>Date: 07/09/22</p>
<p>Direction Photograph Taken: n/a.</p>
<p>Description: TP231 spoil pile showing arisings of River Terrace Deposits.</p>

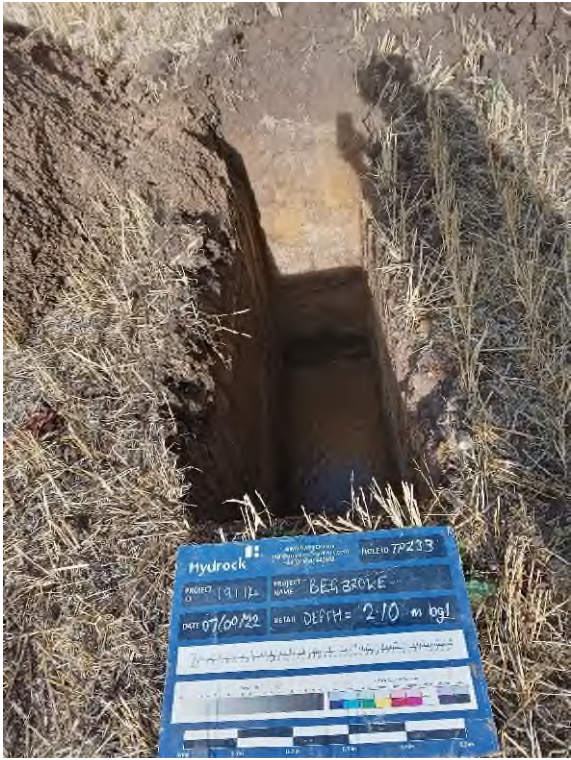
Site Investigation Photograph 81
Date: 07/09/22
Direction Photograph Taken: n/a.
Description: TP233 down pit showing Alluvium, River Terrace Deposits and groundwater strike.

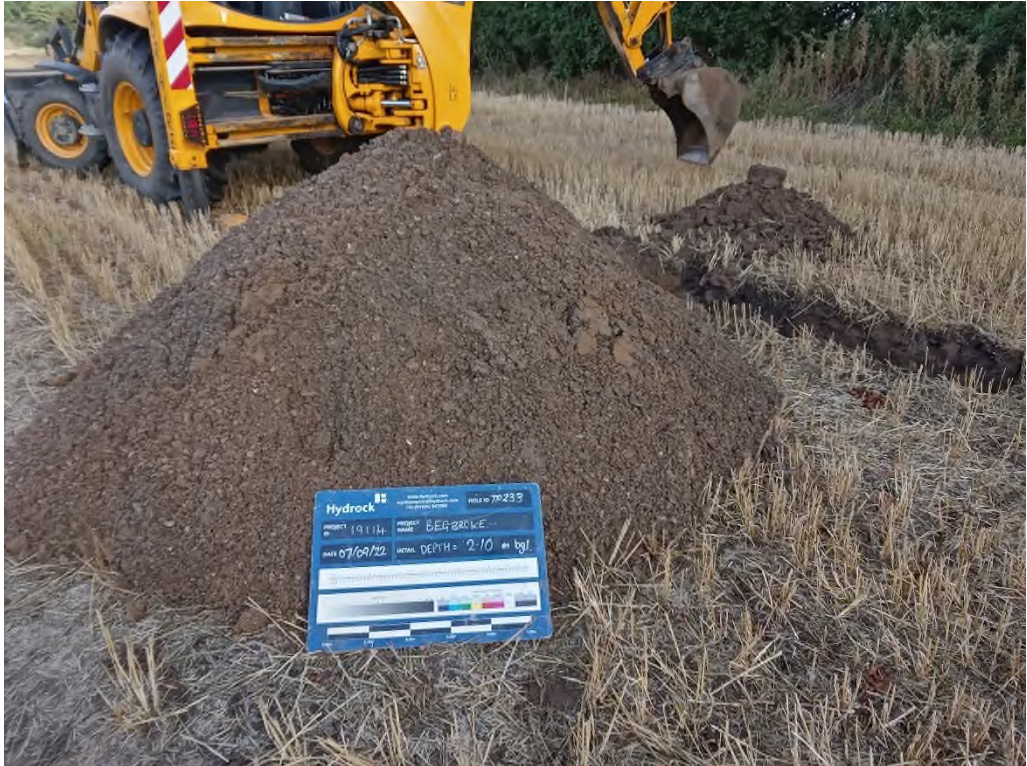
Site Investigation Photograph 82
Date: 07/09/22
Direction Photograph Taken: n/a.
Description: TP233 spoil pile showing arisings of River Terrace Deposits.

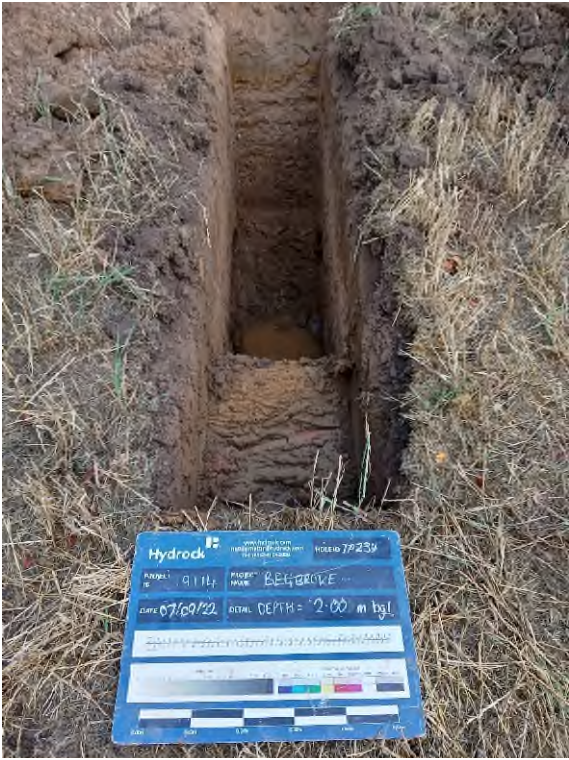
<p>Site Investigation Photograph 83</p>
<p>Date: 07/09/22</p>
<p>Direction Photograph Taken: n/a.</p>
<p>Description: TP234 down pit showing Alluvium over River Terrace Deposits and a ground water strike.</p>

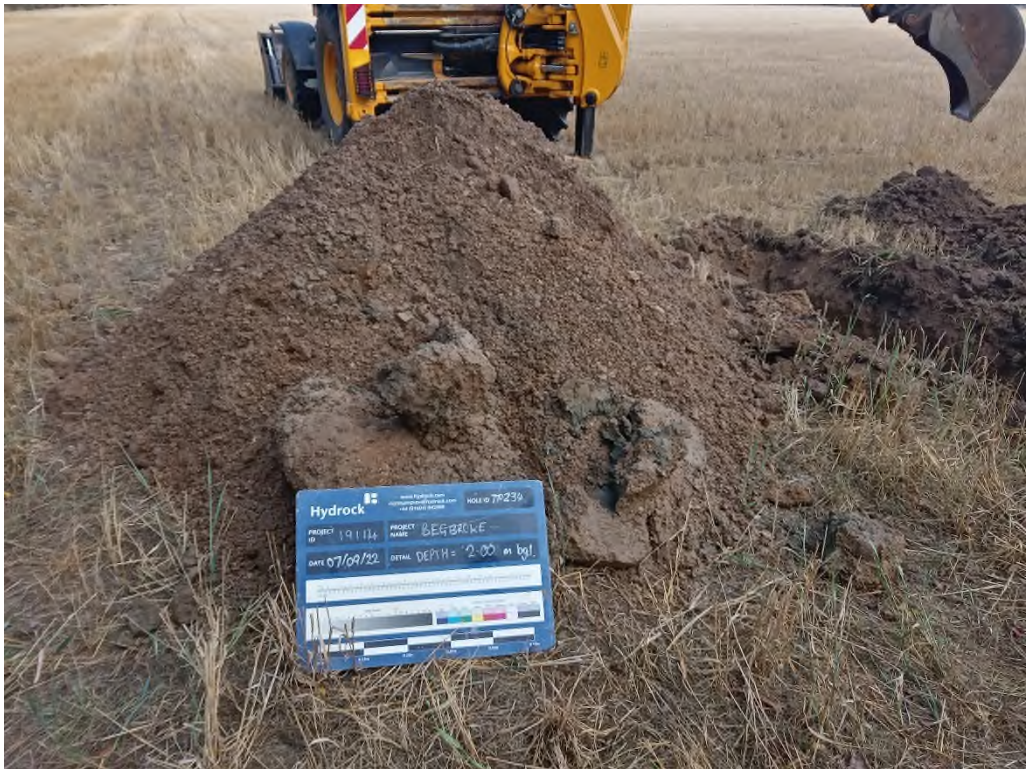
<p>Site Investigation Photograph 84</p>
<p>Date: 07/09/22</p>
<p>Direction Photograph Taken: n/a.</p>
<p>Description: TP234 spoil pile showing arisings of River Terrace Deposits.</p>

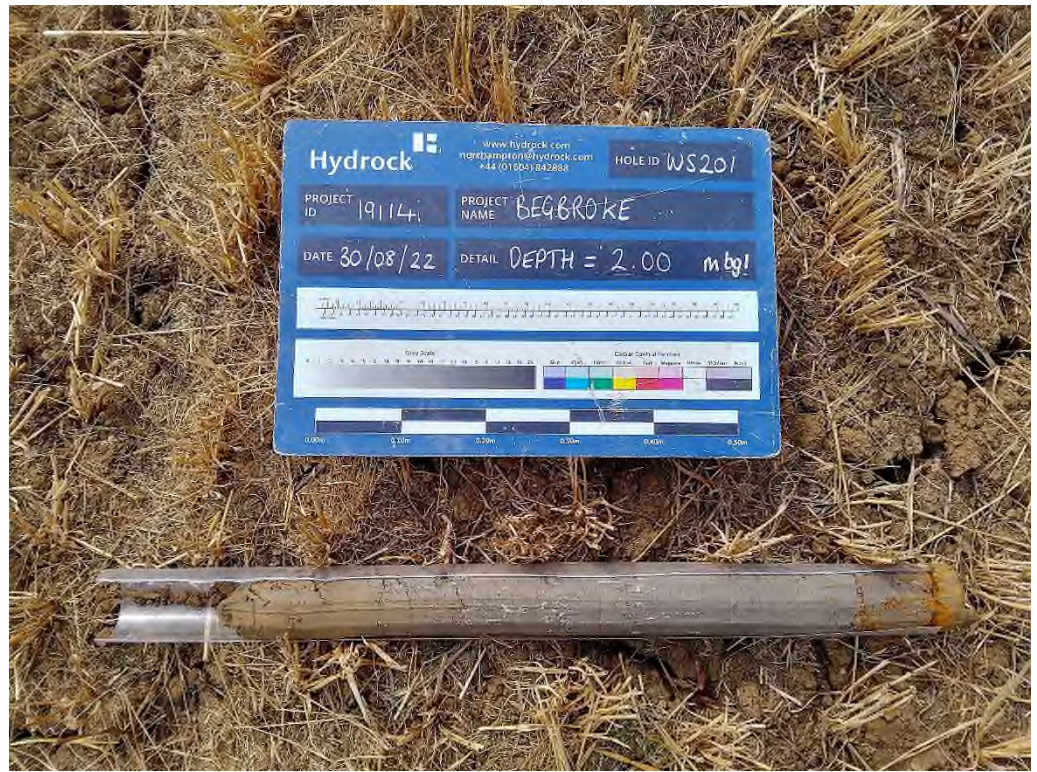
Site Investigation Photograph 85

Description: WS201 1.20 – 2.00m, showing Kellaways Clay Member.

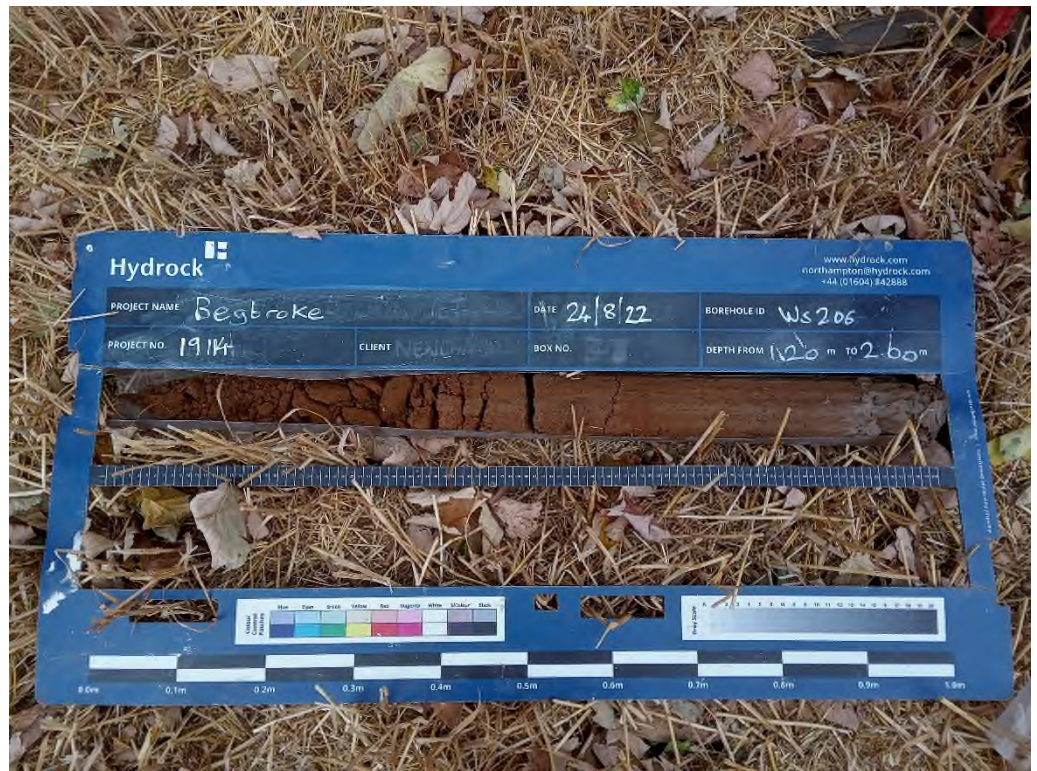
Site Investigation Photograph 86

Description: WS206 1.20 - 2.00m, showing River Terrace Deposits over Kellaways Clay Member.
