Method: Dynamic Sampled & Rotary Cored	Date(s): 07/02/2023	Logged By: ZC	Drilled By: Marshall Drilling
Client: Oxford University Development	Co-ords: 447465.29, 213576.01	Checked By: NT	Flush:
Hydrock Project No: C-19114-C	Ground Level: 68.30m OD		Scale: 1:50

Project: Begbroke

Borehole No
RO308
Page No. 2 of 2

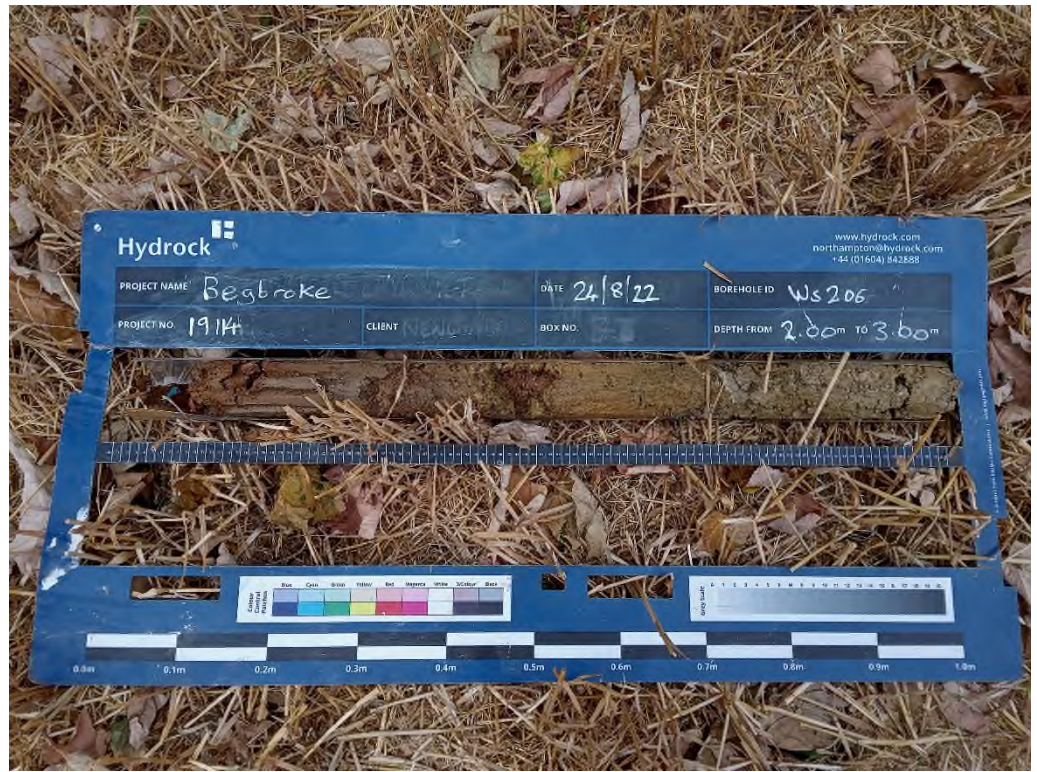
Site Investigation Photograph 87

Description: WS206 2.00 - 3.00m, showing Kellaways Clay Member over Cornbrash Limestone Formation.

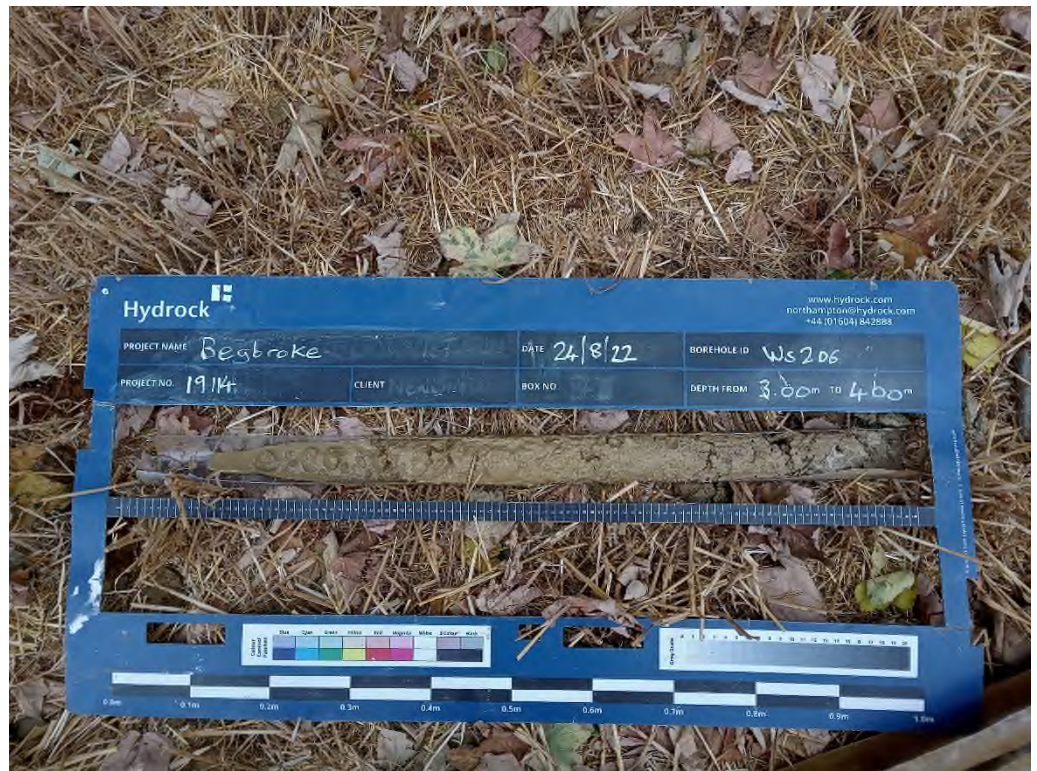
Site Investigation Photograph 88

Description: WS206 3.00 - 4.00m, showing Cornbrash Limestone Formation.

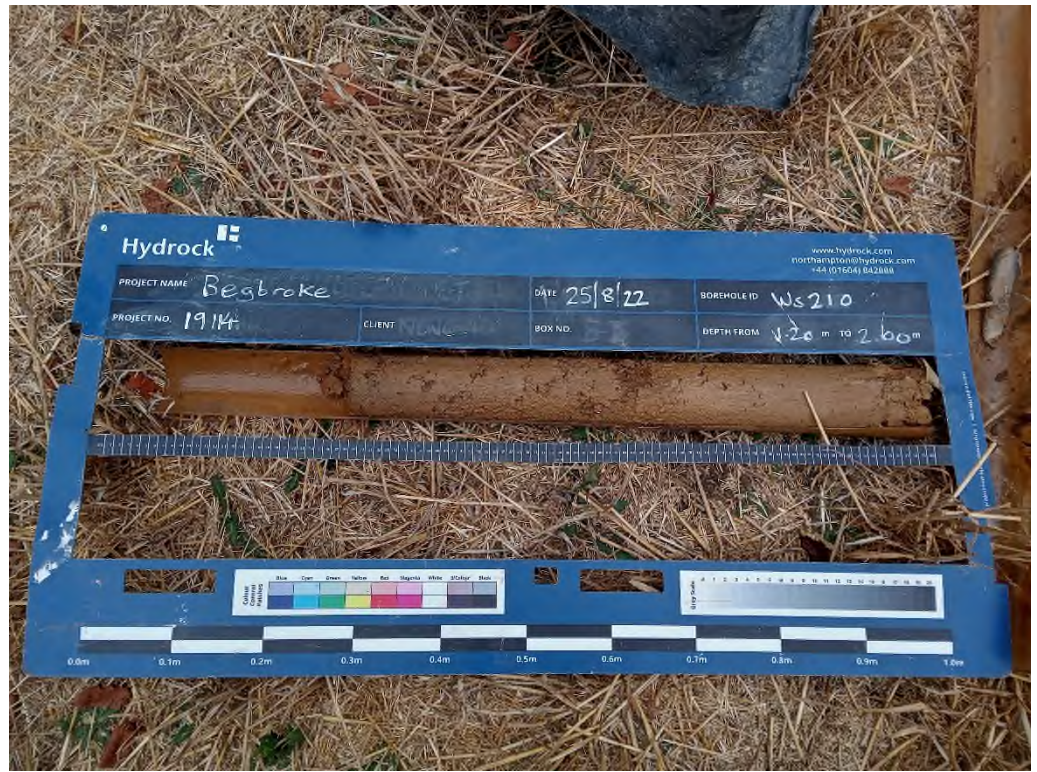
Site Investigation Photograph 89

Description: WS210 1.20 - 2.00m, showing Alluvium.

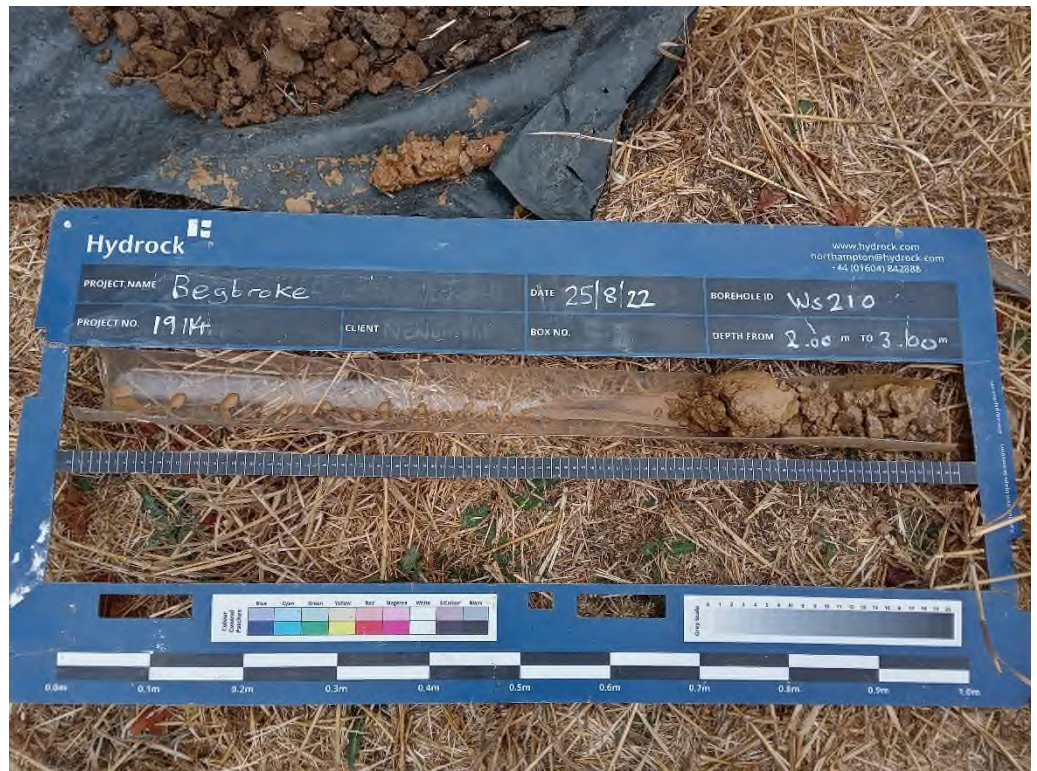
Site Investigation Photograph 90

Description: WS210 2.00 - 3.00m, showing Cornbrash Limestone Formation.

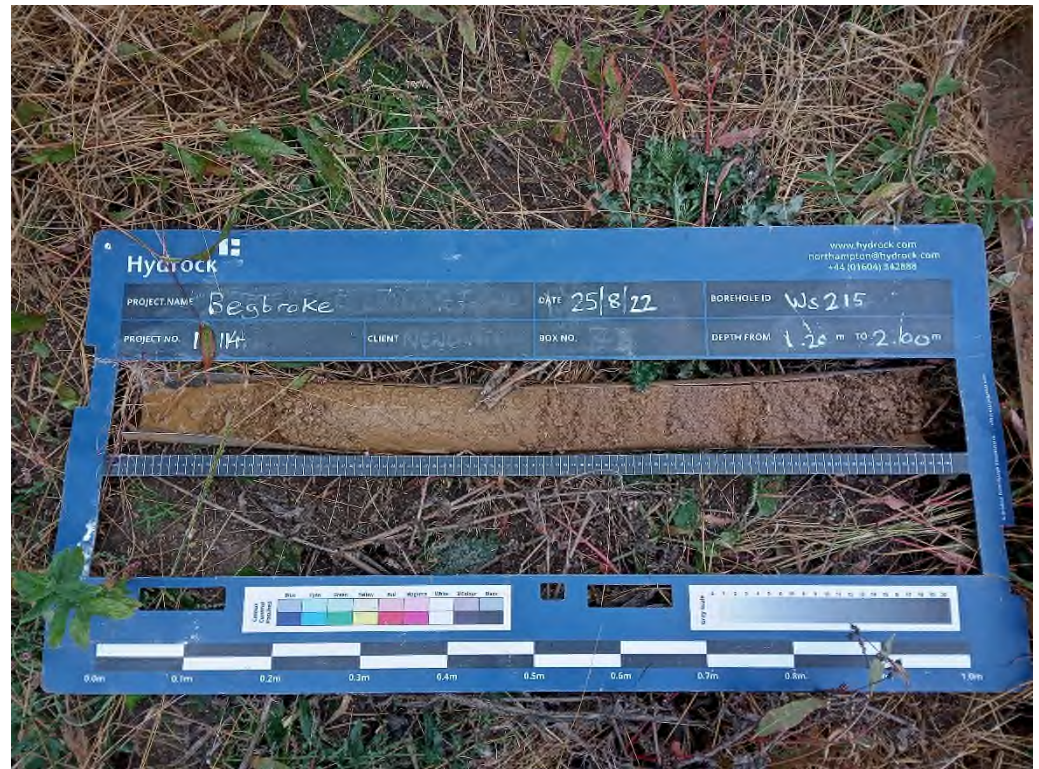
Site Investigation Photograph 91

Description: WS215 1.20 - 2.00m, showing River Terrace Deposits.

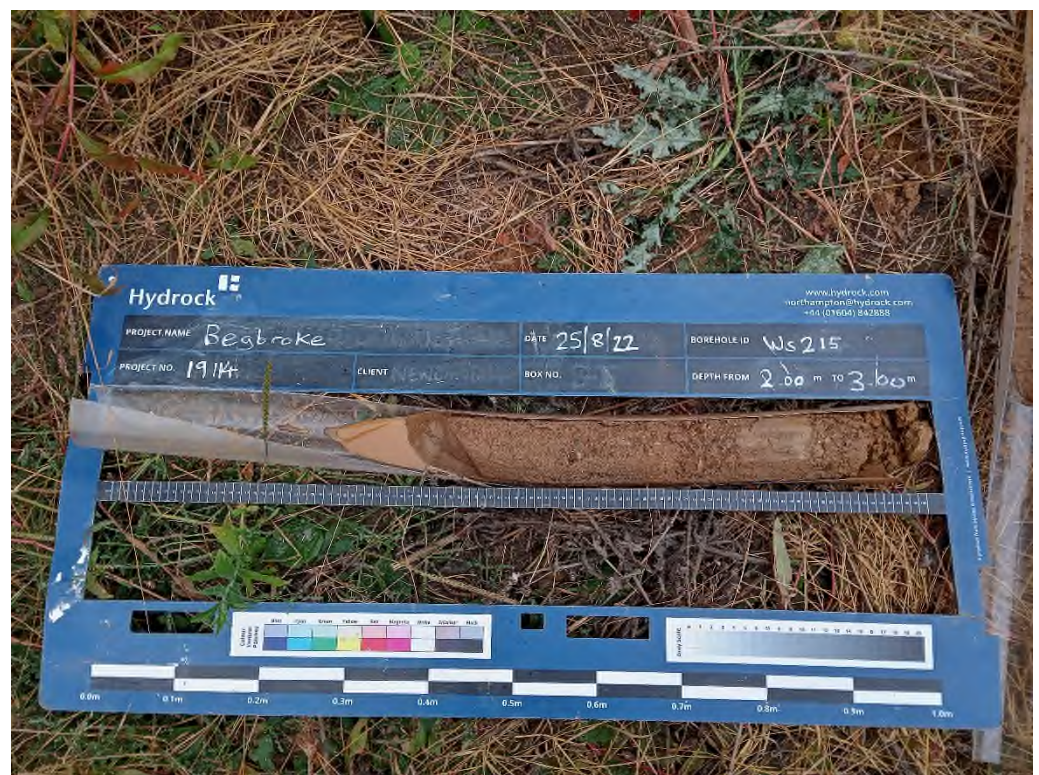
Site Investigation Photograph 92

Description: WS215 2.00 - 3.00m, showing River Terrace Deposits.

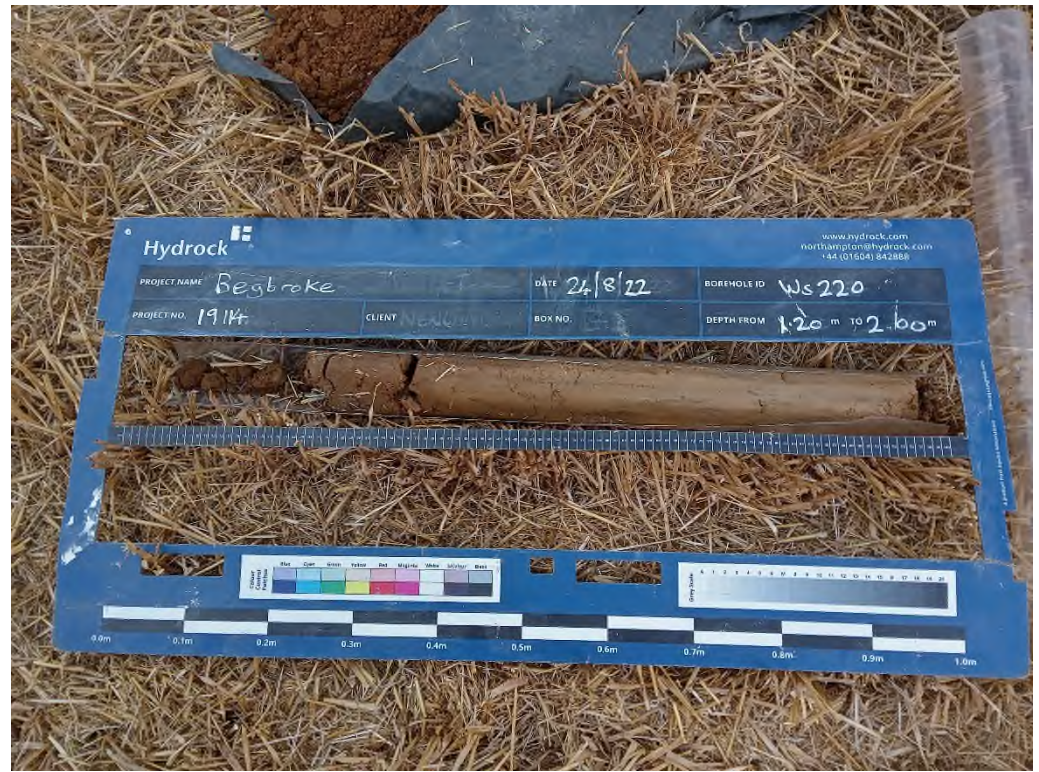
Site Investigation Photograph 93
Date: 24/8/22
Direction Photograph Taken: n/a.
Description: WS220 1.20 - 2.00m, showing Alluvium.

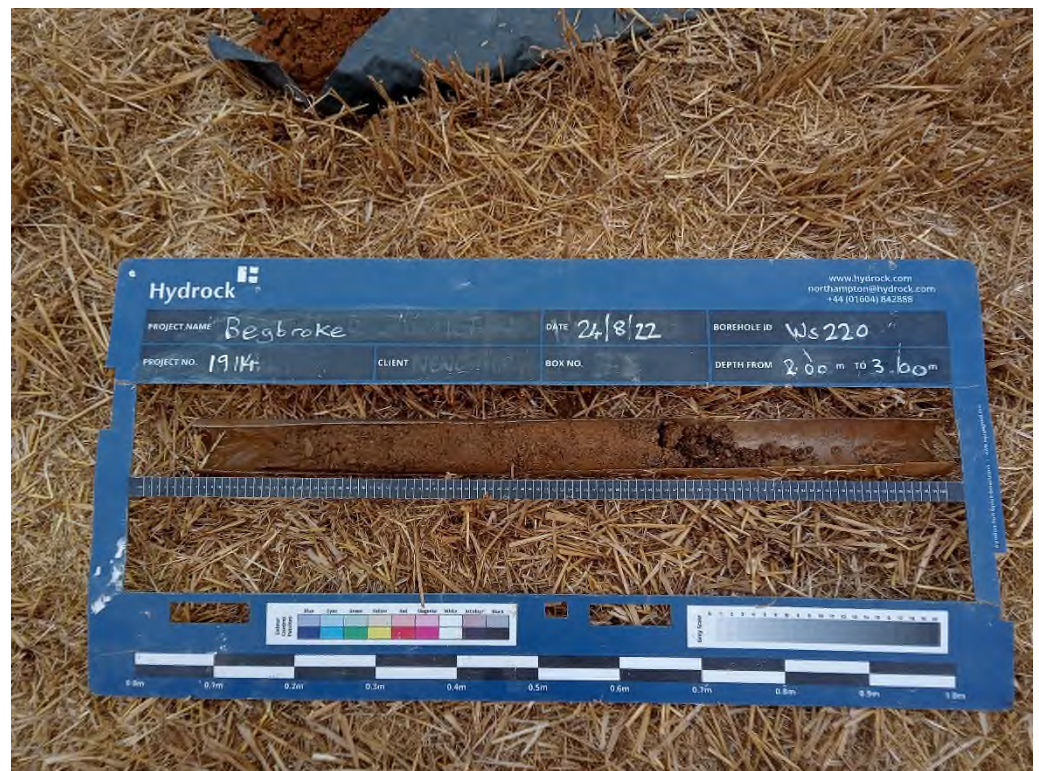
Site Investigation Photograph 94
Date: 24/8/22
Direction Photograph Taken: n/a.
Description: WS220 2.00 - 3.00m, showing River Terrace Deposits.
