Peveril Securities Ltd
Lakeview Drive
Bicester, Oxfordshire

Phase 2 Geo-Environmental Assessment

BIM Document Ref: LDB-BWB-00-XX-EN-RP-0001_PH2_P1

Project Number: NTE2366

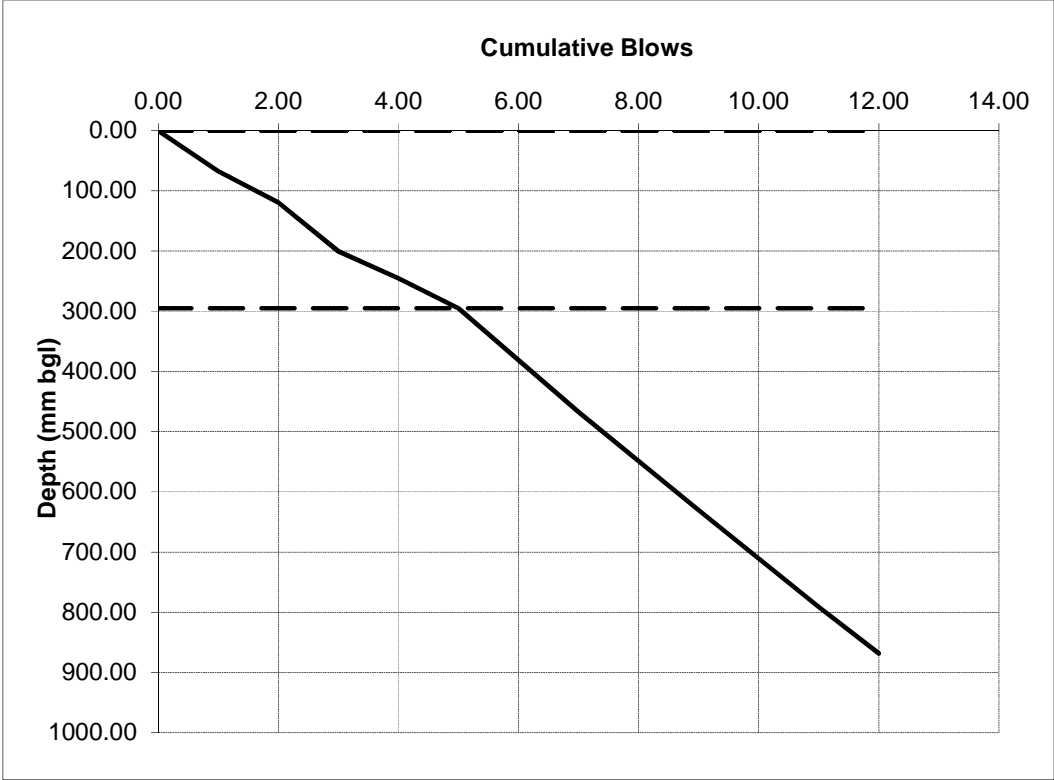
Layer	Blows	Cumulative Blows	Layer Thickness (mm)	Total Depth (mm bgl)	CBR (%)
1	4	4	295	295	3.2
2	5	9	391	686	3.0

CBR Interpretation based on the TRL Equation: $\text{Log}_{10}(\text{CBR}) = 2.480 - [1.057 \times \text{Log}_{10}(\text{DCP Strength})]$

- 7.9 In total 14 TRL DCP tests were undertaken at selected locations across the Site with inferred CBR results ranging between 3.0 and >100%. It is anticipated that re-engineering of the near surface Made Ground and shallow natural ground would be required to provide a suitable development platform.
- 7.10 As a guide it is recommended that roads be designed for 5% CBR, which should be confirmed by in-situ testing once detailed designs are available.
- 7.11 Interim Advice Note 73/06 (IAN73/06) Revision 1 2009 advises that where the in-situ subgrade has an estimated CBR value less than 2.5% it must be improved.

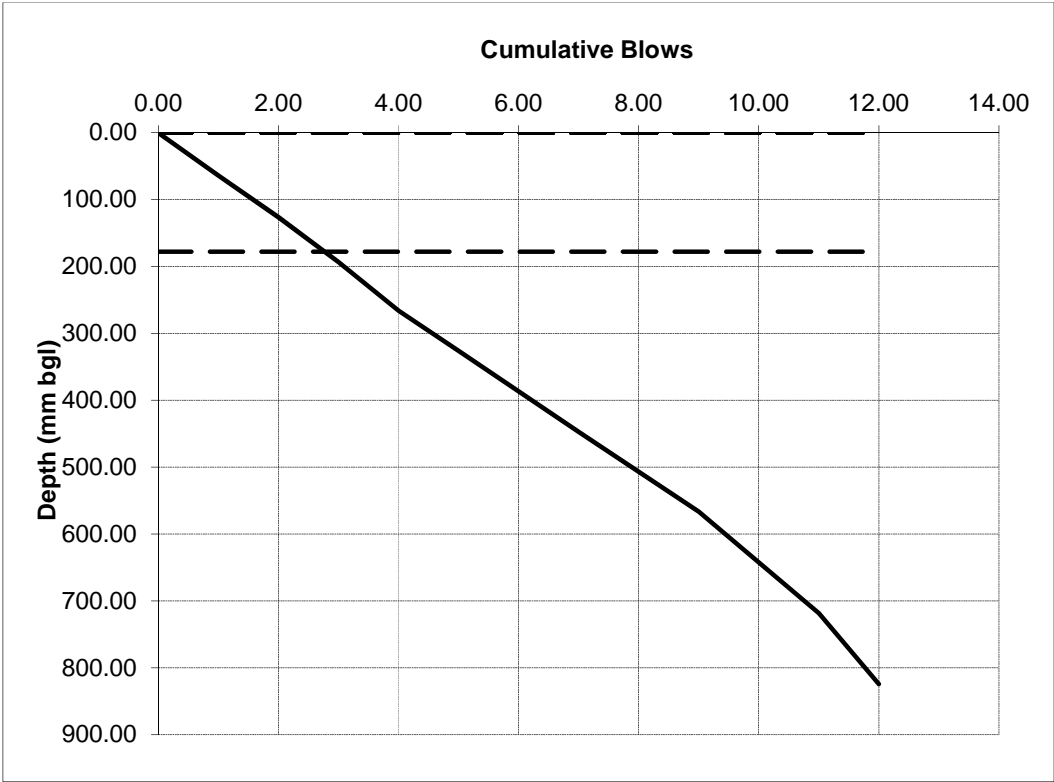
PROJECT NUMBER	NTE2366
PROJECT TITLE	Lakeview Drive, Bicester
TEST REFERENCE	TP119
DATE	15-Aug-17
MATERIAL/ STRATA TYPE	Natural
START DEPTH (mm bgl)	0.30
WEATHER/ GROUND CONDITION	Dry

Layer	Blows	Cumulative Blows	Layer Thickness (mm)	Total Depth (mm bgl)	CBR (%)
1	2	2	178	178	2.6
2	9	11	646	824	3.3

CBR Interpretation based on the TRL Equation: $\text{Log}_{10}(\text{CBR}) = 2.480 - [1.057 \times \text{Log}_{10}(\text{DCP Strength})]$

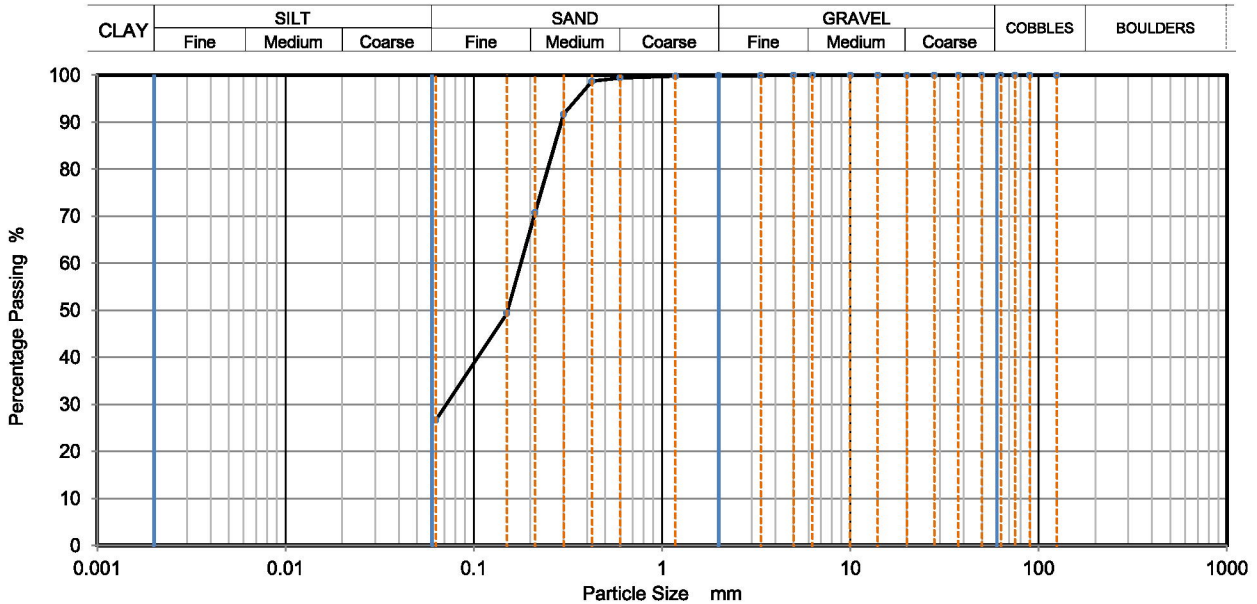
TEST RESULTS Laboratory Reference: 805404
Sample description: Brown very clayey SAND
Location: TP107
Supplier: Not Given

Sieving		Sedimentation	
Particle Size mm	% Passing	Particle Size mm	% Passing
125	100		
90	100		
75	100		
63	100		
50	100		
37.5	100		
28	100		
20	100		
14	100		
10	100		
6.3	100		
5	100		
3.35	100		
2	100		
1.18	100		
0.6	99		
0.425	99		
0.3	92		
0.212	71		
0.15	49		
0.063	27
