LONGVIEW HOUSE, POUND LANE

Preliminary Ecological Appraisal Report

June 2023

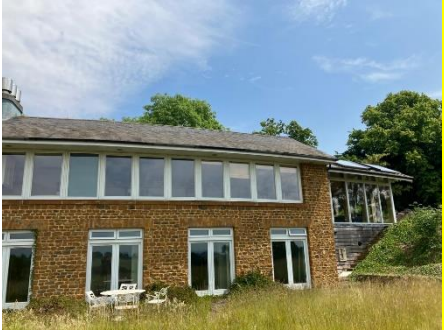
Building Ref	Description	Photograph
<p>External aspect of Main Residential Building (B1)</p>	<p>The main residential dwelling consisted of sandstone brickwork with a slate tile roof. Externally, all brickwork were found to be well sealed with no gaps or crevices. Two vents were identified within the brickwork of the house which were located on the northern and southern aspect. Both vents located on the northern aspect led into a pipe internally and did not provide internal access into the dwelling. The roof consisted of slate tiles where some were lifted and cracked on the eastern and western aspect of the roof. Small gaps were also identified surrounding the chimney of the dwelling, it is possible that this provide internal access into the dwelling these features were identified as PRF's.</p> <p>An extension was located on the southern aspect of the dwelling</p>

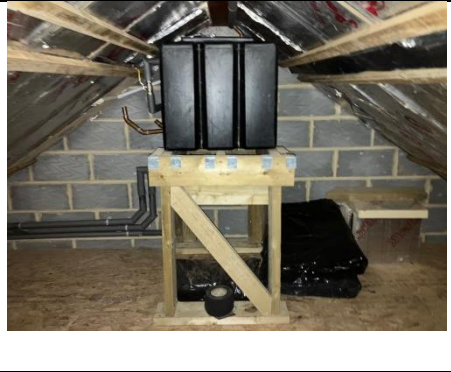
<p>Internal aspect of Smaller residential dwelling (east of the main dwelling) (B2)</p>	<p>Internally the residential rooms of the dwelling were well sealed, and they did not provide any roosting features. The loft space was located on the southern aspect of the building. The loft space consisted of foil insulation with supporting wooden beams. Bat droppings were identified within the loft space of the building. It is possible a cavity is located between the external brick work and internal breezeblock walls located within the loft.</p>

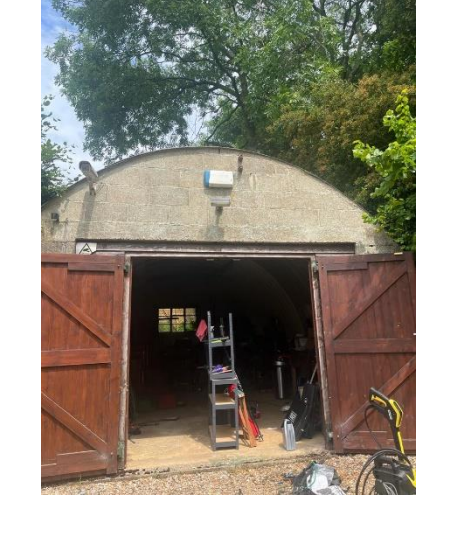
<p>Garage on eastern aspect of the main dwelling. (B3)</p>	<p>A garage was located on the eastern aspect of the site which consisted of single metal sheets, breeze block walls were located on the northern and southern aspect of the garage. The brick walls were well sealed with no gaps or crevices identified throughout. The metal roof was also found to be well sealed and did not provide an access point into the building. There were no PRF's identified throughout the garage.</p>

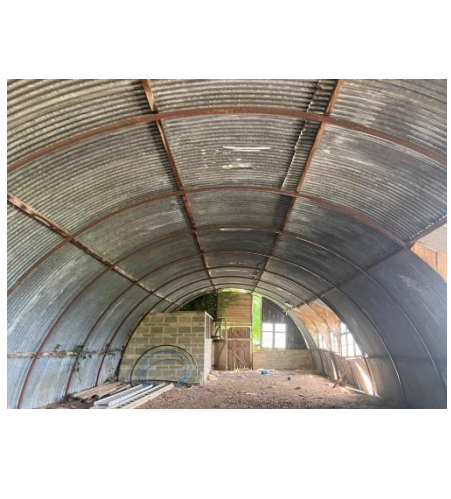
<p>Garage on the southern aspect of the site (B4)</p>	<p>A second garage was located on the southern aspect of the site which consisted of single metal sheets and breeze block walls. Windows were located on the southern and western aspect of the building; one window was broken on the western aspect of the building. The garage was open on the northern aspect and another large gap was also present on the southern aspect of the building. The breeze block walls were found to be well sealed with no gaps or crevices throughout. It is anticipated that the metal roof will fluctuate in temperature and will not provide suitable roosting opportunities for local bat populations. There were no PRFS identified within this garage.</p>

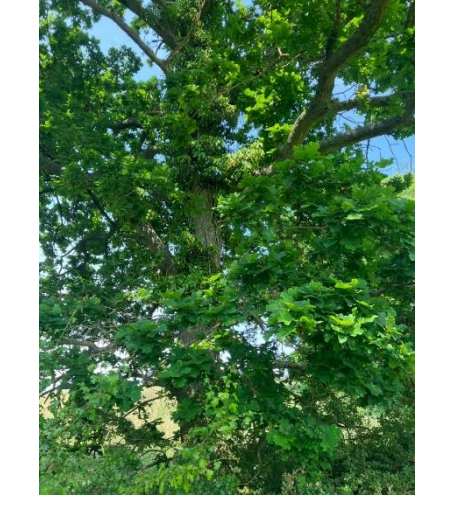
<p>Oak with low bat potential (T1)</p>	<p>An oak tree located at SP3530238920 was found to provide low bat roosting potential due to the dense ivy coverage along the tree.</p>

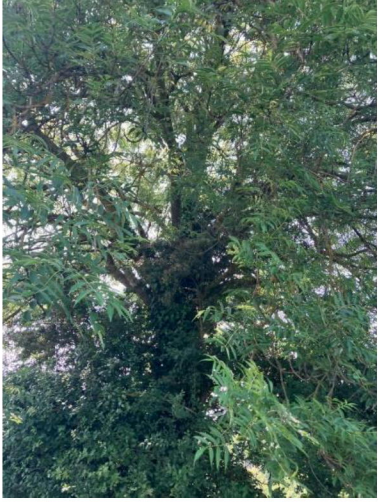
<p>Ash with low bat roosting potential (T3)</p>	<p>An ash tree located at SP3520038925 was found to provide low bat roosting potential due to the dense ivy coverage along the tree.</p>

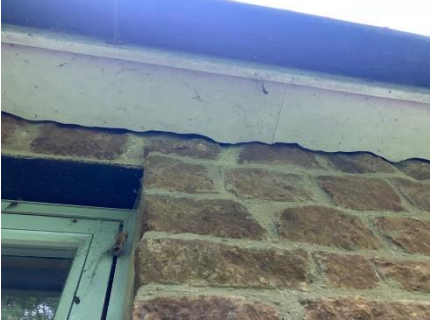
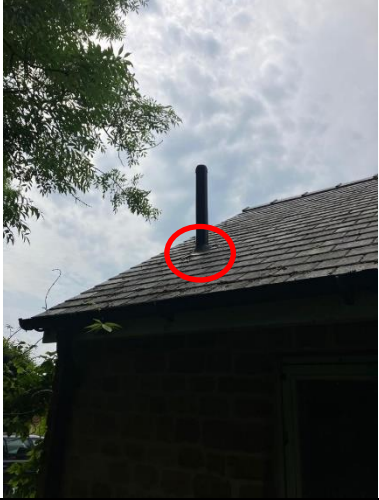
Gap in overhanging eaves on smaller residential dwelling and gap in led flashing

- 5.1.1. Building 1 and 2 were found to provide bat roosting potential, and therefore, in accordance with Best Practice guidance (Collins, 2016) further nocturnal emergence/ re- entry surveys should be undertaken between May-September (inclusive) to determine usage by roosting bats.

- 5.1.2. Both buildings were found to provide moderate bat roosting potential and therefore a minimum of three nocturnal bat surveys are completed, with at least one survey completed between to May to August.

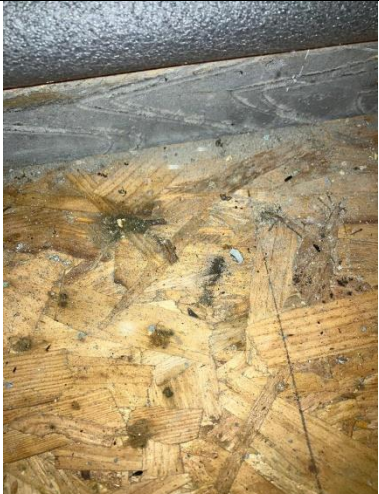
Bat droppings in smaller residential dwelling loft space

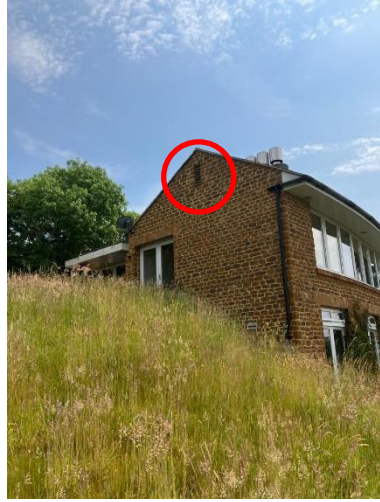
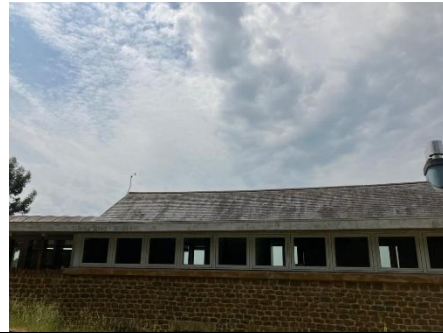
Lifted tiles and vent on the main residential dwelling

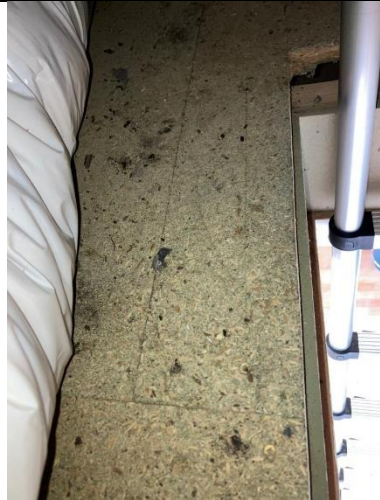
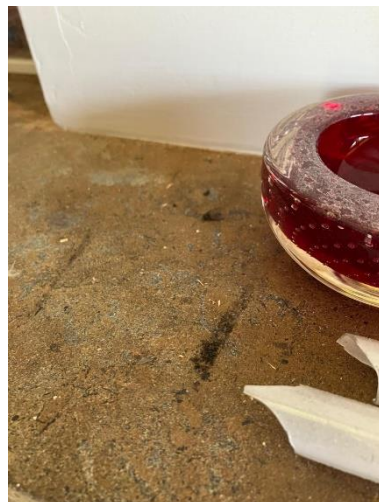
Bat droppings in loft space and residential rooms of main house
