Peveril Securities Ltd
Lakeview Drive
Bicester, Oxfordshire

Phase 2 Geo-Environmental Assessment

BIM Document Ref: LDB-BWB-00-XX-EN-RP-0001_PH2_P1

Project Number: NTE2366

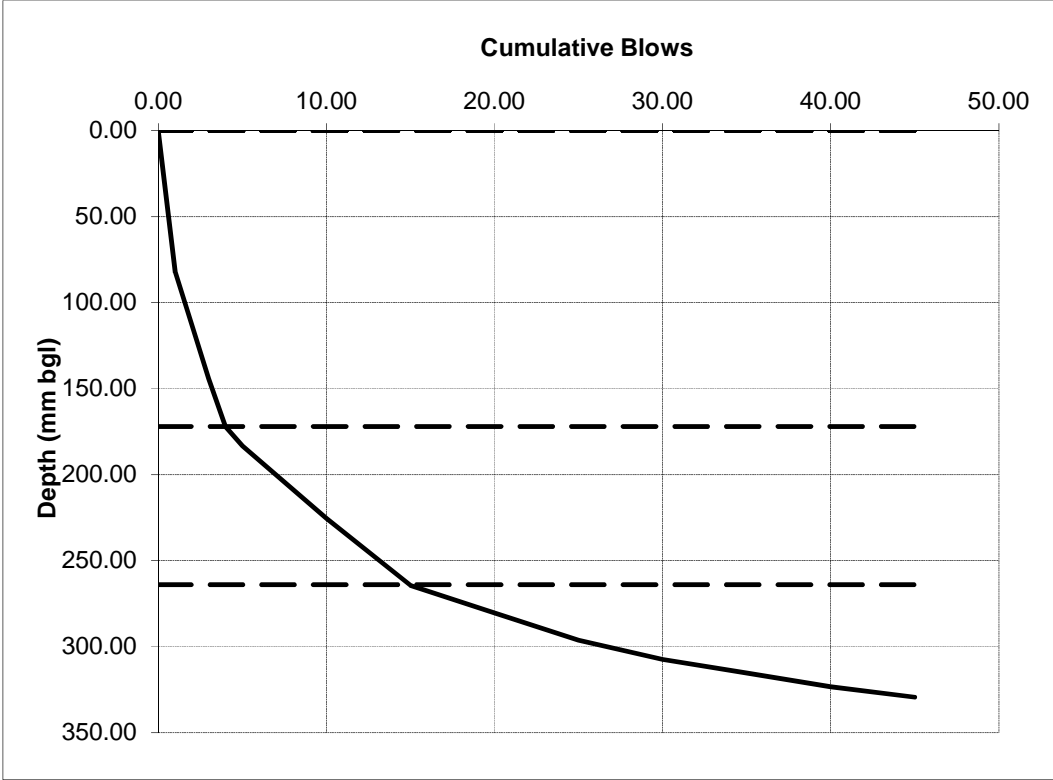
Layer	Blows	Cumulative Blows	Layer Thickness (mm)	Total Depth (mm bgl)	CBR (%)
1	3	3	172	172	4.2
2	7	10	92	264	19.8
3	30	40	65	329	>100

CBR Interpretation based on the TRL Equation: $\text{Log}_{10}(\text{CBR}) = 2.480 - [1.057 \times \text{Log}_{10}(\text{DCP Strength})]$

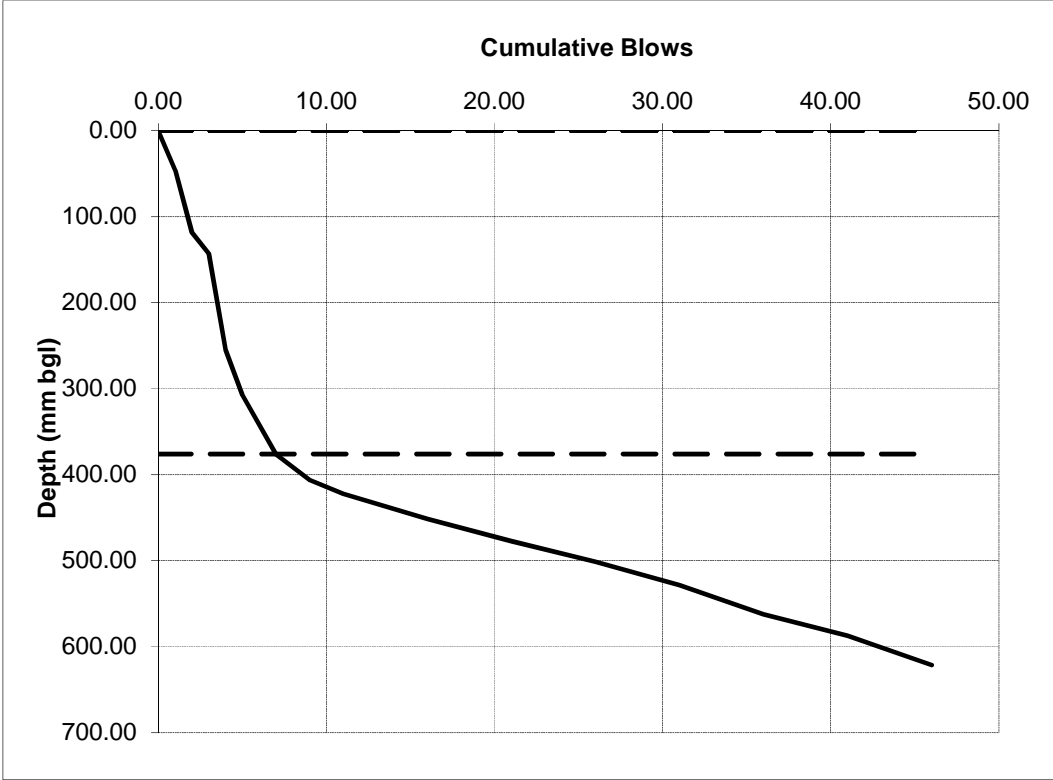
Layer	Blows	Cumulative Blows	Layer Thickness (mm)	Total Depth (mm bgl)	CBR (%)
1	5	5	376	376	3.1
2	36	41	245	621	39.8

CBR Interpretation based on the TRL Equation: $\text{Log}_{10}(\text{CBR}) = 2.480 - [1.057 \times \text{Log}_{10}(\text{DCP Strength})]$
