Preliminary Ecological Appraisal

Cedar Lodge, Steeple Aston

Ref: 22-0480

Date: February 2023

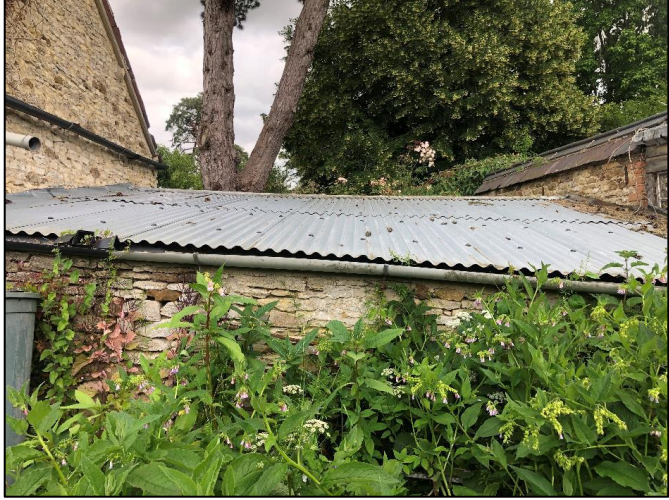
<p data-bbox="555 779 938 808">Figure 12: West facing elevation of B3</p> <p data-bbox="371 824 563 853">Evidence of bats: None.</p> <p data-bbox="371 891 571 920">Evidence of birds: None.</p>	
<p data-bbox="204 958 240 987">B4</p>	<p data-bbox="371 958 475 987">External: Single storey former bathhouse. B4’s north, east and west walls were of stone construction. The stone walls were in good condition and no gaps suitable for roosting bats were recorded. The south wall of B4 was comprised of glass panels between timber frames.</p> <p data-bbox="371 1151 1118 1211">The roof of B4 was also comprised of glass panels between timber frames and featured no gaps.</p> <p data-bbox="371 1249 472 1279">Internal: The stone walls inside B4 were in good condition and no gaps were recorded. The glass roof allowed for substantial light spill within all areas of B4.</p>

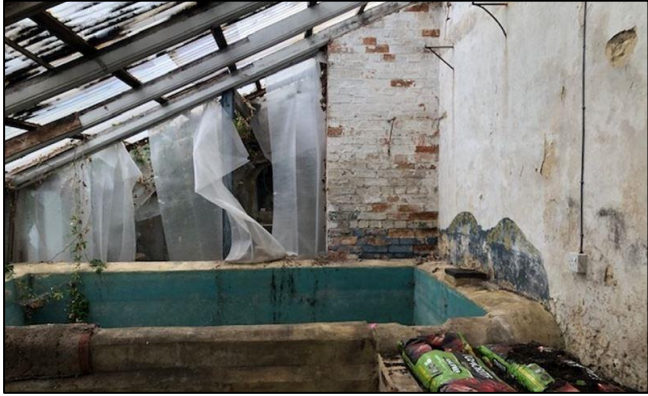
<p data-bbox="600 1805 890 1834">Figure 13: East section of B4</p> <p data-bbox="371 1883 563 1912">Evidence of bats: None.</p> <p data-bbox="371 1951 571 1980">Evidence of birds: None.</p>	<p data-bbox="1145 958 1257 987">Negligible</p>

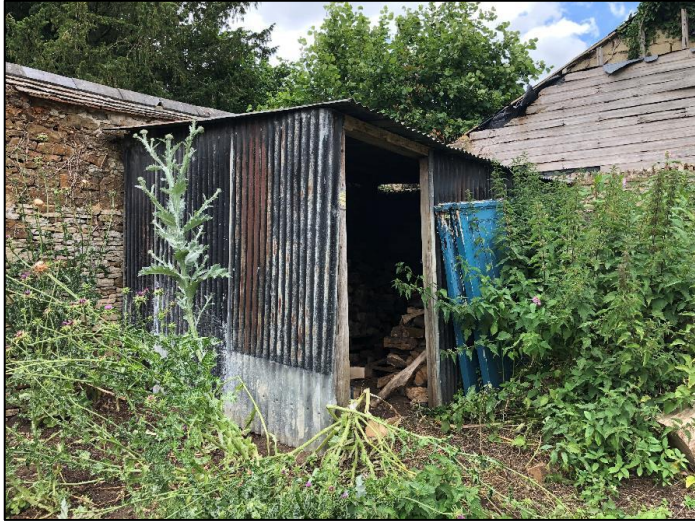
Building No.	Description	Suitability for Roosting Bats
	<p>Timber storage lean-to approximately 2m in height. Comprised of corrugated metal walls at the east and south, adjoined to stone walls which formed B5's west and north elevations. The roof of B5 was flat and of corrugated metal construction. No external features suitable for roosting bats were identified.</p>

<p>Figure 14: Southeast elevation of B5</p> <p>Internal: B5 was used for timber storage and was subject to substantial light spill via gaps between corrugated metal sheeting. Five gaps approximately 5cm wide between stonework at the west wall of B5 were present. The gaps were approximately 10cm in depth and were suitable for hibernating bats.</p>

- 10.19 B5's stone wall is of Moderate suitability to roosting bats. However, works to B5 will not directly impact any potential roosting features. Although no further survey work at B5 is recommended, works should take place outside of the bat hibernation period (October-March) as a precaution.

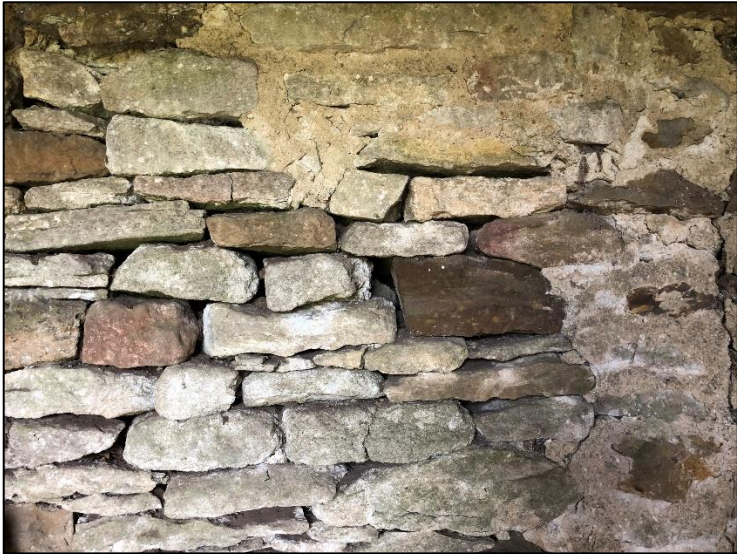
<p>Figure 15: Gaps between B5's stone wall</p> <p>Evidence of bats: None.</p> <p>Evidence of birds: None.</p>

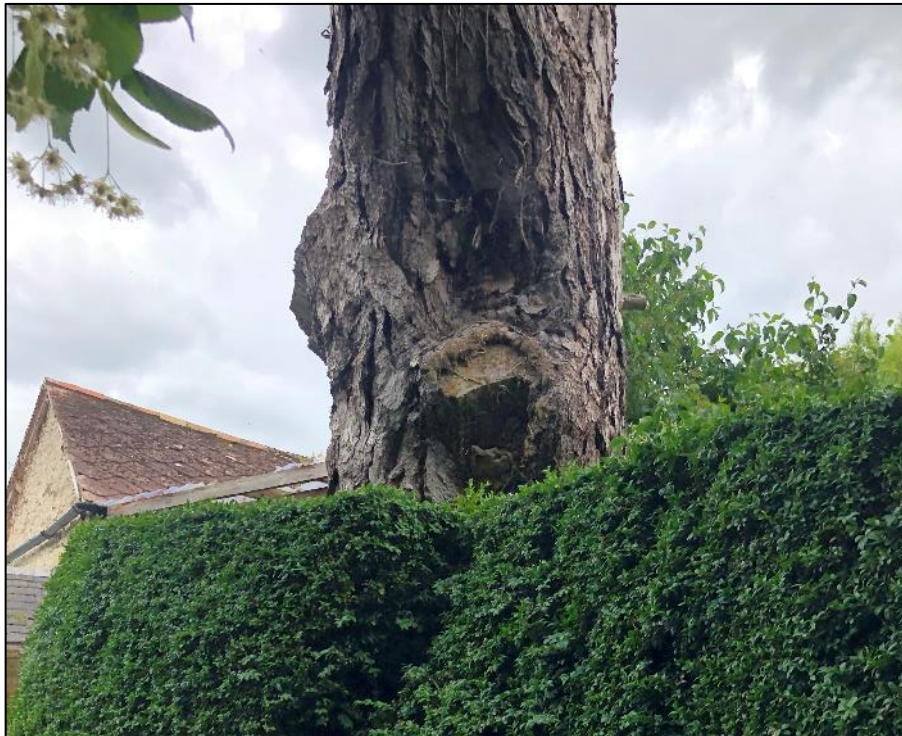
Figure 19: Rot hole at T1's south facing elevation
