Geology 1:50,000 scale - Artificial and made ground

It is understood that the Site is to be developed for residential and light-commercial end-use. The assessment is required in order to identify potential ground related risks and present preliminary design options and solutions for the ground engineering aspects of the proposed scheme. As part of these works, the assessment will advise on potential environmental (contaminated land) risks associated with the proposed development and the prevalent ground, ground gas and groundwater conditions at the site. Previous phases of intrusive investigation have been undertaken by WSP across the site. Where applicable, this information has been used to supplement this investigation.

TITLE:
Kingsmere Phase 2, Bicester

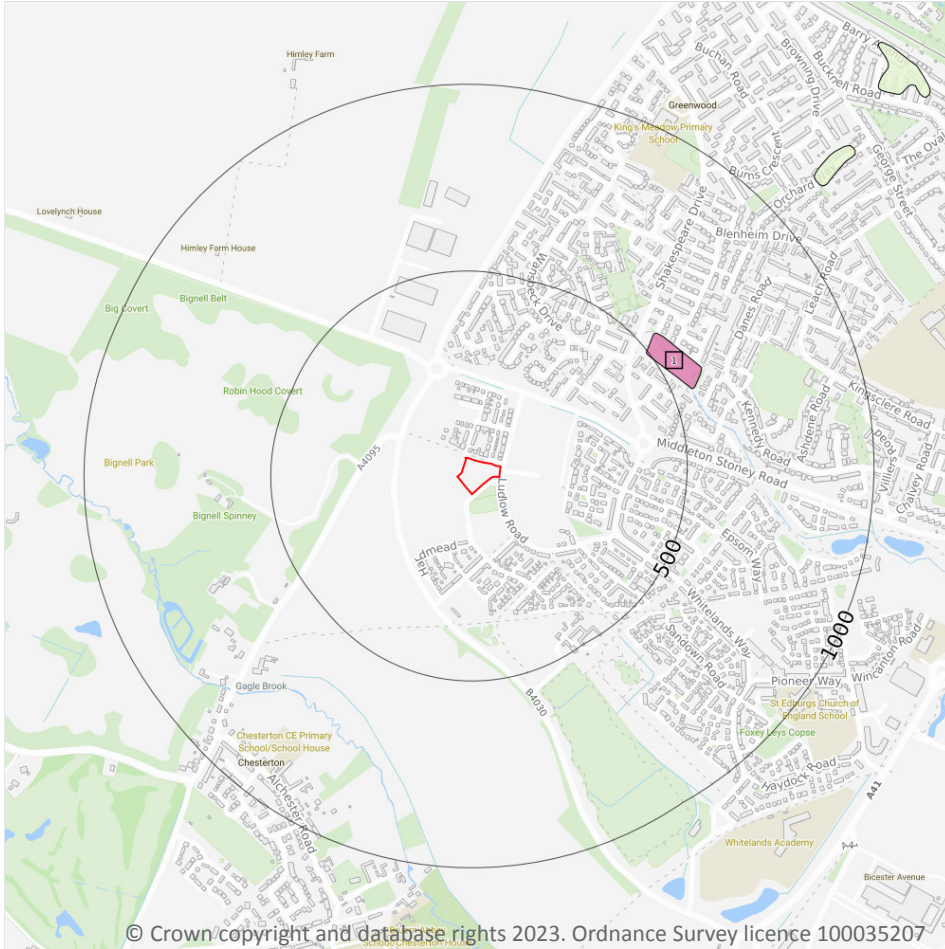
Details of made, worked, infilled, disturbed and landscaped ground at 1:50,000 scale. Artificial ground can be associated with potentially contaminated material, unpredictable engineering conditions and instability.

ID	Location	LEX Code	Description	Rock description
1	494m NE	WGR-VOID	WORKED GROUND (UNDIVIDED)	VOID

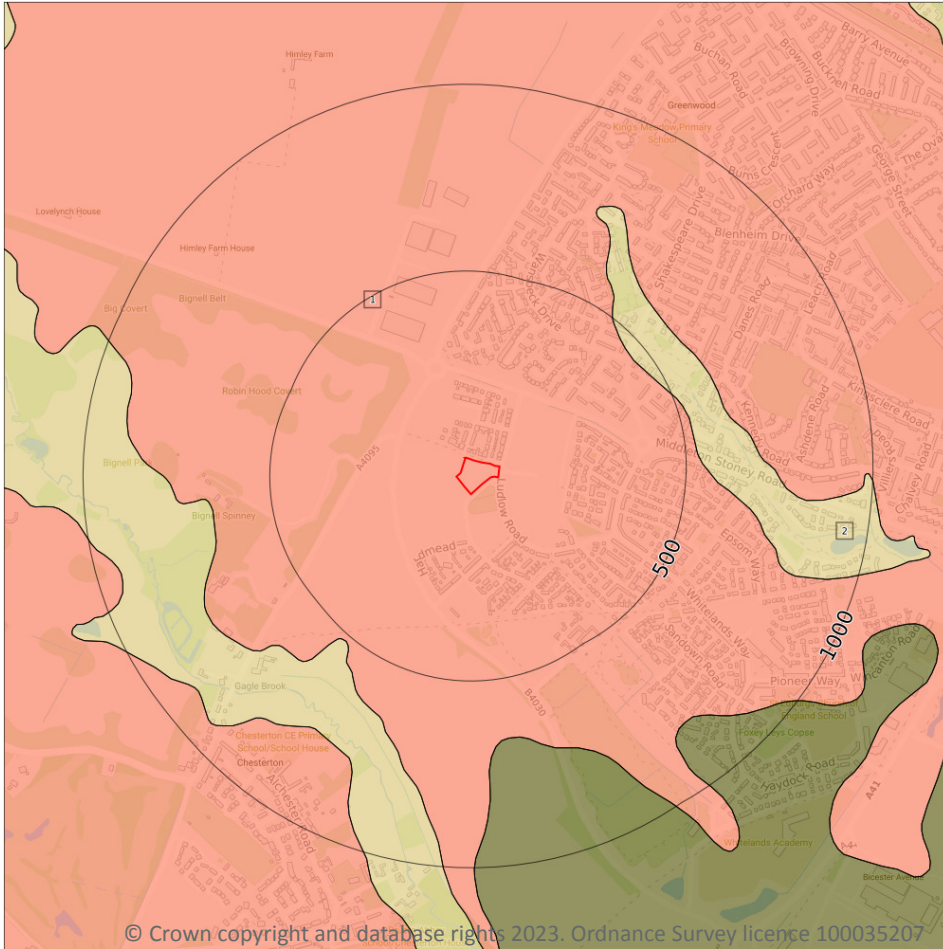
Geology 1:50,000 scale - Bedrock

- Site Outline
- Search buffers in metres (m)
- Bedrock faults and other linear features (50k)
- Bedrock geology (50k)
Please see table for more details.

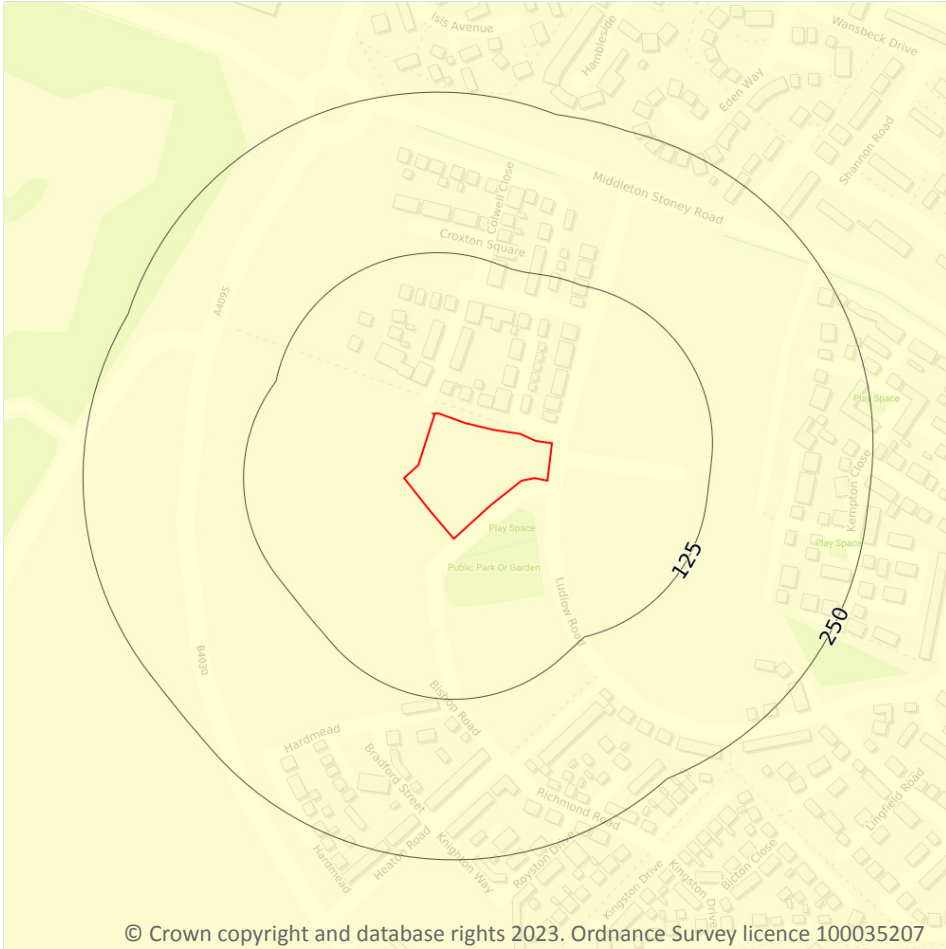
17 Natural ground subsidence - Shrink swell clays

The potential hazard presented by soils that absorb water when wet (making them swell), and lose water as they dry (making them shrink). This shrink-swell behaviour is controlled by the type and amount of clay in the soil, and by seasonal changes in the soil moisture content (related to rainfall and local drainage).

Location	Hazard rating	Details
On site	Negligible	Ground conditions predominantly non-plastic.

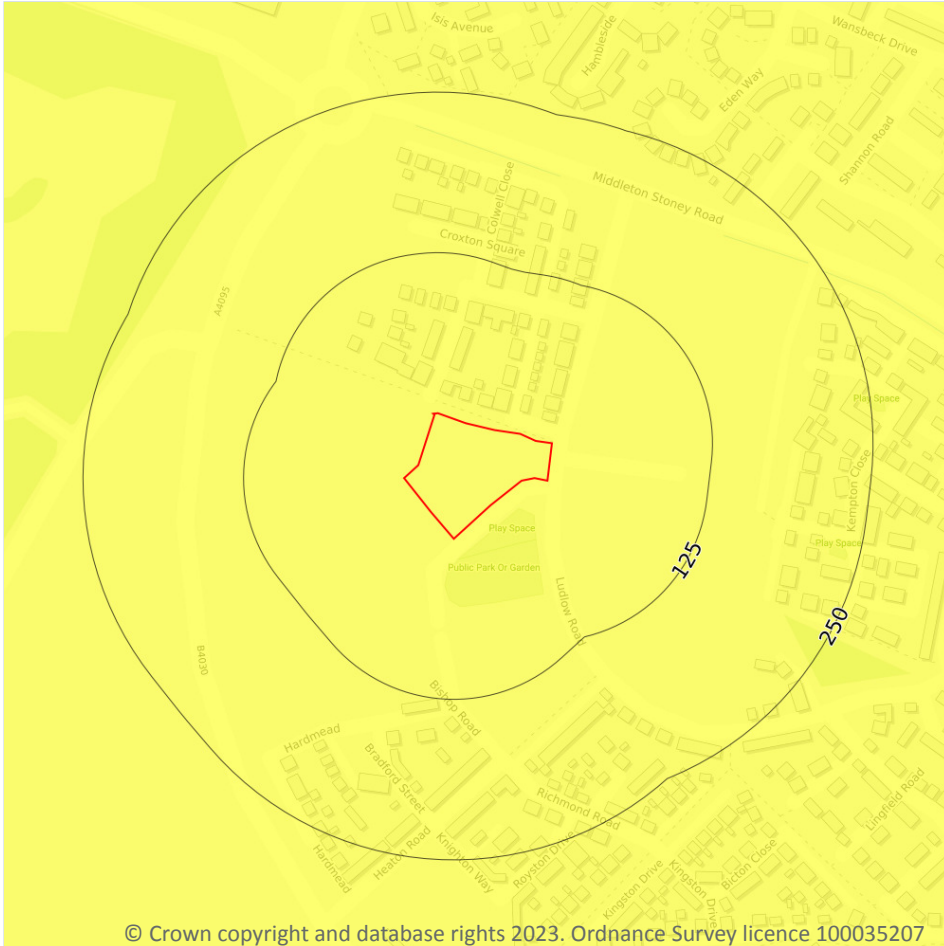
Natural ground subsidence - Ground dissolution of soluble rocks

The potential hazard presented by ground dissolution, which occurs when water passing through soluble rocks produces underground cavities and cave systems. These cavities reduce support to the ground above and can cause localised collapse of the overlying rocks and deposits.

Location	Hazard rating	Details
On site	Very low	Soluble rocks are present within the ground. Few dissolution features are likely to be present. Potential for difficult ground conditions or localised subsidence are at a level where they need not be considered.

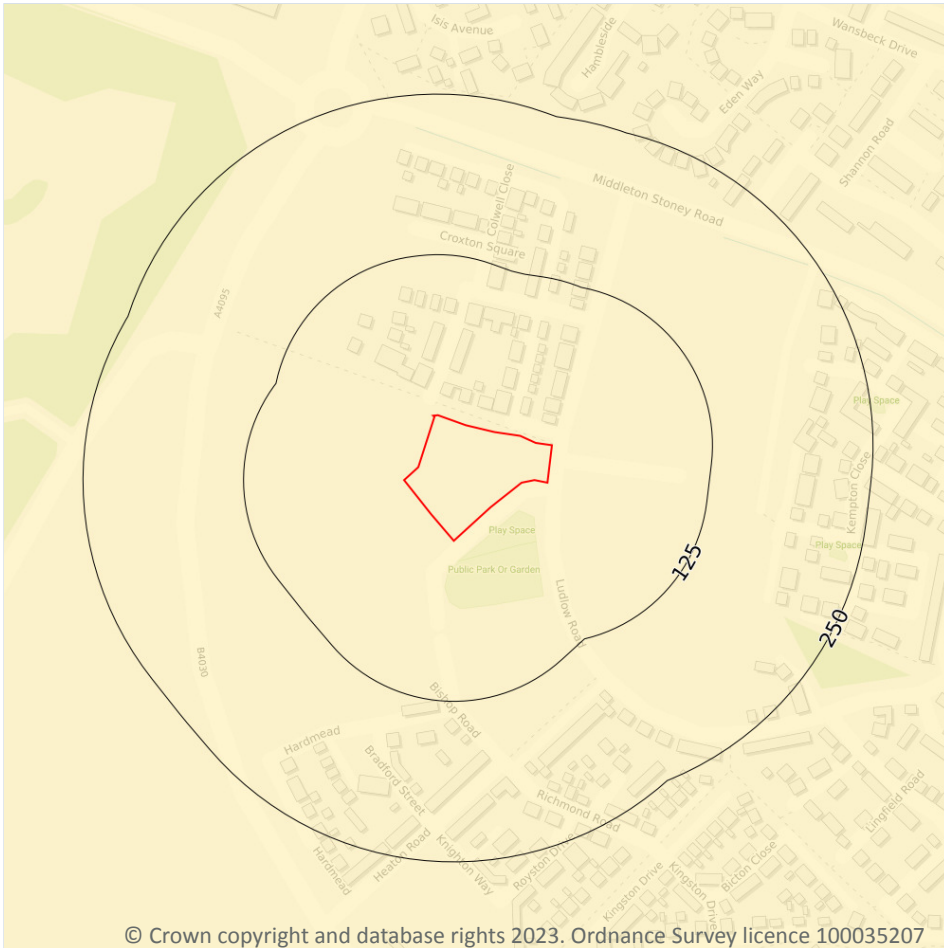
20 Radon

— Site Outline
Search buffers in metres (m)

- Greater than 30%
- Between 10% and 30%
- Between 5% and 10%
- Between 3% and 5%
- Between 1% and 3%
- Less than 1%

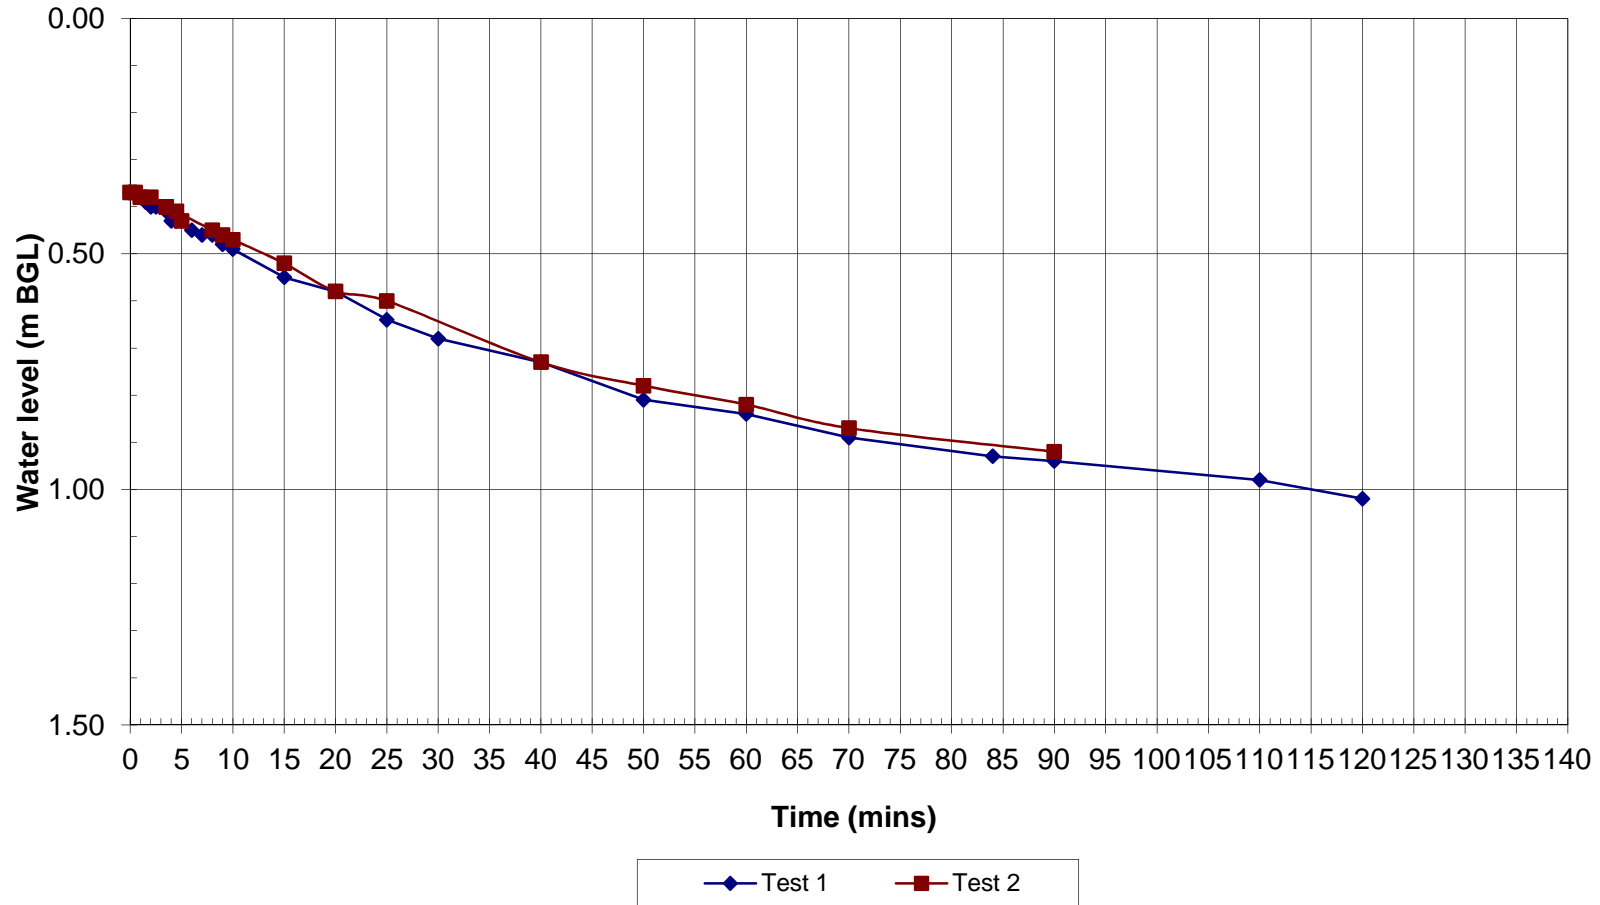
Soakaway TP701

- TP701 – Soil infiltration rate of 3.6×10^{-5} m/s.
- TP705C – Insufficient data. Based on the limited data obtained, the anticipated soil infiltration rate is likely to be less than 1×10^{-9} m/s.
- TP716 – Soil infiltration rates of 1×10^{-4} and 4.2×10^{-5} m/s.

It has therefore, not been possible to derive suitable soil infiltration rates for the strata in accordance with the guidance in the BRE Digest as the fall in water level and number of repeat tests within the pits was not sufficient. Preliminary, indicative infiltration rates based on an extrapolation of the tests performed are summarised as follows:

It should be noted that the above infiltration rates are preliminary and indicative only and should not be used for the design of infiltration drainage.

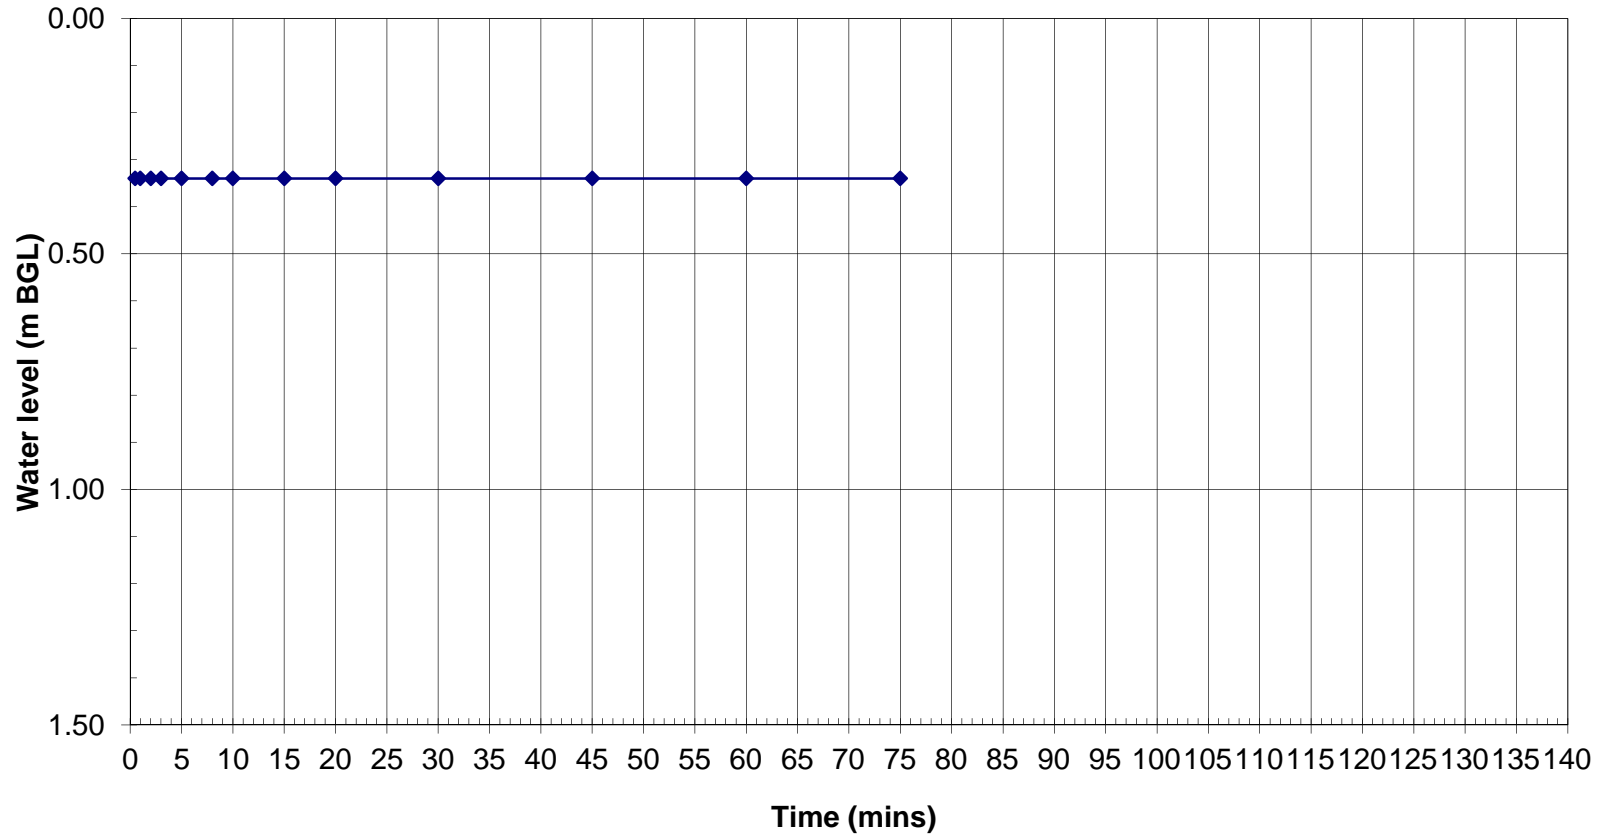
Soakaway TP720

- TP720 – Insufficient data. Based on the limited data obtained, the anticipated soil infiltration rate is likely to be less than 1×10^{-9} m/s.
- TP05 (12370178/001/01, 2007) - Insufficient data. Based on the limited data obtained, the anticipated soil infiltration rate is likely to be less than 1×10^{-9} m/s.

—◆— Test 1 —■— Test 2

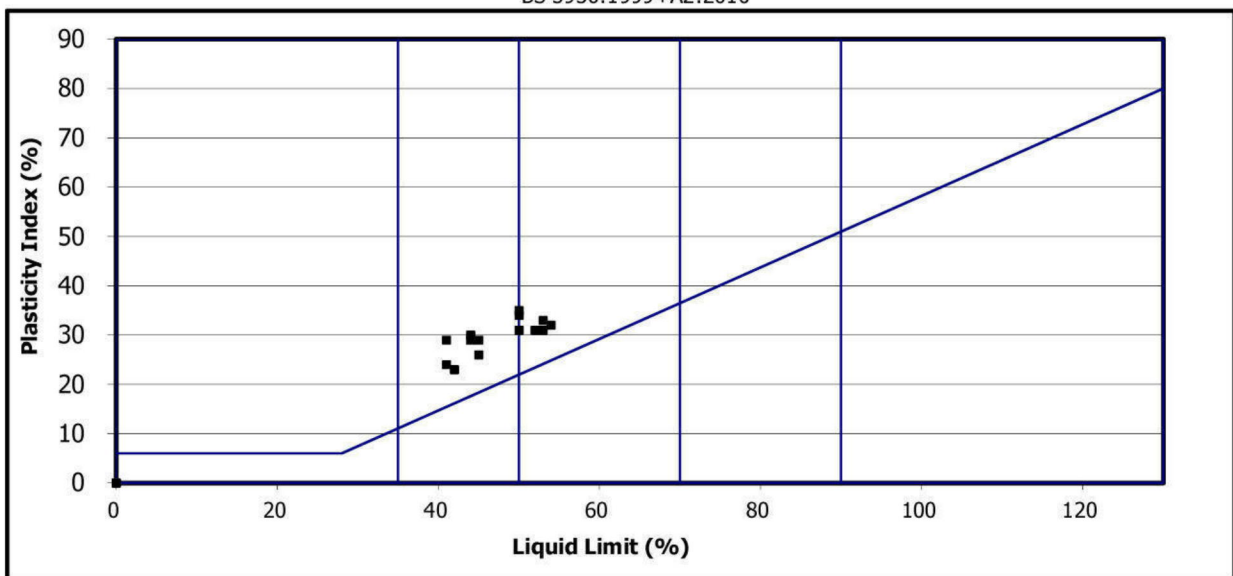
Symbols: NP : Non Plastic # : Liquid Limit and Plastic Limit Wet Sieved
PLASTICITY CHART FOR CASAGRANDE CLASSIFICATION.

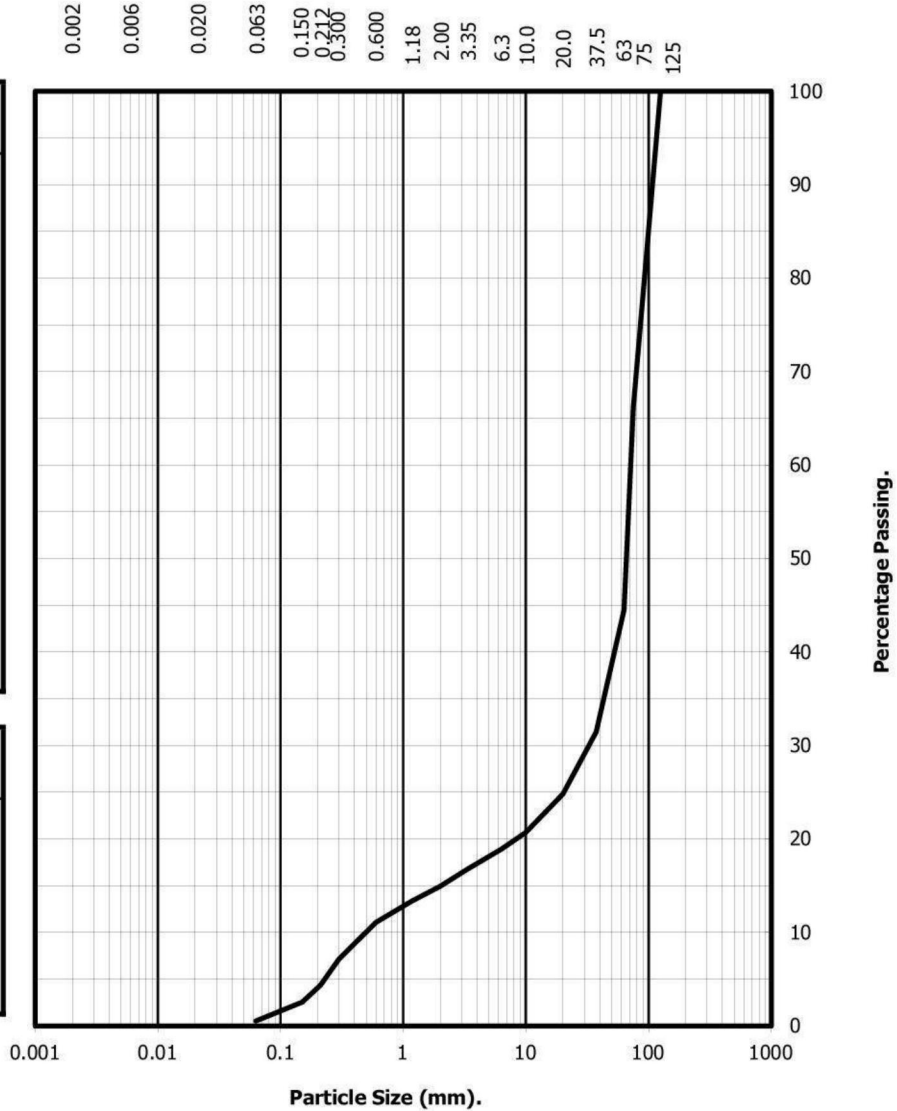
BS Test Sieve	Percentage Passing
125	100
75	66
63	44
37.5	31
20	25
10	21
6.3	19
3.35	17
2.00	15
1.18	13
0.60	11
0.300	7
0.212	4
0.150	3
0.063	1

Soil Fraction	Cobbles	Gravel	Sand	Silt and Clay
Total Percentage	56	29	14	1
