Job No: 07-00723
Site: Bicester, Whitelands Farm (off B4030)

TITLE: Kingsmere Phase 2, Bicester
Exploratory Hole Plan

Countryside Properties (Bicester) Limited

Land South of Middleton Stoney Road, Bicester – Kingsmere, South West Bicester

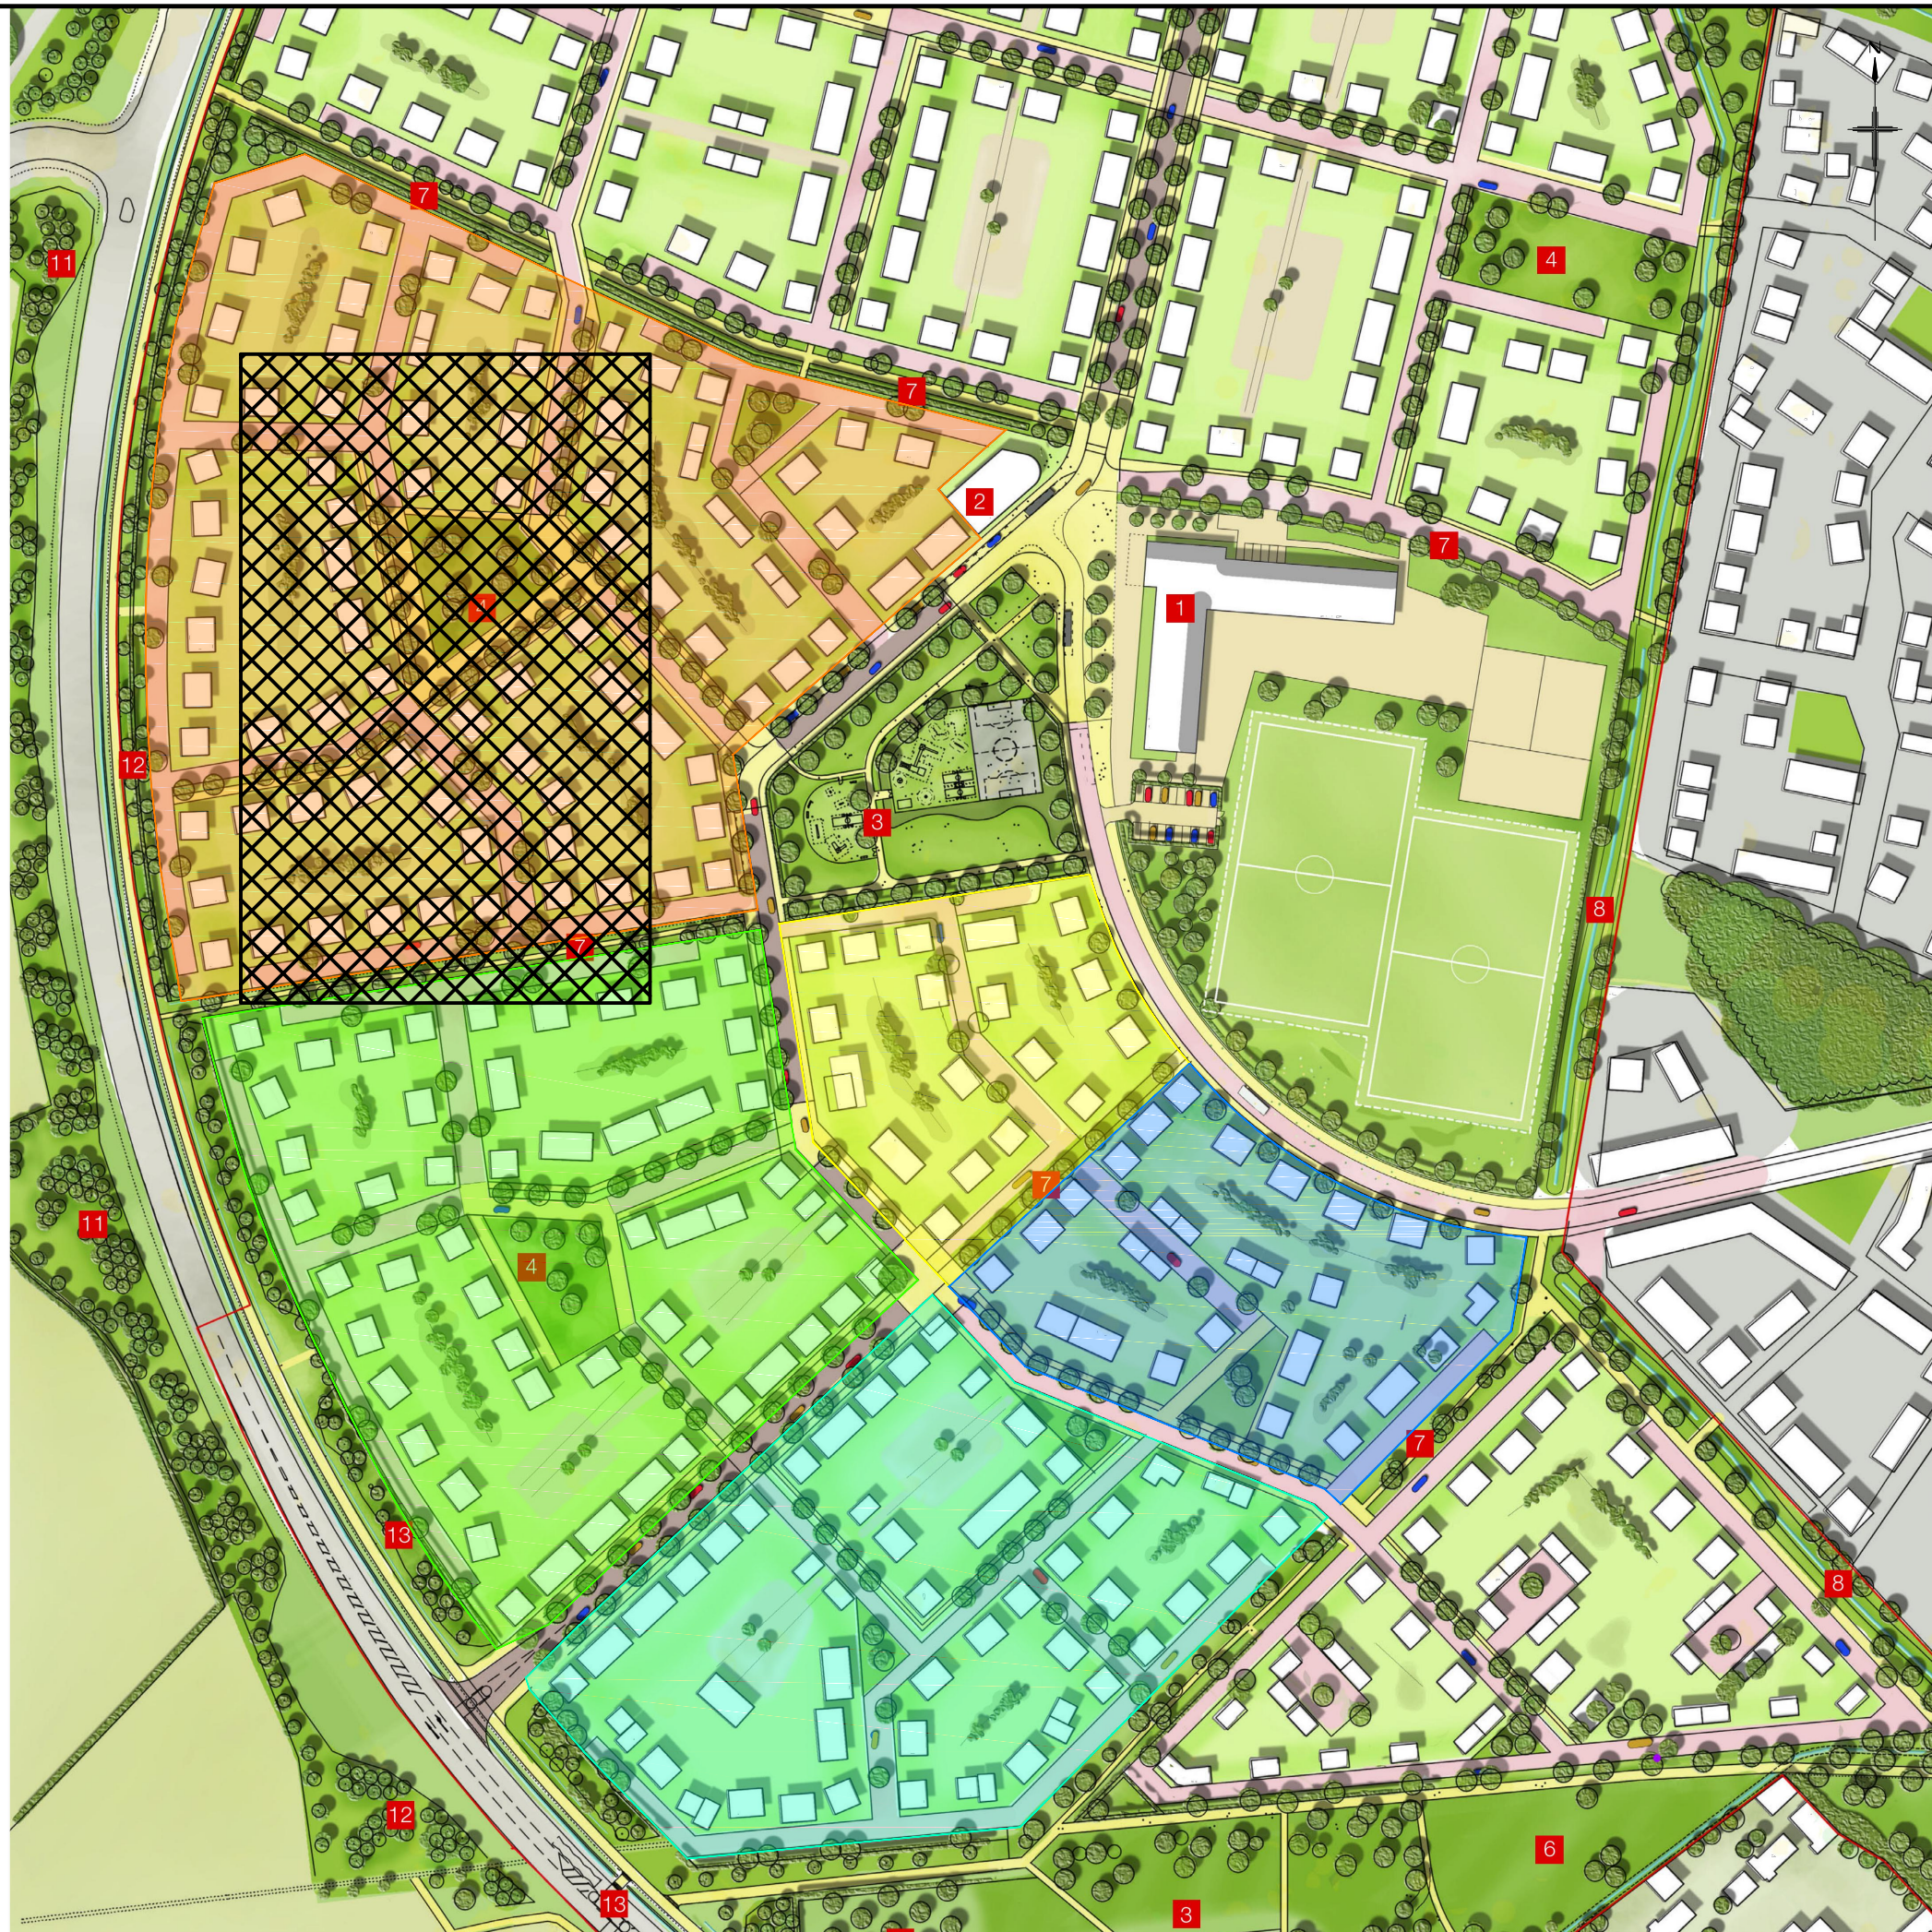
Drawing No.	Rev.
FIGURE 2	P1

Figure 1	Site location plan
Figure 2	Site layout and exploratory hole location plan
Figure 3	Proposed development plan
Figure 4	SPT 'N' value against depth

- Site Boundary
- Parcel J Boundary
- Parcel L Boundary
- Parcel M Boundary
- Parcel N Boundary
- Parcel O Boundary
- Conjectured Area of Low Strength Soils

The site, covering an approximate area of 13.4 hectares, predominantly comprises open fields and agricultural land. The site is bound to the north, east and south by open fields and to the west by the B4030 (Vendee Drive). Light vegetation and hedgerow bounds the site to the northwest and west. A site layout plan is presented as **Figure 2**.

The investigation points were located using GPS for accuracy and are shown in **Figure 2**.

Foundations will need to be locally extended down in to the firm to stiff gravelly clay (approximately 1.5 m bgl) in the vicinity of WSPs TP703 and TP705 (central region of Land Parcel J, presented in **Figure 2** and **Figure 3**). Further investigation is recommended to assess the extent of the low strength soils identified in this area.
