Bicester Motion Innovation Centre

Desk Study Review & Ground Investigation Report

For Bicester Motion

Doc ref: 27280-HYD-XX-XX-RP-GE-1001-S2-P02

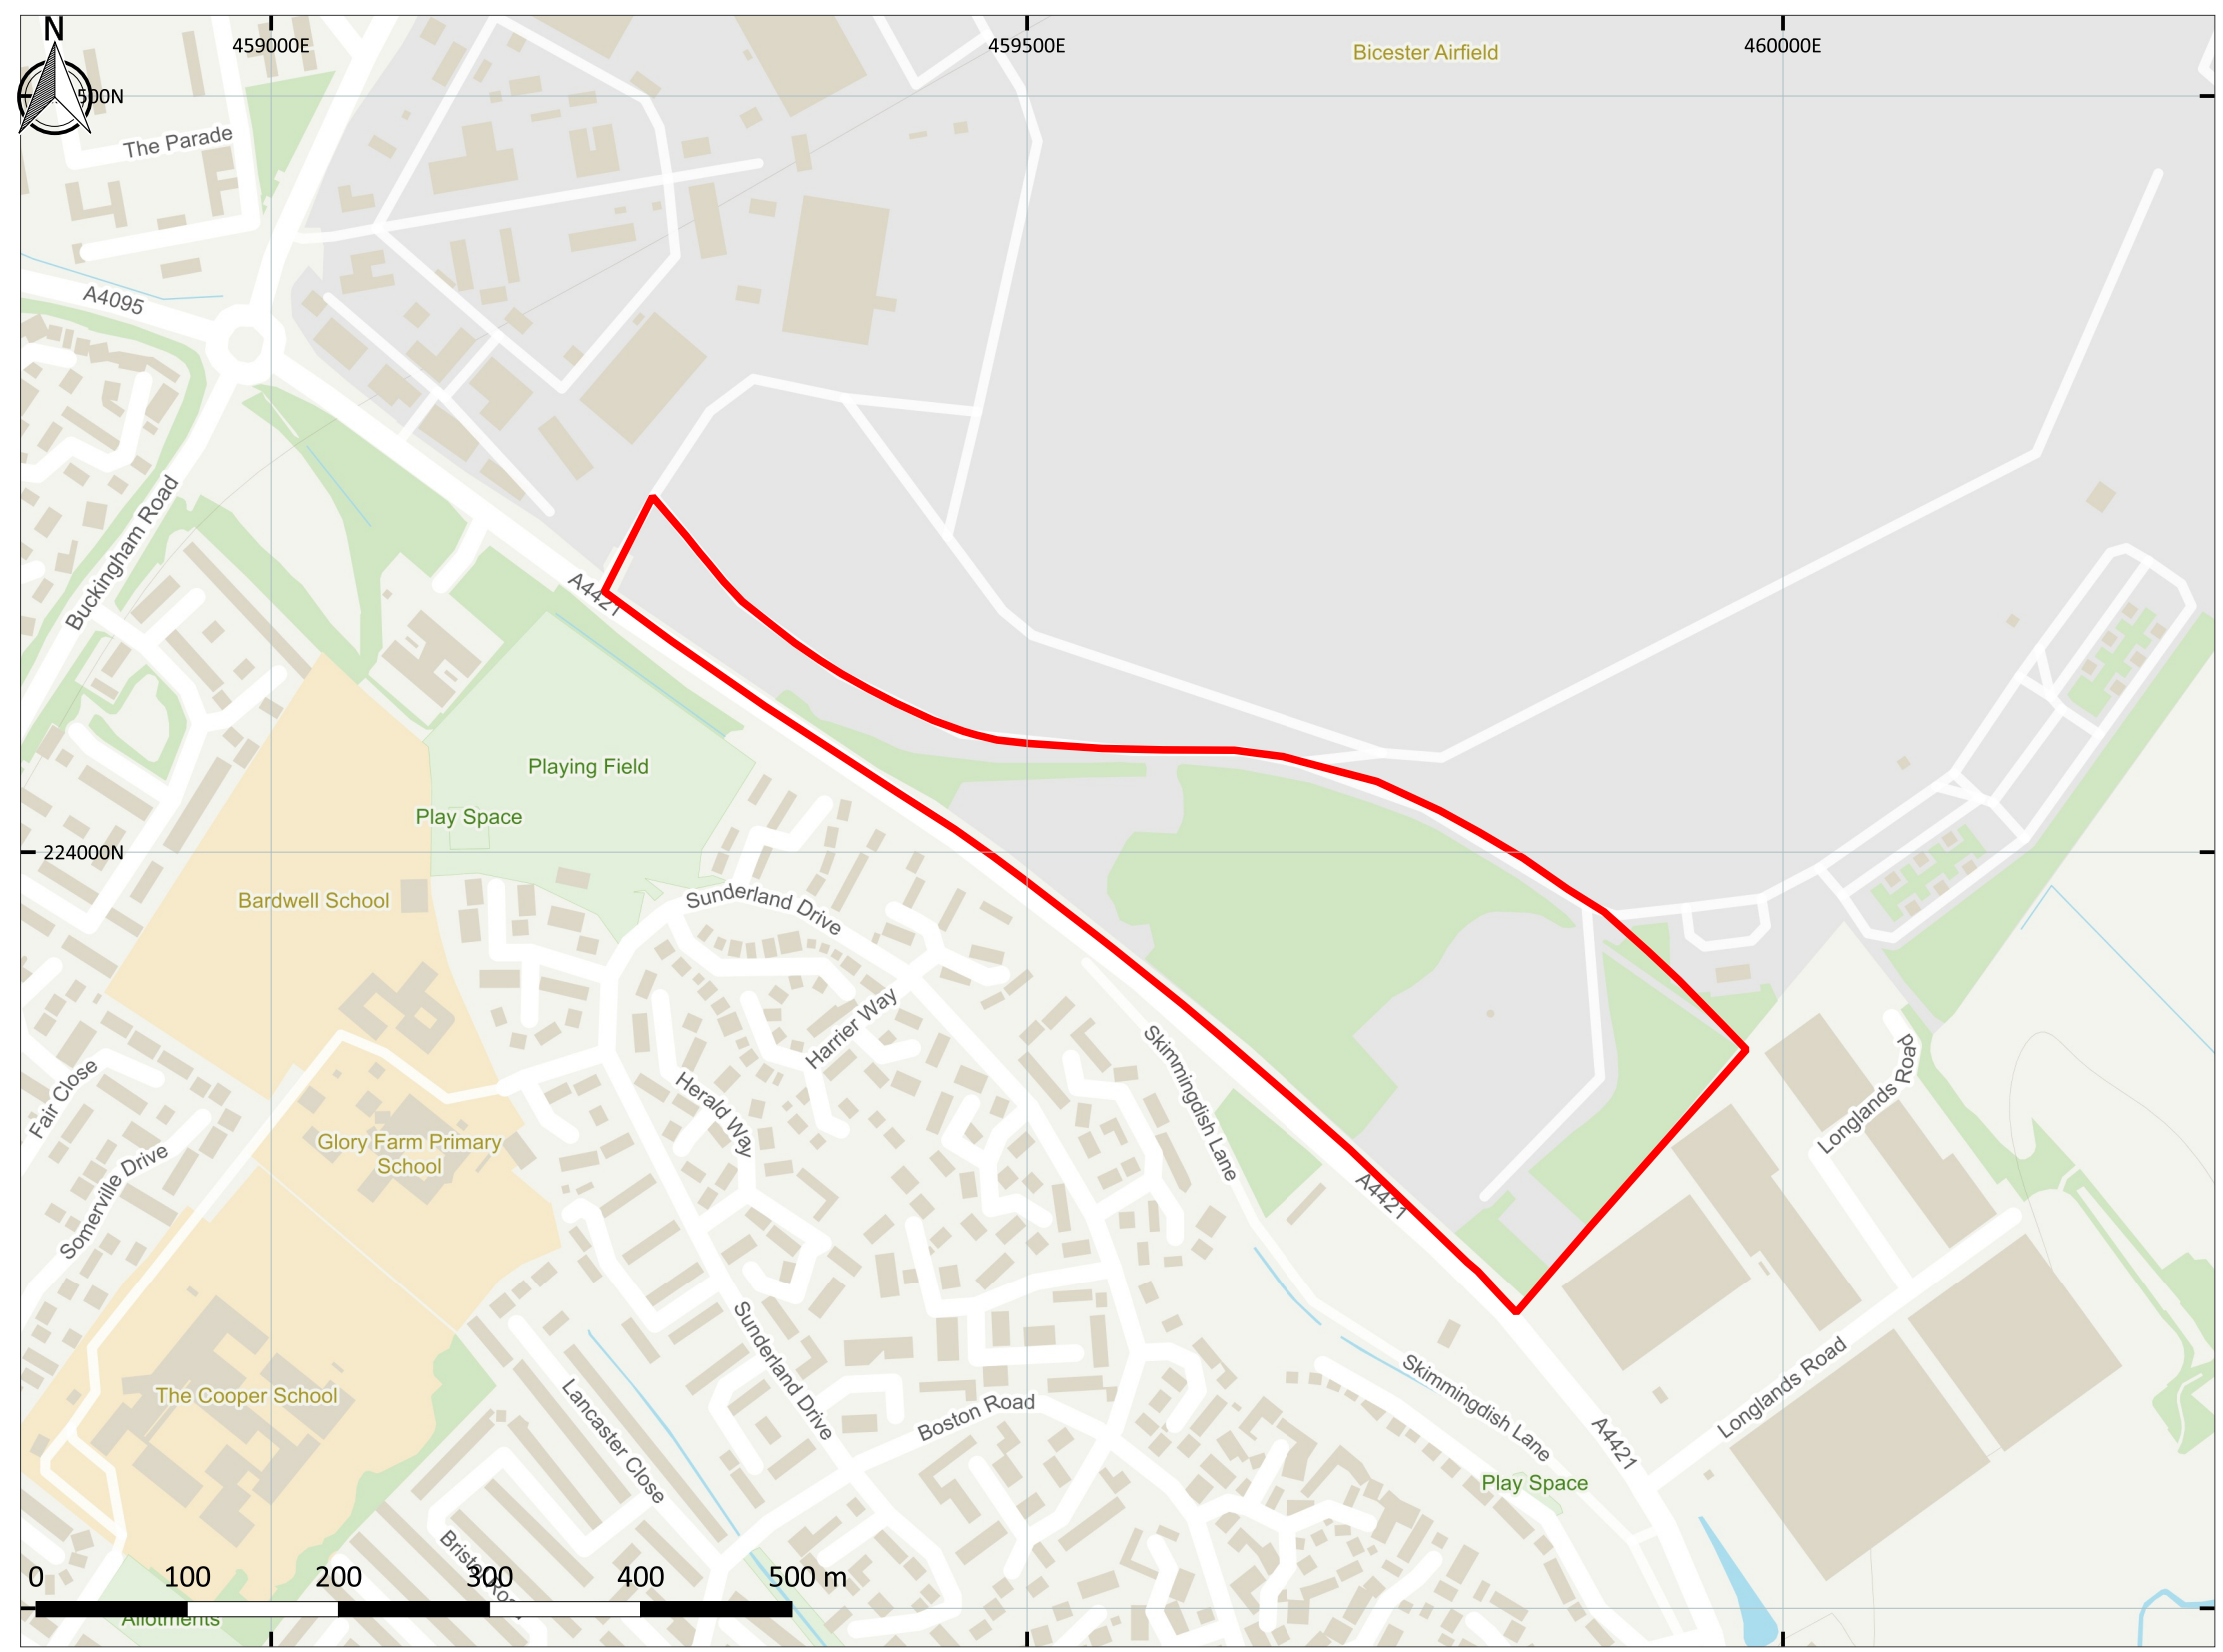
TITLE		
SITE LOCATION PLAN		
HYDROCK PROJECT NO.	SCALE @ A3	
27280	1:5,000	
PURPOSE OF ISSUE	STATUS	
SUITABLE FOR INFORMATION	S2	
DRAWING NO.	REVISION	
27280-HYD-XX-XX-DR-GE-1000	P01

KEY PLAN	
	Site Boundary

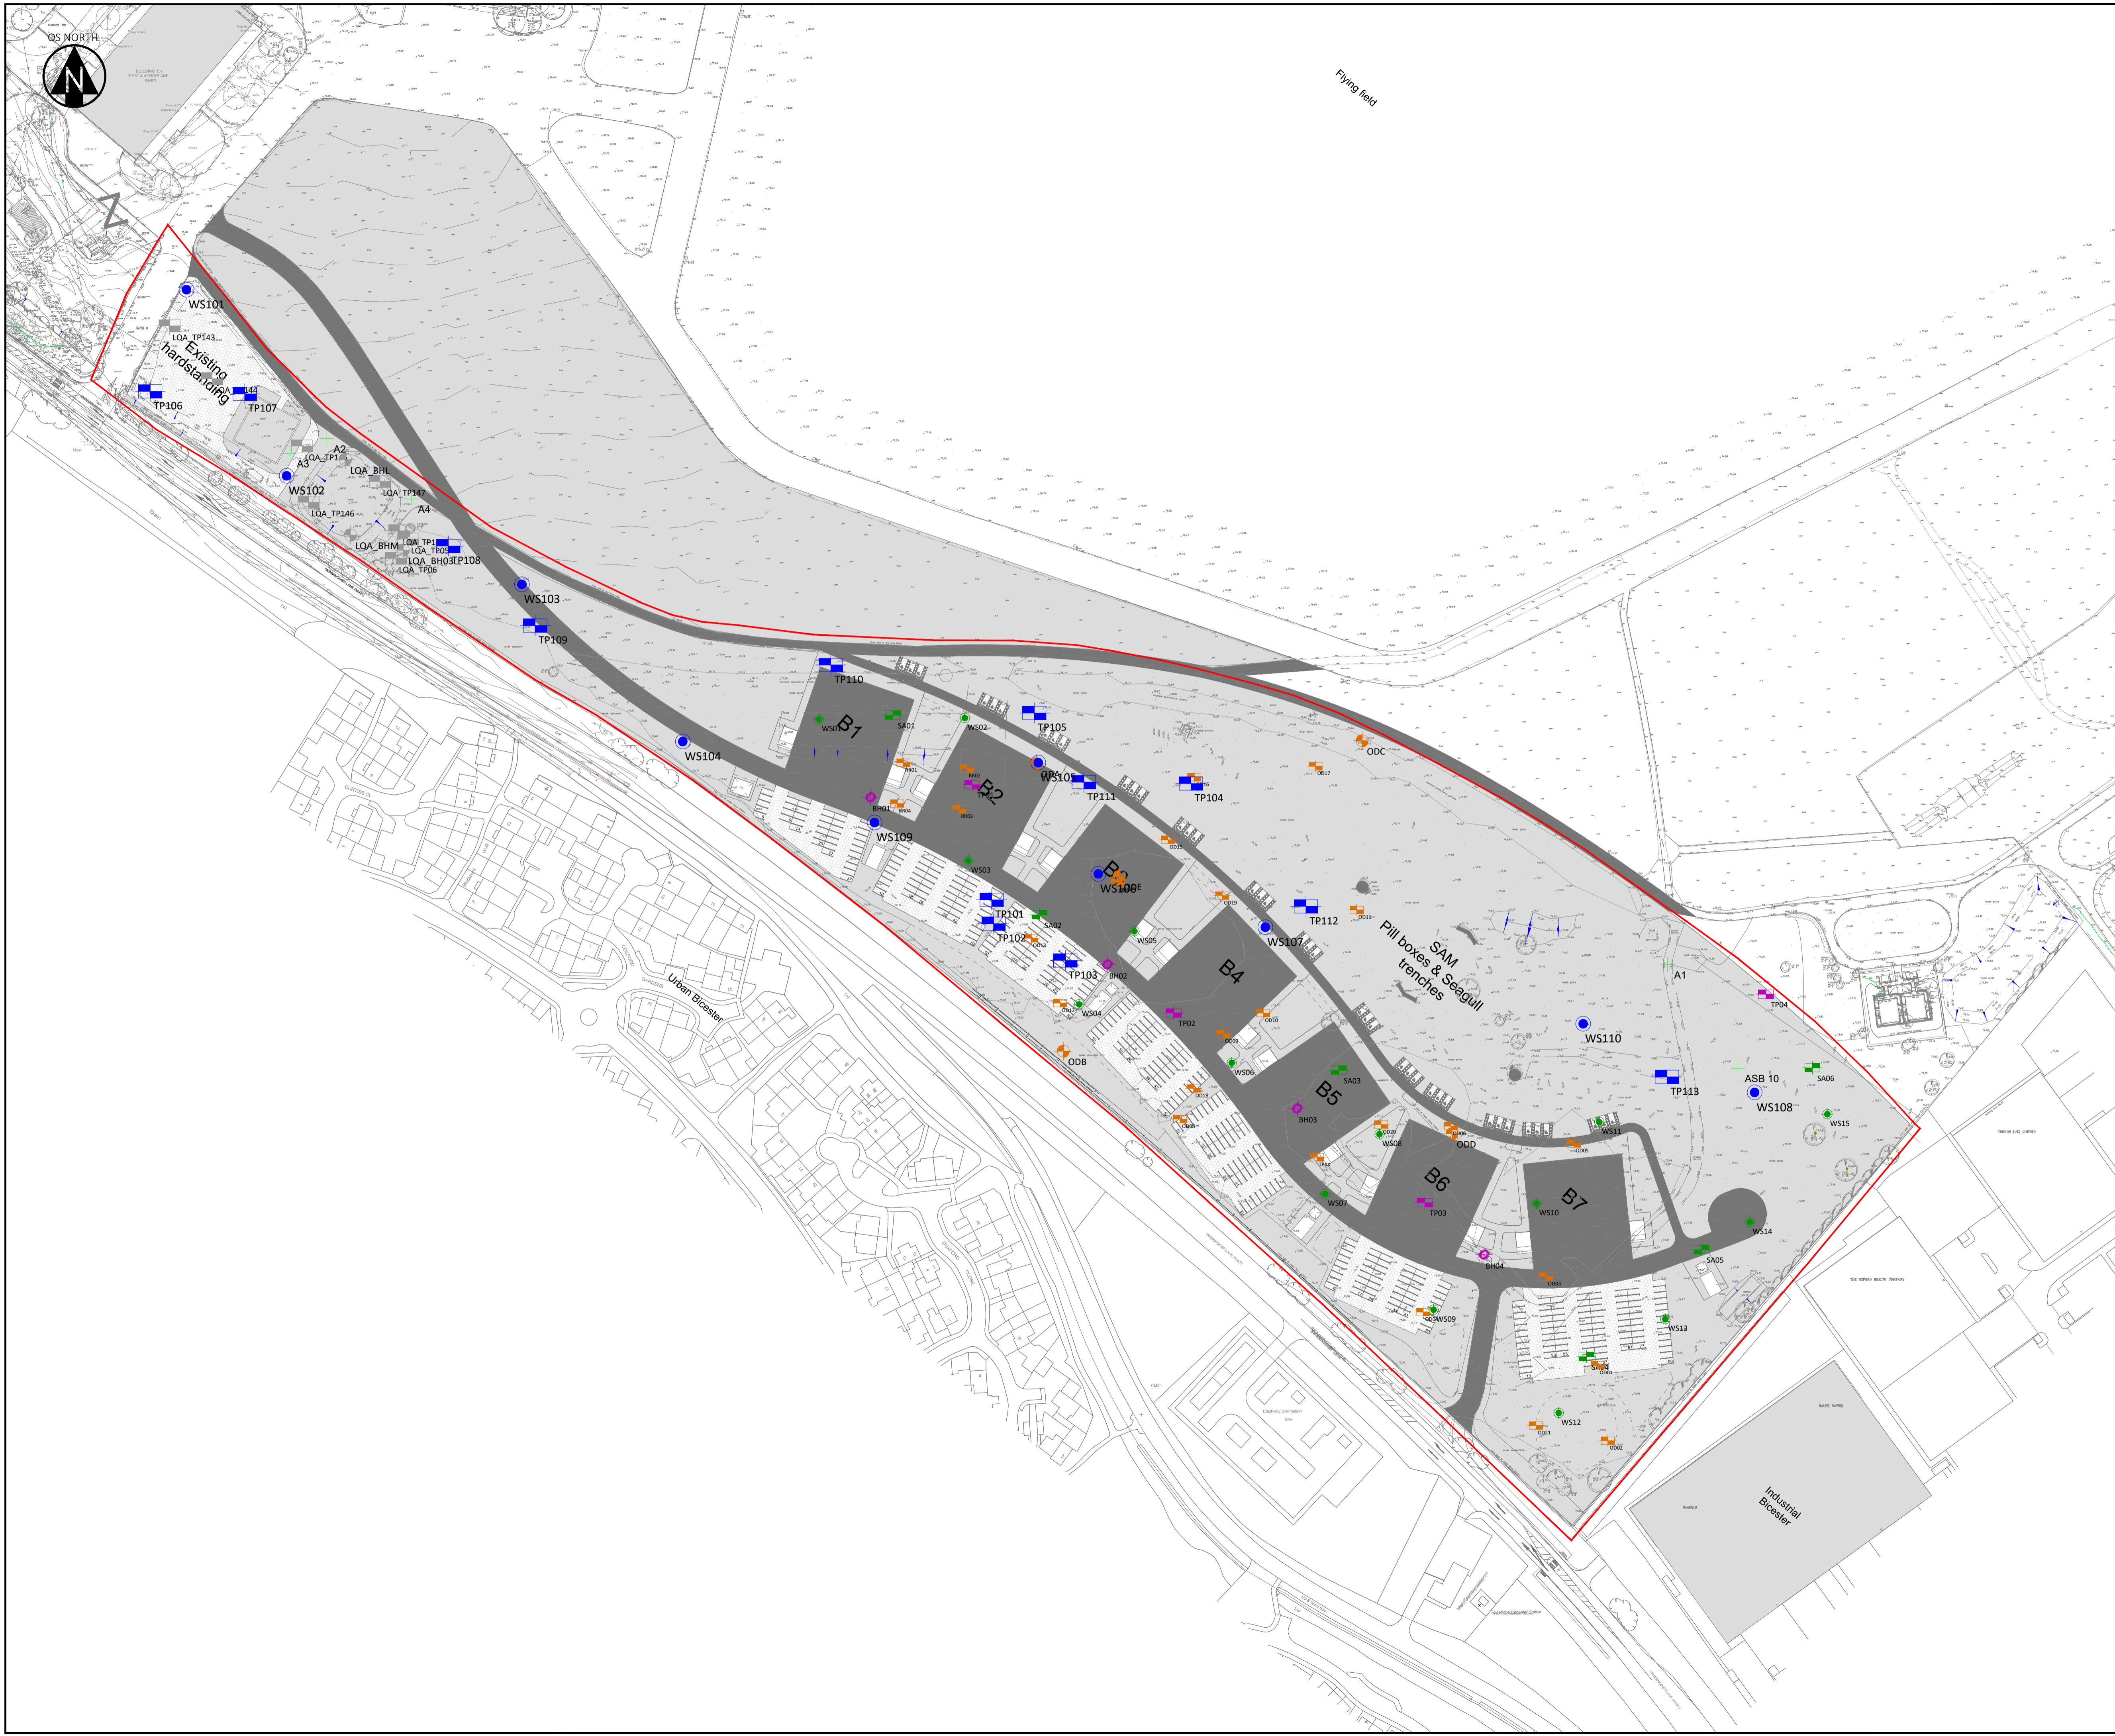
PURPOSE OF ISSUE SUITABLE FOR INFORMATION	STATUS S2
DRAWING NO. (PROJECT CODE-ORIGINATOR-ZONE-LEVEL-TYPE-ROLE-NUMBER) 27280-HYD-XX-XX-DR-GE-1002	REVISION PO2

- KEY**
- Site Boundary (approximate)
 - Hydrock Dynamic Sampler Borehole
 - Hydrock Trial Pit
 - Superficial Samples
- Previous SI: Ridge Property & Construction Consultants (2021)**
- Rotary Borehole
 - Dynamic Sampler Borehole
 - Trial Pit
 - Soakaway Pit
- Previous SI: LQA SI(2003)**
- Trial Pit
 - Borehole
- Previous SI: LQA SI(2007)**
- Trial Pit
 - Borehole
